# 4 September 2010 and 22 February 2011 Christchurch Earthquakes from a Transmission Grid Infrastructure Perspective

## Asset Structural Performance and Lessons Learned

By Craig McGhie and Christophe Tudo-Bornarel

TRANSPOWER

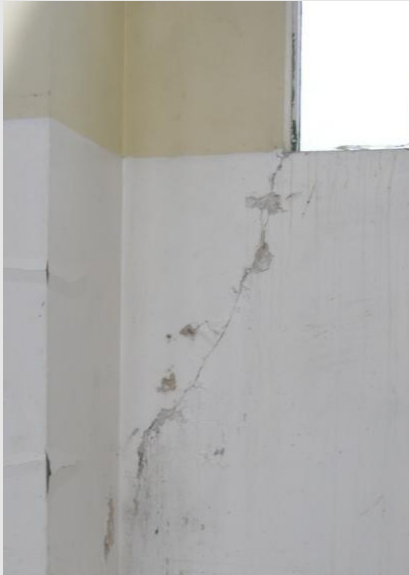
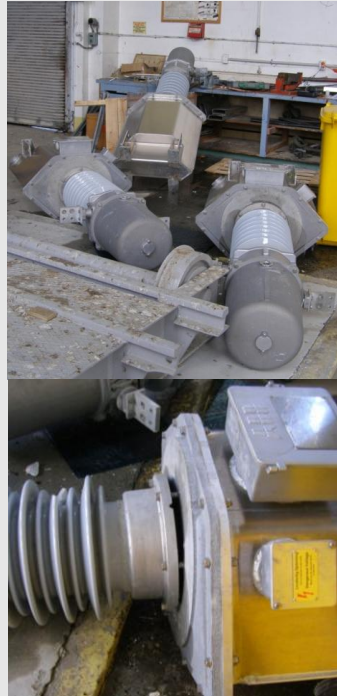
Hororata substation

- 1940's reinforced concrete crane building sustained large shear cracks but repairable.
- Damaged spare 66kV CT

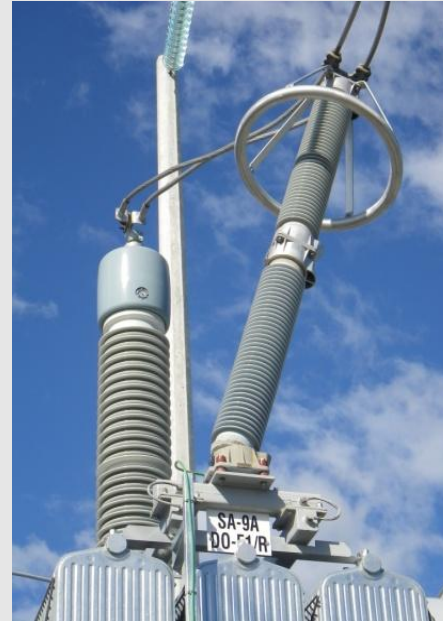
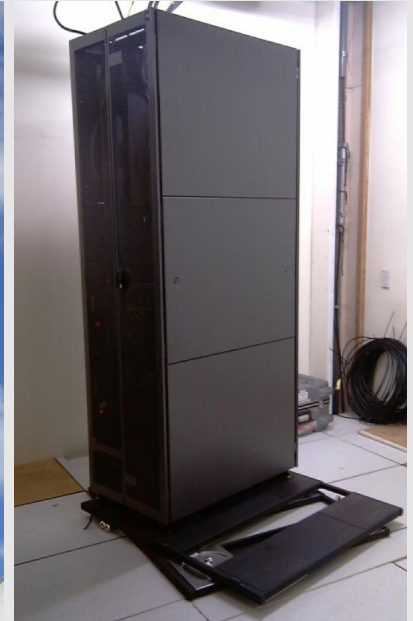
Islington substation

- 220kV surge arrester mounted on top of radiators failed
- Control cabinet dislodged from base isolation unit at Islington ROC

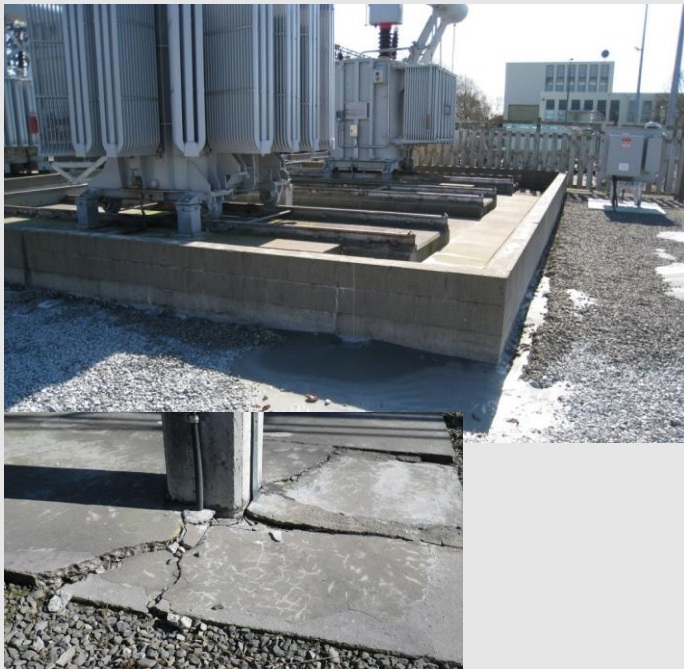
- Liquefaction and minor differential settlement.
- Transformer bund walls and shallow pads with minor cracks

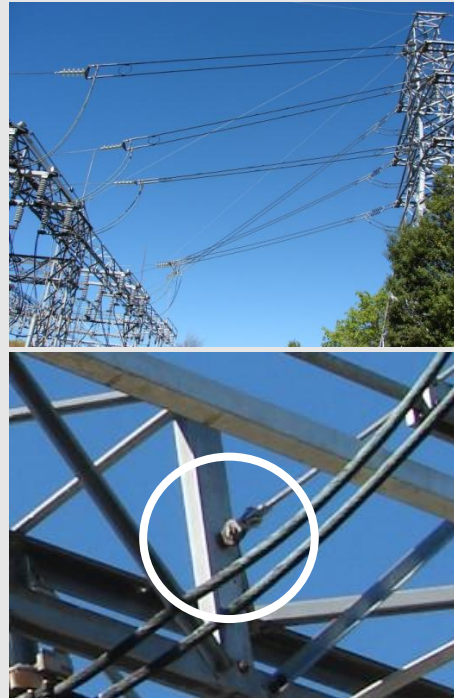
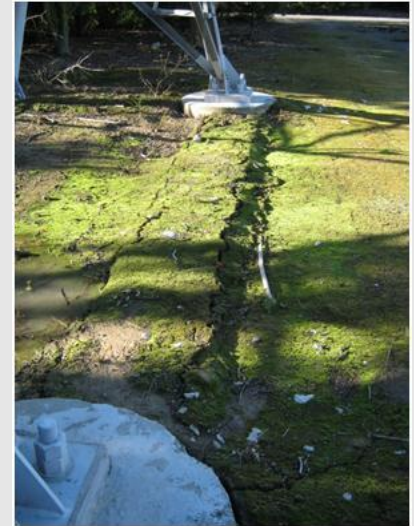
- ISL- PAP B Failed termination span at gantry connection.
- Liquefaction settlement around tower bases

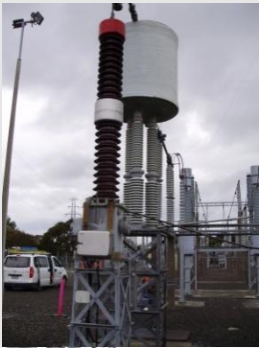
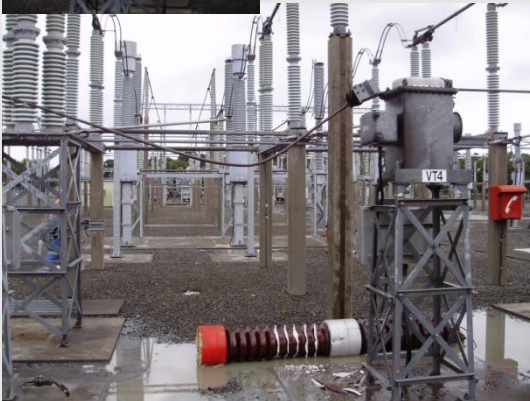
Failure of one 220 kV CVT  
BRY-ISL1 RFS

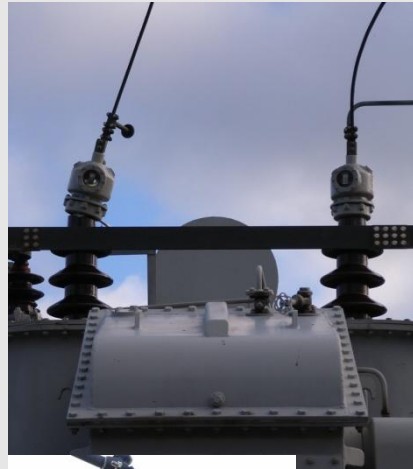
Failure of two HV bushings on  
T2 (66kV/11kV)

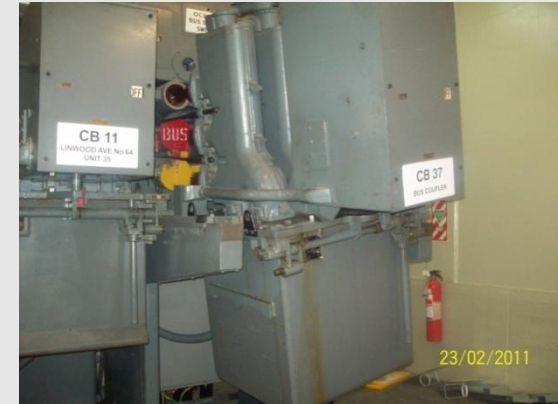
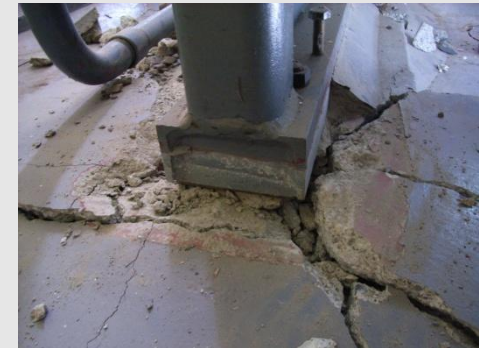
Damage to 11 kV switchboard;  
remained operational during the  
event – is being replaced

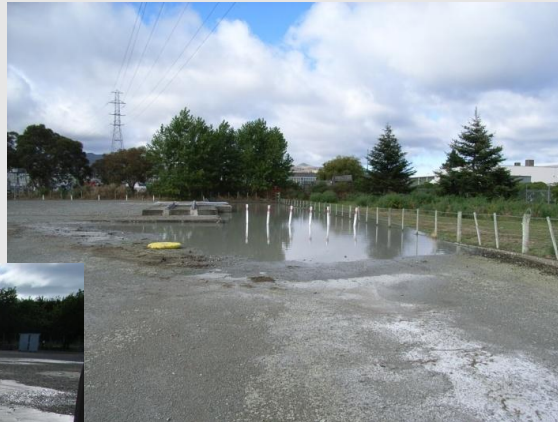
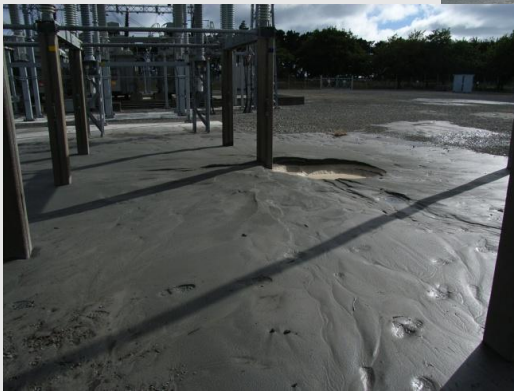
- Intense liquefaction with silt and water covering part of the switchyard
- Foundations remained largely unaffected

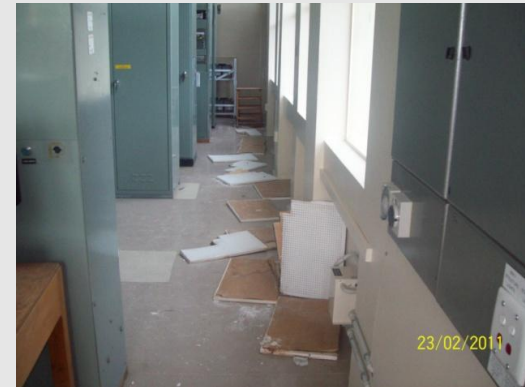
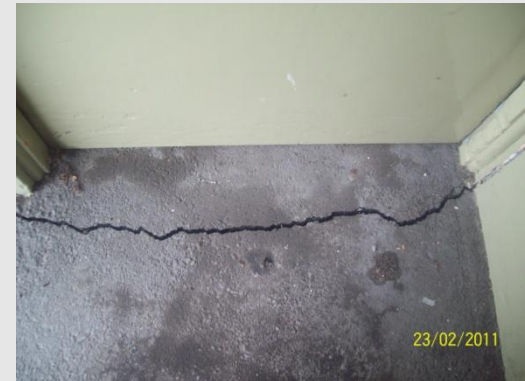
- Only minor non-structural damage to control/relay building

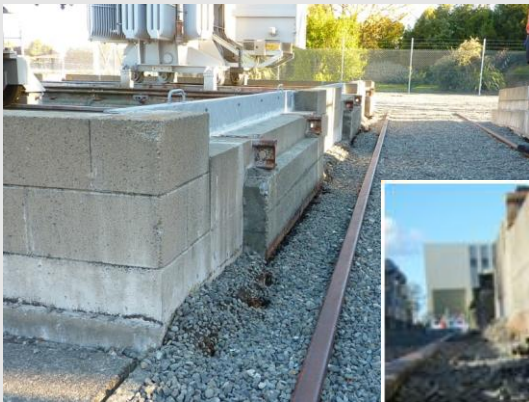
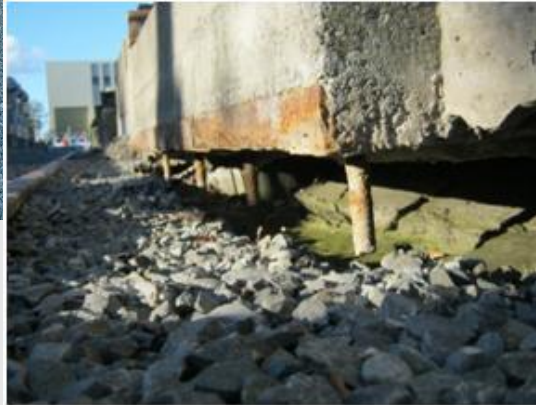
- Damaged during September 2010 earthquake; further liquefaction and soil settlement around the transformer bunds
- New cracks in slab and bund walls

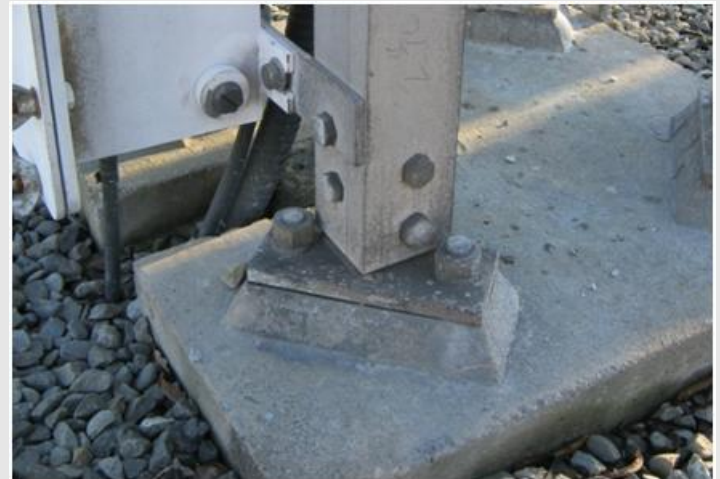
- Yielded holding down bolt supporting cable termination support structure.

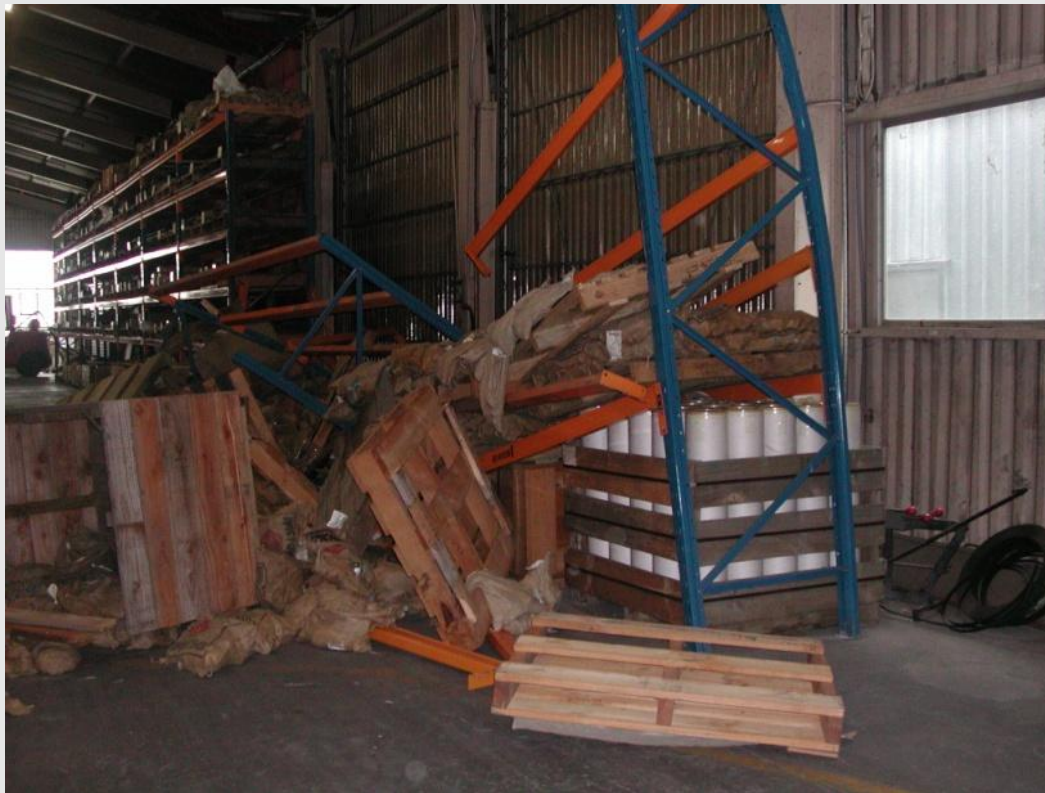
- Collapsed shelving units.
- Similar damage occurred during Darfield earthquake.
- All shelf units to be replaced.

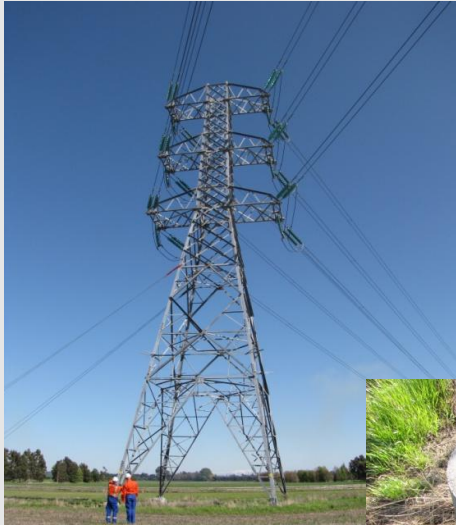
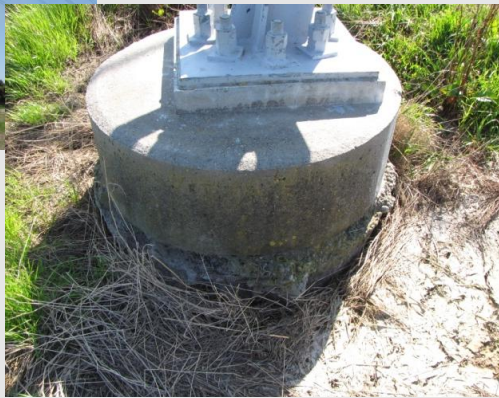
- Liquefaction caused 3 towers on BRY-ISL A 220kV line to lean.
- Remediation to be carried following cessation of aftershocks.

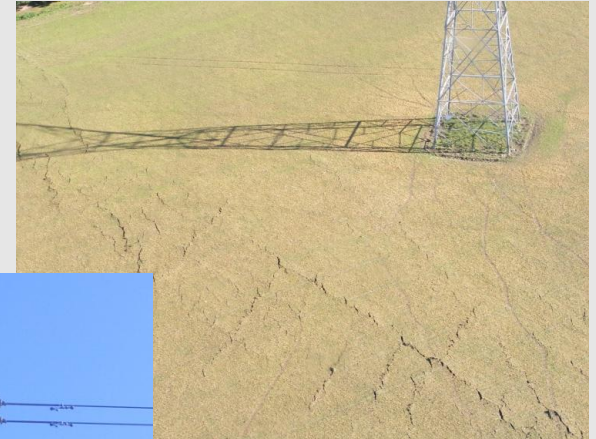
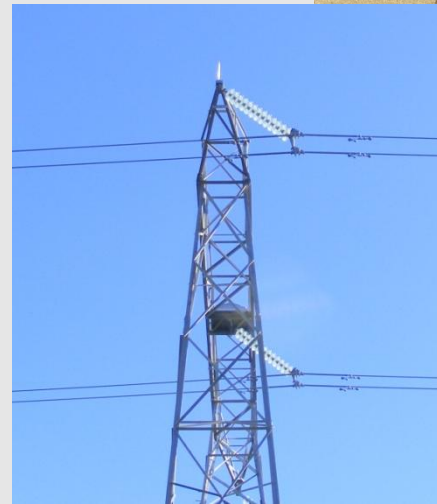
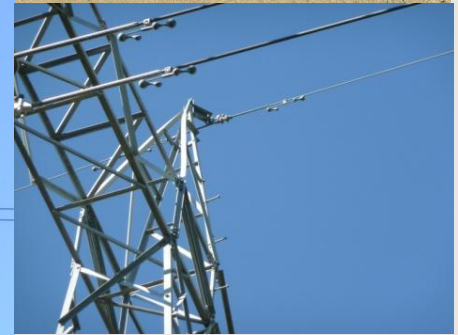
- Fault line cutting the 220kV lines alignment at 45deg angle, strike-slip displacements of 2-4m.
- Insulators displaced (shown) and bent earthwire peaks resulted.

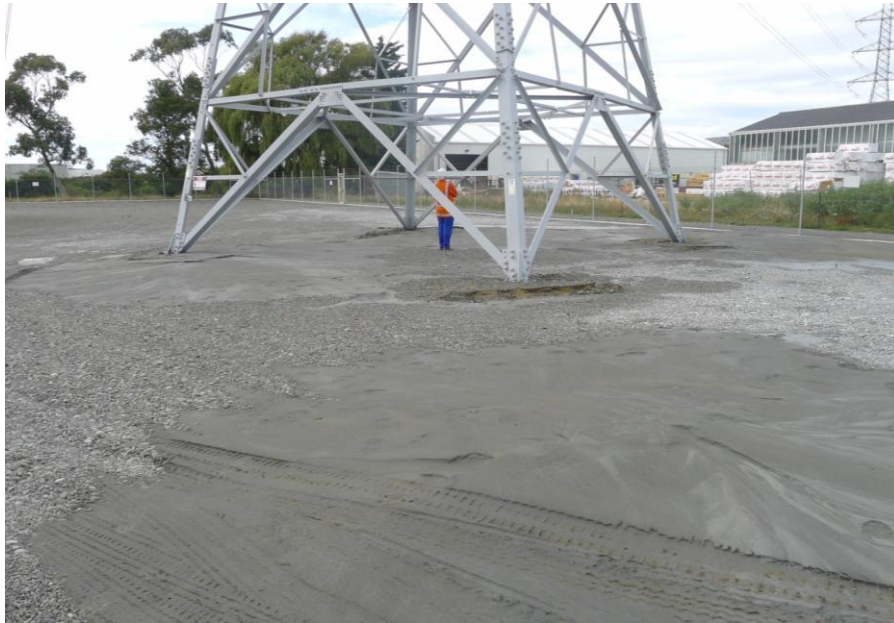
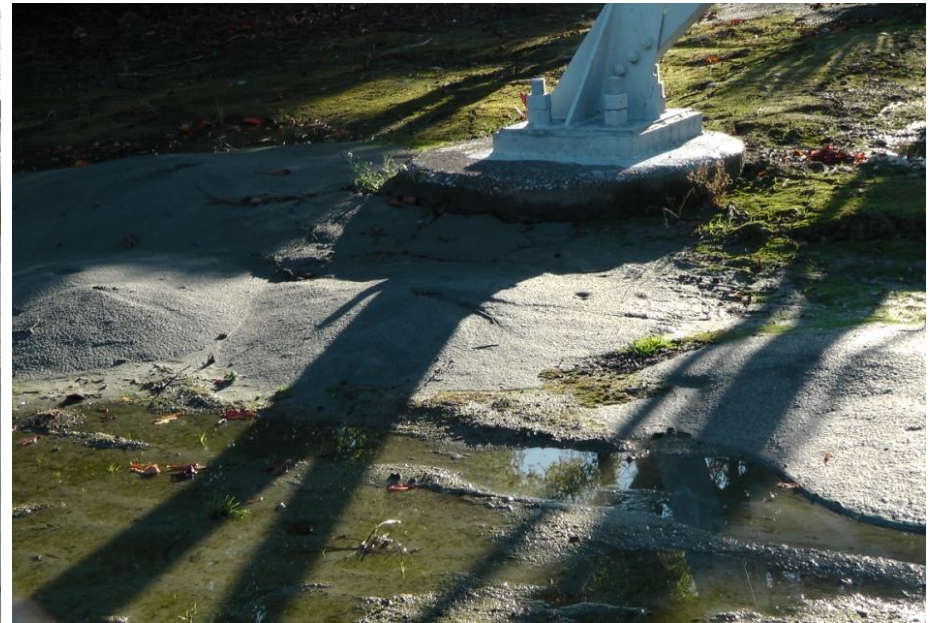
- Liquefaction around piles on BRY-ISL A 220 kV line and ISL-PAP A & B Lines.
- Towers remained stable and no loss of service occurred due to liquefaction.

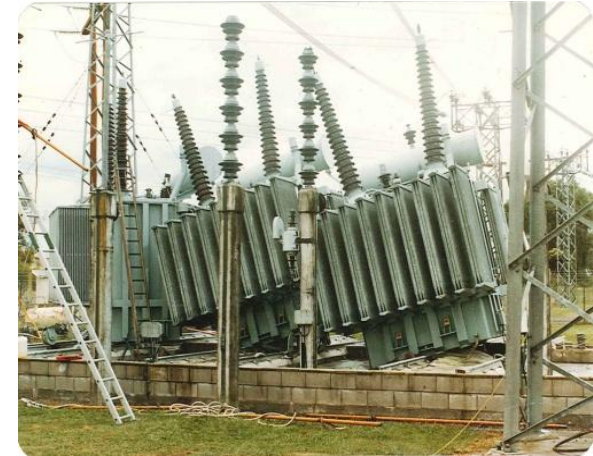
Transformer damage Edgecumbe 1987
