# North Island AUFLS event Loss of Huntly Power Station

## December 13 2011

Presentation for the SRC  
February 2012

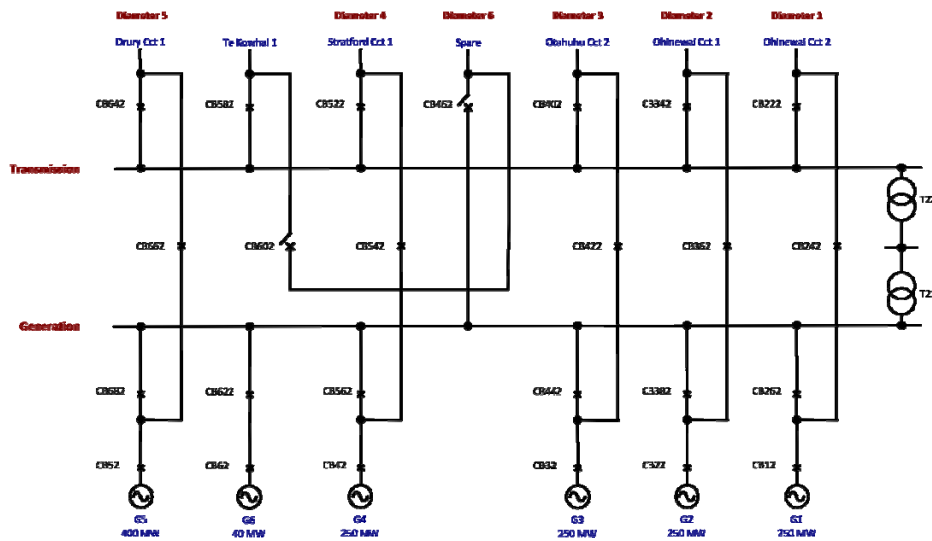
## Huntly – normal configuration

CB462 and CB602 are normally open. All other circuit breaker are normally closed when all generating units and transmission lines are in service.

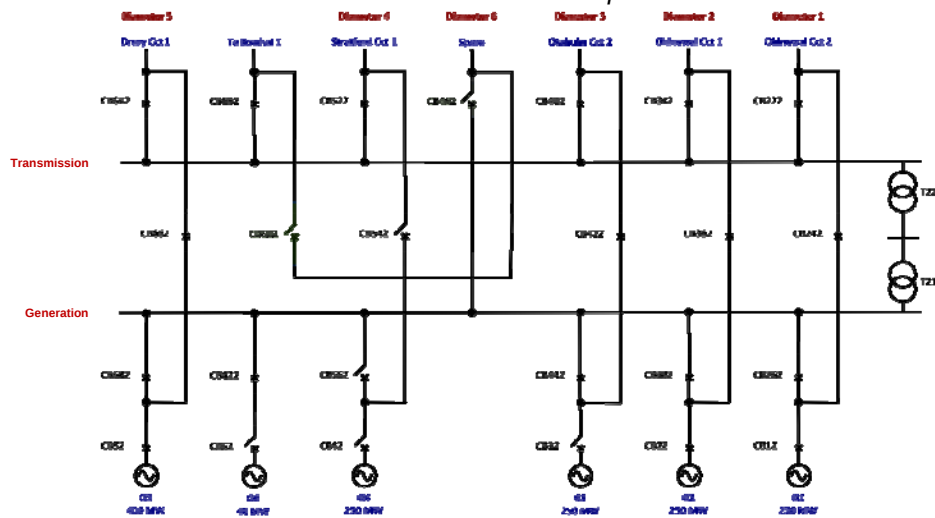
# Huntly - operating configuration

Equipment out of service for maintenance.  
Equipment status normally open.  
Forcing flag, local status transformer T1 and T2 are not shown near earth switches, disconnector etc.

The Unit 4 diameter was open for Unit 4 maintenance with CB542 and CB562 being open (each diameter comprises two main breakers each connected to a 220kV bus and one half breaker coupling main breakers).

Three generators were in service being Units 1, 2 and 5. Units 3, 4 and 6 were out of service.

Supply transformers T21 and T22 coupling Bus A and Bus B were both in service.

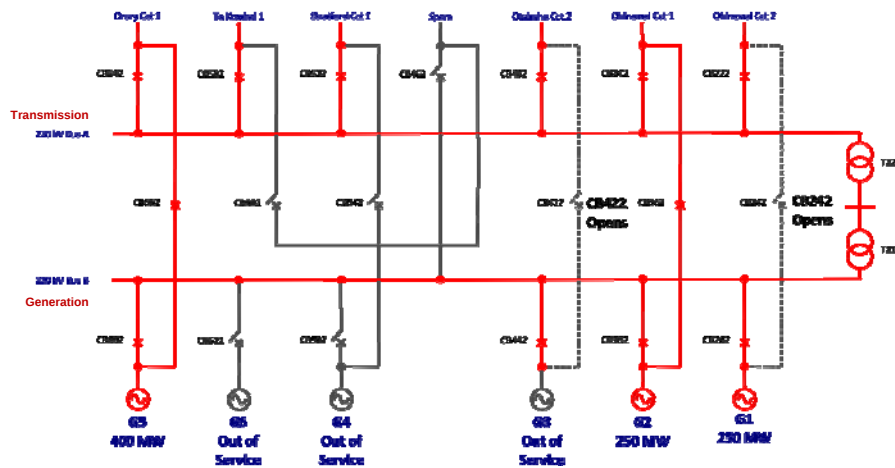
# Transpower trippings (CB242 & 422)

CB422 & CB422 trip

12:11:39.8 pm- Unexpected loss of Diameter 3 (opening CB422)

12:11:39.9 pm - Unexpected loss of Diameter 1 (opening CB242)

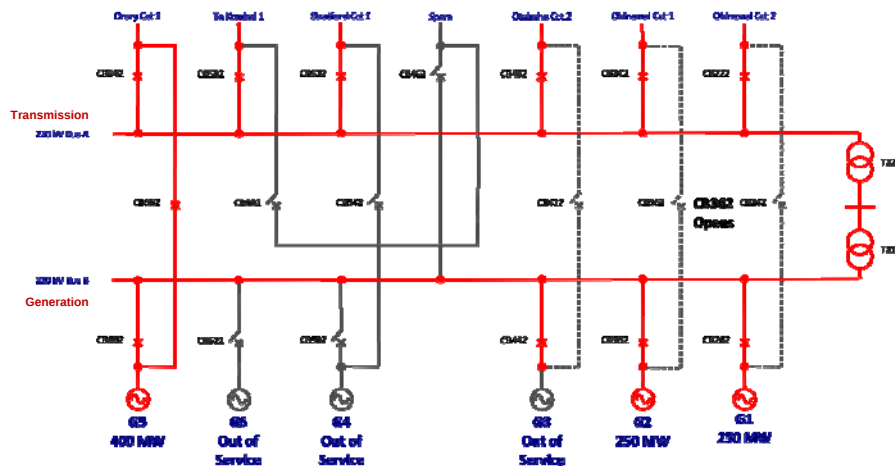
# Transpower trippings (CB362 trips)

## CB362 trip

12:30:44.8 pm - Unexpected loss of Diameter 2 (opening CB362)

12:30:47.4 pm - Attempted close on Diameter 1 (CB242) from RCN fails

12:31:25.5 pm - Attempted close on Diameter 3 (CB422) from RCN fails.

CB closed and opened several times remaining open after about 0.6 seconds.

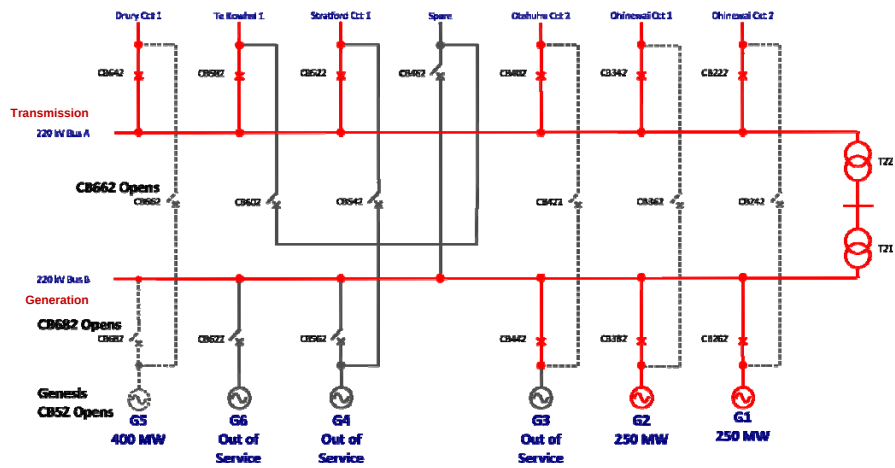
# Generation loss (Unit 5 trip)

## Unit 5 Trip Event

12:33:44.8 pm - Unexpected loss of Unit 5 and Diameter 5 (opening generator CB52, CB682, CB662)

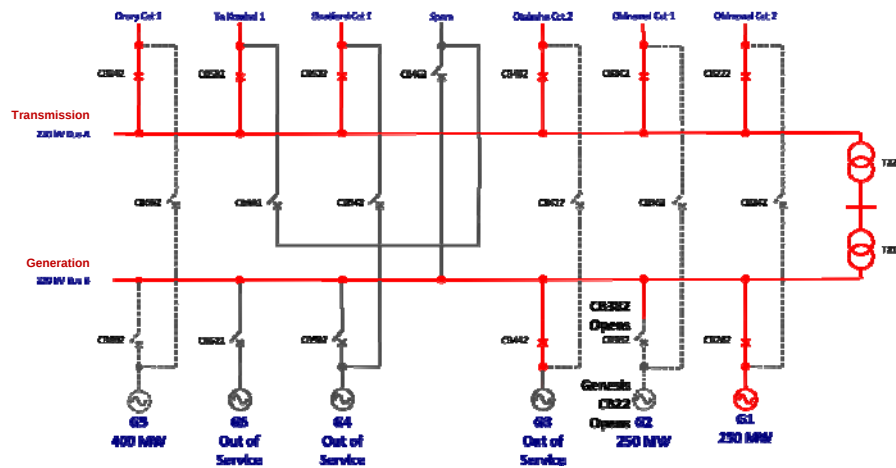
12:33:48 pm

## Unit 2 Trip Event

12:33:47.5 pm - Unit 2 trips from Genesis protection (opening CB382, generator CB22)

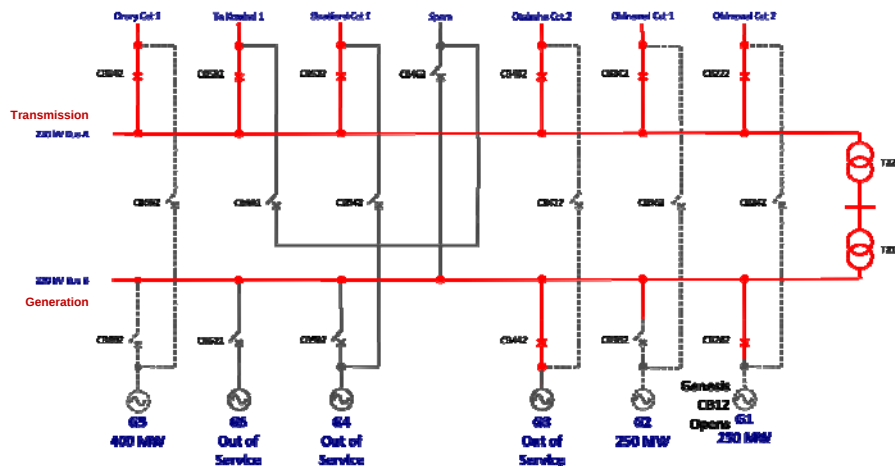
## Generation loss (Unit 1 Trip)

## Unit 1 Event

12:34:07.5 pm - Unit 1 trips from Genesis protection (opening generator CB12)

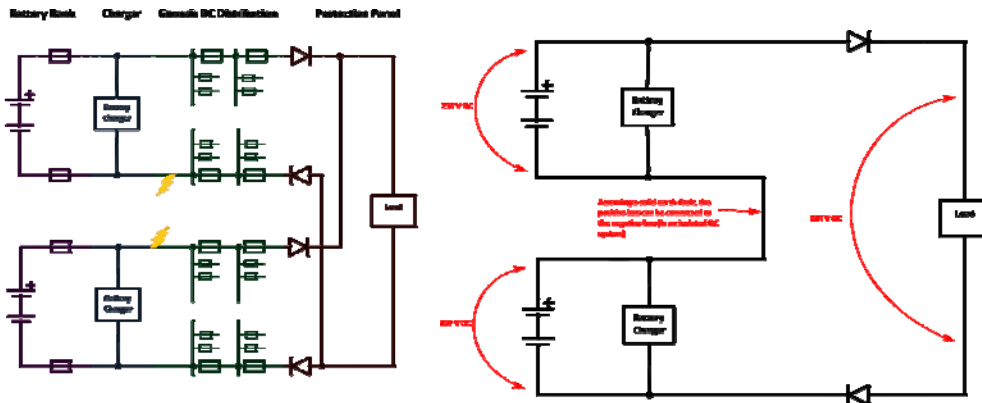
- Trip circuits maloperated due to an over voltage on the CB trip circuits caused by multiple earth faults on the Genesis 220V DC system

The likely over voltage experienced was around twice the Genesis battery charger float voltage of 257 V DC (i.e. 514 V DC). The exact level of the over voltage cannot be determined as it was not directly measured at the point where voltage doubling occurred.

The second earth fault may have occurred during works being undertaken by Genesis' on their emergency lighting system, however, this is difficult to confirm from the limited information available. A similar event on 14/12/11 (i.e. the following day) did occur at the same time as Genesis was undertaken work on the emergency lighting system.

- The circuitry to Transpower relays which caused the 220V DC over voltage has been modified to ensure this type of fault does not recur.
- An additional diameter at Huntly has been placed into service to increase coupling capability between the transmission system and generation.
- Both Genesis and Transpower have tested equipment which might have been damaged by the over voltage. No additional equipment has been found damaged.
- Transpower understands that Genesis are modifying Unit 5 protection settings

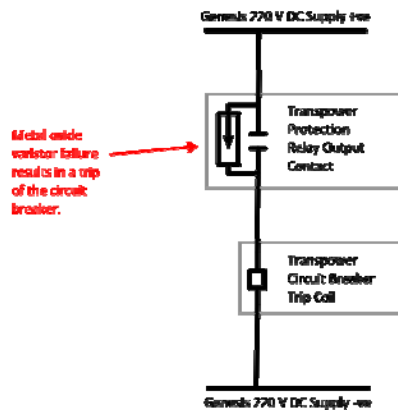
- The over voltage on the 220 VDC trip circuits caused the Transpower protection relay output contact to fail to a low resistance and trip Transpower circuit breakers CB242, CB442 & CB362

The metal oxide varistor (MOV) associated with the output contact is rated for 330 V DC.

When excessive voltage was applied to the metal oxide varistor it became thermally unstable and failed to a short circuit condition (i.e. effectively closing the contact).

The protection relay manufacturer has undertaken tests and has confirmed that for a similar situation the MOV will fail to a short-circuit state.

The over voltage also resulted in damage to transistors internal to the relay.
