# North Island AUFLS event

## December 13 2011

Presentation for the SRC  
January 2012

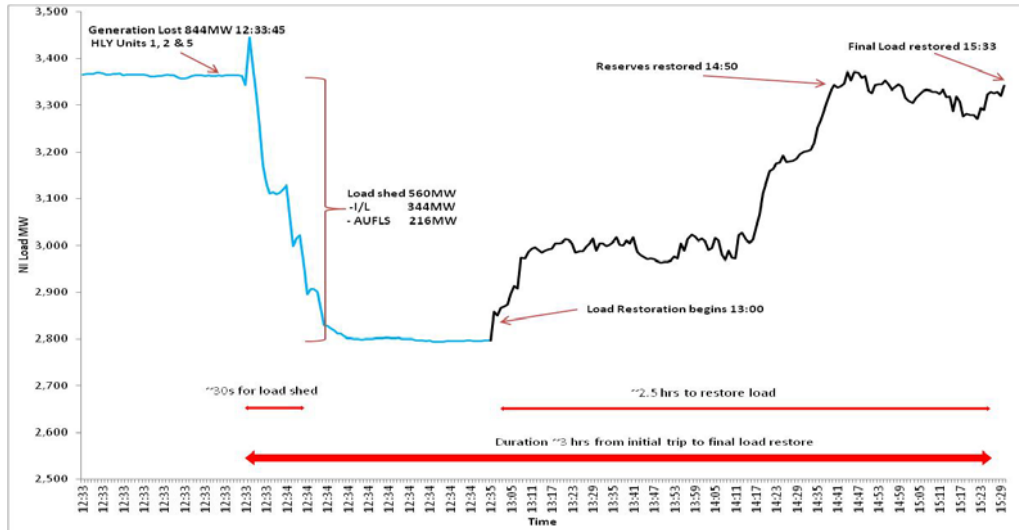
# Load loss and restoration

This slide shows the disconnection and reconnection of loads - note there are 2 time scales.

AUFLS disconnected 216MW, or 6.4% of load, while total shed is 16.5% .

The reason for the low amount of AUFLS tripping is discussed on the next slide.
