Report Title: Examination of cable joints from Penrose Substation

Client: Vector Ltd and Transpower NZ Ltd

Report Number: 2015-0356

2. Failed Heat Shrink PILC to XLPE Transition Joint 3-B-0, PN33

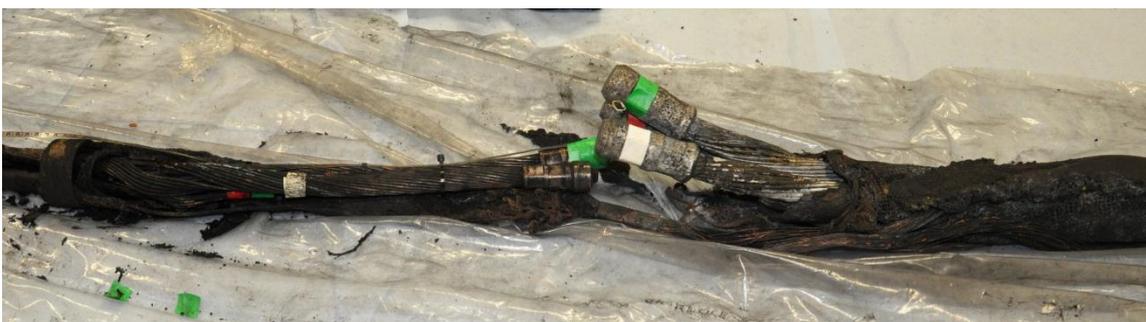
Figure 1: Failed transition joint from 3-B-0

Most of the heat-shrink material, XLPE core insulation and PILC cable insulation had been burnt away in the fault and subsequent fire, Figure 1. There was no evidence of any electrical breakdown on the XLPE side of the joint.

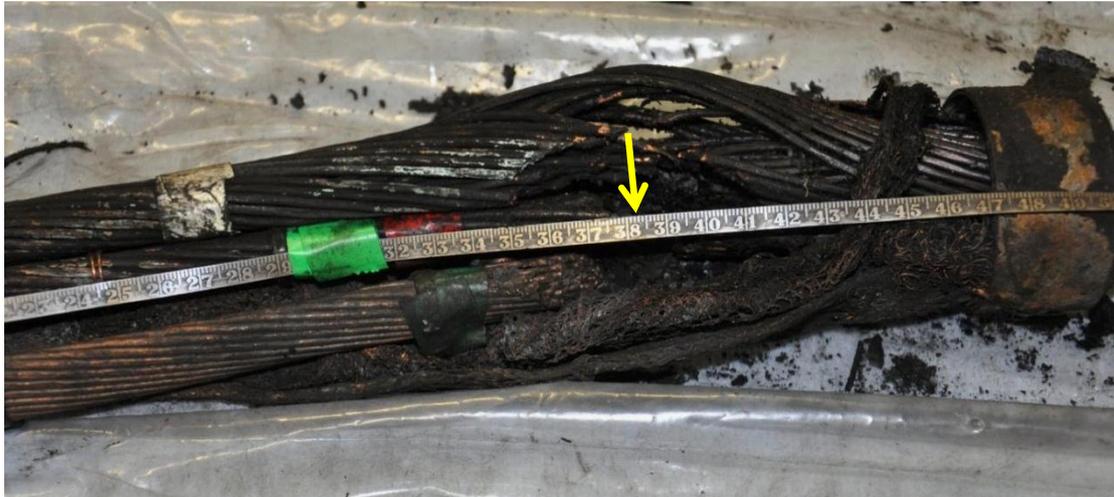
Figure 2: Distance to fault measured from friction weld on ferrule

The lead sheath had melted from the PILC cable. There was arc erosion on all 3 cores of the PILC cable but the erosion was most severe on the core wrapped with green PVC tape which had been cut through by the arc erosion. The approximate centre of the erosion was close to the PILC cable crutch and was measured to be 384mm from the copper side of the friction weld, Figure 2.

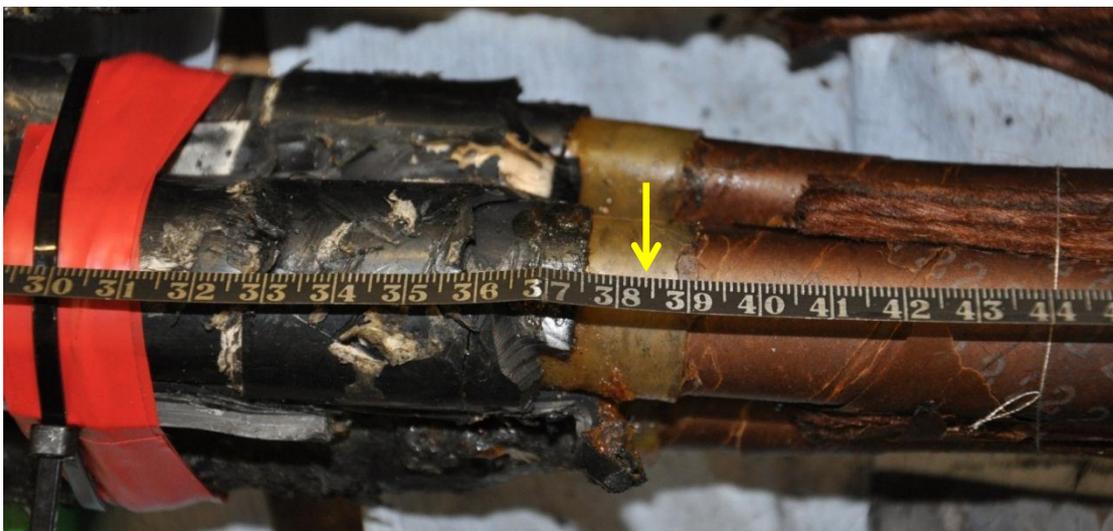
Figure 5: Position of fault on failed joint highlighted on un-failed transition joint

The arc eroded area extended between 345mm and 425mm from the bi-metallic connector interface. From measurements on the unfaulted transition joint from the same circuit, if the two joints were made to the same dimensions, the straight arc eroded edge was at or close to the lead sheath cut back position and the centre of the arc eroded area was at or close to a point 5mm from the end of the translucent heat shrink tube, Figure 5.

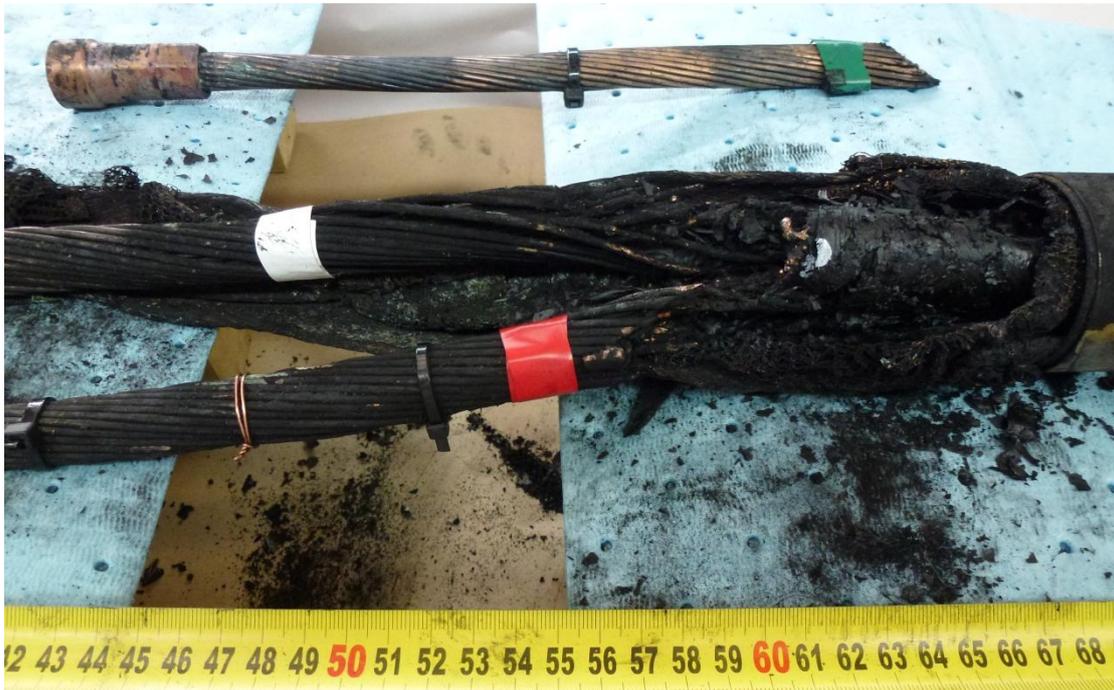
Figure 6: P1070015 from examination in New Zealand

From photographs P01070015 and P01070019, taken during the partial strip down in New Zealand, the remains of the core insulating tapes were still present on the cable side of the fault position right up to the edge of the fault eroded region, Figure 6 and Figure 7.

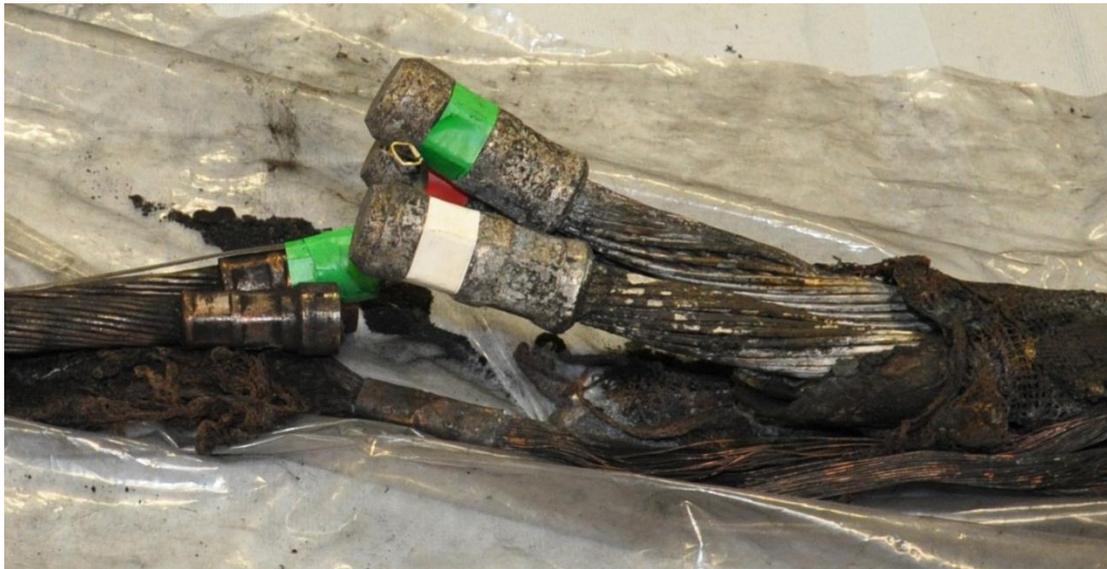
Figure 10: Parted bi-metallic ferrules on failed joint

The bimetallic connector ferrules appeared to be correctly compressed onto the aluminium and copper conductors. The connectors had parted at the friction welds. The central insulators and core papers had burnt away or been removed on either side of the bi-metallic connectors, Figure 10.

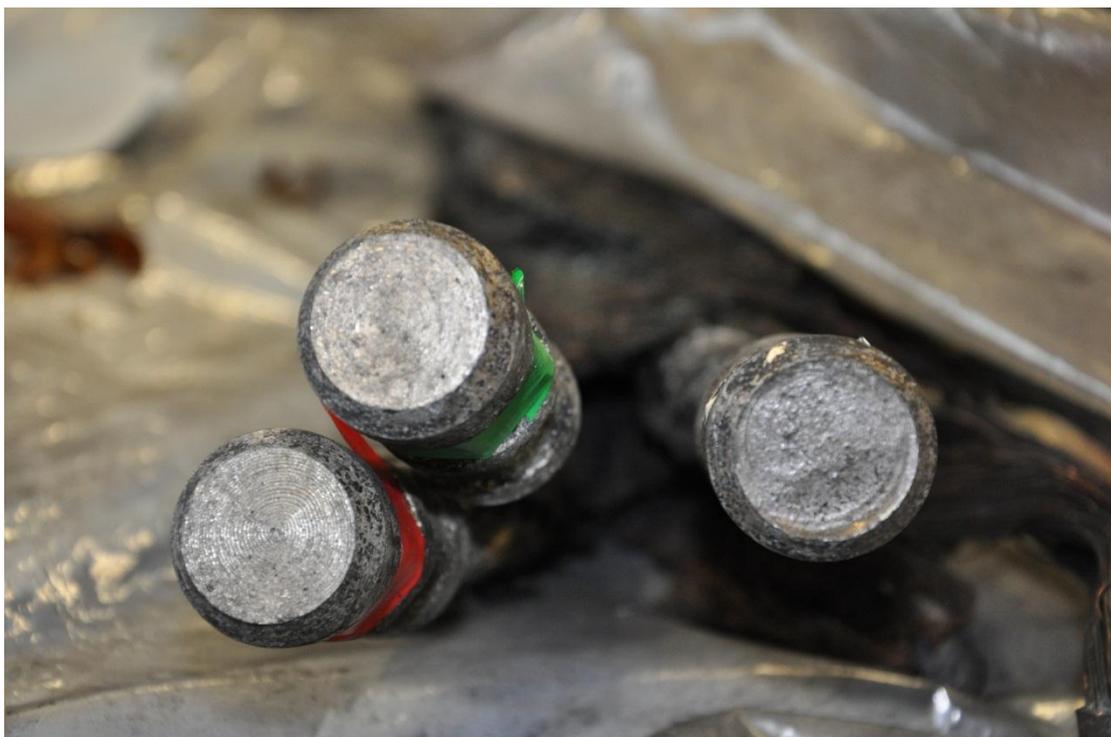
Figure 11: Aluminium side of bi-metallic connectors

There was little of the copper and aluminium material left adhering to the other side of the friction weld interfaces on the red and green taped cores. On the white taped core there was an indentation on the surface of the aluminium side and a raised area of what appeared to be aluminium on the copper side, Figure 11 to Figure 14.

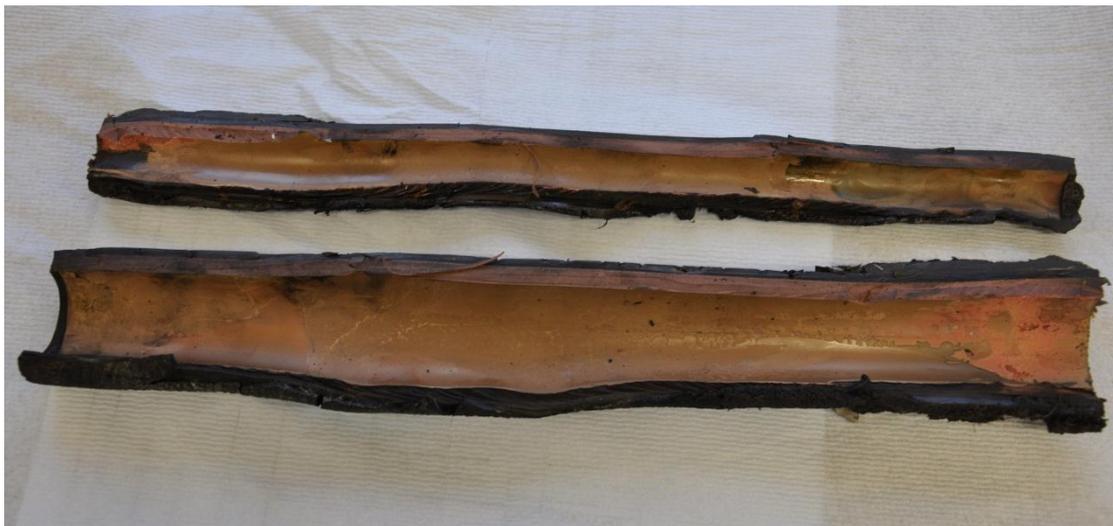
Figure 17: Central insulating sleeve from un-failed joint

The central red/black insulating sleeves were cut open and removed. The central insulation sleeves did not have an inner semi-conducting layer. The insulation had partly discoloured from the original salmon pink colour to a grey brown colour, Figure 17 and Figure 18.

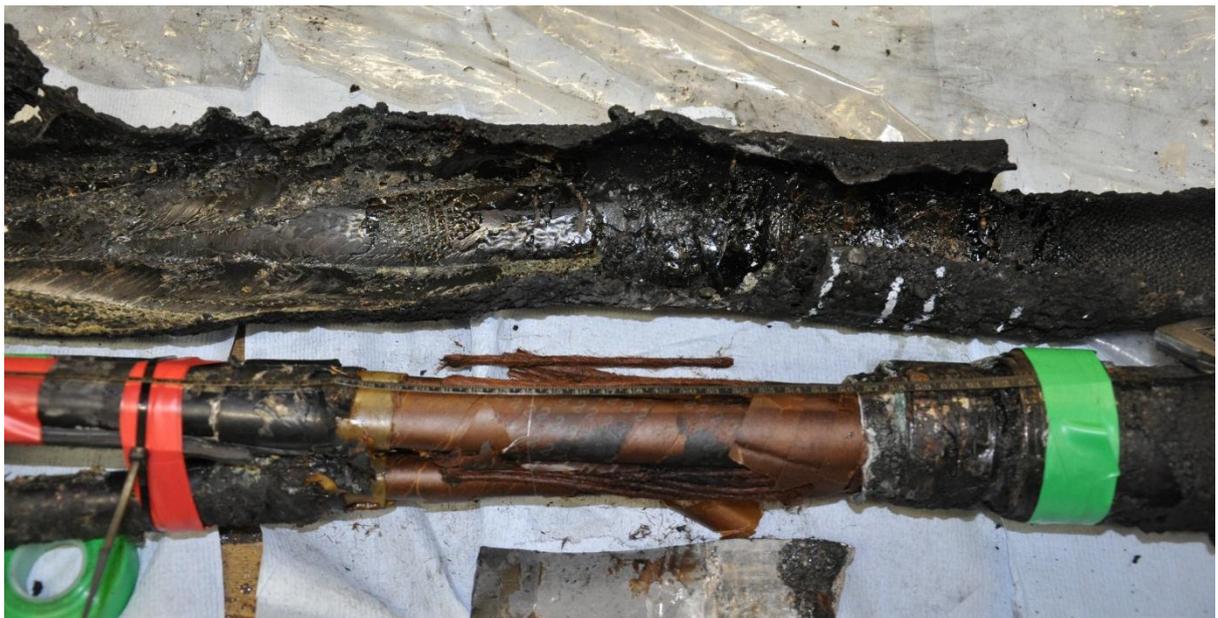
Figure 19: Dark surface on core 2 beneath belt papers and lead sheath

Figure 19 shows the blackened area on the outer core identification papers on core 2 extending from the lead sheath cut back position back under the lead sheath for a distance of at least 100mm beneath the belt papers which were not blackened.

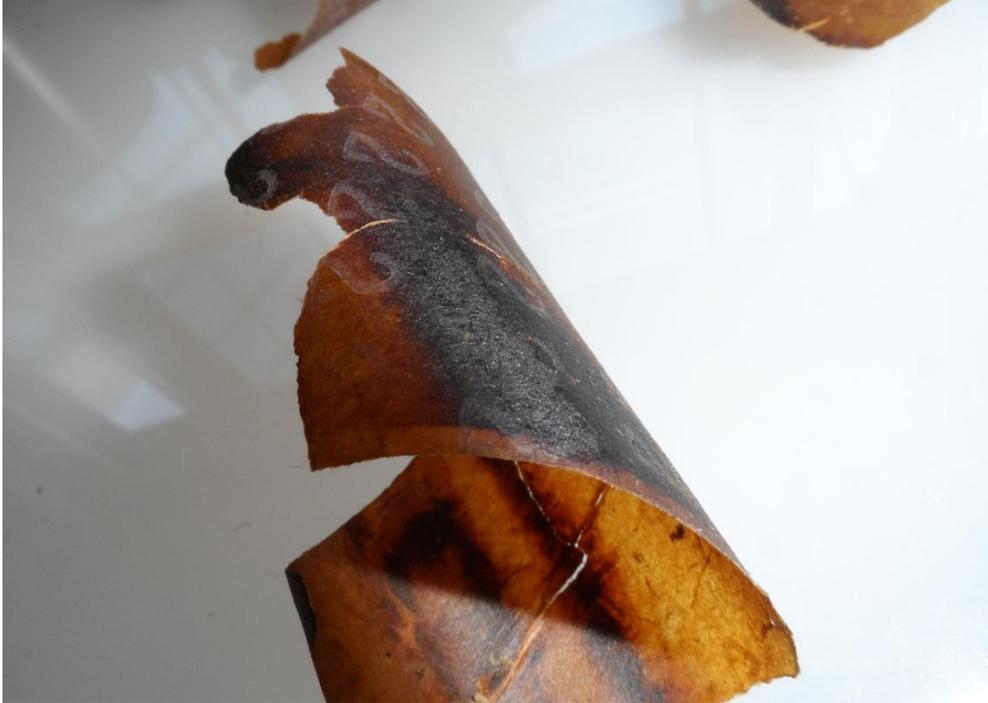
Figure 20: Section of discoloured core identification paper from core 2

A section of discoloured core identification paper from core 2 is shown in Figure 20. As well as being discoloured, the core 2 identification papers tended to crack along the butt gaps.

From the visual examination, three distinct zones were identified on the core 2 identification tapes: the light brown relatively unaffected areas, the areas where the paper was blackened and the areas where there were deposits of what appeared to be blackened impregnating compound on top of the paper. These three zones can be seen in Figure 20.

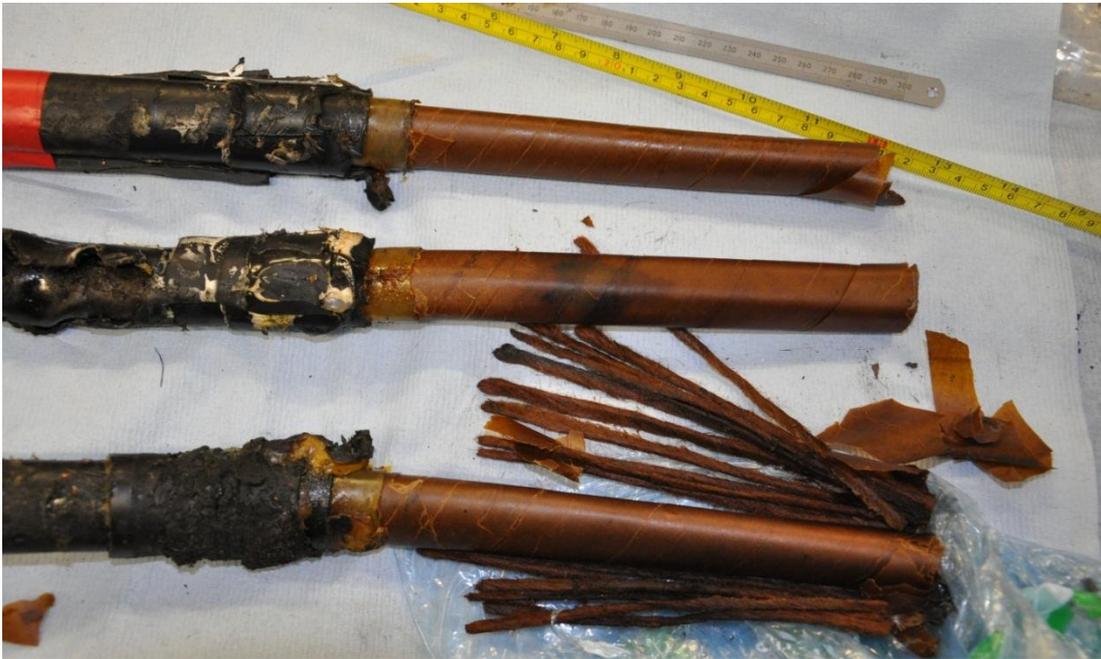
Figure 21: Three cores of PILC cable with localised discolouration on core 2

The three PILC cores shown in Figure 21 were stripped down to the conductor between the end of the translucent heat shrink sealing tube and the PILC cable end. The papers were dry towards the cable end and burnt and oily nearer to the ferrule. The inner papers had a tendency to split along the butt gaps. The conductor strands were slightly bird-caged on the outside of the bend where the jointer had used a temporary spacer to separate the 3 cores.

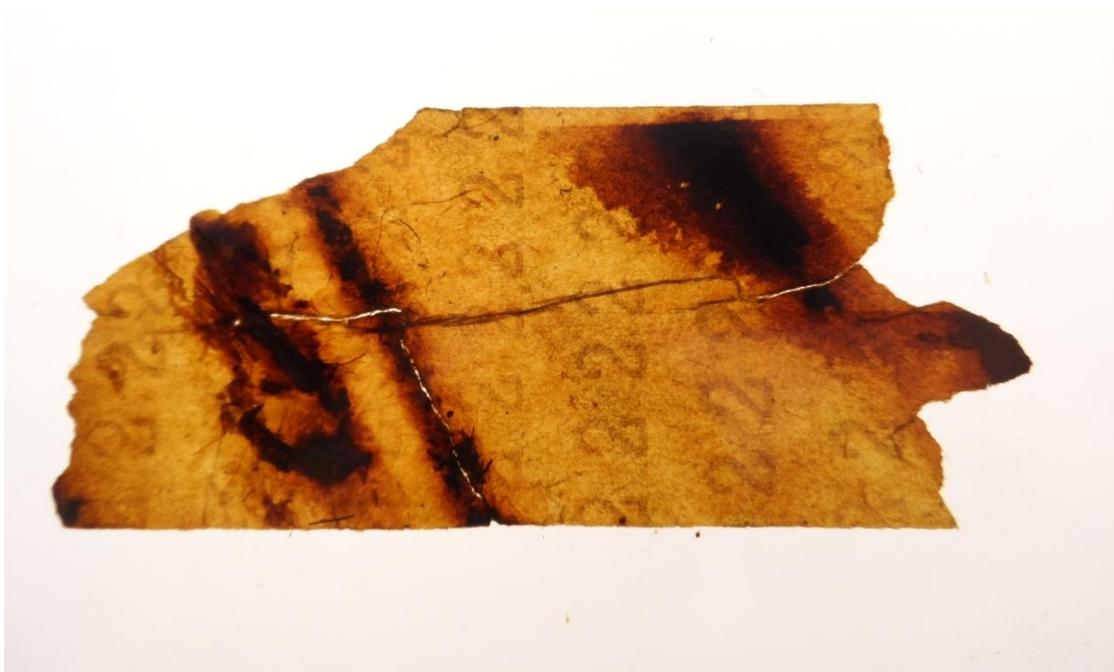
Figure 26: Identification paper from core 2, un-failed transition joint

Close examination and staining of the outer papers on core 2 (taken from the area with the dark feature shown in Figure 19 and 20) indicated waxing, blackening and degradation, Figure 29, of the paper fibres in the butt gaps on core 2 as well as the more widespread blackening away from the butt gaps, Figure 26. The black deposits in the butt gaps could be bitumen from the original cast iron, bitumen filled, cable joint.

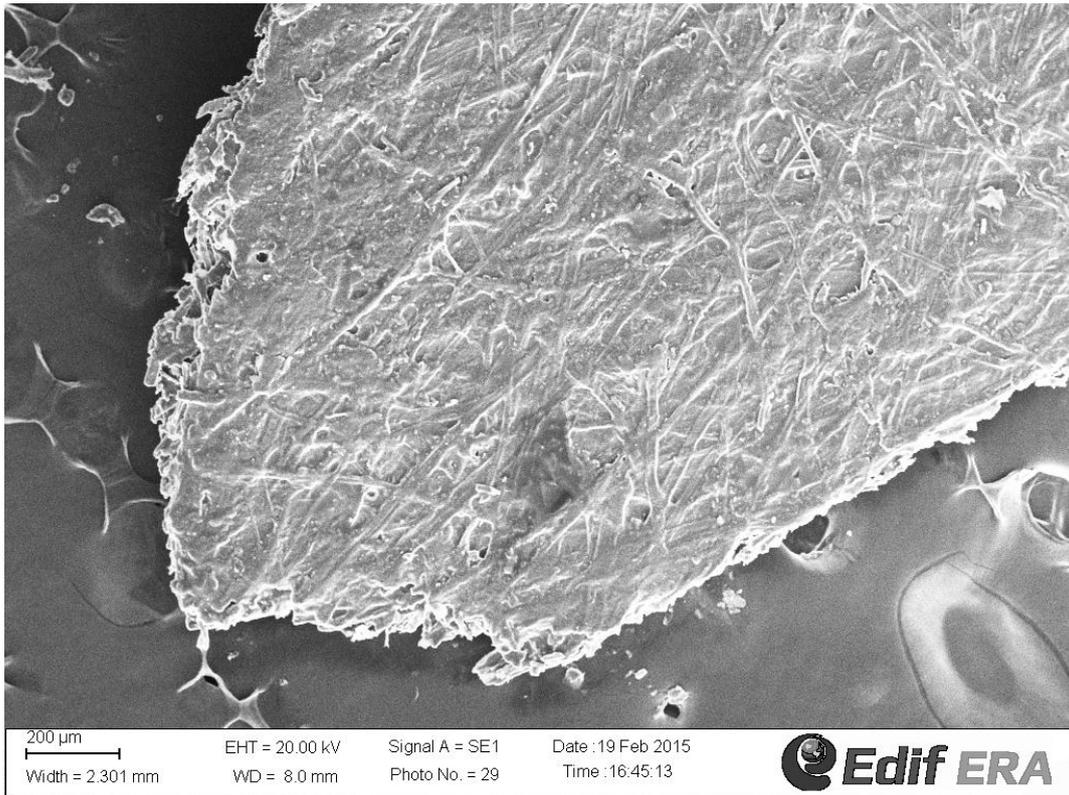
Figure 29: SEM image of fractured edge of degraded paper

- The blackened areas all had chlorine, carbon, silicate and oxygen present.
- Where the papers had badly deteriorated, Figure 29, and fractured, the smooth areas that bonded the fibres together, Figure 28, had mainly been lost. These areas also had chlorine, carbon, silicate and oxygen present.

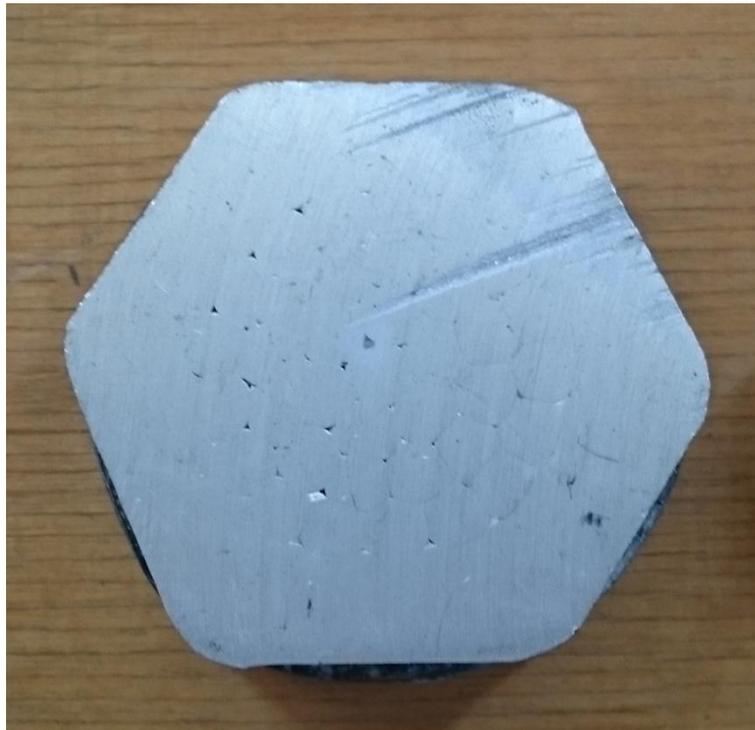
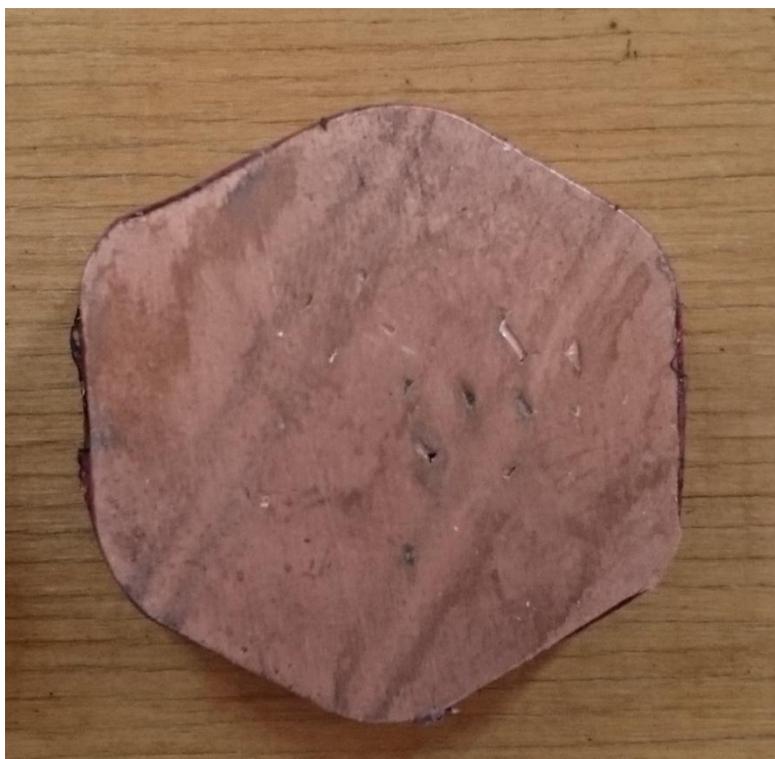
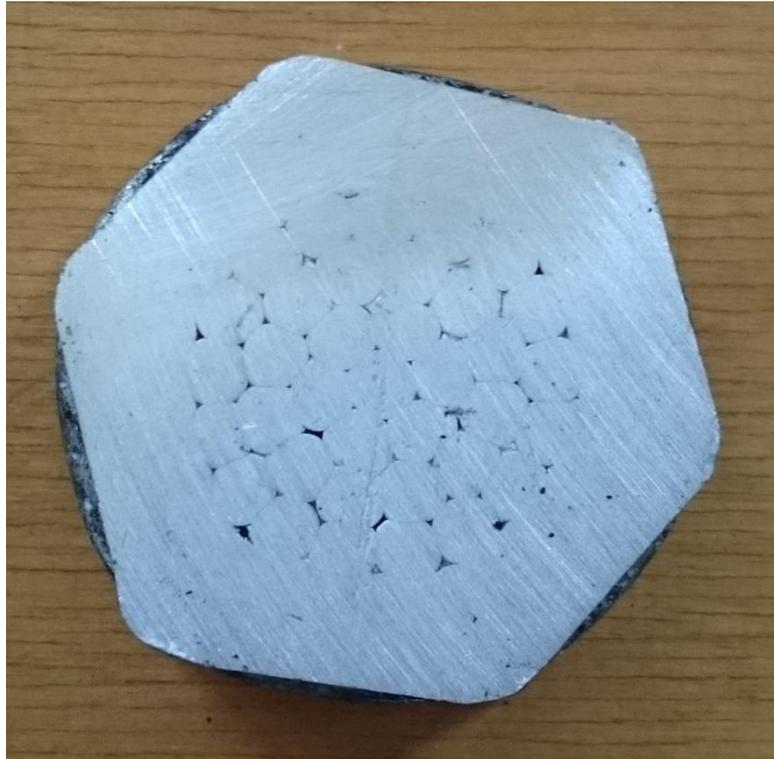
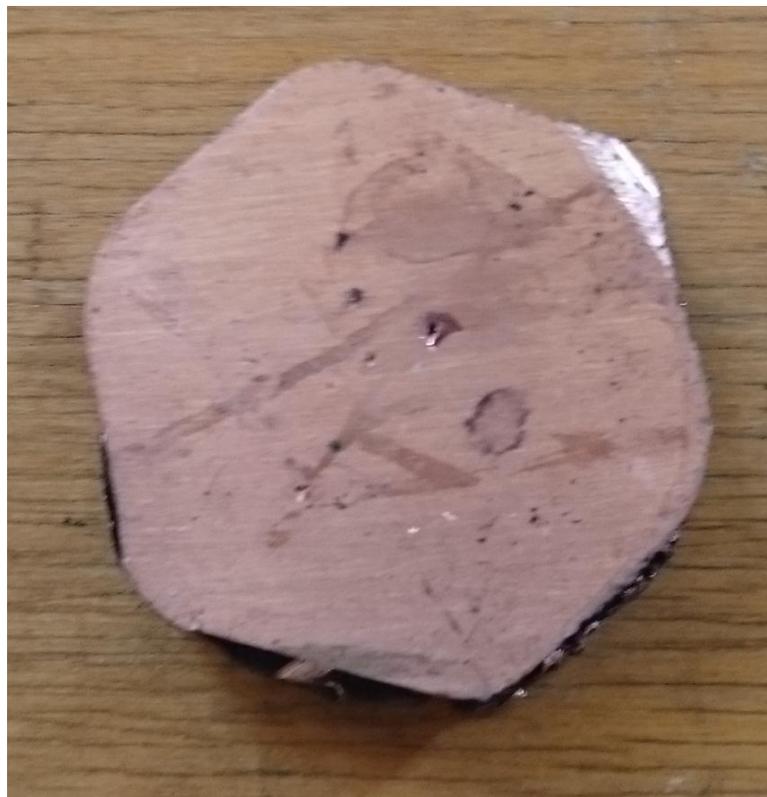
The degree of compaction of the conductor strands in the ferrules of each of the connectors, apart from those that had been tensile tested, was also assessed visually. Both the aluminium and copper sides of the PN 33 red and white connectors appeared well compacted, with only small gaps visible between strands, Figure 37, Figure 38, Figure 39 and Figure 40.

Figure 37: PN 33 (failed joint) Good compaction on Red Al, crimped section

Figure 38: PN 33 (failed joint) Good compaction on Red Cu, crimped section

Figure 39: PN 33 (failed joint) Good compaction on white Al, crimped section

Figure 40: PN 33 (failed joint) Good compaction on white Cu, crimped section

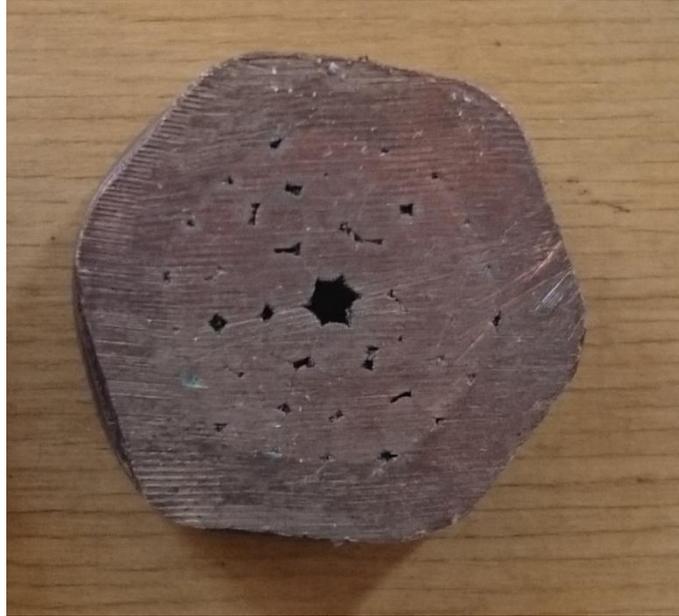
Figure 41: PN 53 white, copper, crimped section

Larger gaps were observed between the strands of the PN33 green connector copper section and the PN53 white connector copper section, Figure 41 and Figure 42.

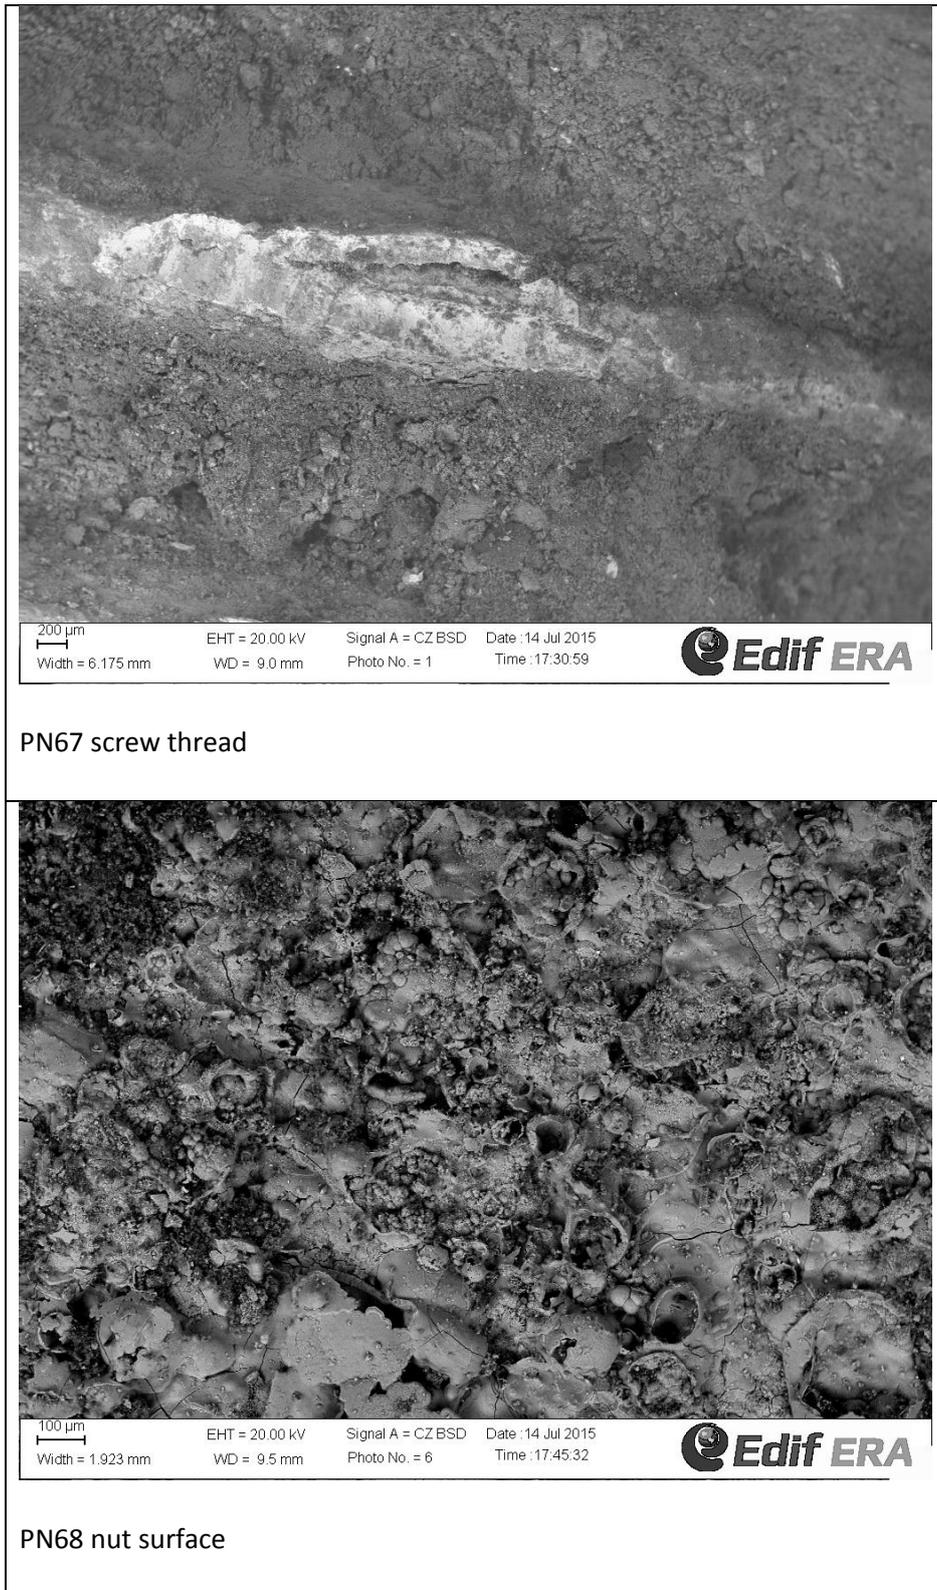
There was evidence of the galvanising layer splitting at thread tips and blistering of the galvanised layer on the nuts (see images above). Both indicate that the parts have been exposed to high temperature that has led to softening and bubbling of the zinc layer during formation of the high temperature oxide. The literature suggests that this damage will be encountered when the localised temperature exceeds 250-350 °C, references 2, 3 and 4.

Figure 53: Damage to galvanised layer due to temperatures above 250-350°C

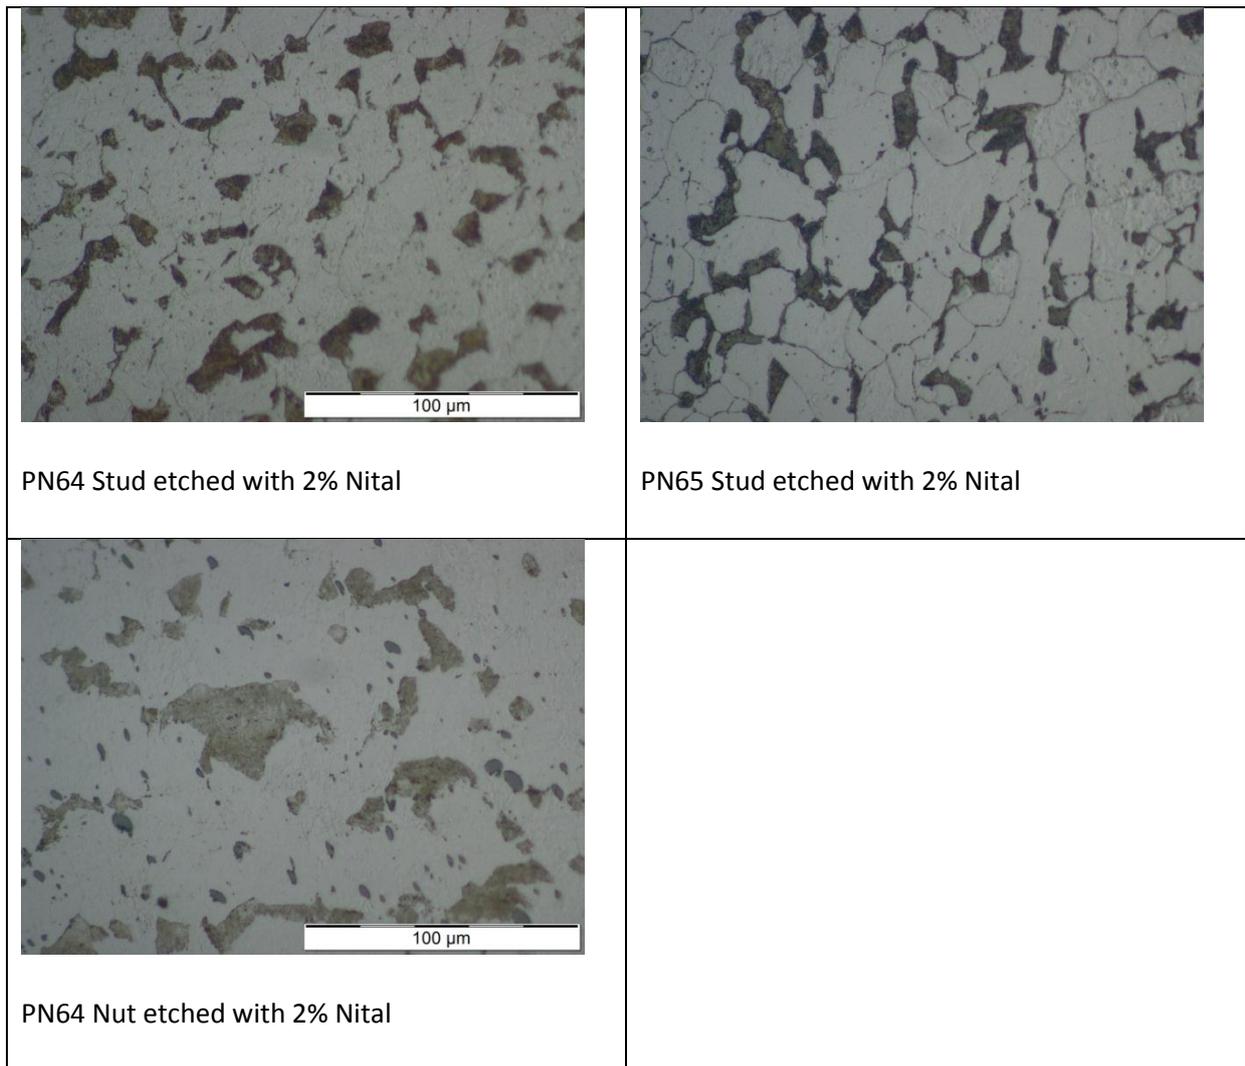
Figure 57: PN64 and PN65 microstructure

The etched microstructures of the studs and bolts are shown below, Figure 57. These consisted of pearlite islands (dark phase) within a ferrite matrix (light phase).

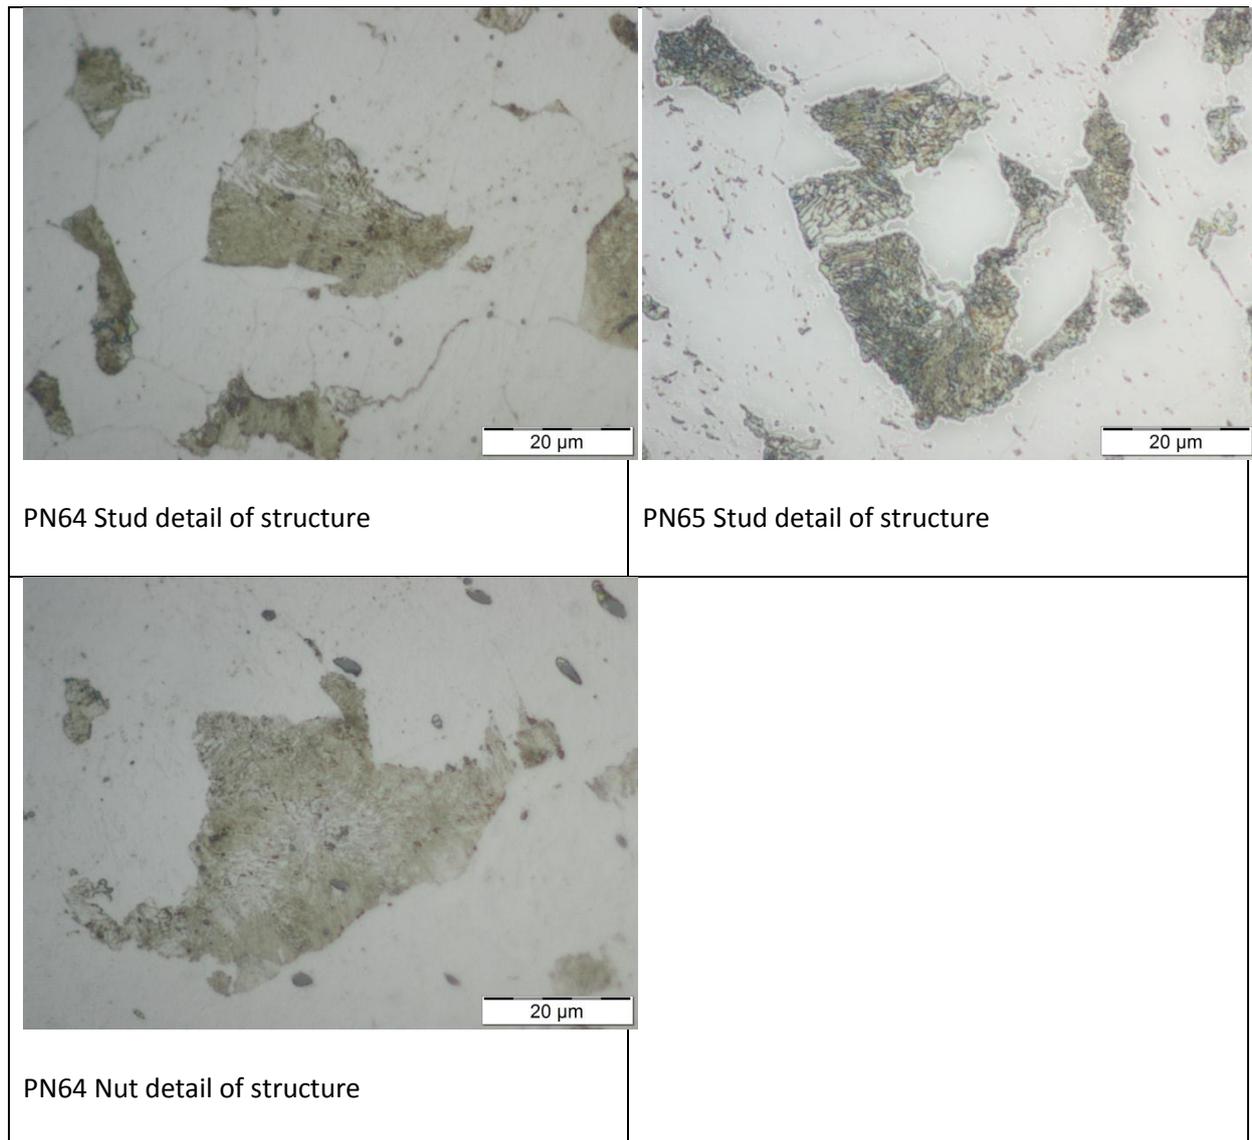
Figure 58: Higher magnification views of PN64 and PN65 pearlite microstructure

Detail of the lamellar spacing within the pearlite indicated that the material had not been exposed to high temperature $>500^{\circ}\text{C}$ for any prolonged time period as there was no spheroidization of the pearlite.

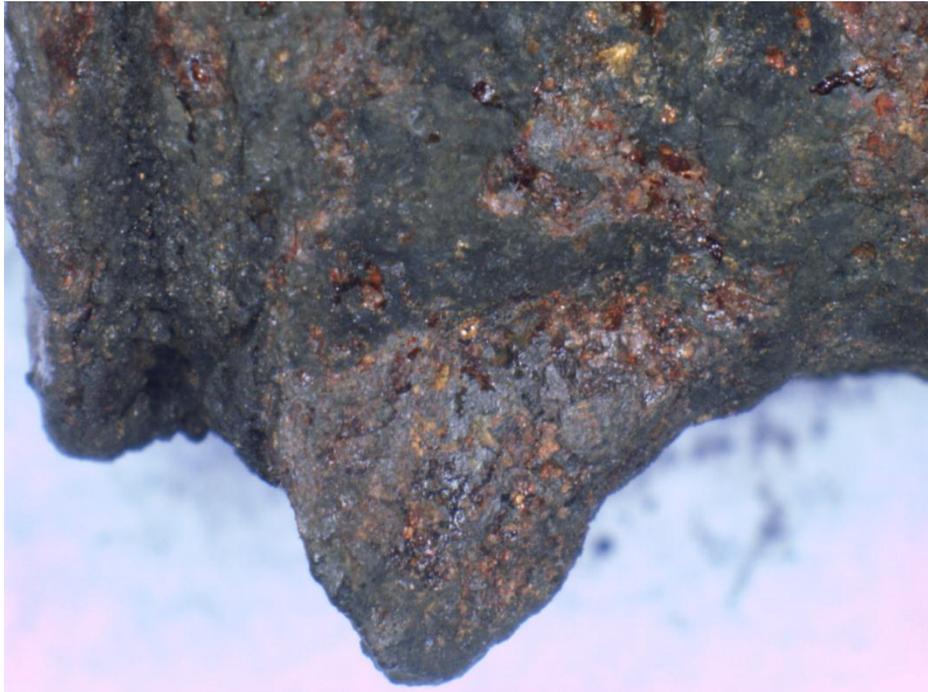
Examination of the stud surface therefore suggests that the extensive damage was associated with arcing to the stud and bolt, producing a temperature sufficiently high to melt the surface but of an insufficient duration to alter the internal structure of the steel. Had the damage been associated with an intense fire for a prolonged period, spheroidization of the pearlite in the metal would be observed together with melting/loss of the galvanised layer between the stud and nut. Neither of these features was present.

Figure 59: Surface nodule on Stud PN64 indicative of arcing and localised melting

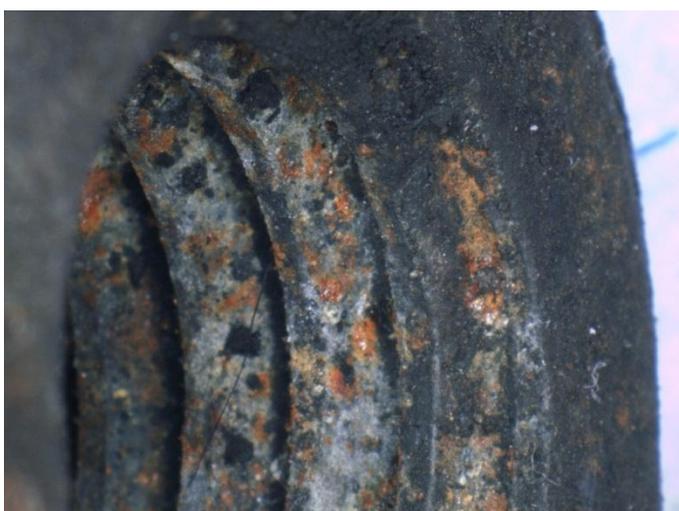
The PN66 nut threads showed no significant damage, other than the surface corrosion seen on all studs and bolts. It is unclear if the nuts had been positioned on studs at some time. However, the intact nature of the threads and the zinc galvanising layer indicate that the nuts did not detach from the studs at raised temperature during any “fire event.” More significant damage to the thread and galvanising layer would be expected and probably some evidence of stud thread residue would be visible on the nut.

Figure 60: Surface corrosion on PN66 nut screw-threads

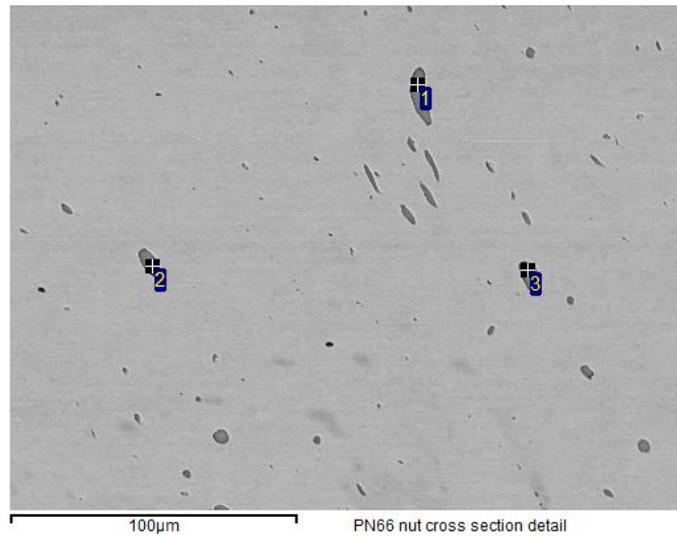
Figure 62: PN66 nut cross section microstructure

Free cutting steel (sulphur addition) had also been used for these nuts (see image below, Figure 62, again showing backscattered electron image of microstructure, including spherical manganese sulphide particles associated with additions of sulphur to the alloy to improve its machinability).

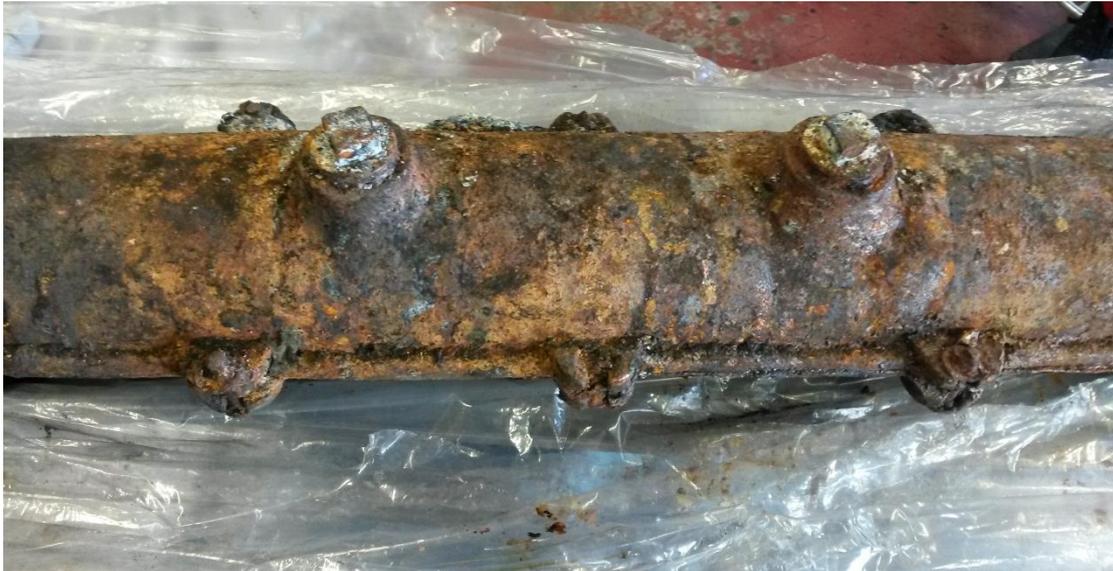
The cast iron housing was corroded and the bolts securing the two halves of the joint shell together were in some cases almost completely corroded away, Figure 65 and Figure 66. The cable steel tape armour was severely corroded in places. The lead sheath, hessian and papers were missing from the cable on both sides of joint. Papers were still present within the cast iron housing but the lead had melted and re-solidified in the base of the cast iron housing.

Figure 65: Corroded joint shell, PN57

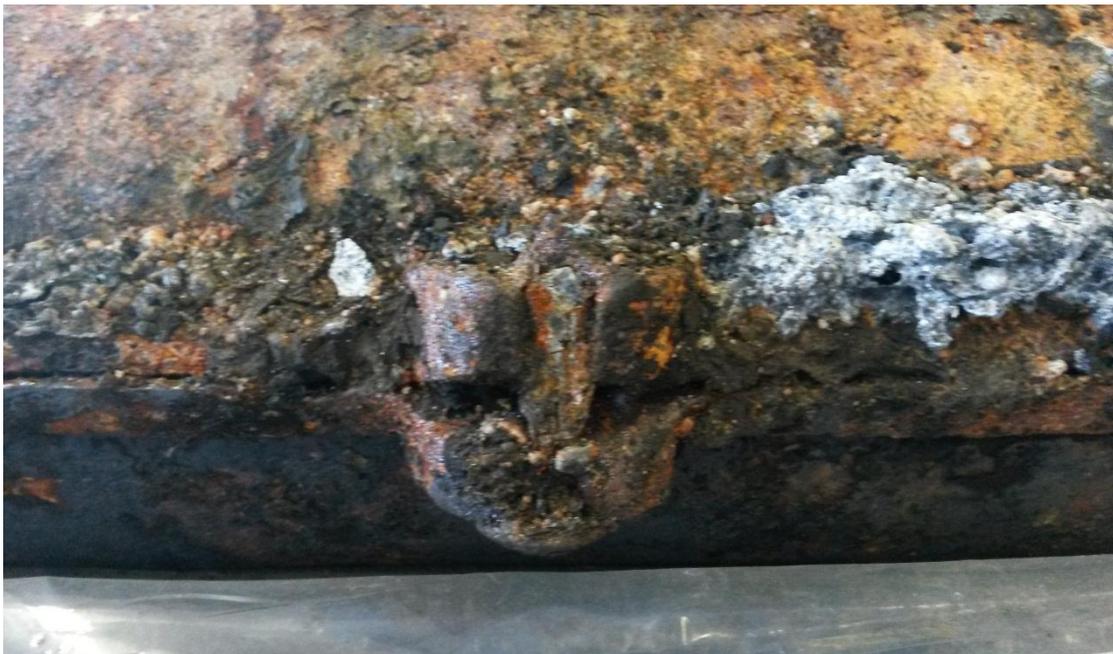
Figure 66: Severely corroded joint shell retaining bolt, PN57

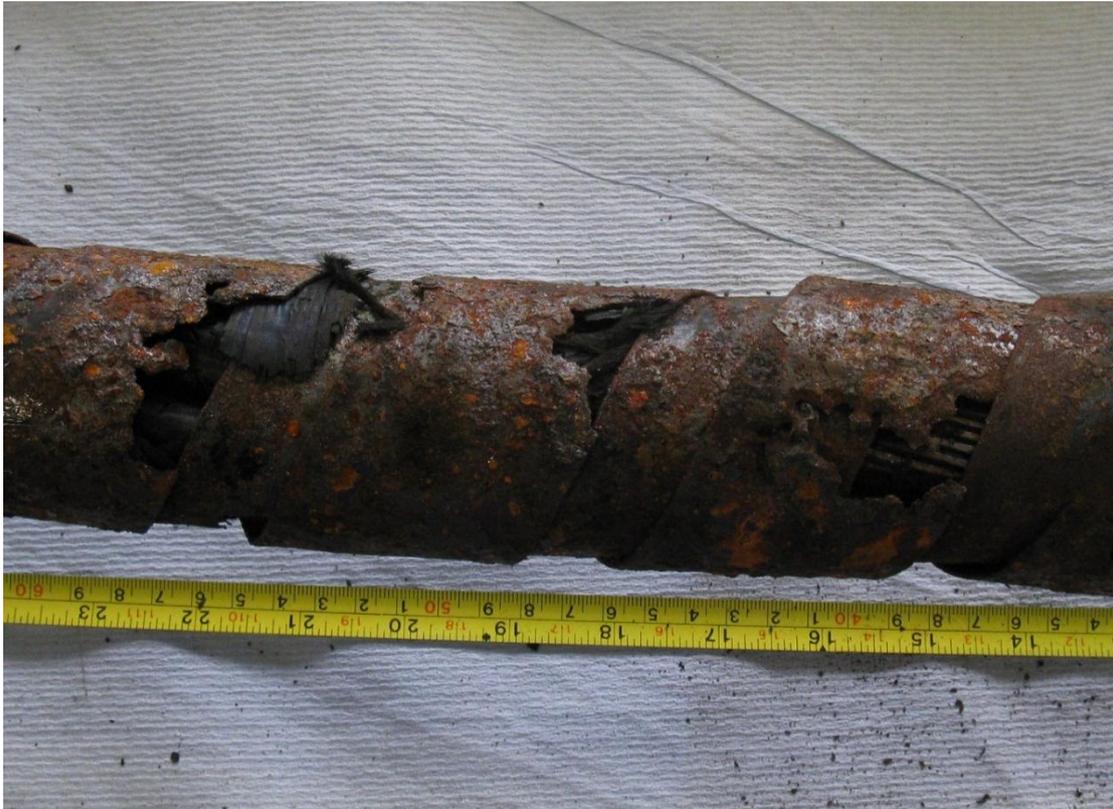
Figure 67: Corroded steel tape armour, PN57

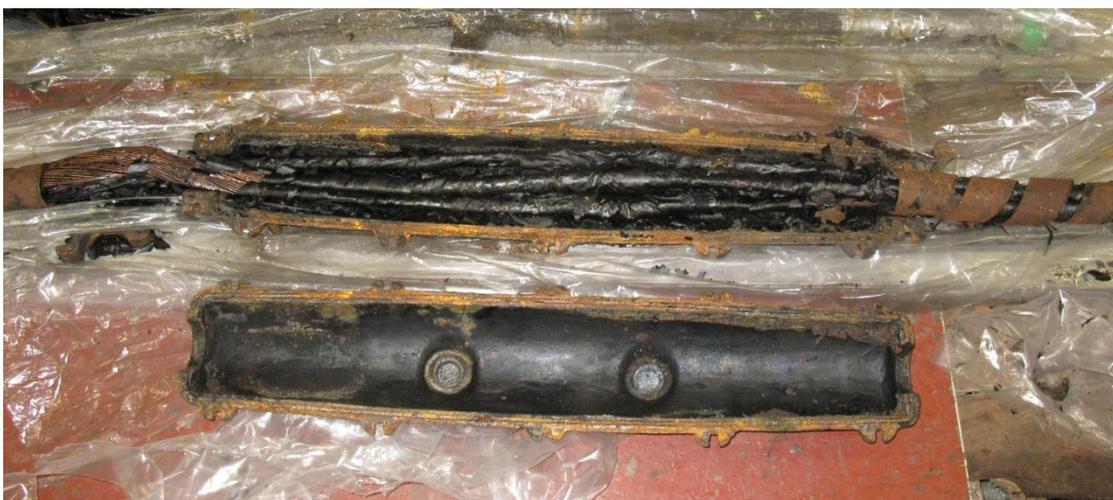
Figure 68: S shaped profile of cores within joint shell and kink at switchroom end, PN57

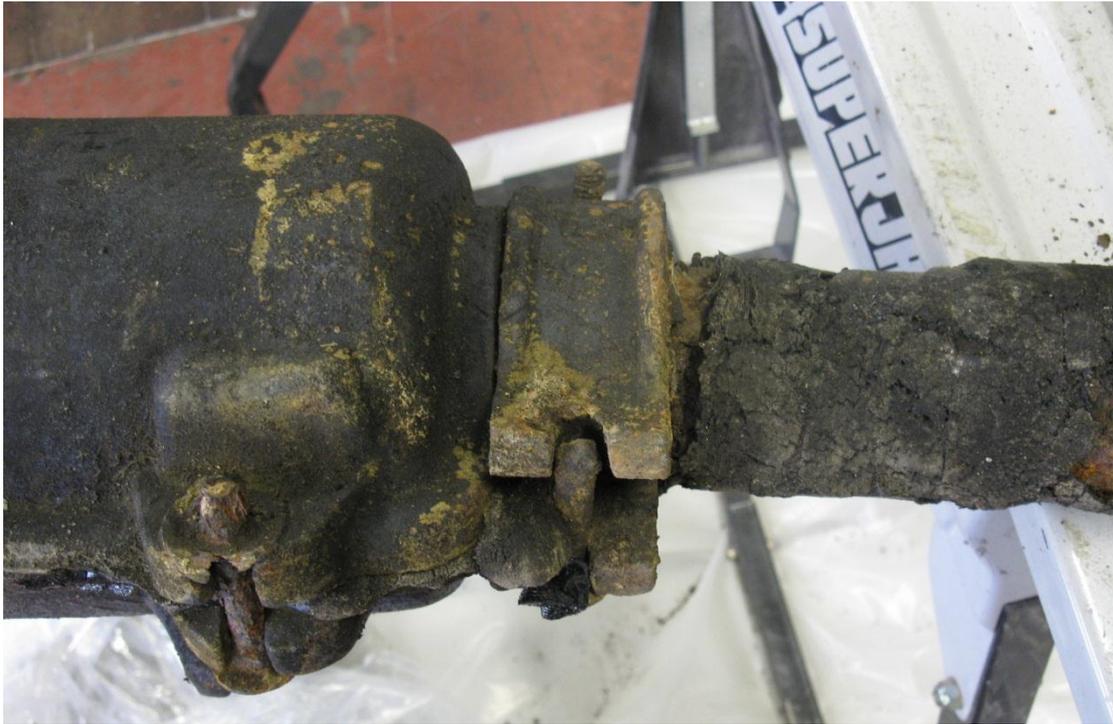
Figure 73: Eroded bolt on cast iron joint shell, PN60
