Report Title: Examination of cable joints from Penrose Substation

Client: Vector Ltd and Transpower NZ Ltd

Report Number: 2015-0356

2. Failed Heat Shrink PILC to XLPE Transition Joint 3-B-0, PN33

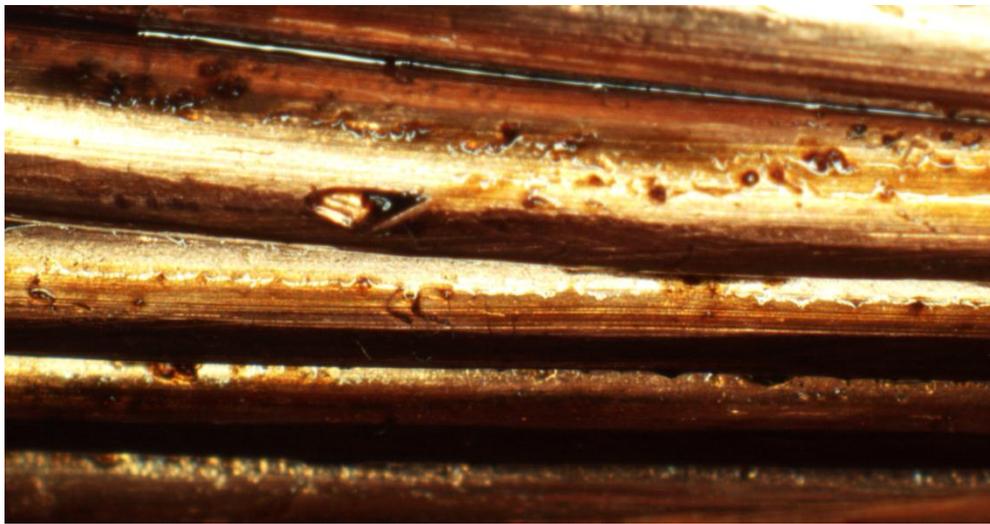
Figure 75: Sharp protrusion from PILC conductor strand, PN60

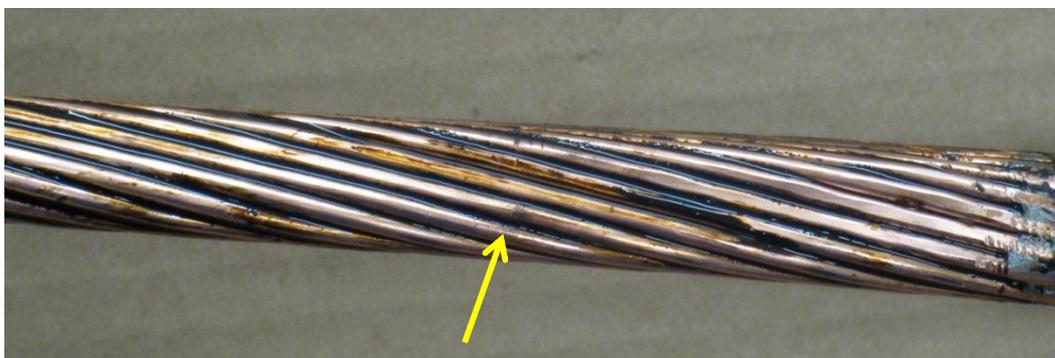
Figure 76: Dark stain on conductor beneath hole in core papers, PN60

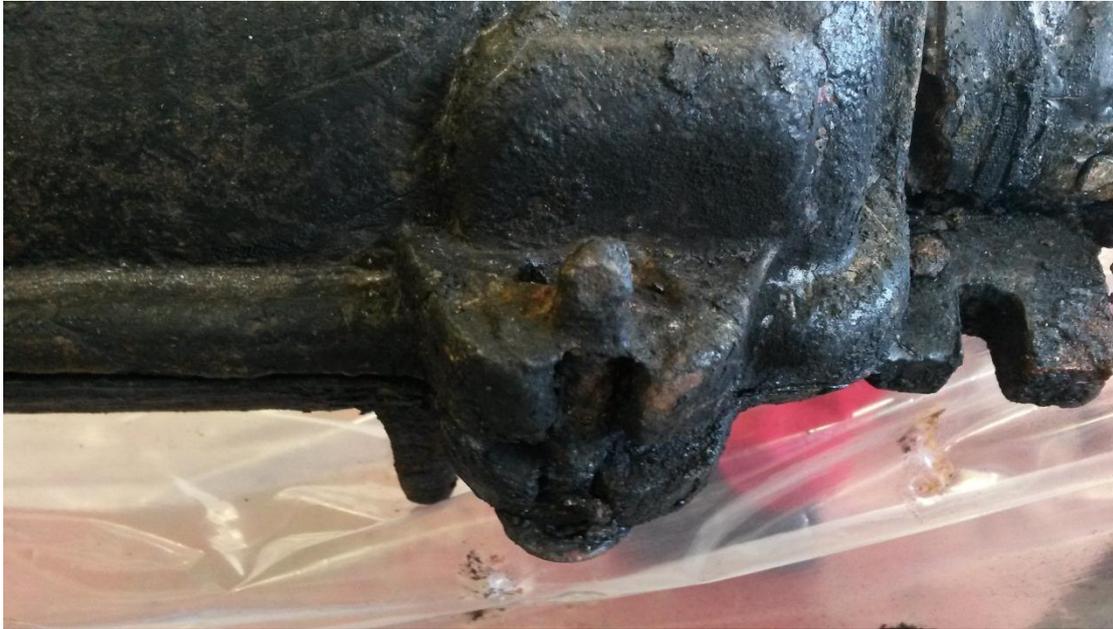
Figure 77: Corroded bolt on cast iron joint shell, PN28

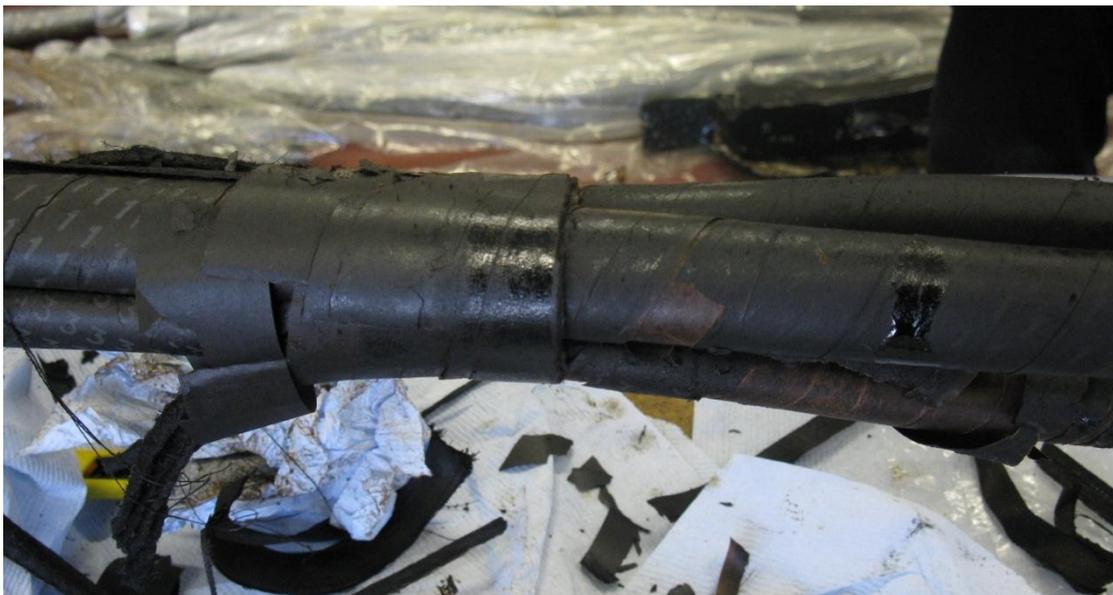
Figure 78: Degraded belt papers, PN28

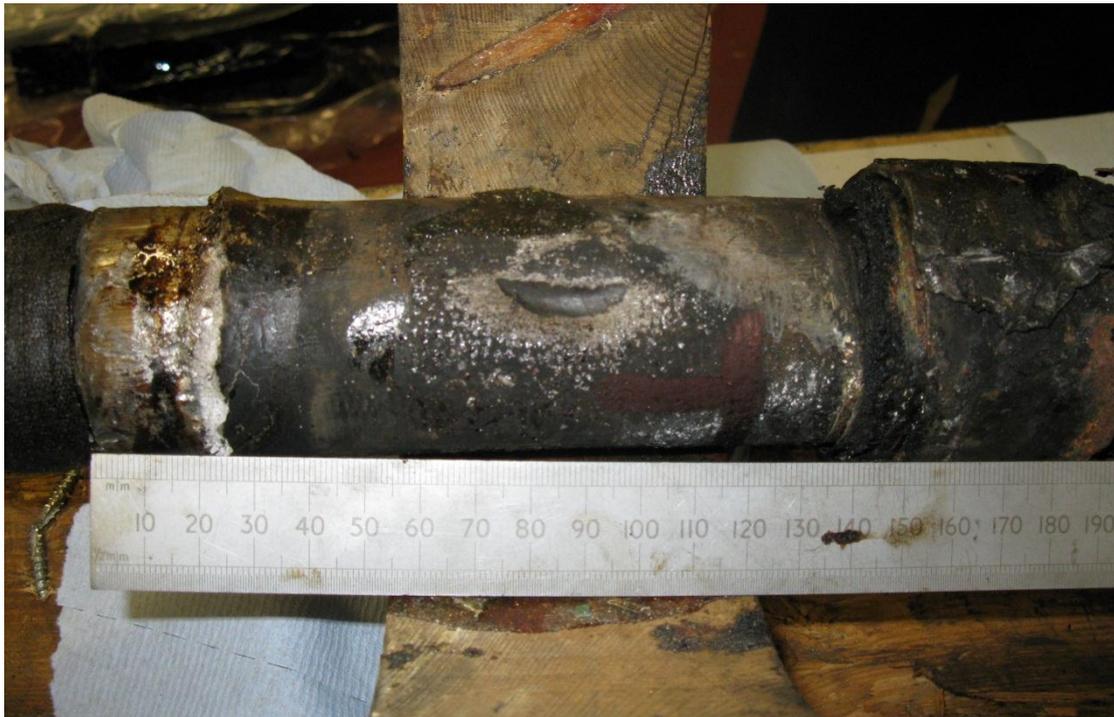
Figure 81: Dent in lead sheath, PN28

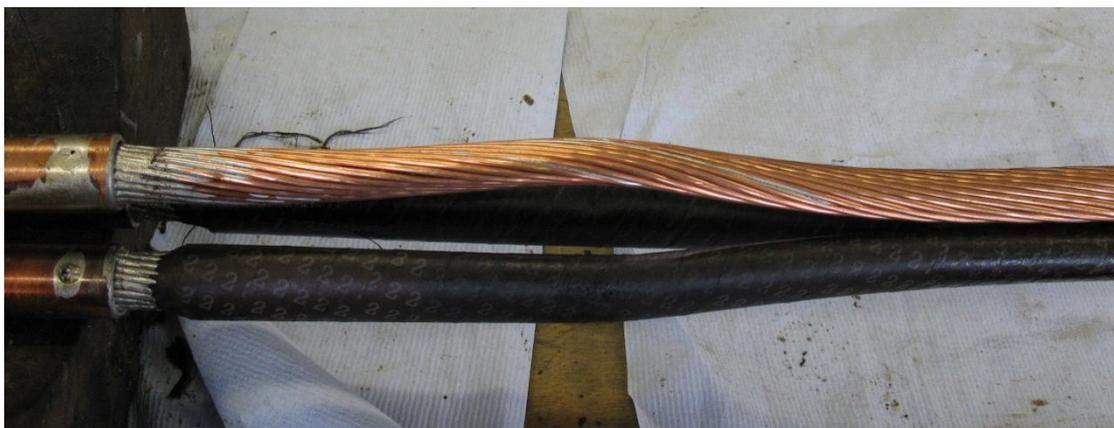
Figure 82: Bend at temporary spreader position and penetration of lead solder, PN28

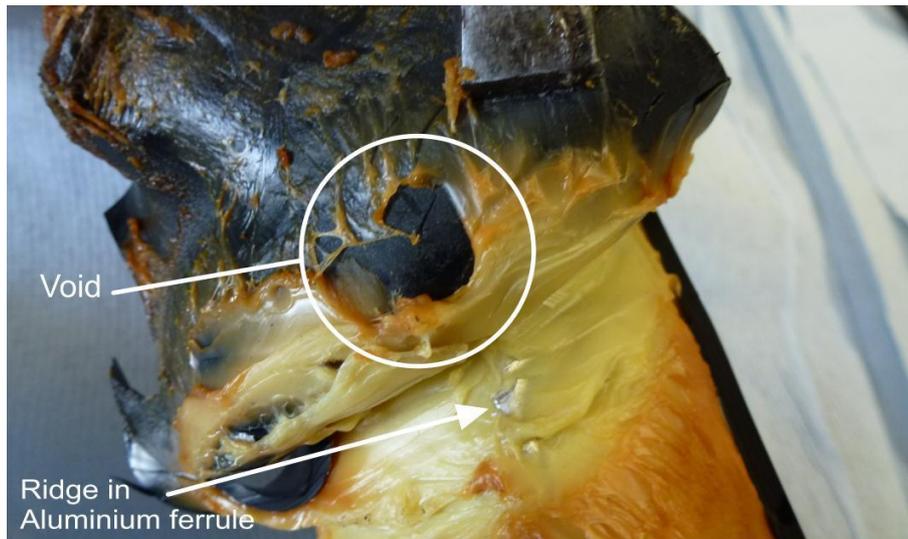
Figure 101: yellow mastic showing void and ridge of aluminium ferrule PN 56
