Penrose substation fire 5 October 2014

Report on the inquiry conducted by the
Electricity Authority under section 18 of the
Electricity Industry Act 2010

20 November 2015

Inquiry into the Penrose substation fire and power outage 5-7 October 2014

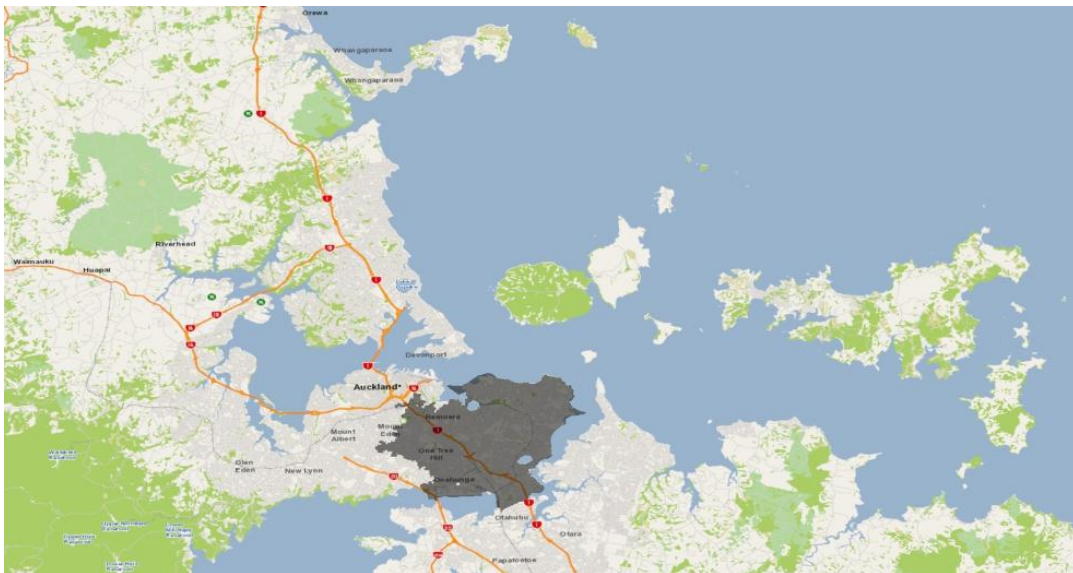
Figure 2 – Supply area affected by the Penrose substation fire

- 2.9 Figure 2 shows the area affected by the power outage.

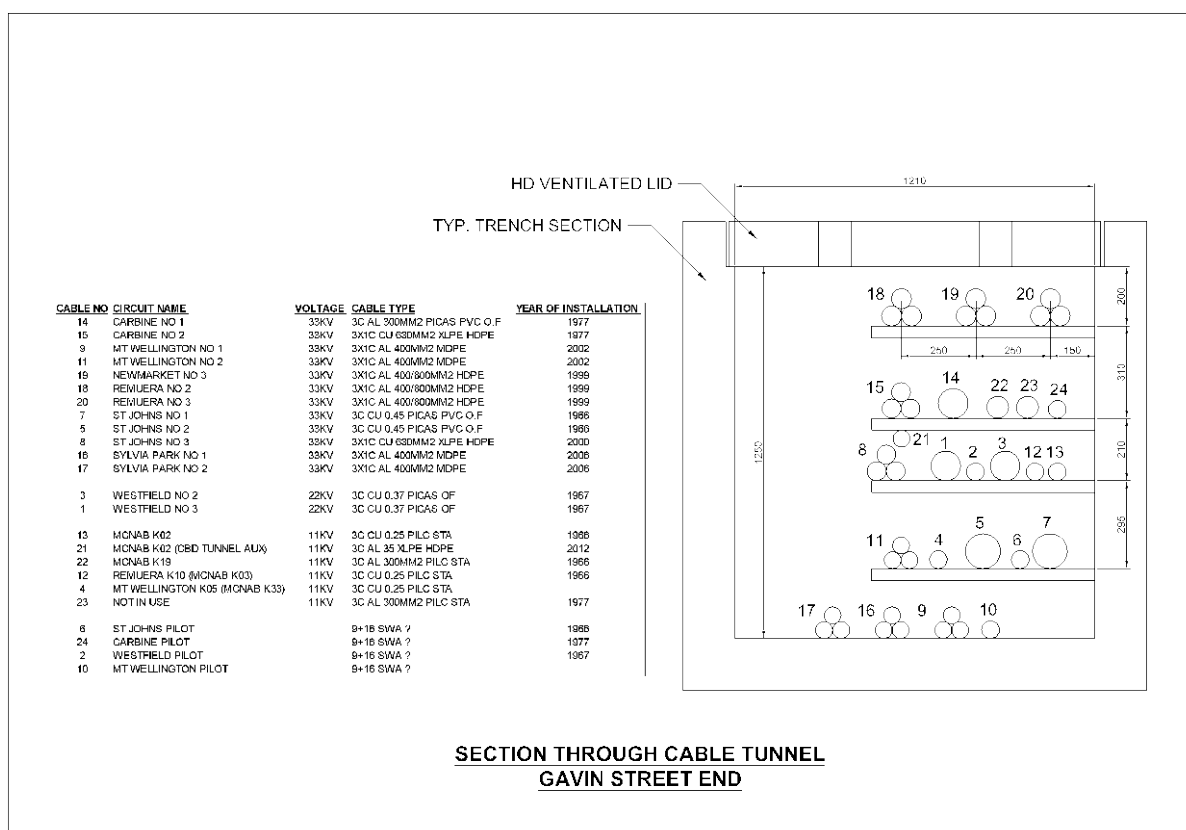
Figure 4 – Cable trench cross-section as at October 2014

3.15 At the time of the fire, the cable trench contained:

3.17 The combined equivalent single length of all the power cables in the cable trench was found by CCI to be 3.99 km.²⁹ The power cables in the cable trench had 15 in-air cable joints installed in their length.

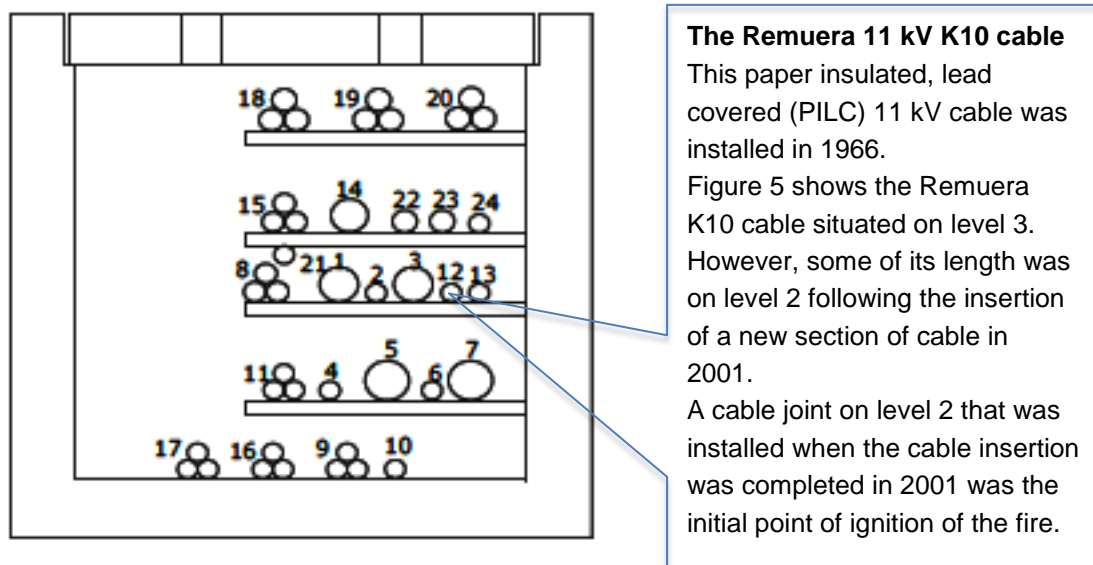
Figure 5 – Cross-section of the Penrose substation trench Gavin Street end

5.9 Figure 5 shows the cables in the cable trench in 2014, and the location of the cable that contained the joint that failed. The material used in the cables provided the fuel for the fire.

5.10 The cable trench is covered with ground-level removable concrete lids. At the time of the fire, the cable trench had no fire barriers or fire, heat or smoke detectors. No fire suppressant systems had been installed. Figure 6 is a

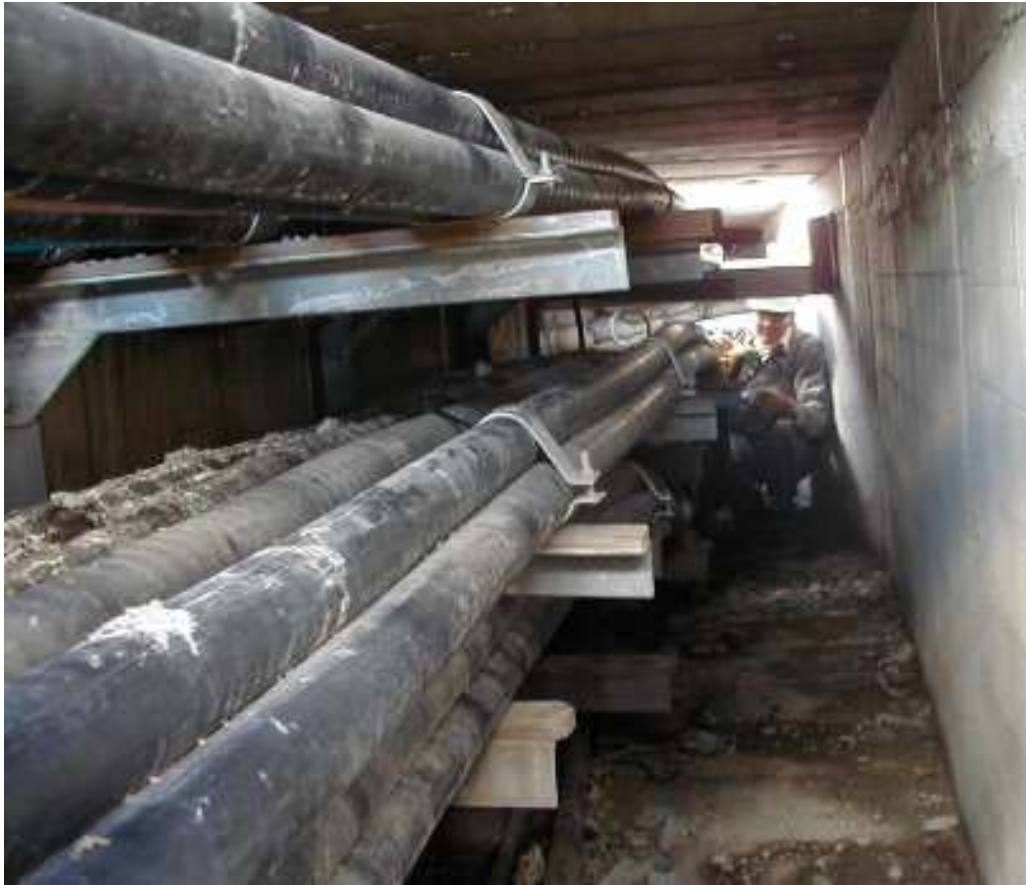
Figure 6 – Penrose cable trench in 2001

photograph of the cable trench taken in 2001. Note that more cables were added to the trench after this photograph was taken.

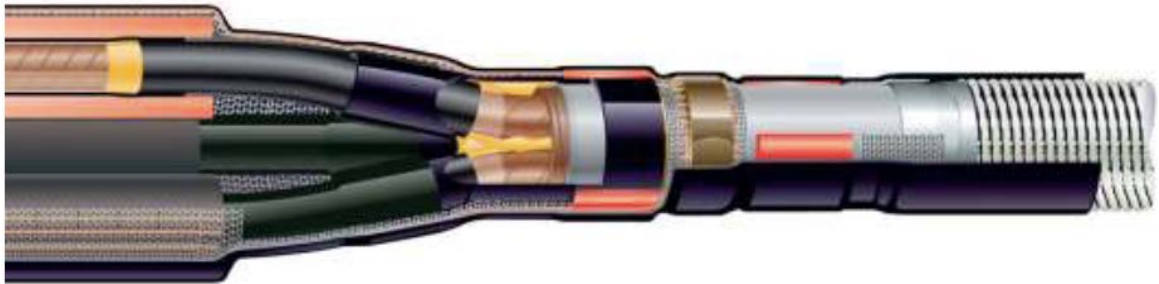
Figure 7 – PILC to XLPE transition joint example

- 5.15 Figure 7 is a cutaway diagram of an 11 kV, three-core, heat-shrink sleeve PILC to XLPE transition joint.

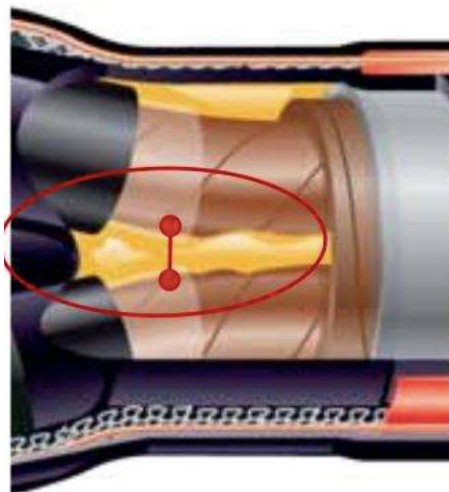
Figure 8 – The arc position in the failed transition joint

- 1.28 CCI concluded that the cause of the transition joint failure was a vulnerability of the transition joint design. CCI concluded that the jointing quality was satisfactory. CCI states that a number of technical factors contributed to the cable joint failure. These factors included the lack of a straight alignment of the joint and the cable, and the lack of cable cleats and joint supports.¹³

- 5.16 CCI's detailed examination identified that a power arc occurred in the 'crutch' of the transition joint at the location shown in figure 8.⁵⁴ CCI concludes that the fire is likely to have ignited from the 11 kV power arc that would have resulted as the insulation material in the joint failed.
