Penrose Substation Fire

05 October 2014

Investigation Report

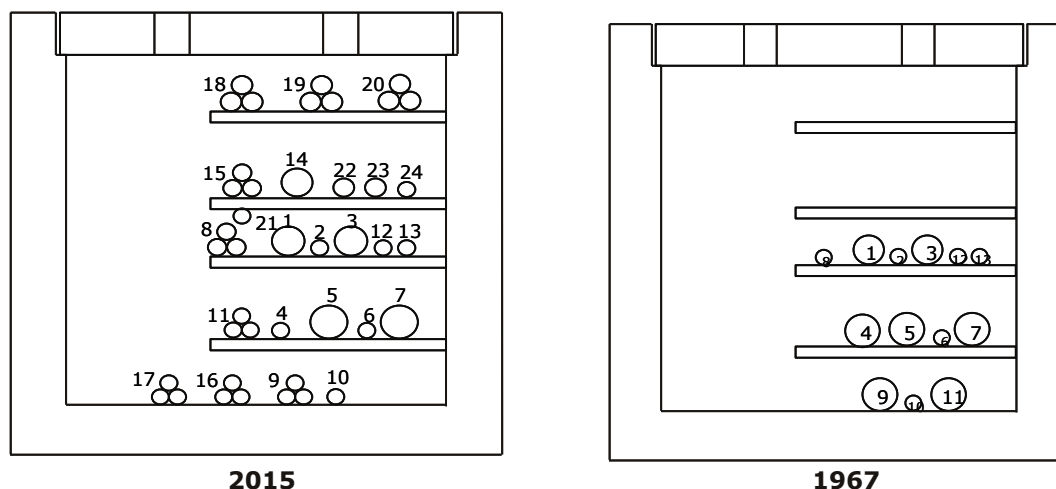
Figure 10 Trench Cross Section

By the end of 1967, AEPB had five 33 kV, two 22 kV and three 11 kV cables, plus three pilot cables, in the cable trench, as shown in Figure 10
