TITLE: Investigation into a Fire in a Cable Trench in Penrose Substation

REPORT: ER 763

CUSTOMER: Vector Ltd and Transpower New Zealand Ltd

DATE: 3rd November 2015

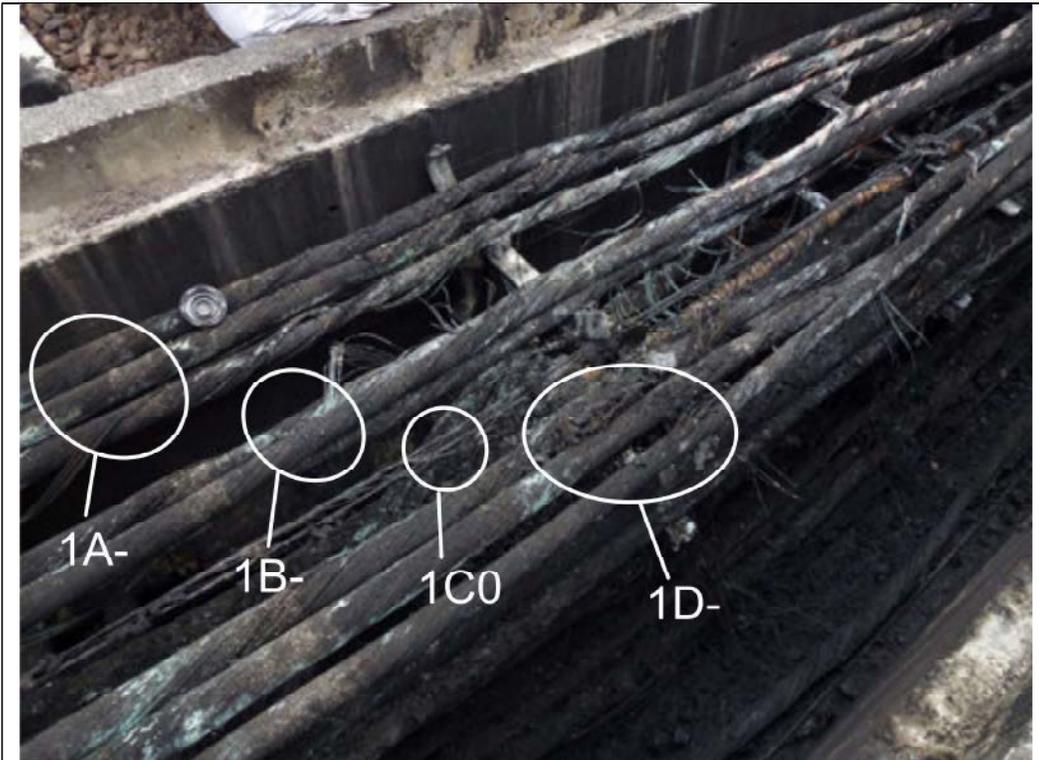
One phase of a 33 kV S/C XLPE cable had fallen from a higher level onto the cable circuit on the floor.

Figure 8 Photograph of cable trench at 73 m, looking eastwards, taken after the fire in October 2014

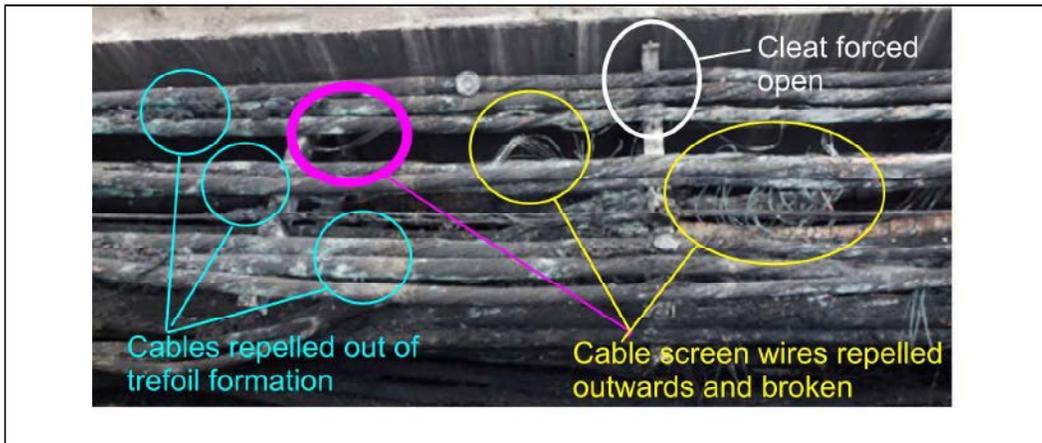
Disturbances of the outer conductor screen wires on Level 1 were seen between 72 m and 74 m. The view facing north at this location is shown in Figure 9. The disturbance is indicative of the presence of one or more short-circuit power arcs that had severed the wires and electromagnetic forces that had violently displaced both the wires from their concentric formation and the cables from their trefoil formations. The cable cleats on the top support arm to the right of the photograph (at 73 m) had been burst open by the short circuit forces and in some locations melted.

Figure 9 Disturbances indicative of violent electrical activity at 72 m - 74 m

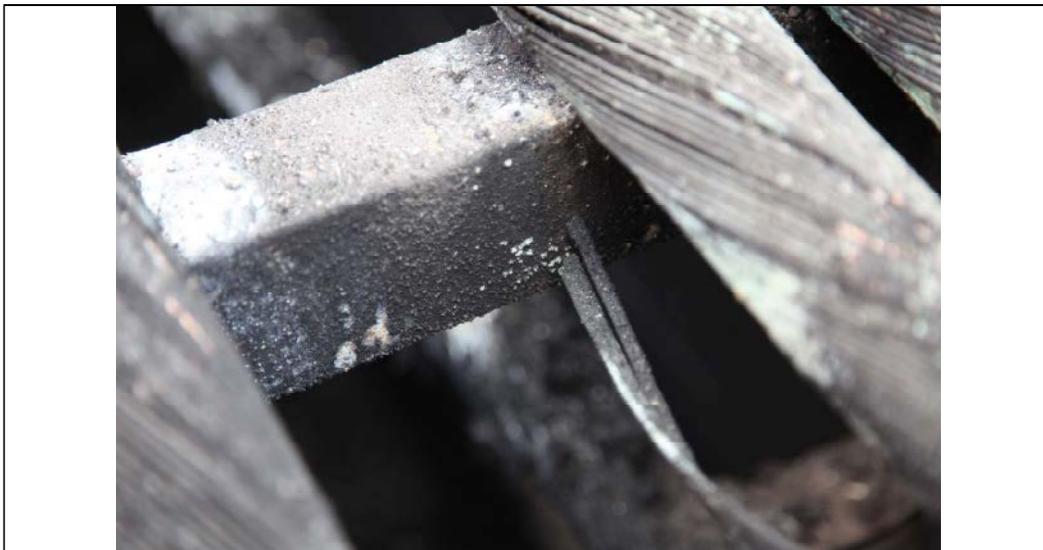
Figure 10 shows the pink ringed detail from Figure 9, looking west along the trench at 94 m chainage where the copper screening wires on the 33 kV XLPE cable 1AZ had been parted by arc burning where they had contacted the top face of the steel support arm on Level 1 (after the PE and PVC sheaths had been burnt away). The parted ends of the wire had then arced to the side face of the steel support arm. A group of larger arc marks is present to the left.

Figure 10 Minor arc burning between steel support and ends of parted copper screen wires on cable 1AZ at 73 m

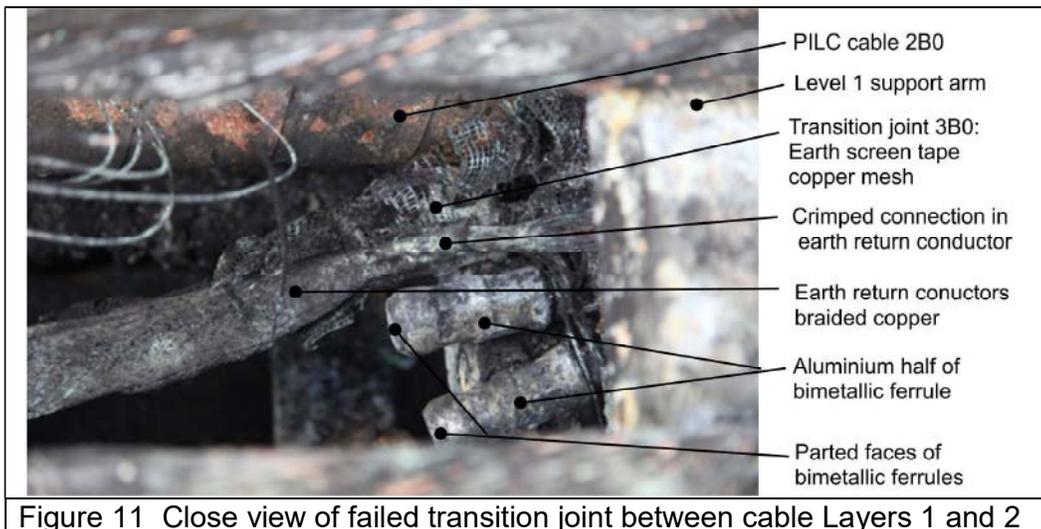
Two grey cylinders could be seen, these being the aluminium halves of the transition joint's bimetallic ferrules that would normally connect the aluminium conductors in the XLPE cable to the copper conductors in the PILC cable. The factory-made friction welds that normally join the aluminium ferrule to the copper ferrule were seen to have parted and the copper conductors on the PILC cable side (to the left of the aluminium connectors) were missing.

Figure 11 Close view of failed transition joint between cable Layers 1 and 2

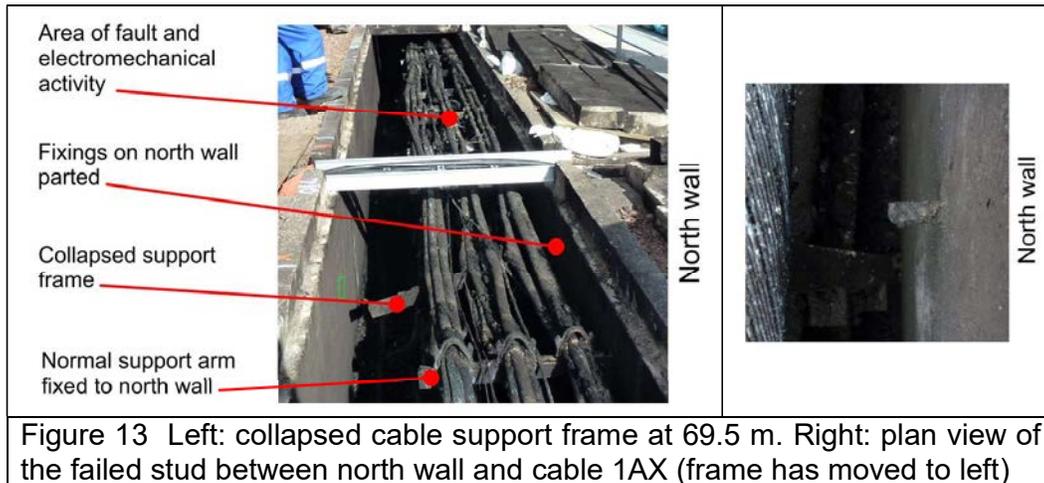
Edif ERA laboratories for analysis. Two nuts that had been found on the floor in the vicinity of the frame were sent to assess whether or not they had been fitted to the suspect studs. Reference samples were also sent from a support frame that had been in its correct position.

Figure 13 Left: collapsed cable support frame at 69.5 m. Right: plan view of the failed stud between north wall and cable 1AX (frame has moved to left)

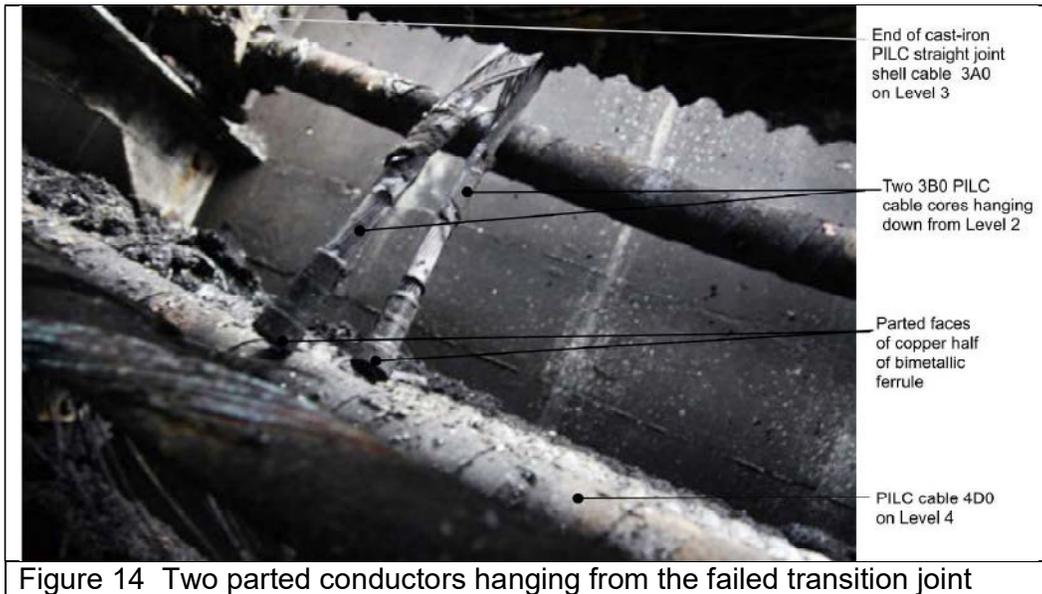
Figure 14 is a photograph taken from within the trench, horizontally between Levels 2 and 3. The three missing copper conductors from the 3B0 11 kV Remuera K10 transition joint were found. Two conductors had been partly severed by power arc burning at the end of the joint adjacent to the PILC cable and were hanging vertically downwards, Figure 14.

Figure 14 Two parted conductors hanging from the failed transition joint

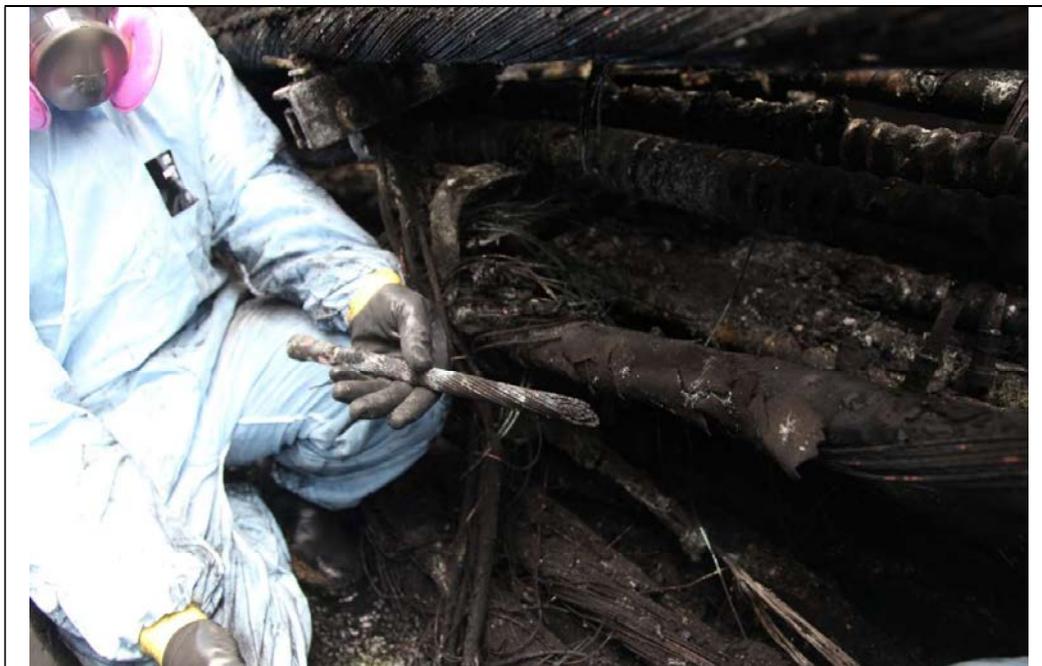
The third conductor had been completely severed and had fallen downwards onto Level 3, Figure 15. It was confirmed that all three copper ferrules had parted at the centre face of the bimetallic connector.

Figure 15 The severed third conductor from the Remuera K10 transition joint

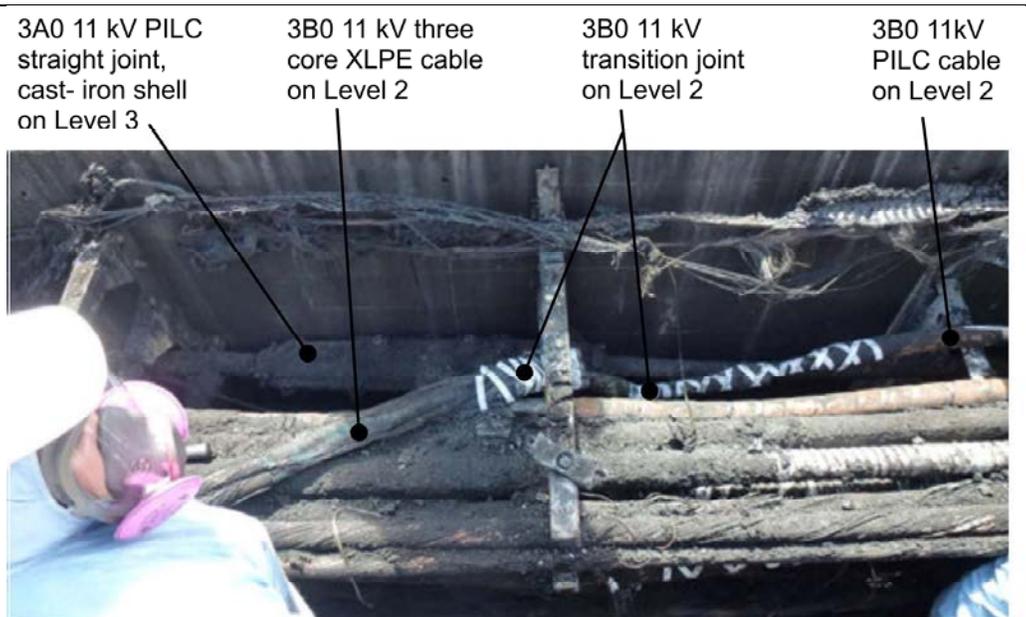
Figure 16 Level 1 cables removed. Revealed are a failed transition joint on Level 2 and a conventional cast iron straight joint on Level 3

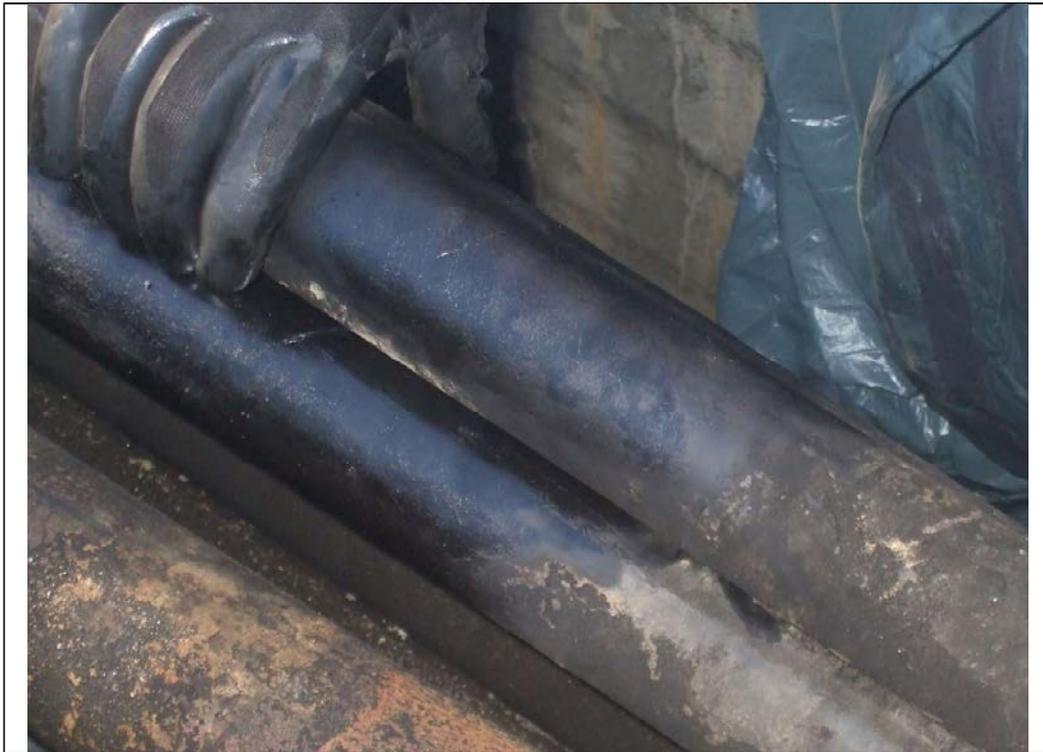
Figure 17 Char of the PE oversheath on Level 1 at 20.3 m chainage

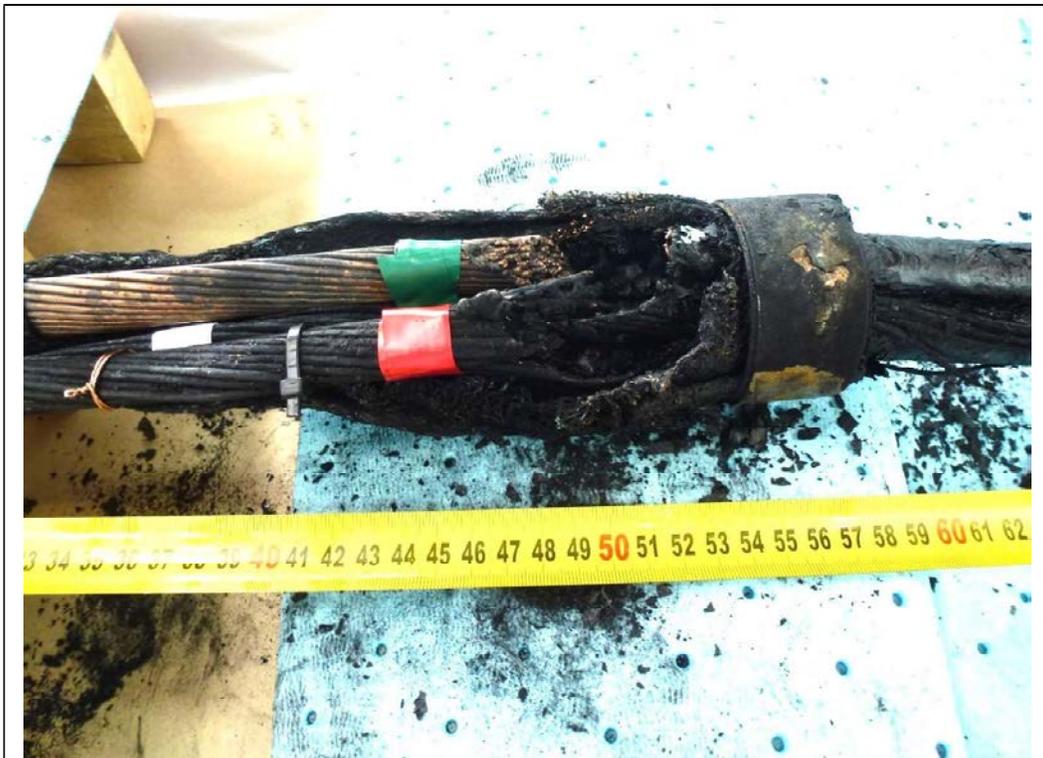
There was a pronounced, large arc crater present in the three conductors as shown in Figure 19. During the dissection, its position was measured and transferred to the unfailed joint to find as closely as possible the centre-line of the electrical fault path that had initiated the power arc.

Figure 19 Failed joint: arc crater in the three conductors

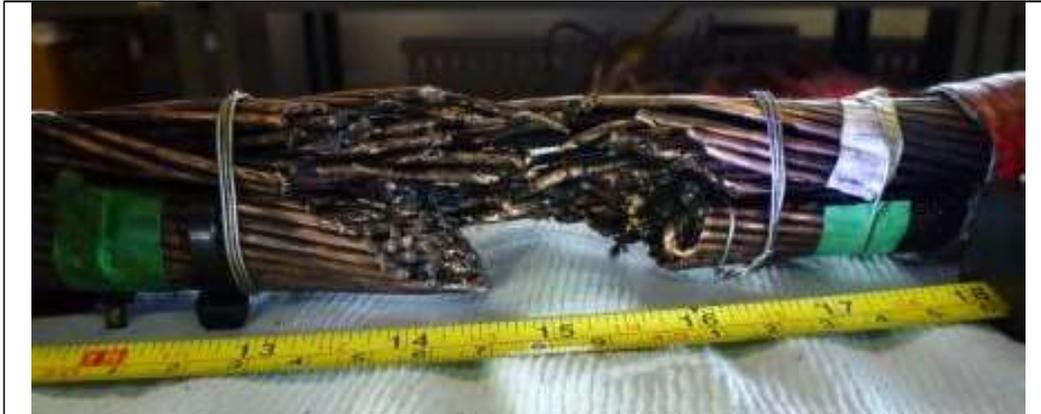
Figure 20 shows the arc crater after the conductors had been cleaned and re-assembled by the CCI Author at the laboratories of Edif ERA. In both photographs the PILC cable is on the right hand side and the centre of the joint is towards the left hand side. The fault current had been fed from Remuera Substation (right hand side) as the cable was open ended at McNab. The sloped eroded face of the conductors on the left hand side shows that the arc was fed from the right hand side and so had looped outwards under electromagnetic forces to the left.

Figure 20 Failed Remuera K10 joint: Arc crater in three conductors after cleaning and re-assembly

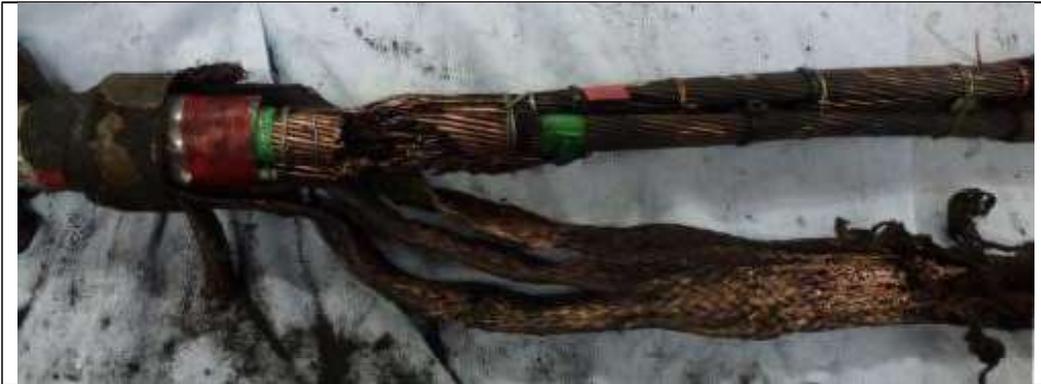
- The arc burning did not result in major erosion of the earth braid conductors. The burning had not severed the conductors and was not deep.
- The arc burning on the braid is not in radial alignment with either
 - The arc crater in the conductor
 - The parted bimetallic connectors
- There is no arc burning on the power conductors in the radial vicinity.
- The original fault was recorded as initially phase to phase and then for the majority of time as three phase. The reclose fault was recorded as three phase.

Figure 21 Failed joint: Arc burning to the earth continuity braided conductors

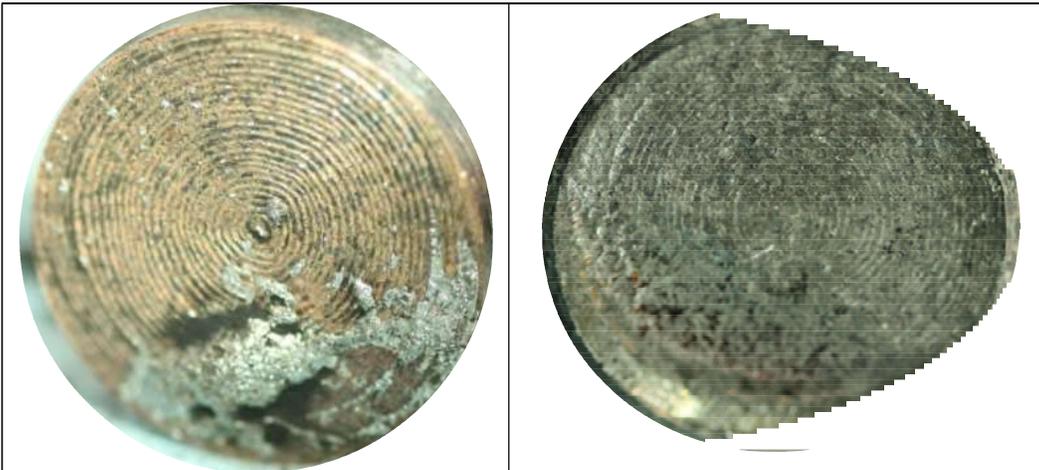
Figure 23 Electrically failed 11 kV Remuera K10 transition joint: parted faces in connector B

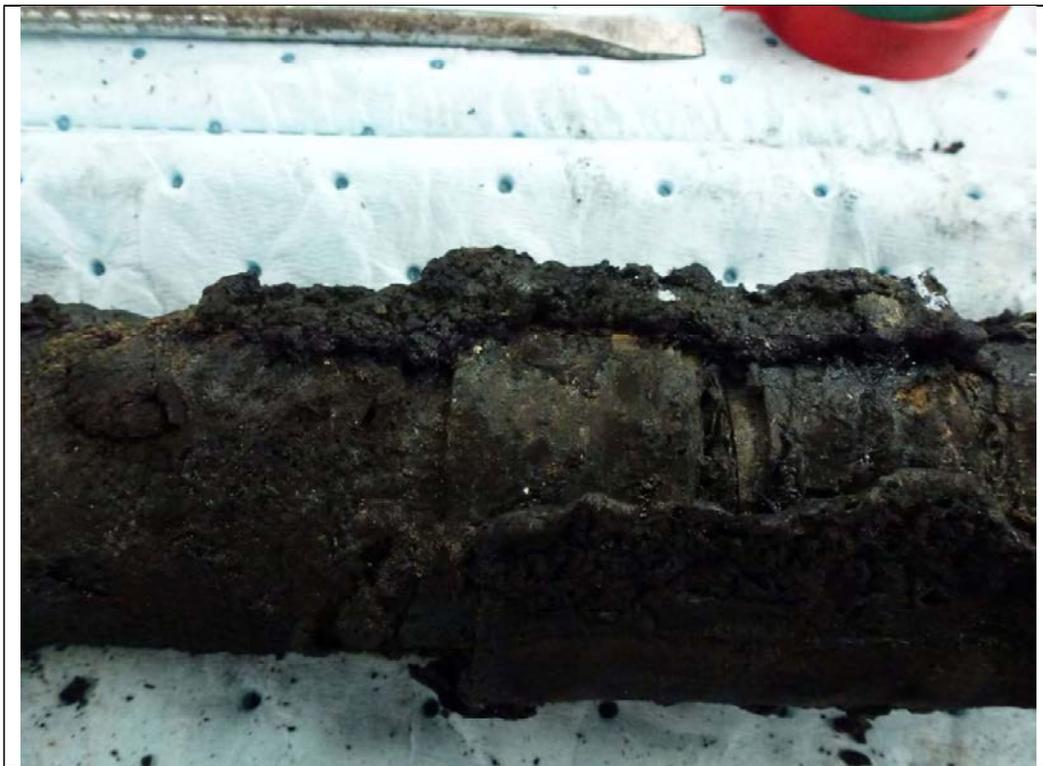
Although the fire damage had been less severe at the 79 m location of the unfailed joint, the outer heatshrink sleeve had suffered fire damage and, although still adhered, had been burnt away along one line of its circumference. The ablation revealed the steel roll springs that were on the lead sheath on the PILC cable side of the joint, Figure 25.

Figure 25 Unfailed joint: The steel roll springs could be seen on the PILC side

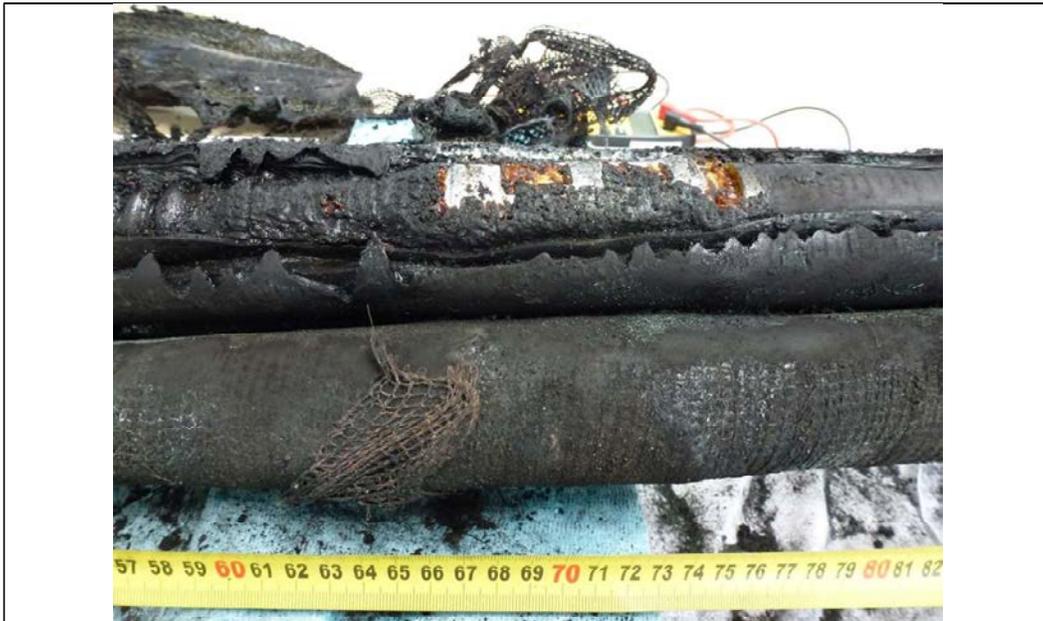
The fire had also burnt along the central heat shrink insulation packages to varying degrees to reveal part of one of the bimetallic connectors, Figure 26.

Figure 26 Unfailed joint: Fire damage to the heat-shrink insulation package

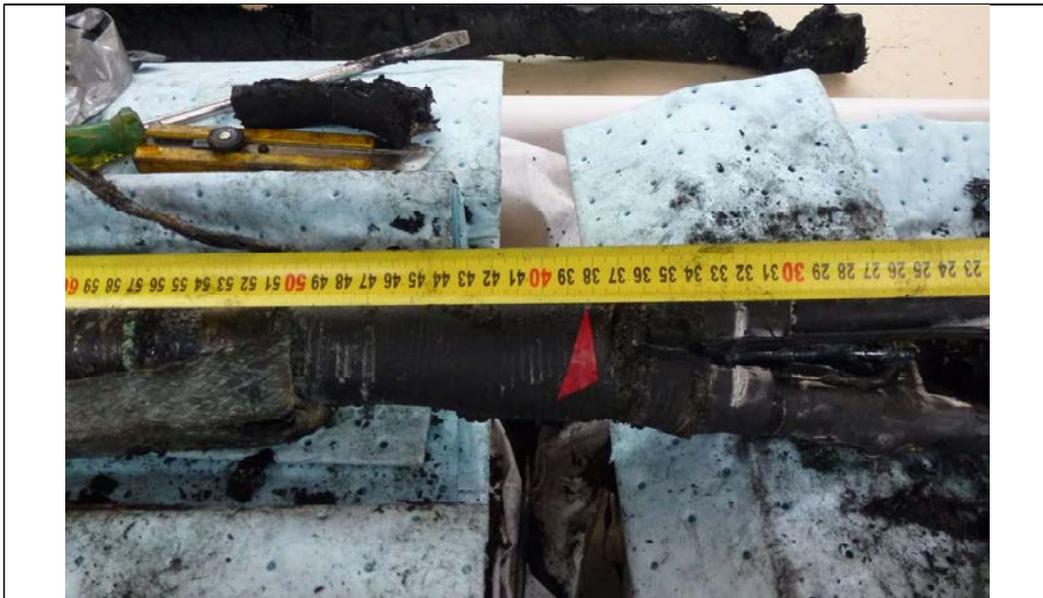
The arc centre-line was denoted by a red pointer and was found to be within the 'break-out' glove and close to the internal exit of the core spouts, Figure 29.

Figure 29 Unfailed joint: Arc centre transferred from failed joint

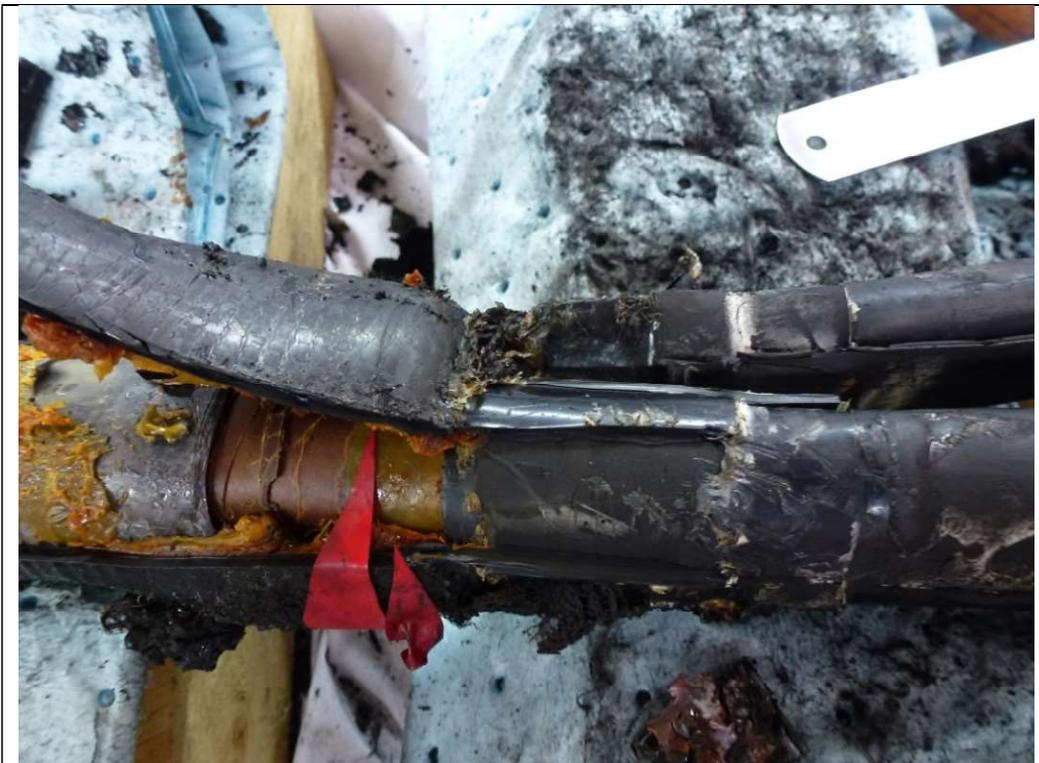
A strip of the semi-conducting heat shrink break-out glove was removed. The adhesive void-filling yellow compound was removed partly by cutting and partly by stretching and tearing. The PILC paper insulation was revealed, comprising the core insulation and the end step in the belt's paper insulation. The measured centre-line of the arc in the failed joint was transferred to the unfailed joint (red arrow). This position is close to the end of the yellow barrier/insulation tube and adjacent to the termination of the 'belt'. The purpose of the barrier/insulation tube is threefold, i) to prevent loss of the cable's hydrocarbon impregnating compound, ii) to prevent the compound from degrading the outer polyolefin heatshrink insulation and protective sleeves and iii) to part replace the paper belt insulation removed from the PILC cable.

Figure 30 Unfailed joint: Arc centre is in PILC crutch close to oil barrier sleeve

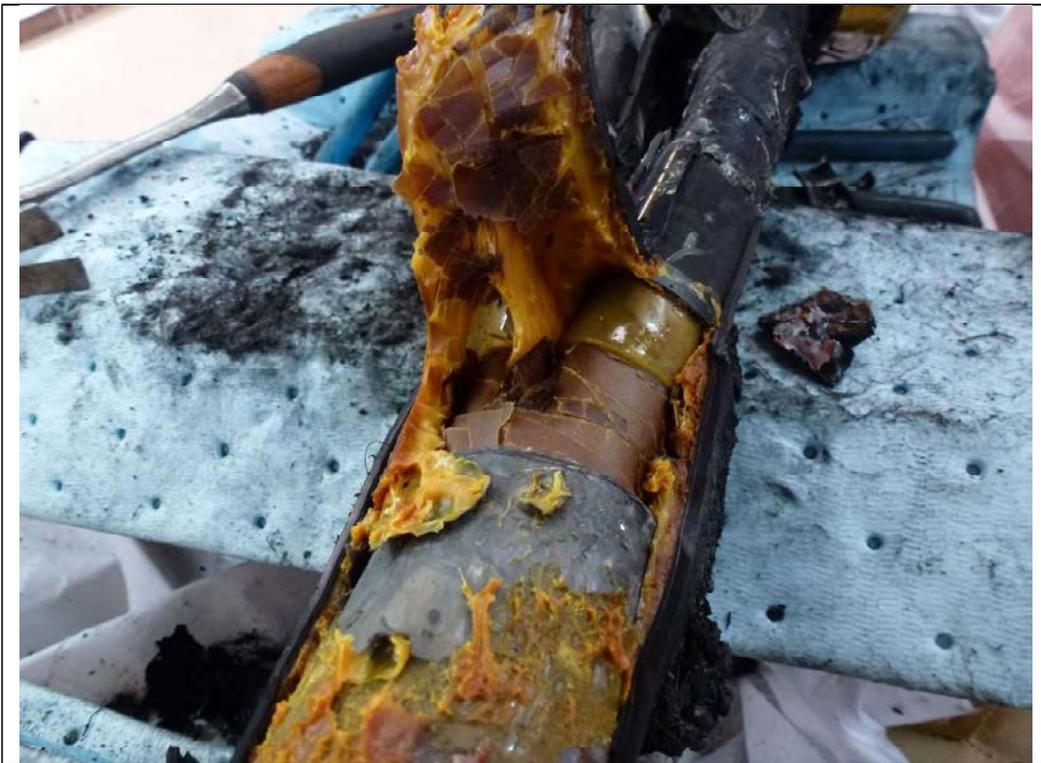
Figure 31 The compound had not uniformly adhered to the lead sheath

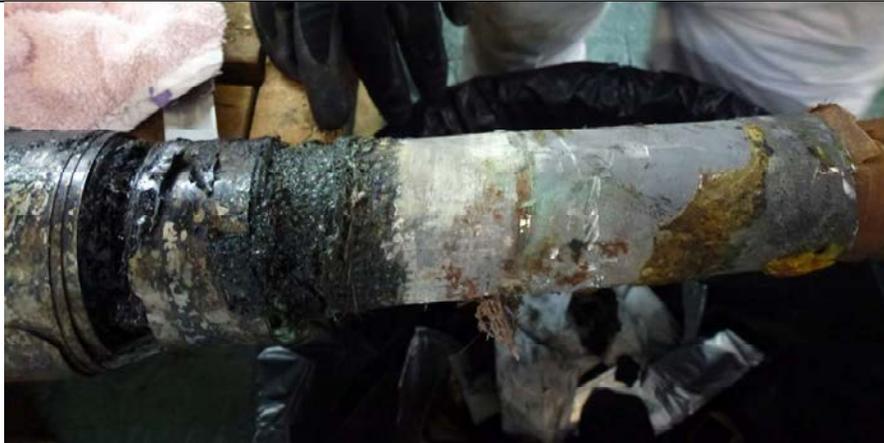
Figure 34 White corrosion products at the current contact with the lead sheath

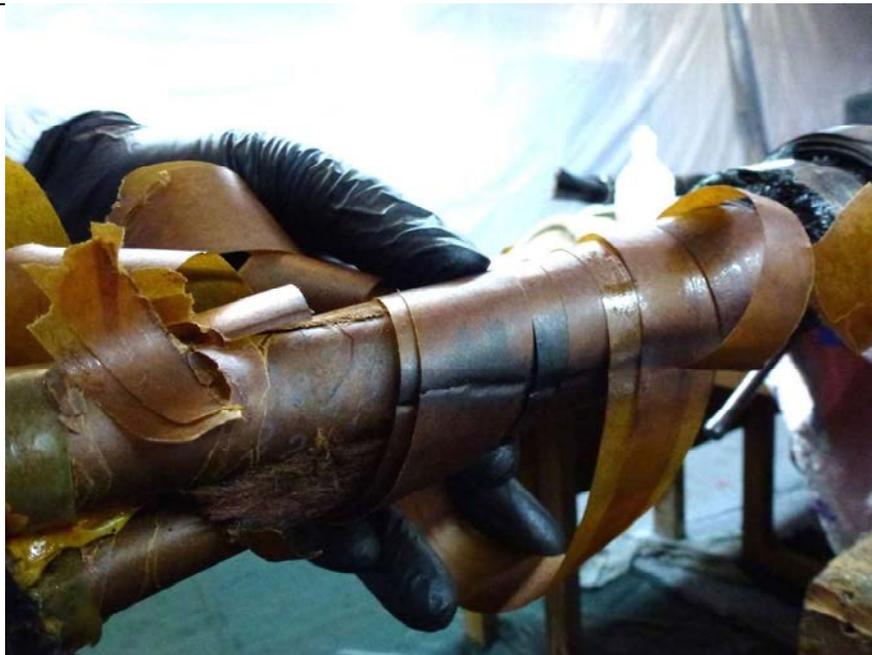
Figure 35 Blackening in belt creases above the core interstices

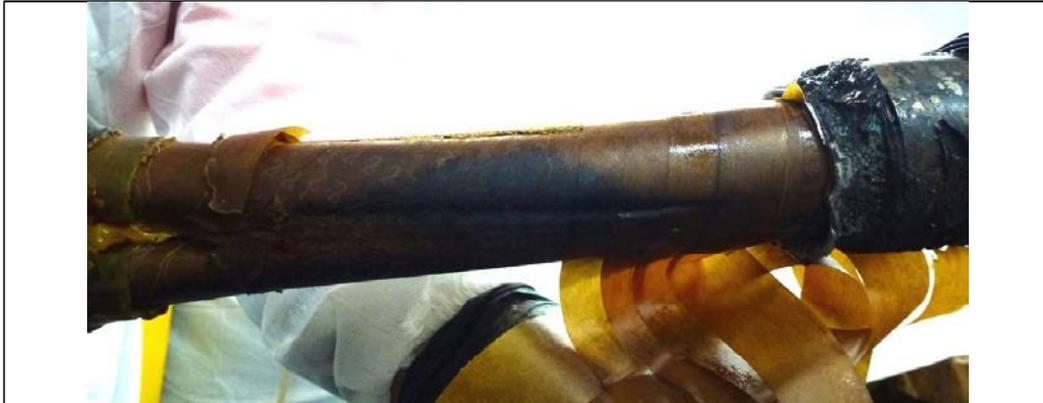
Figure 36 Large black feature between Cores No 2 and No 1

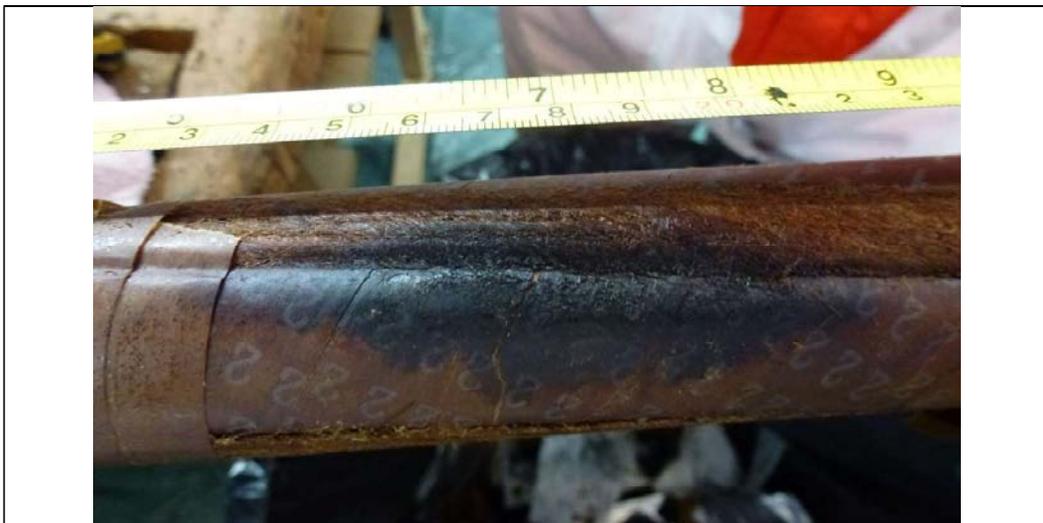
Figure 37 Black feature on the paper insulation of Cores No 2 and No 1

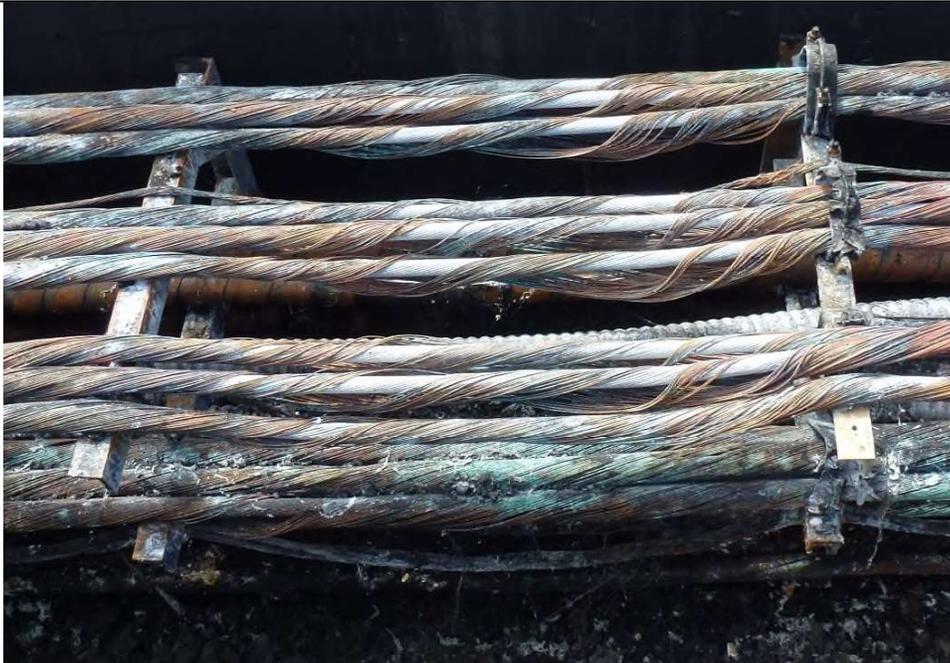
Figure 55 High fire intensity at 37 m (33 kV XLPE cables on Level 1)

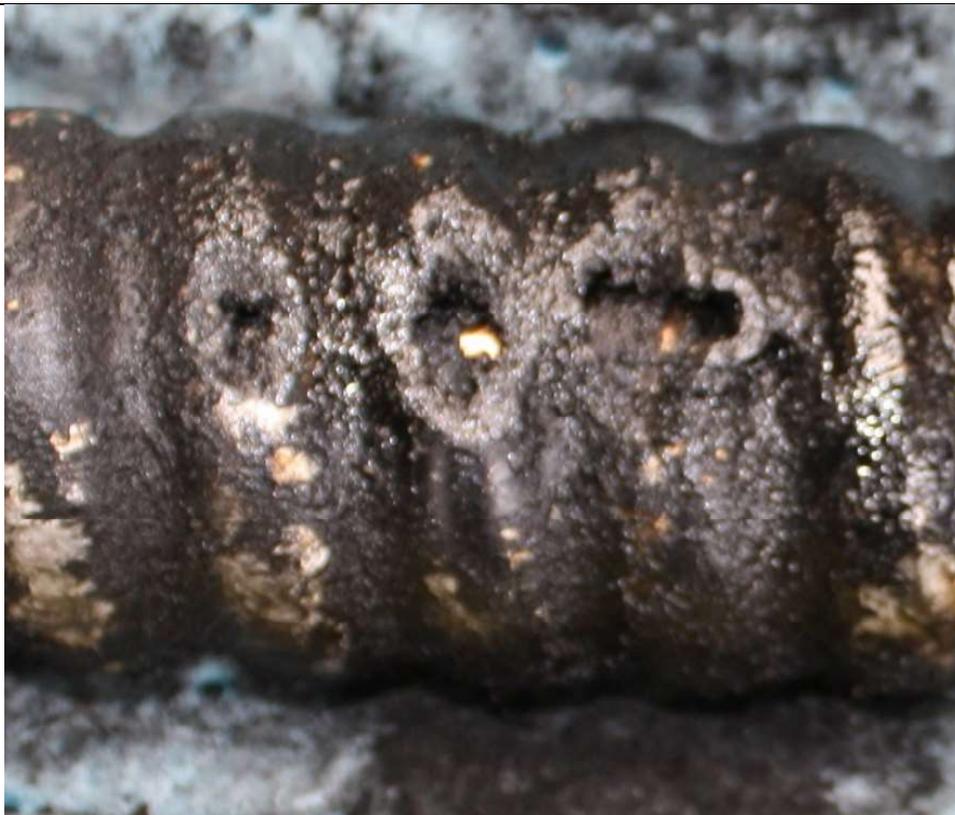
Figure 56 Holes in OF cable aluminium sheath, cable 2D0 at 66 m to 71 m

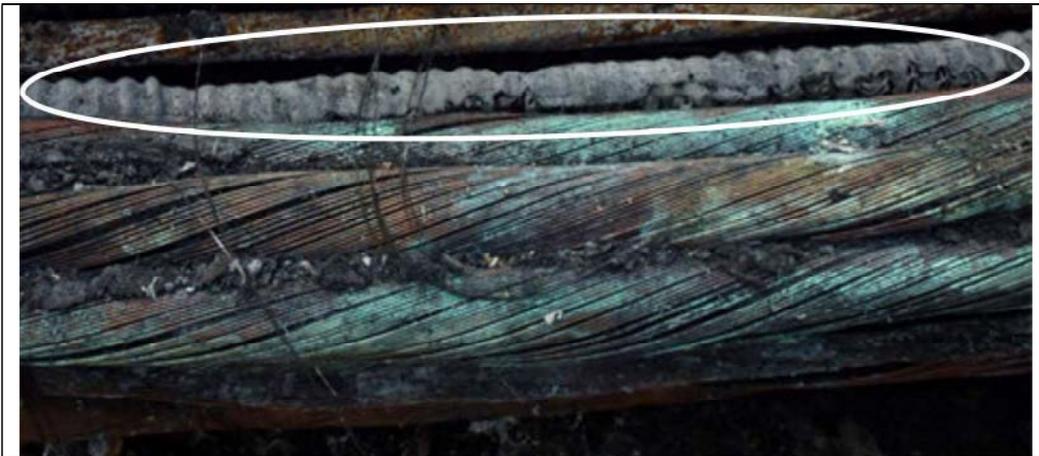
Figure 57 Heat deformed and ruptured OF cable corrugated aluminium sheath
