# Penrose substation fire inquiry report

9 November 2015

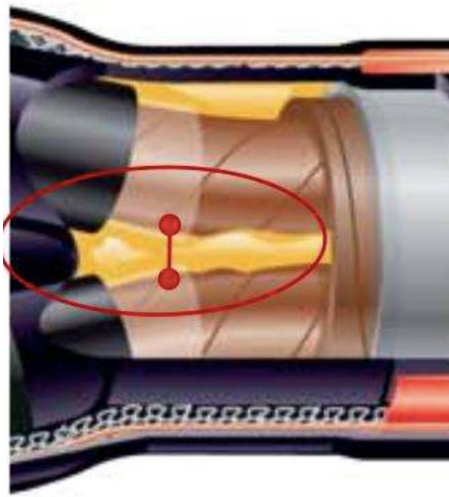
**Figure 8 – The arc position in the failed transition joint**

- 1.28 CCI concluded that the cause of the transition joint failure was a vulnerability of the transition joint design. CCI concluded that the jointing quality was satisfactory. CCI states that a number of technical factors contributed to the cable joint failure. These factors included the lack of a straight alignment of the joint and the cable, and the lack of cable cleats and joint supports.<sup>12</sup>

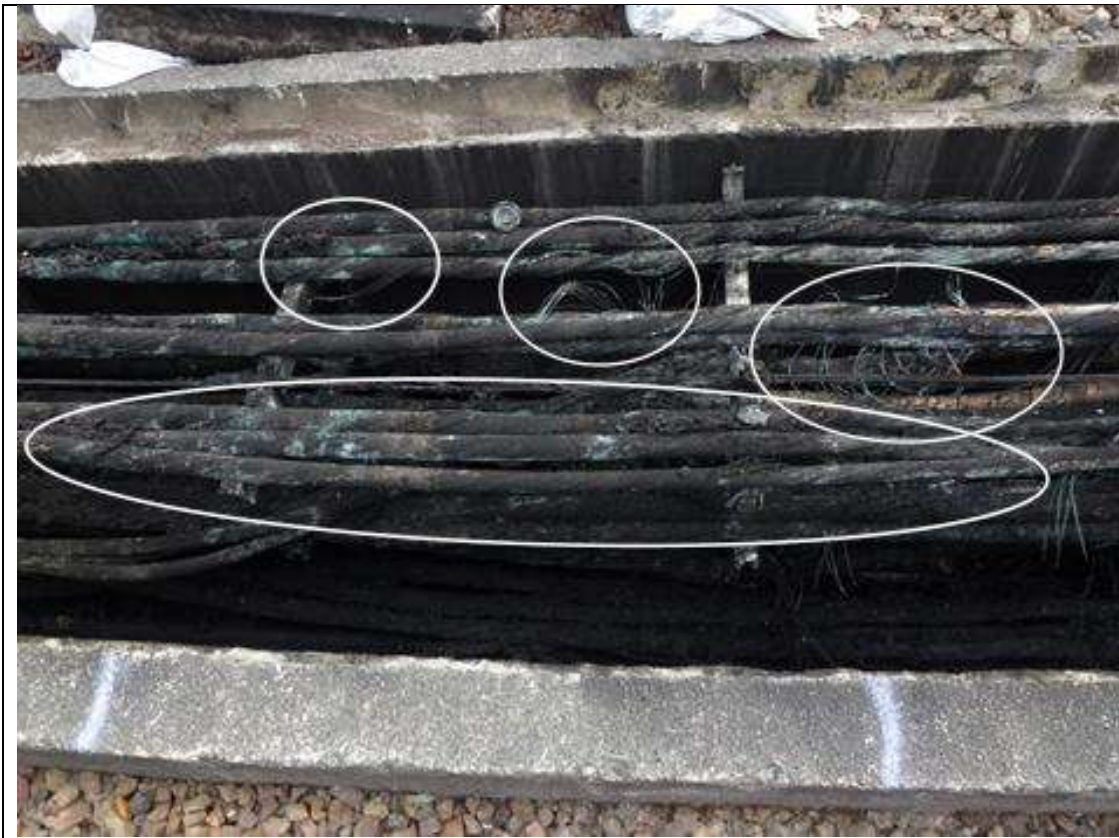
Disturbance of the outer conductor screen wires on Level 1 was seen between 72 m and 74 m, Figure 9, (the view is facing North). The disturbance is indicative of the presence of one or more short-circuit power arcs that had severed the wires and electromagnetic forces that had violently displaced both the wires from their concentric formation and the cables from their trefoil formation. It can be seen that the cable cleats on the top support arm to the right of the photograph (at 73 m) had been part burst open by the short circuit forces and part melted.

Figure 9 Disturbance indicative of violent electrical activity at 72 m- 74 m

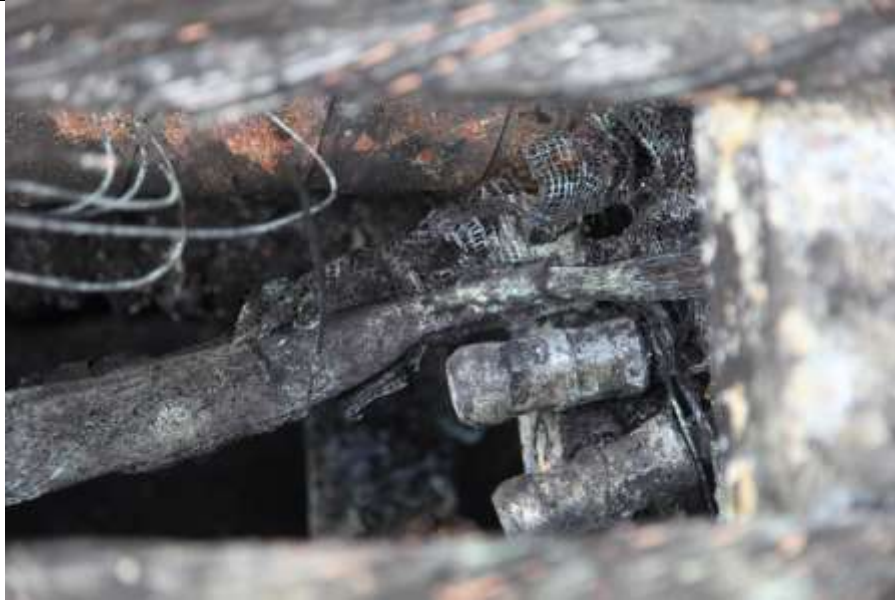
ferrule were seen to have parted and the copper conductors on the PILC cable side (to the left of the aluminium connectors) were missing.

Figure 10. Close view of failed transition joint between cable Layers 1 and 2

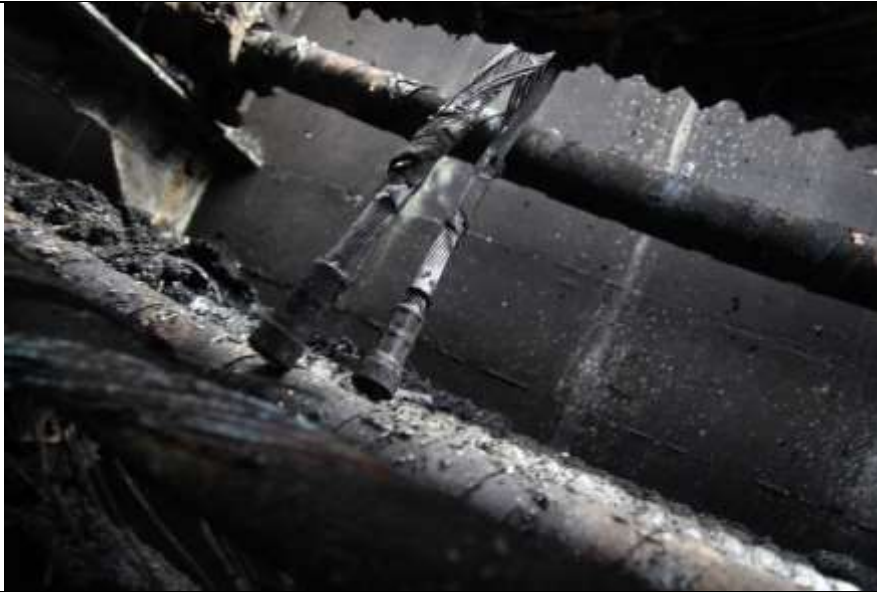
Figure 12 is a photograph taken from within the trench, horizontally between Levels 3 and 2. The three missing conductors were found. Two conductors had been partly severed by power arc burning at the end of the joint adjacent to the PILC cable and were hanging vertically downwards.

Figure 12 Two parted conductors hanging from the failed transition joint

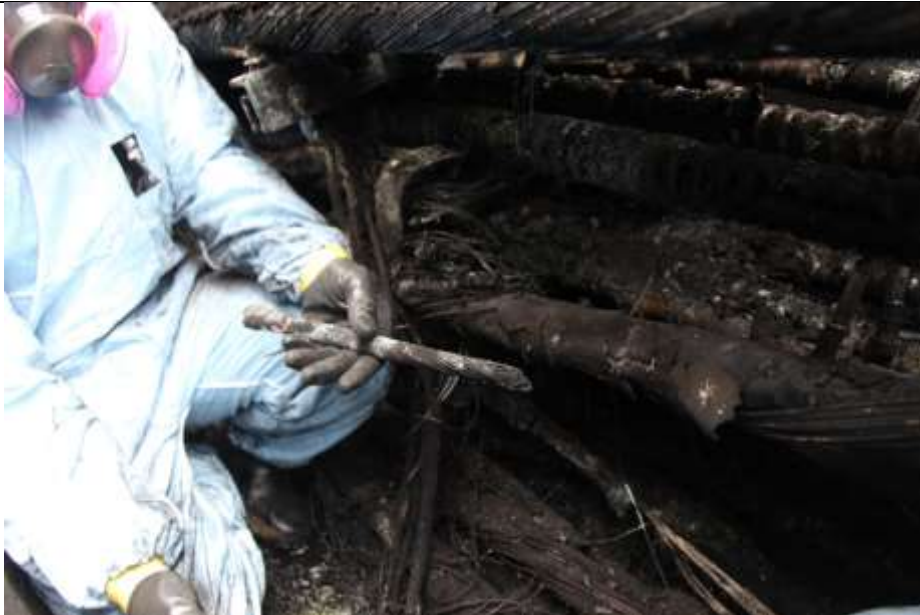
One conductor had been completely severed and had fallen downwards onto Level 3, Figure 13. All three copper ferrules were confirmed to have parted at the central bimetallic connector.

Figure 13 The severed conductor from the Remuera K10 transition joint

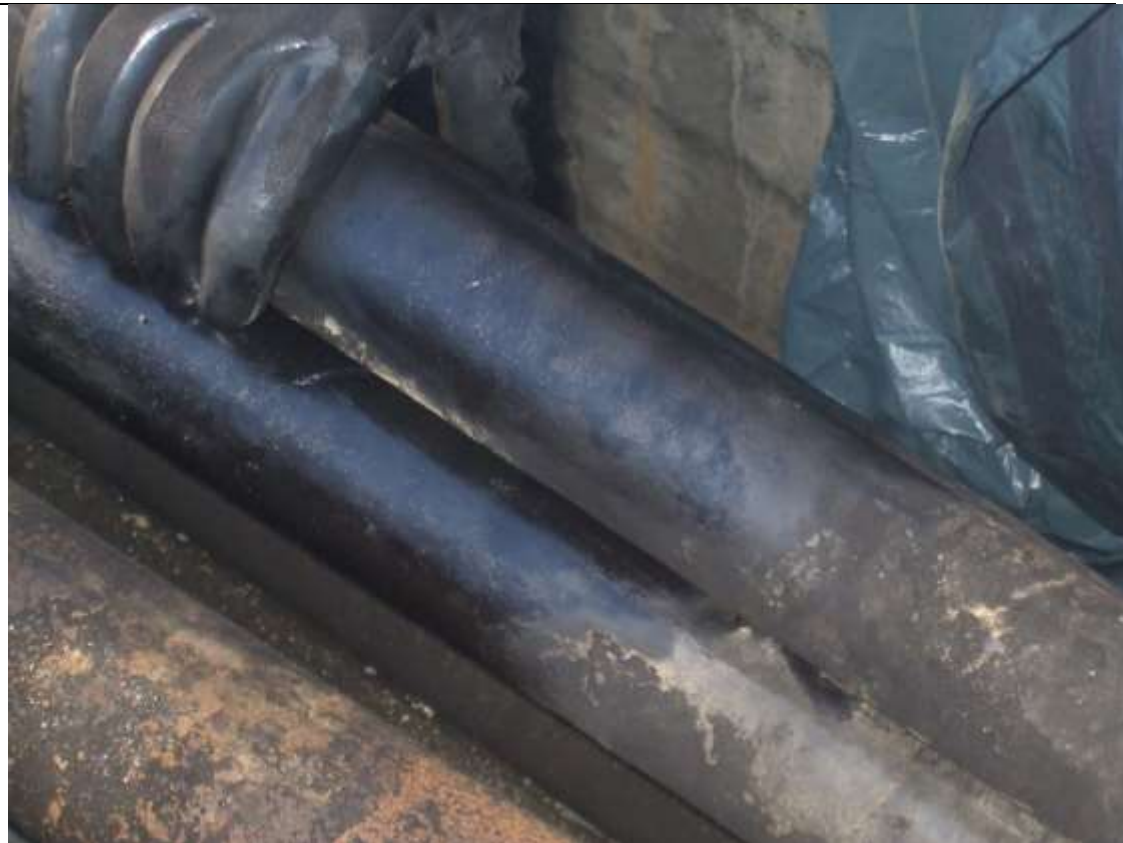
Figure 15 Char of the PE oversheath on Level 1 at 20.3 m

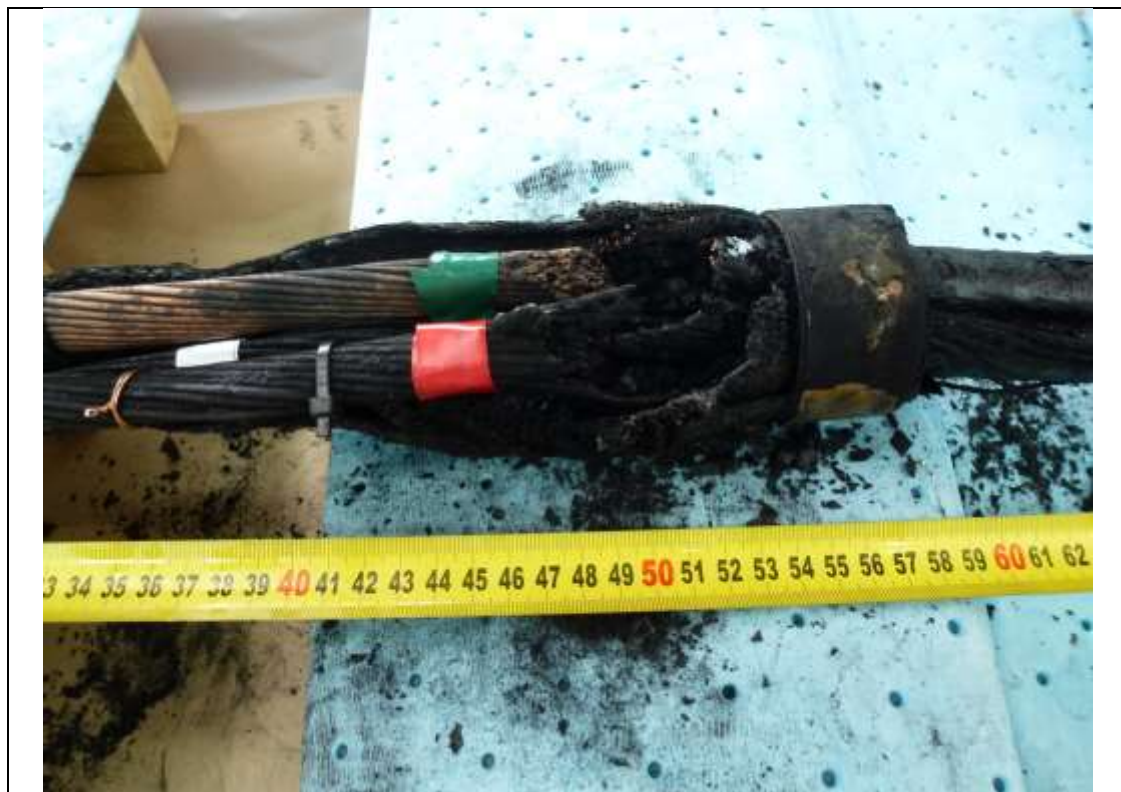
Figure 17 Failed joint: arc crater in the three conductors

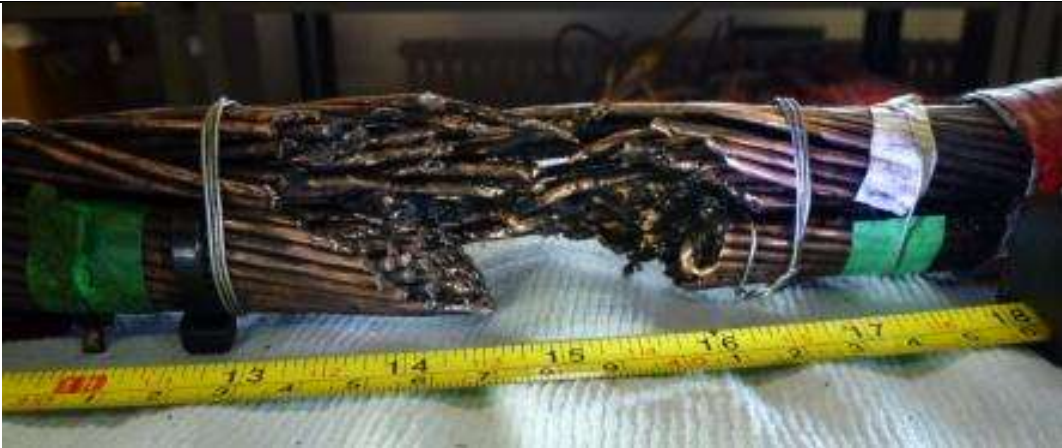
Figure 18 shows the arc crater after the conductors had been cleaned and re-assembled by the Author at Edif ERA. In both photographs the PILC cable is on the right hand side and the centre of the joint is towards the left hand side. The fault current had been fed from Remuera Substation as the cable was open ended at McNab. The sloped eroded face of the conductors on the left hand side shows that the arc was fed from the right hand side and so looped outwards under electromagnetic forces to the left.

Figure 18 Failed Remuera K 10 joint: arc crater in three conductors after cleaning and re-assembly

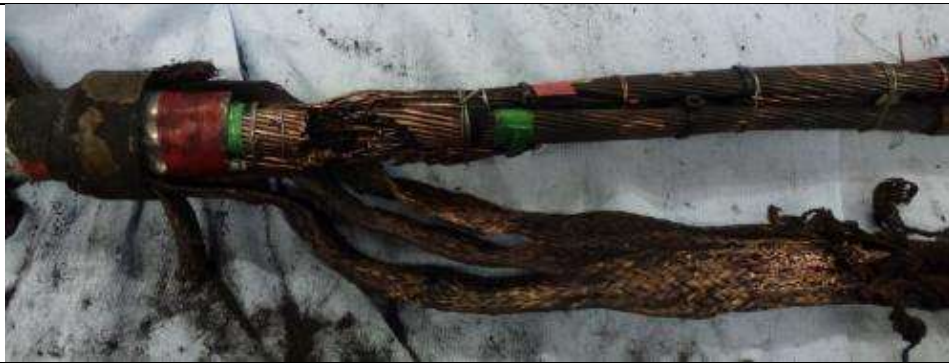
- The arc burning did not result in major erosion of the earth braid conductors. The burning had not severed the conductors and was not deep.
- The arc burning on the braid is not in radial alignment with either
  - The arc crater in the conductor
  - The parted bimetallic connectors
- There is no arc burning on the power conductors in the radial vicinity.
- The original fault was recorded as initially phase to phase and then for the majority of time as three phase. The reclose fault was recorded as three phase.

Figure 19 Failed joint: Arc burning to the earth continuity braided conductors

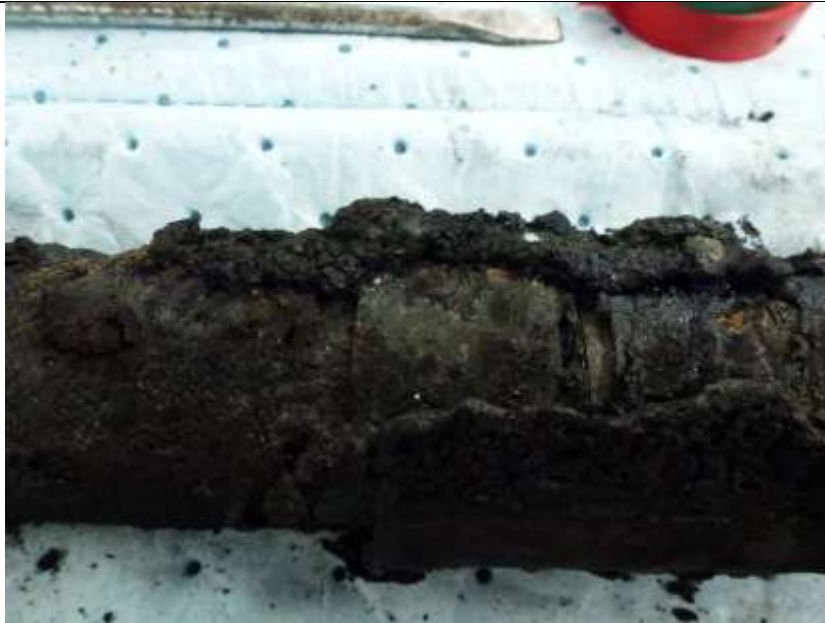
Although the fire damage had been less severe at 79 m the outer heatshrink sleeve had suffered fire damage and, although still adhered, had been burnt away along one line of its circumference. It revealed the steel roll springs that were on the lead sheath on the PILC side, Figure 23.

Figure 23 Unfailed joint. The steel roll springs could be seen on the PILC side  
The fire has also burnt along the central heat shrink packages to varying degrees to reveal part of the bimetallic connectors, Figure 24.

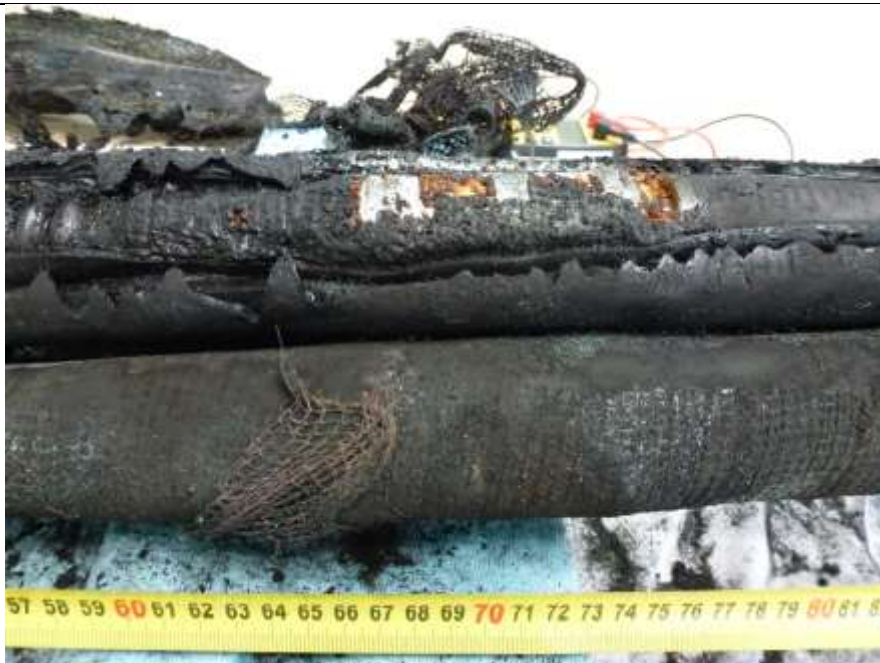
Figure 24 Unfailed joint. Fire damage to the heat-shrink insulation package  
The outer protective heat shrink sleeve was removed to reveal the internal joint components, Figure 25.

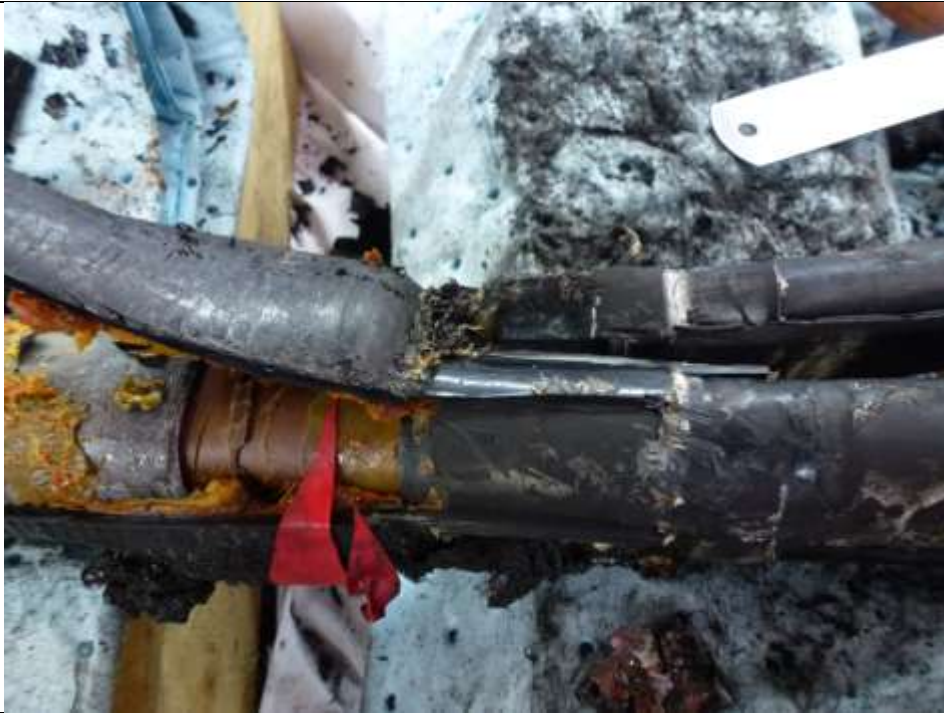
A strip of the semi-conducting heat shrink break-out was removed. The adhesive void filling yellow mastic was removed partly by cutting and partly by pulling. The PILC paper insulation was revealed comprising the core insulation and the end step in the belt's paper insulation. The measured centre-line of the arc in the failed joint was transferred to the unfailed joint (red arrow). This position is close to the end of the yellow barrier tube and adjacent to the termination of the 'belt'. The purpose of the barrier tube is two-fold, i) to prevent loss of the cable's hydrocarbon impregnating compound and ii) to prevent it from degrading the outer polyolefin heatshrink insulation and protective sleeves.

Figure 28 Unfailed joint. Arc centre is in PILC crutch close to oil barrier sleeve

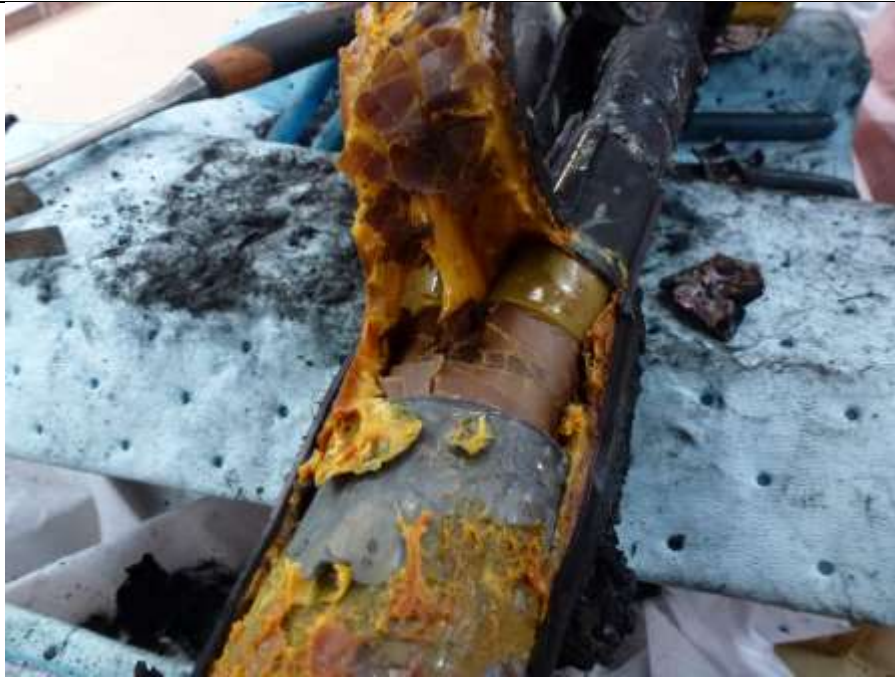
Figure 29 The mastic had not uniformly adhered to the lead sheath

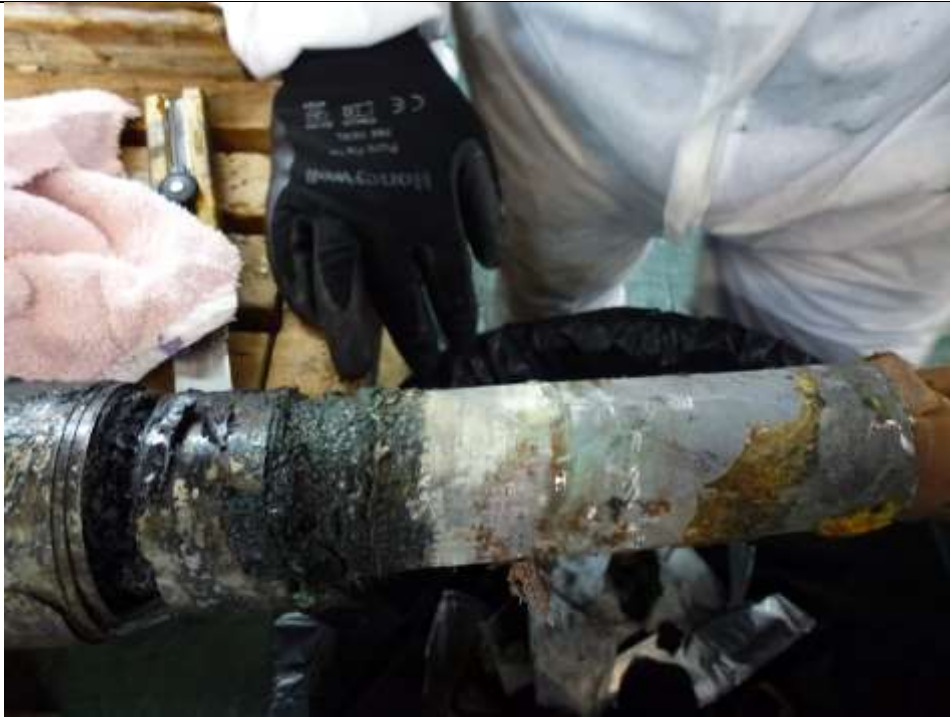
The spring roll connection of the earth braid to the lead sheath of the PILC cable was removed, Figure 32. The jointer had correctly wrapped a copper mesh over the lead sheath. However there were white corrosion products on the lead and green products on the copper mesh and also on the copper braided earth continuity conductor. In the Author's opinion this contact would have overheated and led to failure in a single core joint, in which the contact is required to carry circulating currents in everyday use and short-circuit currents in the event of a system fault. The Author could find no evidence that the connection had overheated and damaged the paper insulation within the sheath. Fortunately in a three core cable there are no circulating sheath currents, however phase to earth system faults can occur that could damage a joint that was otherwise sound. It was concluded that this was not a factor in the joint failure as i) the connector was not located adjacent to the arc cavity in the primary conductors, but at the centre of the joint and ii) the connector appeared to have been mechanically sound before the fire.

Figure 32 White corrosion products at the current contact with the lead sheath

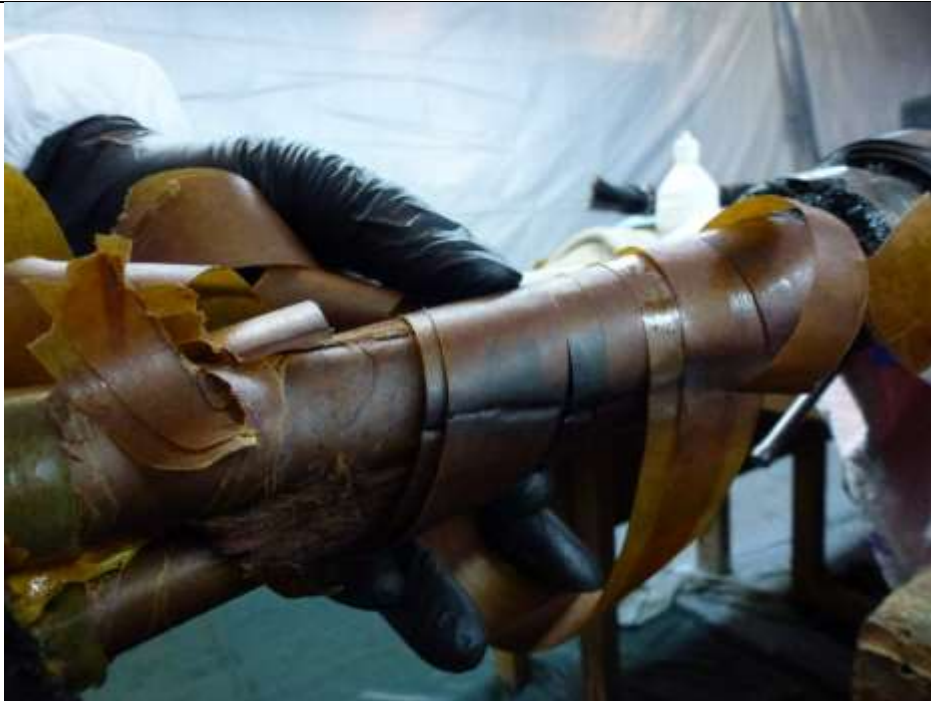
The lead sheath was removed. The belt papers tapes were largely satisfactory and still had sufficient resilience to resist cracking when bent indicating that they had not suffered excessive thermal damage from the fire. The tapes were unwound and very significant blackening uncovered in large interstitial creases immediately above the cores, Figure 33.

Figure 33 Blackening in belt creases above the core interstices

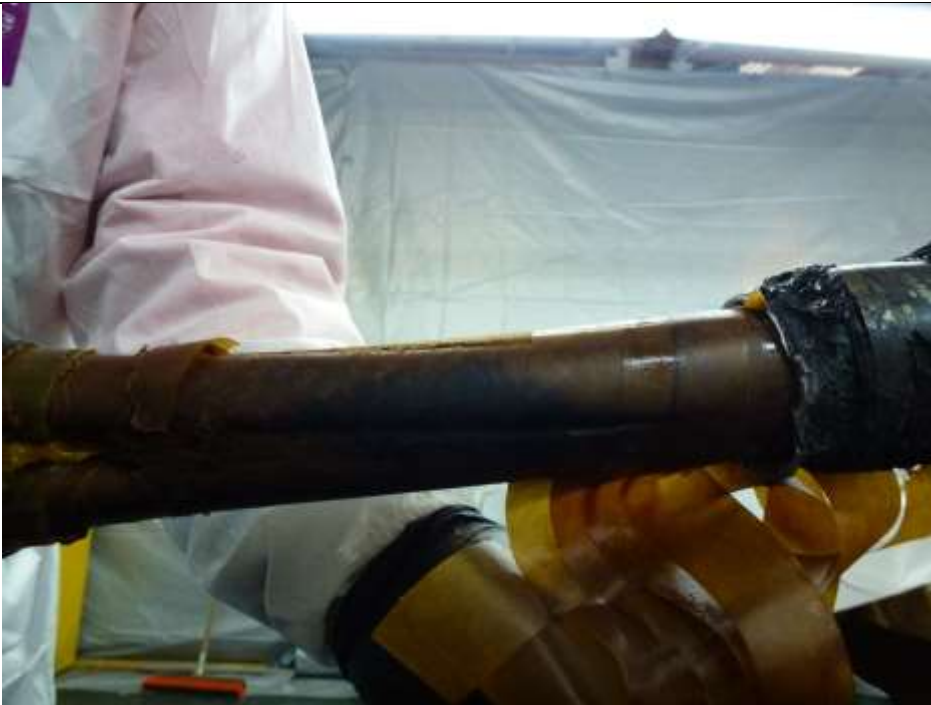
The last belt papers were removed to reveal a large black feature of 86 mm length that straddled the interstices containing the jute string fillers between cores No 2 and No 1. A smaller black feature was present between core 2 and core 3.

Figure 34 Large black feature between core 2 and 1

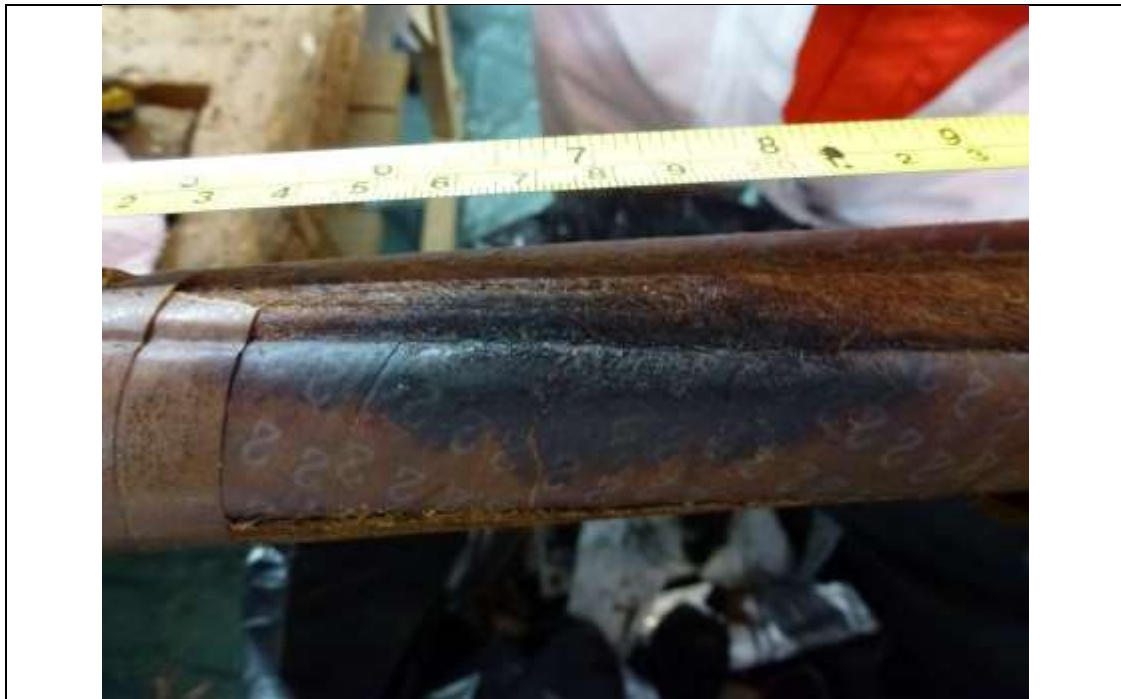
Figure 35 Black feature on the paper insulation of cores No 2 and No 1

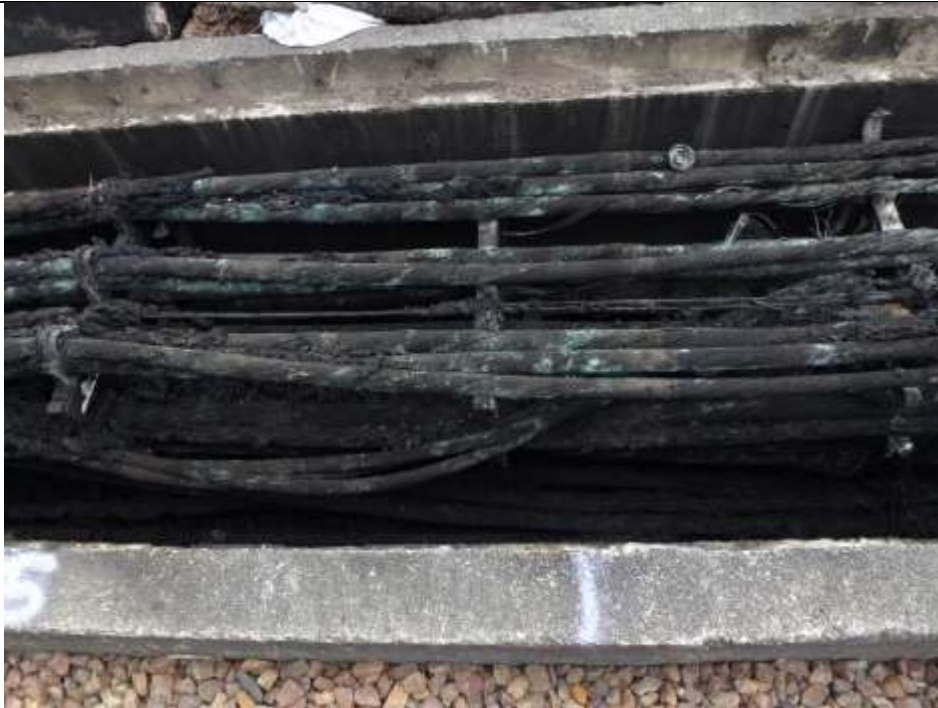
Figure 42 Bow shape in the 11 kV three core XLPE cable between 73 m and 77 m chainage

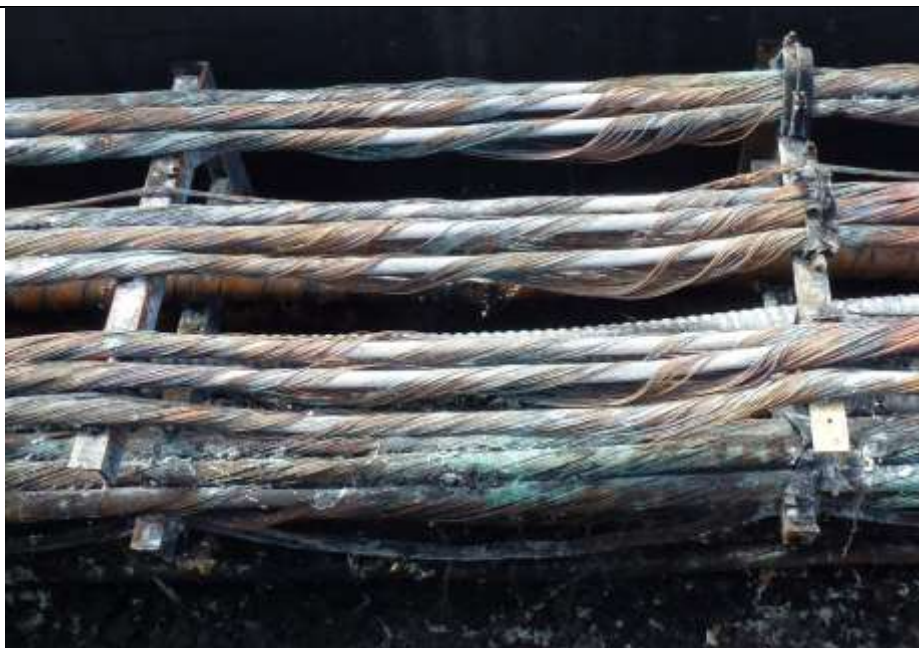
Figure 52 High fire intensity at 37 m (33 kV XLPE cables on top Level)

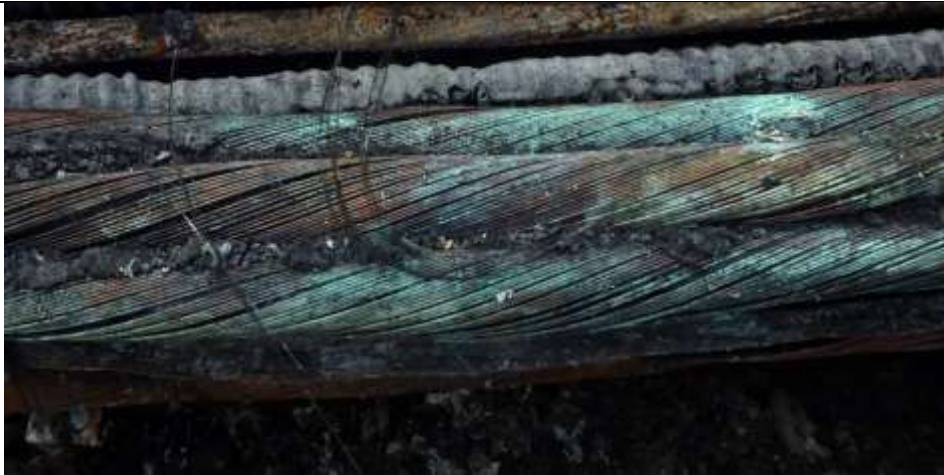
Figure 54 Heat deformed and ruptured OF cable corrugated aluminium sheath
