**ELECTRICITY INDUSTRY PARTICIPATION CODE  
DISTRIBUTED UNMETERED LOAD AUDIT REPORT**

**SOUTHLAND DISTRICT COUNCIL AND  
MERIDIAN ENERGY**

Prepared by: Tara Gannon

Date audit commenced: 19 March 2018

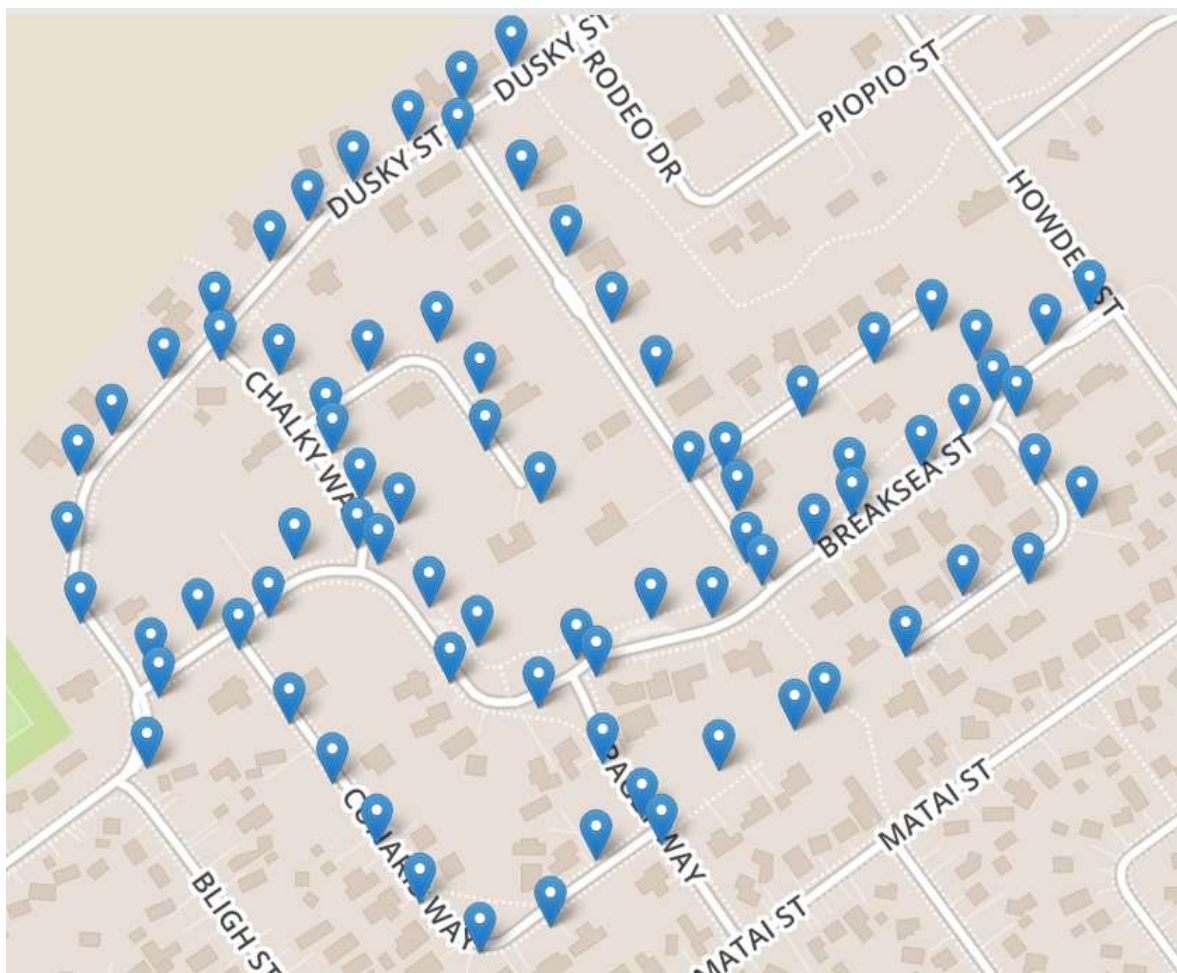
Aurora Energy's embedded network covers part of the Heritage Estate subdivision as shown in the map below. The remaining lights in the Heritage Estate are expected to be recorded in PowerNet's database. I found that some lights in Heritage Estate outside the Aurora Energy embedded network were not recorded in PowerNet's database, including:

- Some lights on Dusky Street, east of Rodeo Drive
- All lights on Rodeo Drive
- All lights on Asher Avenue
- All lights on Pounamu Drive; and
- All lights on Piopio Street.

This is recorded as non-compliance below.

Meridian will transition to using SDC's validated RAMM database as the source of information for settlement. This is currently planned for June submissions.		01 July 2018
