ELECTRICITY INDUSTRY PARTICIPATION CODE
DISTRIBUTED UNMETERED LOAD AUDIT REPORT

VERITEK

FAR NORTH HOLDINGS JETTY AND WHARF
LIGHTS BOSCO

Date audit commenced: 26 April 2018

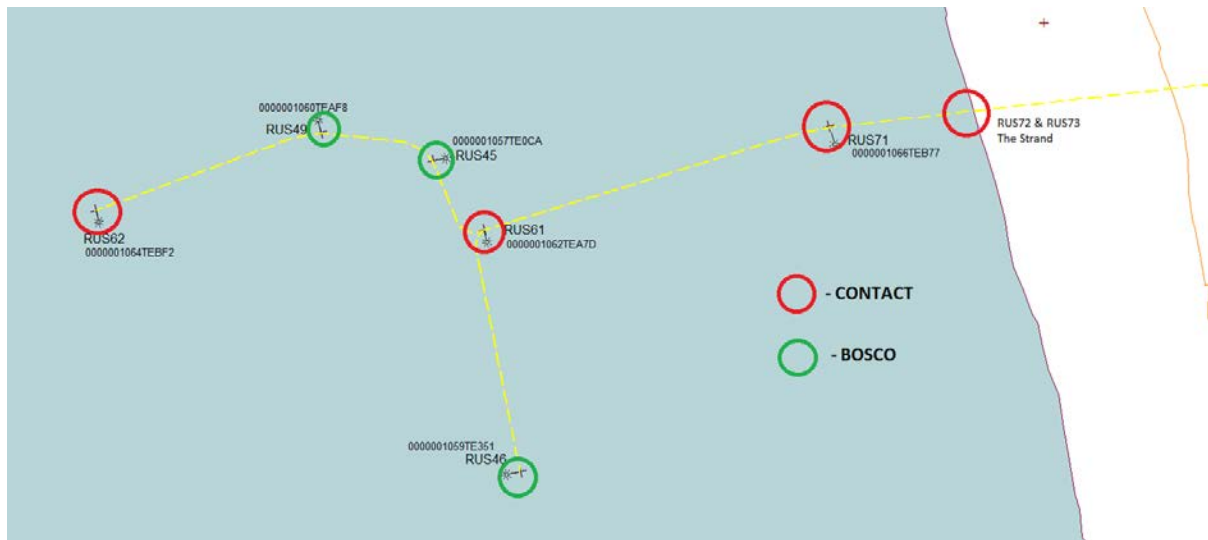
Location of lights on Russell Wharf

All load checked was recorded in the database except one extra LED lamp on the Russell Wharf and one additional 250 watt HPS on the Totara North Wharf. The lamp discrepancies are recorded as non-compliance in **section 3.1**.

I note that there is a total of 16 lights on the Russell Wharf. Contact holds ICP 0000910450TE75D which is described on the registry as “UNMETERED WHARF LIGHTS RUSSELL”. Top Energy have provided a drawing detailing the light locations on the Russell wharf, I have included this below. The drawing confirms that there are lights under both the Bosco ICP 0000003947TE02E and Contact ICP 0000910450TE75D. I recommend that a full audit of these lights be undertaken to ensure that the correct load is recorded against each ICP and to determine if the lights should be consolidated onto one ICP if they are on the same circuit.

Recommendation	Description	Audited party comment	Remedial action
Regarding: Clauses 11(3) of Schedule 15.3	Work with Contact Energy to determine correct recording of the Russell Wharf lights.	As a first step Bosco will be contacting the customer to understand their needs.	Investigating
