OIA request - 2 March 2017 South Island AUFLS event

Determining the causes of the 2 March 2017 under-frequency events

Field Issues Investigation Report

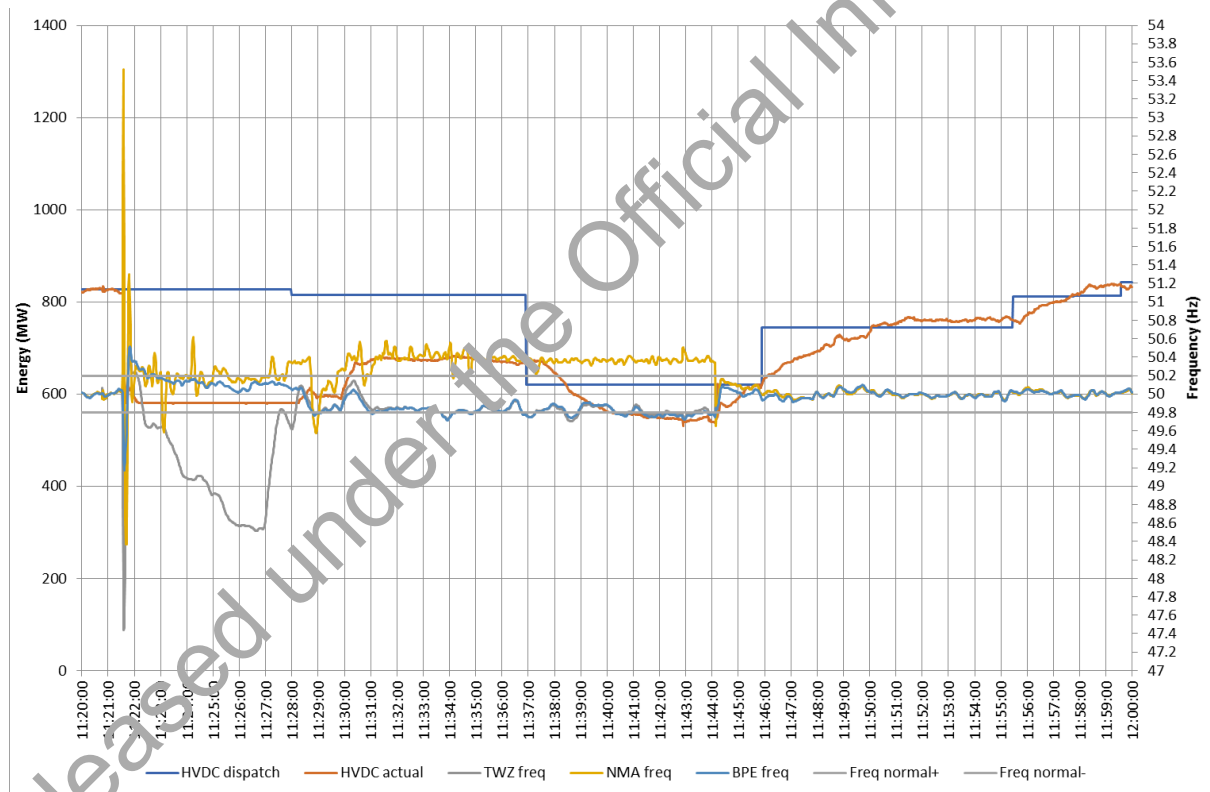
Figure 4 – HVDC link response vs. dispatch, and system frequencies during the event. Note HVDC transfer (red line) drops immediately following event and remains at minimum modulation until TWZ system frequency returns to the normal band. HVDC transfer and dispatch only converge following South Island re-synchronisation at 11:44.

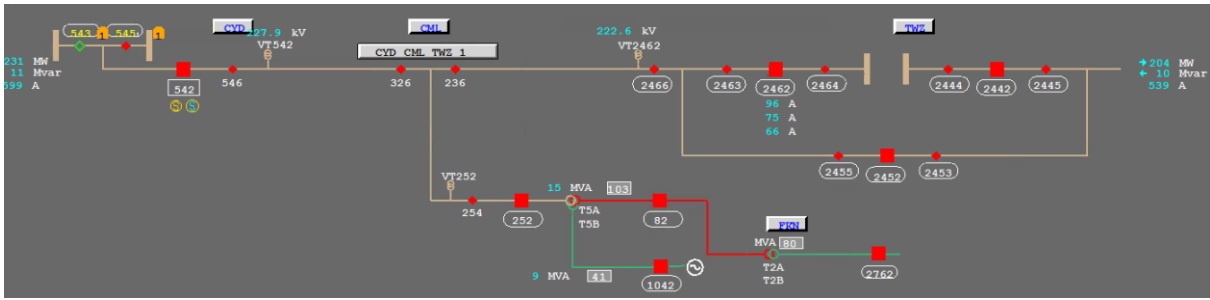
Figure 6 – SCADA single line display of CYD_CML_TWZ_1 circuit. Note symbols below CB_542 on left hand side of the display indicating this breaker has Autosync available.

The procedure to operate Autosync was not accessed (or followed) during this period. When the security co-ordinator instructed the action to close the circuit breaker and the grid asset controller attempted to operate Autosync, normal manual switching occurred instead. Neither the security co-ordinator or the grid asset controller were aware of the misalignment in island frequency and phase angle; they simply saw that the circuit breaker had closed, and current was flowing on the circuit. The security co-ordinator and grid asset controller then proceeded with switching to restore the second circuit.

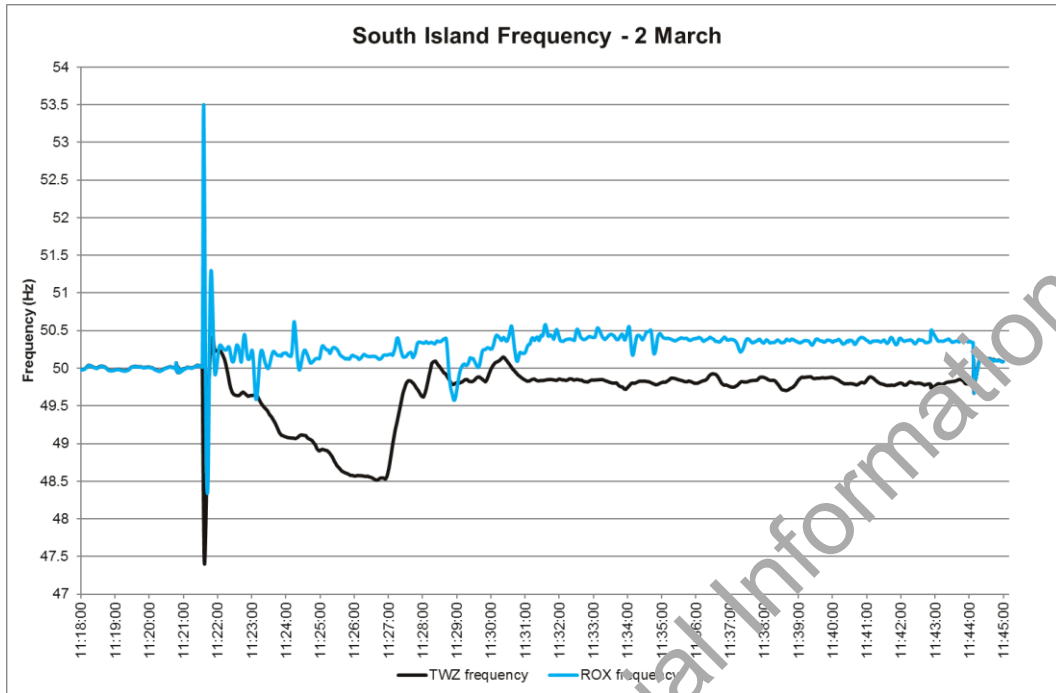
Figure 1 – South Island frequency from two minutes pre event until re-synchronisation.

In the Upper South Island system there was a second fall in frequency which reached a low of 48.52 Hz about 5 minutes after the event. This was due to an unexpected reduction in power at the Aviemore generation station. The cause of the reduction has been identified and rectified.

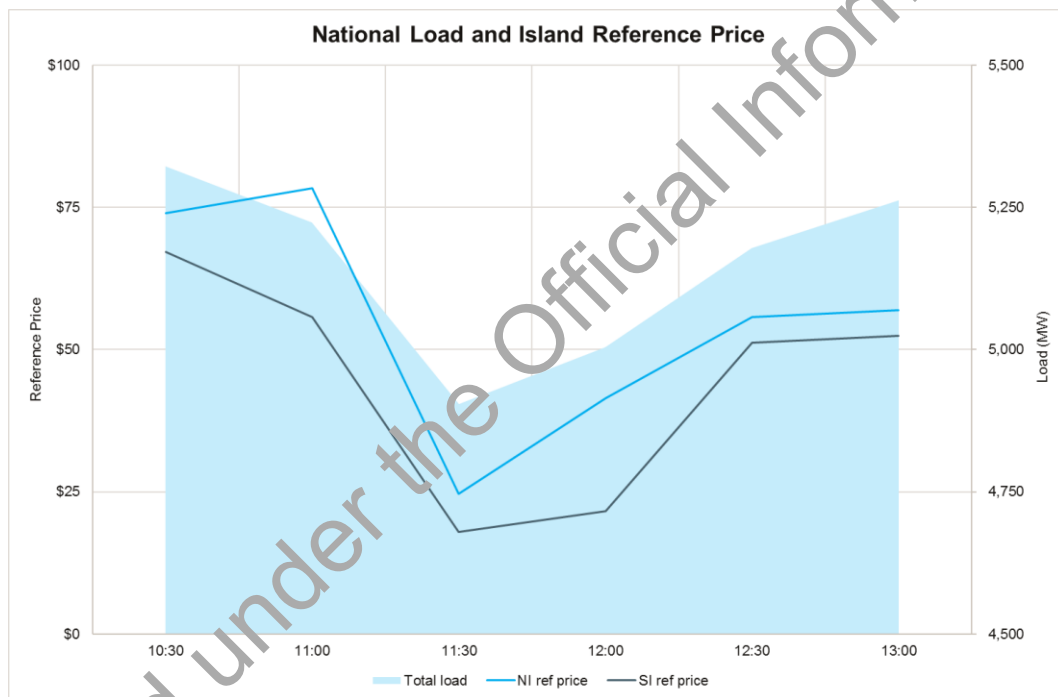
Figure 3 – National load drop and island reference price effects

In the North island, interruptible load operated in response to the under frequency event. AUFLS operated in the upper South Island. Each combined to materially reduce national load (shown in Figure 3). The unexpected lower load caused prices to fall sharply, by approximately \$50 per MWh. Prices gradually increased as load was restored in stages, returning to normal by the 13:00 trading period.

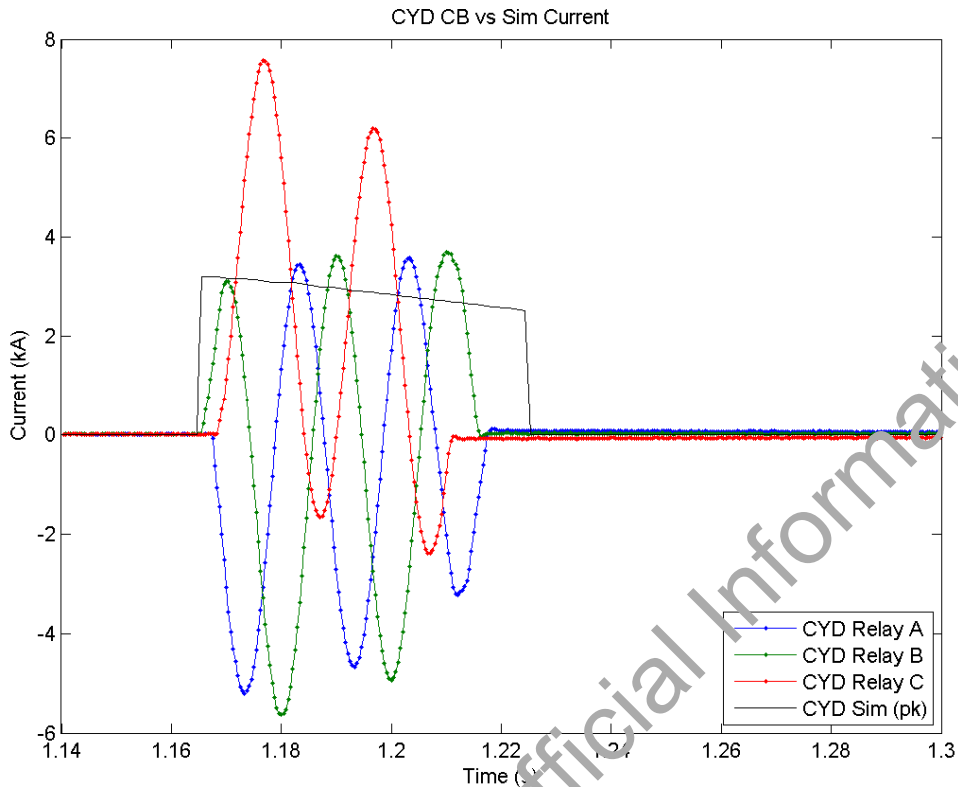
Figure 5A. 1st Attempt to Re-synchronize – Current in Clyde Circuit Breaker

The two out-of-phase re-synchronizations resulted in disturbances to the system and raised concerns that damage may have occurred to generators. The torques on the generators are not recorded but they can be estimated by calculation.

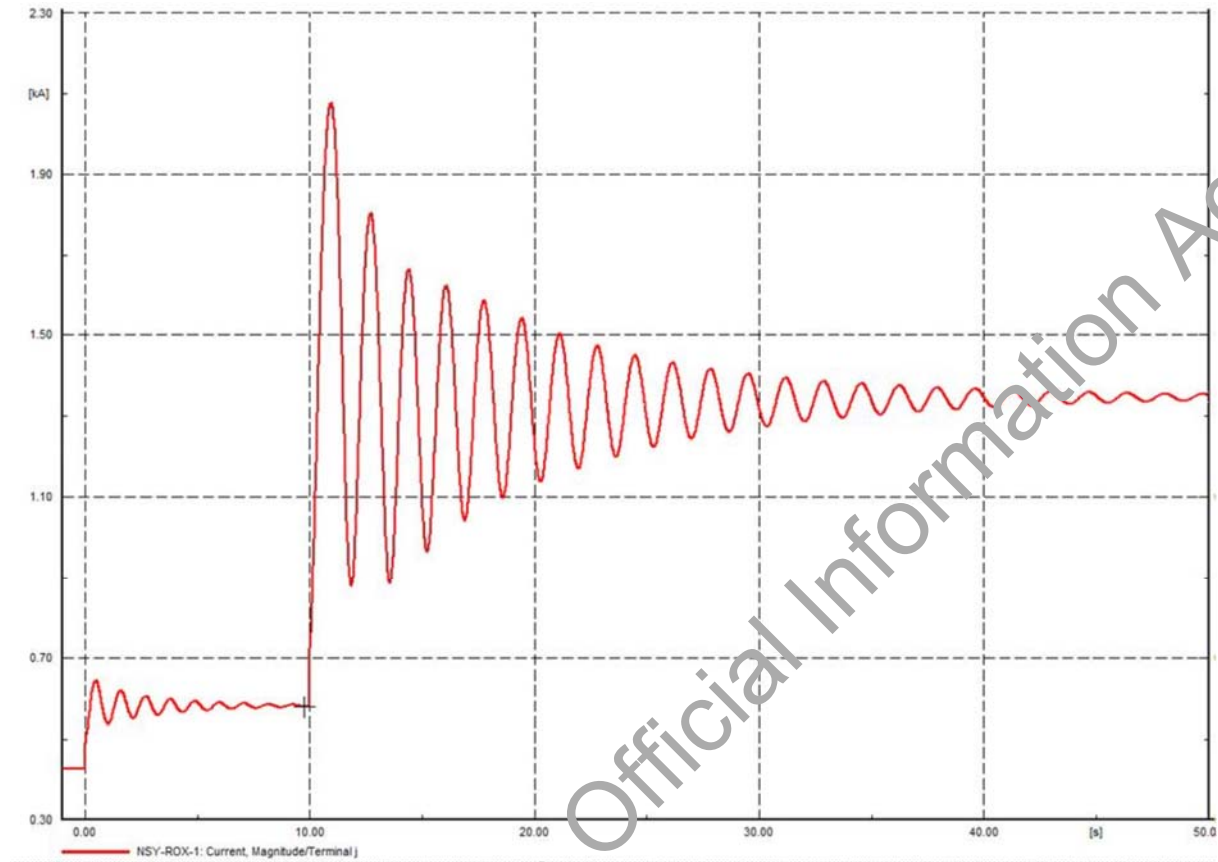
Figure 9. Simulated Current Oscillations on Naseby – Roxburgh Circuit (kA)

The simulations suggest that if the Clyde – Cromwell – Twizel circuits had been tripped whilst the Livingstone – Naseby – Roxburgh circuit was still in service then the network split would still have occurred.

PSC recommends that Transpower's outage planning process considers the effect of N-2 contingencies when there is a heightened risk associated with protection maintenance work.

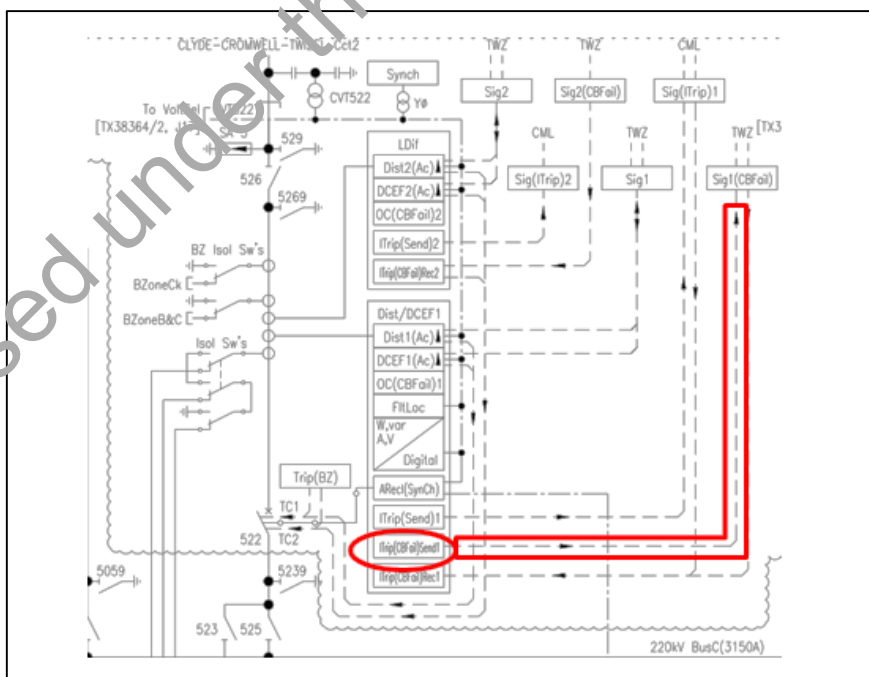
For the Clyde bus zone and CB fail WMS preparation the technicians first consulted the R & I diagram. He observed the intertrip to Twizel originating from within the line protection. With no bus zone CB fail initiation input into the Twizel line protection shown, he concluded that the ITrip (CBfail) was contained completely within the line protection. He noted that CLD-CRM-TWZ 1 had a note saying "CB fail from external timer not shown". He puzzled over why one circuit had this note.

It is noteworthy that the specification guiding the requirements for relay and instrument diagrams has been updated to require CB fail initiate paths to be shown with a broken orange line.

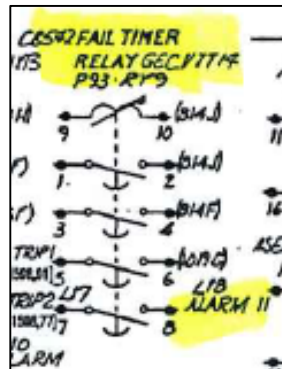
For CLD-CML-TWZ-1 the altered use of the contact was not shown.

This contact is now used to drive an auxiliary relay to provide contacts for the bus zone CB fail intertrip.

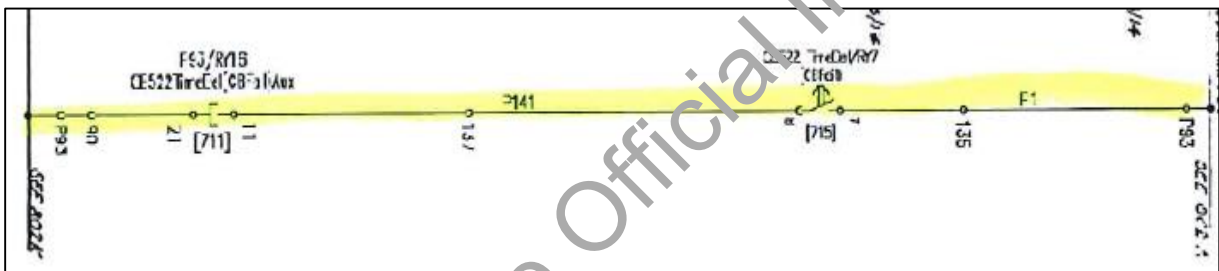
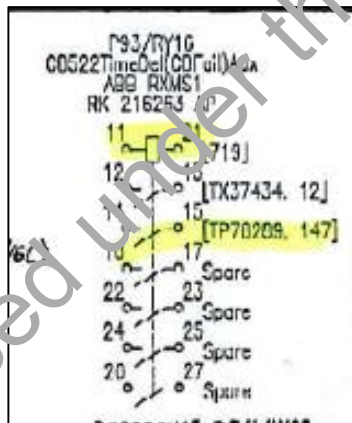
For CLD-CML-TWZ-2 the modification to the circuitry is shown, see drawing below:

These contacts are used for the bus zone CB fail intertrip modifications. Other drawings need to be consulted to understand the function.
