**ELECTRICITY INDUSTRY PARTICIPATION CODE  
DISTRIBUTOR AUDIT REPORT**

**POWERCO**

Prepared by: Rebecca Elliot

Date audit commenced: 8 June 2018

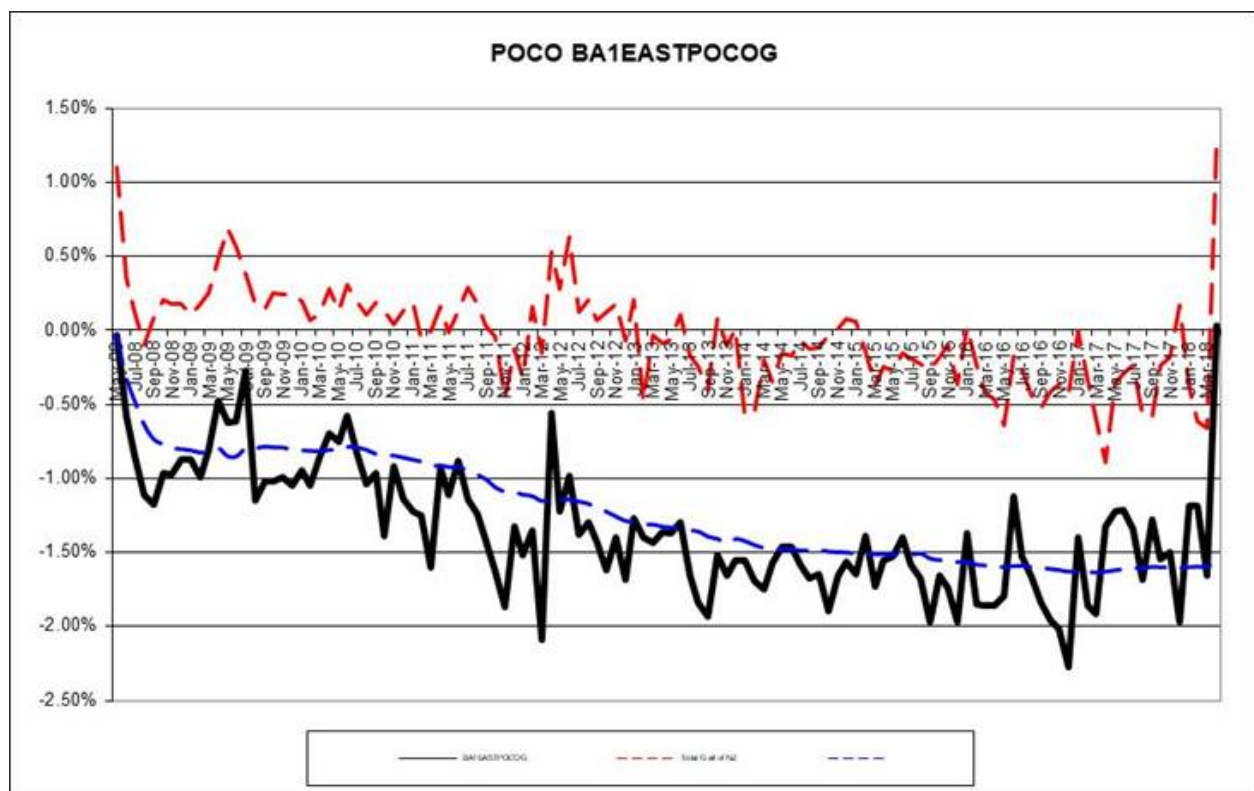
Assessment of all the balancing areas using the rolling UFE figures provided by the Electricity Authority. I identified one balancing area where the losses appear to be too high as the rolling UFE is -1.5% as detailed in the graph below:

The balancing encompasses the Tauranga area with 63,757 active ICPs. The losses are not accurate for this balancing area. I note that the unaccounted for electricity (UFE) is allocated to traders so there is no adverse impact on reconciliation, however traders will make pricing decisions based on published loss factors and if the factors are not accurate this may have an impact. New traders in particular may rely more on published loss factors because they will not have their own history.
