**ELECTRICITY INDUSTRY PARTICIPATION CODE
DISTRIBUTED UNMETERED LOAD AUDIT REPORT**

NZTA TAUPO AND TRUSTPOWER

Prepared by: Rebecca Elliot

Date audit commenced: 12 November 2018

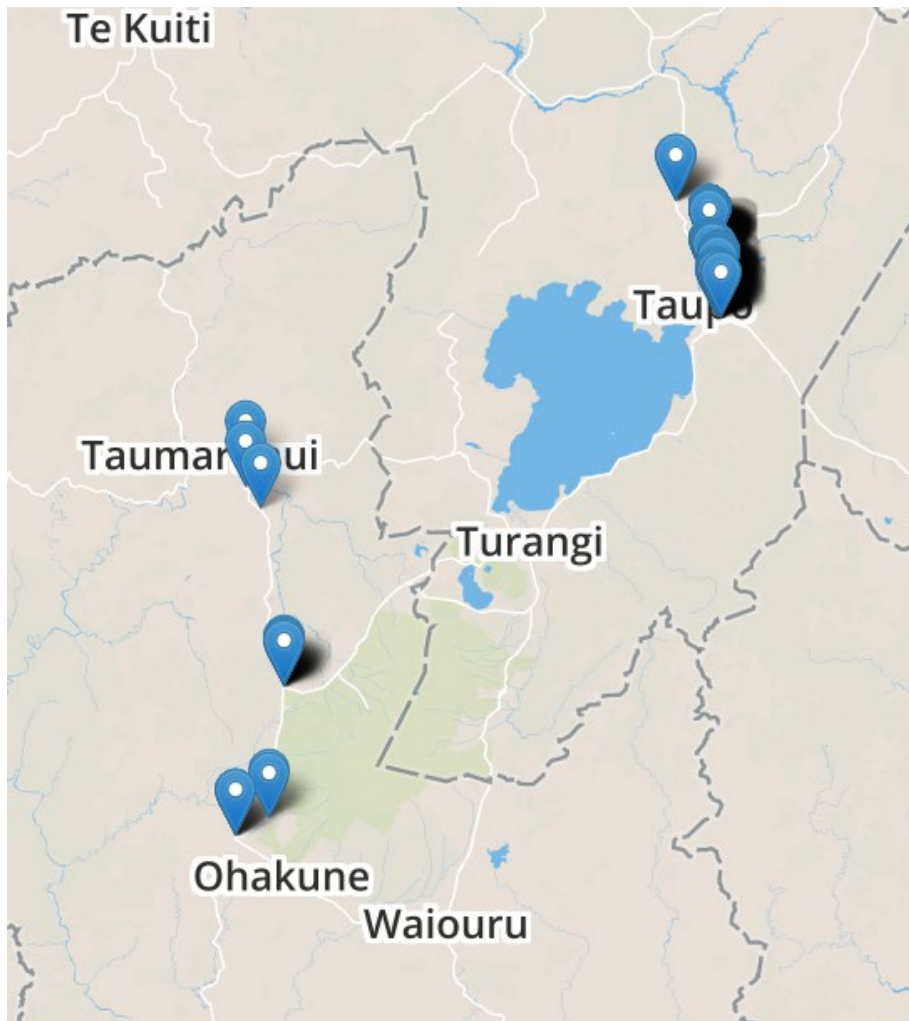
Trustpower reconcile 23 items of load on the Unison network ICP for this load. I identified 22 lights in the database on State Highways 4, 32 and 47. These lights are located on the Lines Company network. These can be seen in the picture below:

I recommend that Trustpower liaise with the relevant parties to determine where and if the additional lights are being reconciled.
