ELECTRICITY INDUSTRY PARTICIPATION CODE
RECONCILIATION PARTICIPANT AUDIT REPORT

POWERSHOP NEW ZEALAND LTD

Date audit commenced: 16 July 2019

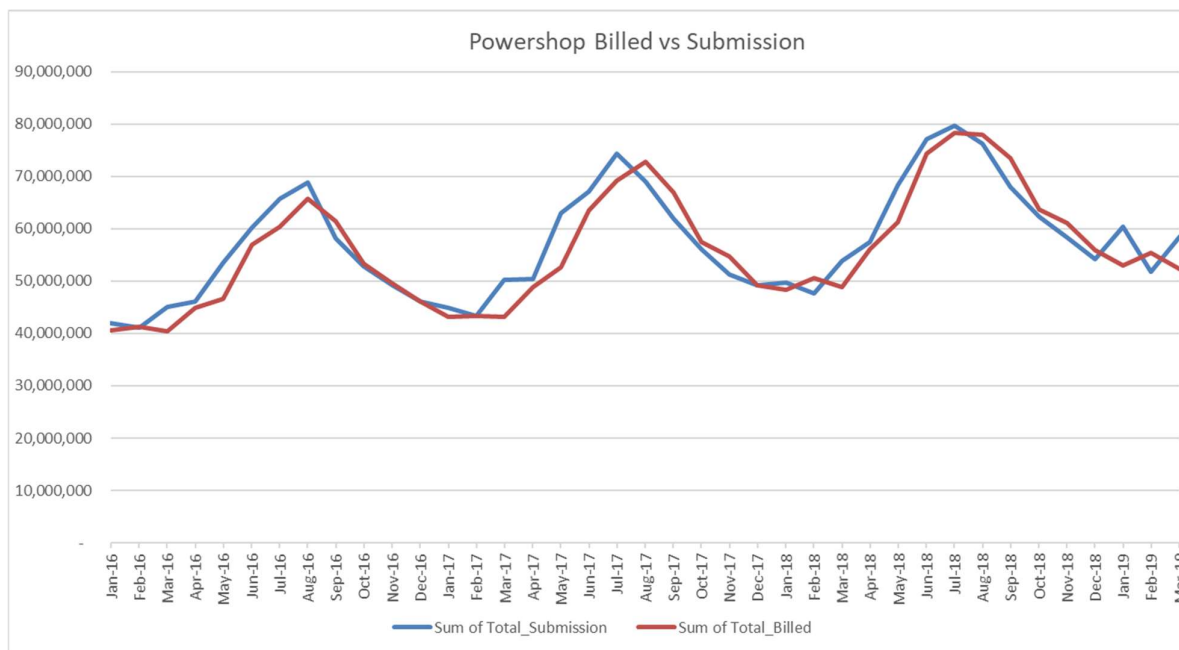
The chart below shows a comparison between submission and billed volumes. At an aggregate level, submitted data is 1.3% higher than billed data for the year ended March 2019 and 1.4% higher than billed data for the two years ended March 2019. This is an improvement from a 3.7% difference between billed and submitted data found in the 2018 audit. Investigation following the 2018 audit found that the AV120 report was including invoices generated before the last day of the submission month, instead of including the last day of the submission month. The change was released into production on 17/08/18 and revision submissions have been provided.

I checked the spike in submission for January 2019 and found it related to one ICP which switched in with a very high switch read. The billed data was correct, and the difference in submission data has now been washed up following a read renegotiation.
