**ELECTRICITY INDUSTRY PARTICIPATION CODE
DISTRIBUTOR AUDIT REPORT**

UNISON NETWORKS LIMITED

Prepared by: Steve Woods, Veritek Limited

Date audit commenced: 28 January 2020

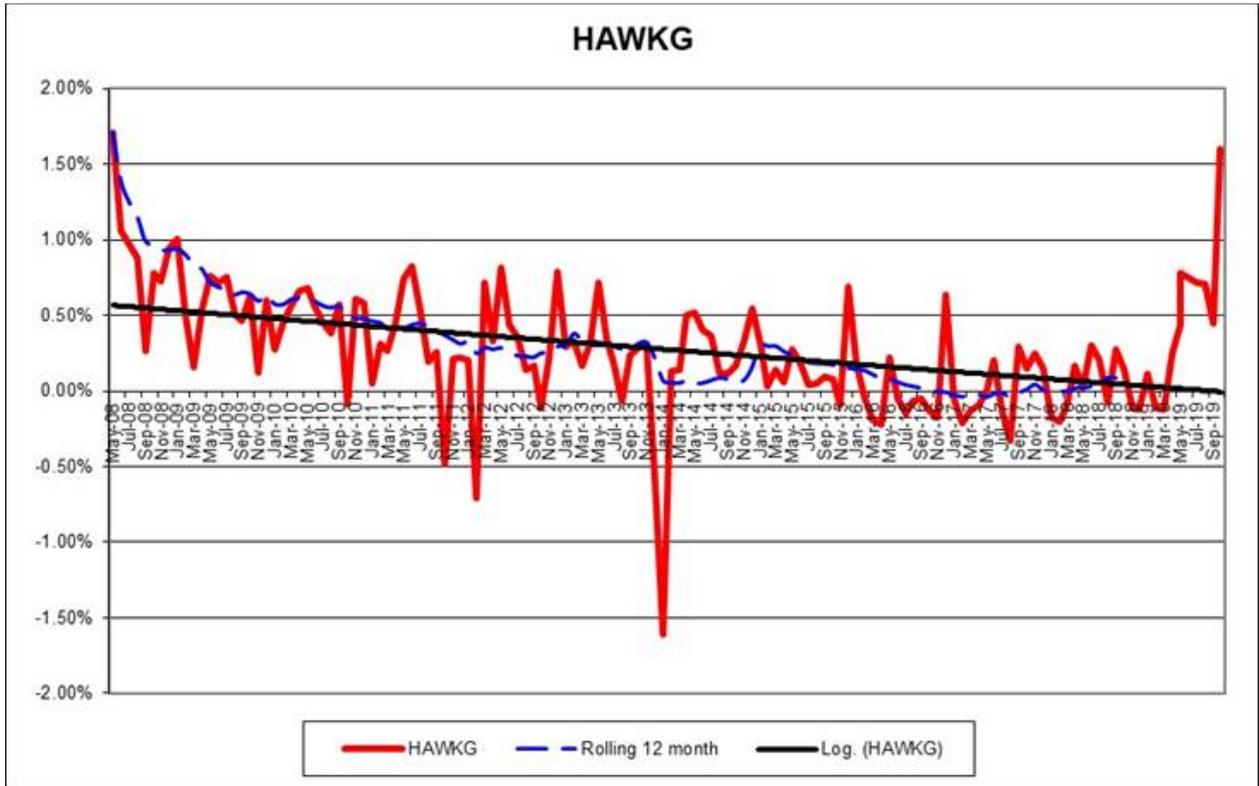
The Electricity Authority provided the reconciliation losses which indicate losses are tracking within the +/- 1% threshold indicated in the guideline. The Electricity Authority confirmed that by the 14-month wash up, losses were tracking at less than 0.1% (0.1 to -0.05%) since April 2016.
