ELECTRICITY INDUSTRY PARTICIPATION CODE DISTRIBUTED UNMETERED LOAD AUDIT REPORT

NAPIER CITY COUNCIL AND GENESIS ENERGY

Prepared by: Steve Woods

Date audit commenced: 4 May 2020

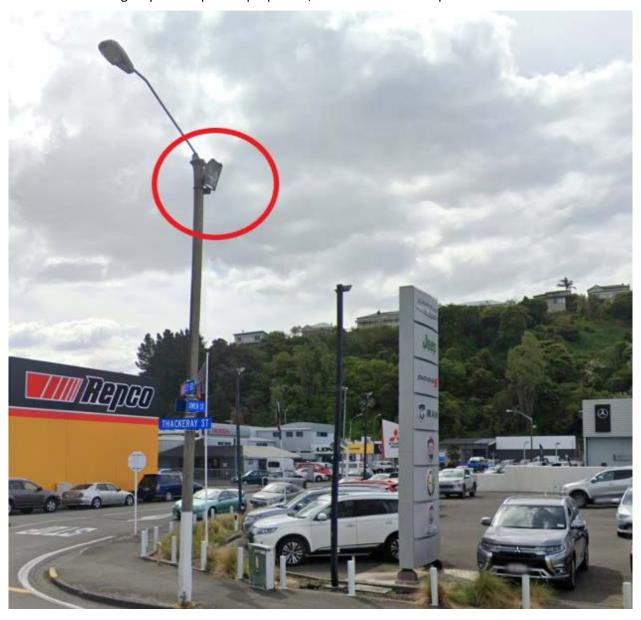
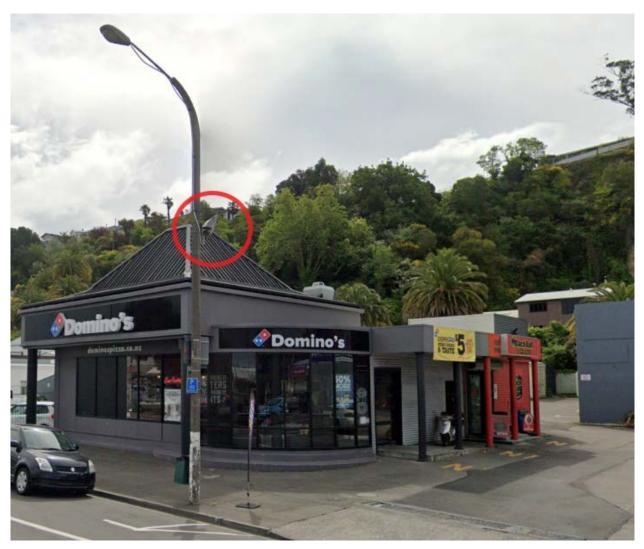
This matter was raised with Unison during their distributor audit and they had evidence for a small number of lights that they were originally owned by NCC when they were installed. Many of the lights in rest homes, council flats or commercial premises could be the responsibility of the owner of the customer network, depending on how they are connected. Unison is investigating the connection arrangements for 121 items of load, but 49 of the 170 are recorded against one of the NCC ICPs but are excluded from reconciliation. Most of the 49 are where additional lights have been connected to existing streetlights and are illuminating carparks or private properties, as shown in the two pictures below.

I've recorded non-compliance for the under submission, because these 49 items of load have ICPs, therefore alternative arrangements need to be made for reconciliation before Genesis excludes them from their reconciliation.
