**ELECTRICITY INDUSTRY PARTICIPATION CODE
DISTRIBUTED UNMETERED LOAD AUDIT REPORT**

**NZTA HAWKES BAY AND MERIDIAN
ENERGY**

Prepared by: Steve Woods

Date audit commenced: 1 February 2021

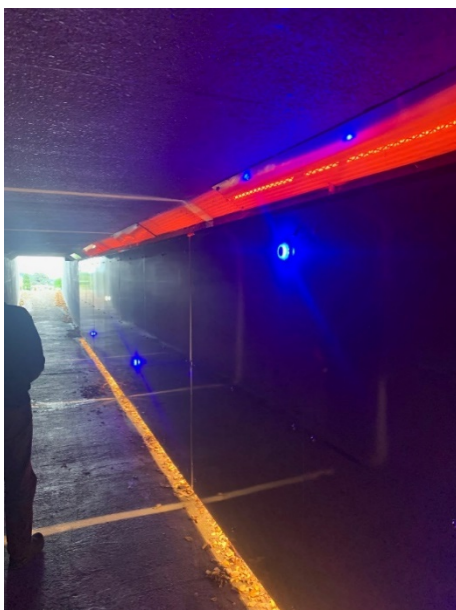
As recorded in the previous audit for ICP 0000939905HB23E, the Burness Road underpass lights are recorded in the database as 3x 36W fluorescent light. These lights have been replaced with an LED panel that is on 24 hours a day (see picture below for reference). It is thought that these are connected to the metered pump supply which is housed at one end of the tunnel. This was being investigated at the time of the previous audit. If these are unmetered LEDs, then a new ICP needs to be created to correctly reconcile this load. The 3 x 36W fluorescent lights should be removed from the database. This is recorded as non-compliance in **section 3.1** as part of the database accuracy clause.

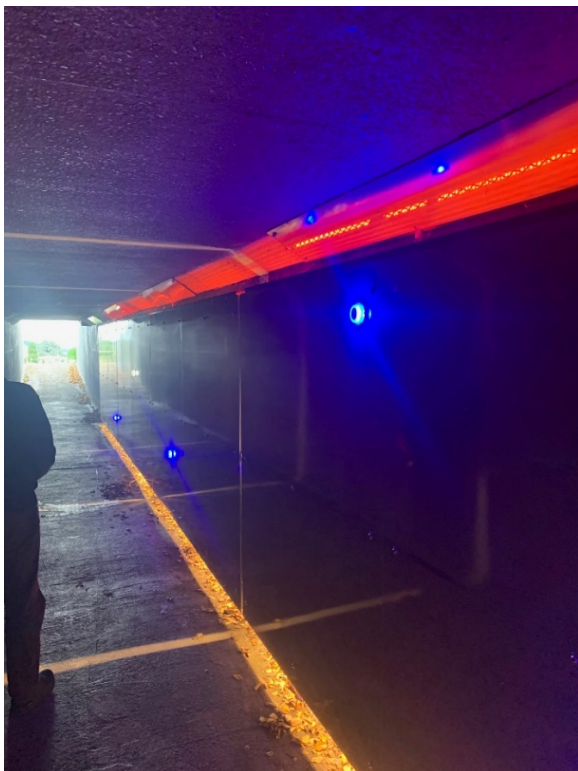
As recorded in the previous audit for ICP 0000939905HB23E, the Burness Road underpass lights are recorded in the database as 3x 36W fluorescent light. These lights have been replaced with an LED panel that is on 24 hours a day (see picture below for reference). It is thought that these are connected to the metered pump supply which is housed at one end of the tunnel. This was being investigated at the time of the previous audit. If these are unmetered LEDs, then a new ICP needs to be created to correctly reconcile this load. The 3 x 36W fluorescent lights should be removed from the database. This is recorded as non-compliance in **section 3.1** as part of the database accuracy clause.

All issues identified have been corrected in the database. The Burness Road lights were identified as metered on another ICP and this is now reflected in the database.		Feb 2021	Identified
Preventative actions taken to ensure no further issues will occur		Completion date

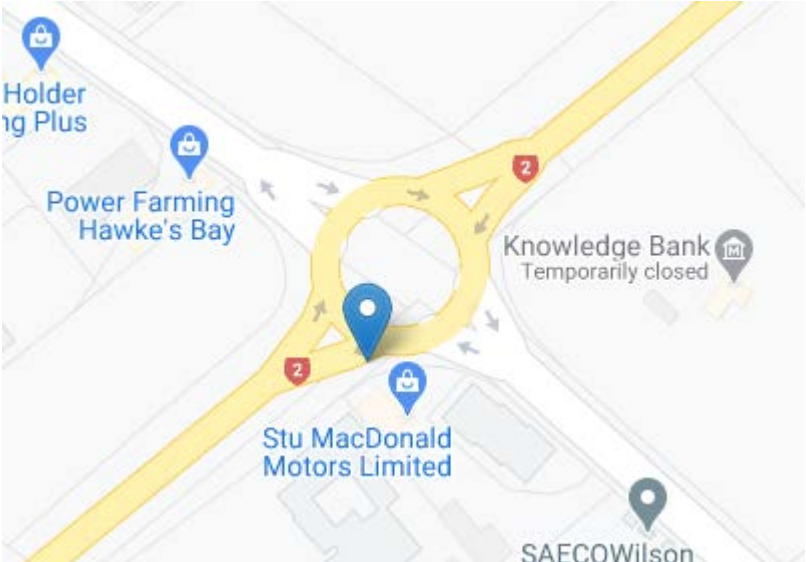
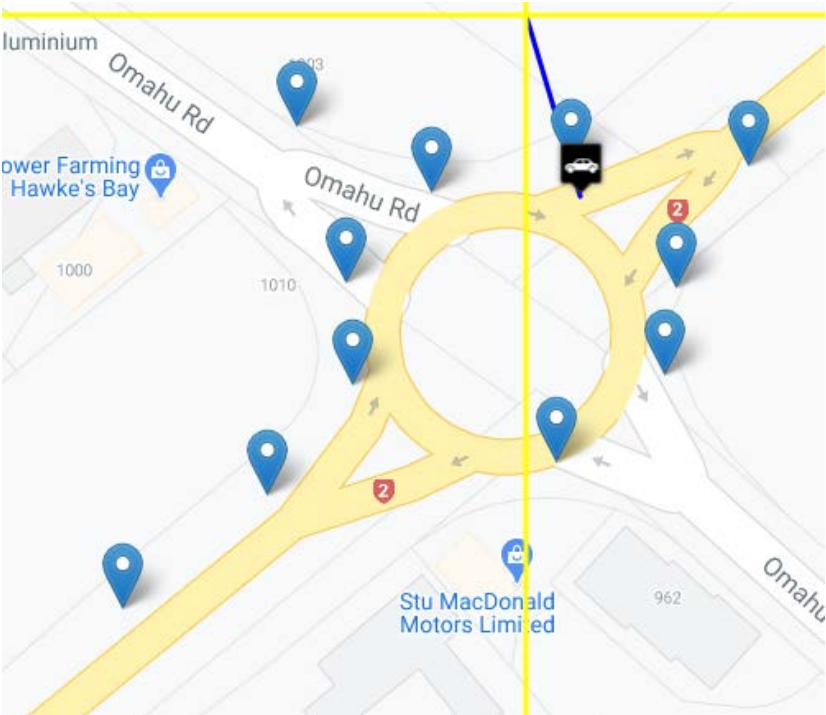
Light ID 58378 on Road ID 3863 appears to have the incorrect ICP. It is at the Omahu Roundabout, but all other items of load at this roundabout are against ICP 0000048331HBAC2. The maps below show this item of load and the bottom map shows the other items of load.

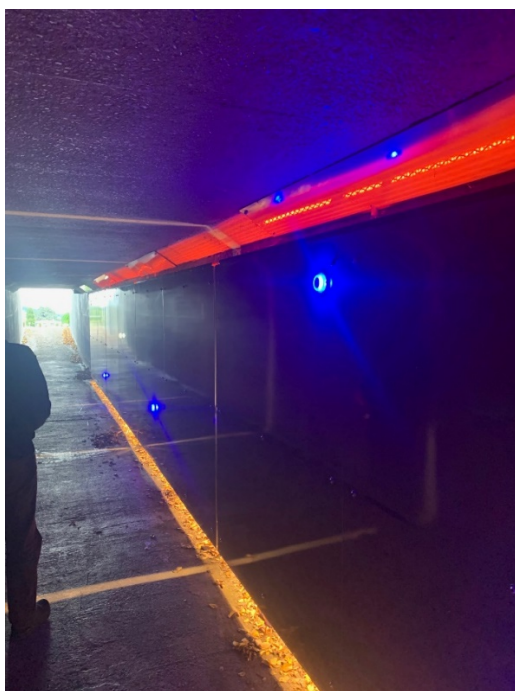
As recorded in the previous audit for ICP 0000939905HB23E, the Burness Road underpass lights are recorded in the database as 3x 36W fluorescent light. These lights have been replaced with an LED panel that is on 24 hours a day (see picture below for reference). It is thought that these are connected to the metered pump supply which is housed at one end of the tunnel. This was being investigated at the time of the previous audit. If these are unmetered LEDs, then a new ICP needs to be created to correctly reconcile this load. The 3 x 36W fluorescent lights should be removed from the database. This is recorded as non-compliance in **section 3.1** as part of the database accuracy clause.
