**ELECTRICITY INDUSTRY PARTICIPATION CODE
DISTRIBUTED UNMETERED LOAD AUDIT REPORT**

**NZTA OTAGO QLDC RAMM DATABASE
AND TRUSTPOWER**

Prepared by: Rebecca Elliot

Date audit report completed: 3 March 2021

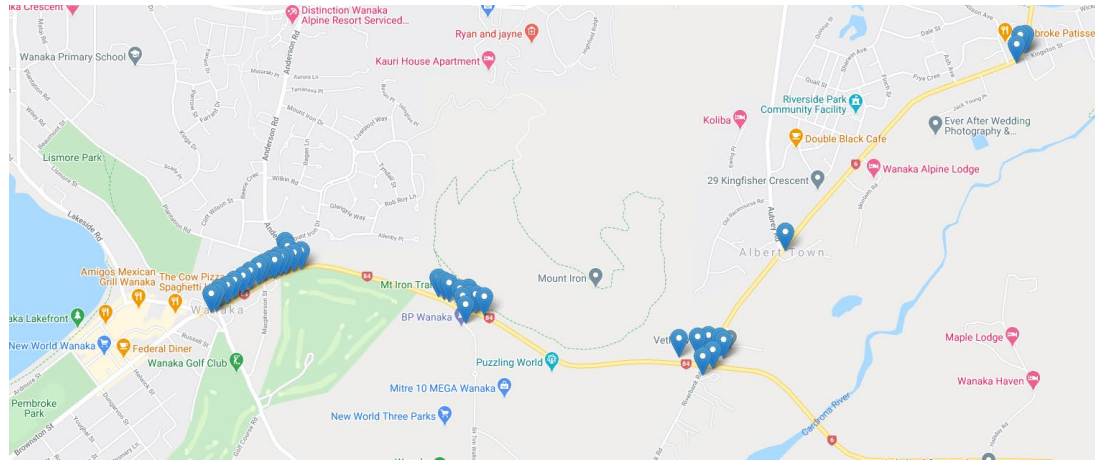
NZTA Aurora database

Examination of both databases found that there are approximately 30 lamps recorded in both databases. The QLDC RAMM database has 30 lamps associated with ICP 0000027638CECB5 (Franklin NSP). The Aurora database has 36 lamps against ICP 0000486695CE506 (Cromwell NSP). It is likely that the light count is correct in the QLDC database, but this needs to be confirmed. These lights are being fed from the Cromwell NSP and not Franklin NSP and therefore these are being submitted against the wrong ICP in the QLDC database. I recommend in both audits that these lights are investigated to confirm which database they should be recorded in. These are being submitted twice and will be resulting in an estimated annual over submission of 19,818 kWh.

I have included a GPS plot of the lights in each database for reference:

Description	Recommendation	Audited party comment	Remedial action
Database accuracy	Determine the correct database and ICP for the NZTA lights in Wanaka and surrounds.	We are investigating to see if the issue is valid or not	Investigating
