**ELECTRICITY INDUSTRY PARTICIPATION CODE  
DISTRIBUTOR AUDIT REPORT**

**WAIPA NETWORKS LIMITED**

Date audit commenced: 26 May 2021

Date audit report completed: 30 July 2021

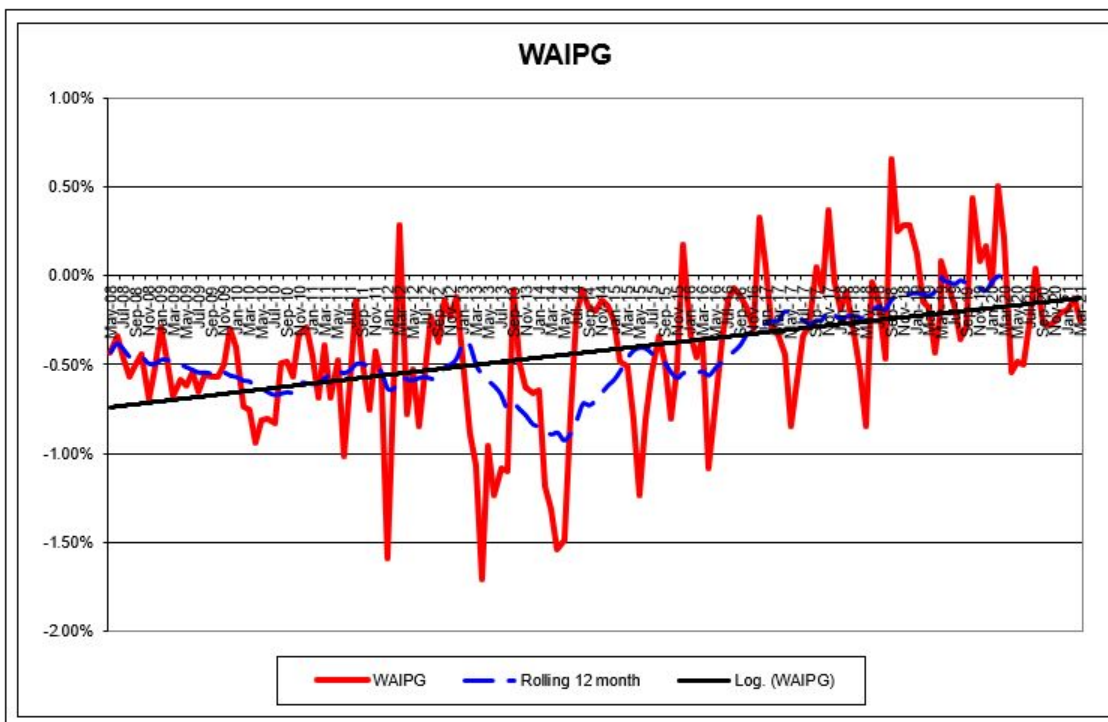
I was provided by the Electricity Authority the reconciliation losses (UFE) which indicate they are tracking within the +/- 1% threshold:
