ELECTRICITY INDUSTRY PARTICIPATION CODE  
RECONCILIATION PARTICIPANT AUDIT REPORT

CONTACT ENERGY LIMITED

Prepared by: Rebecca Elliot and Tara Gannon

Date audit commenced: 7 July 2022

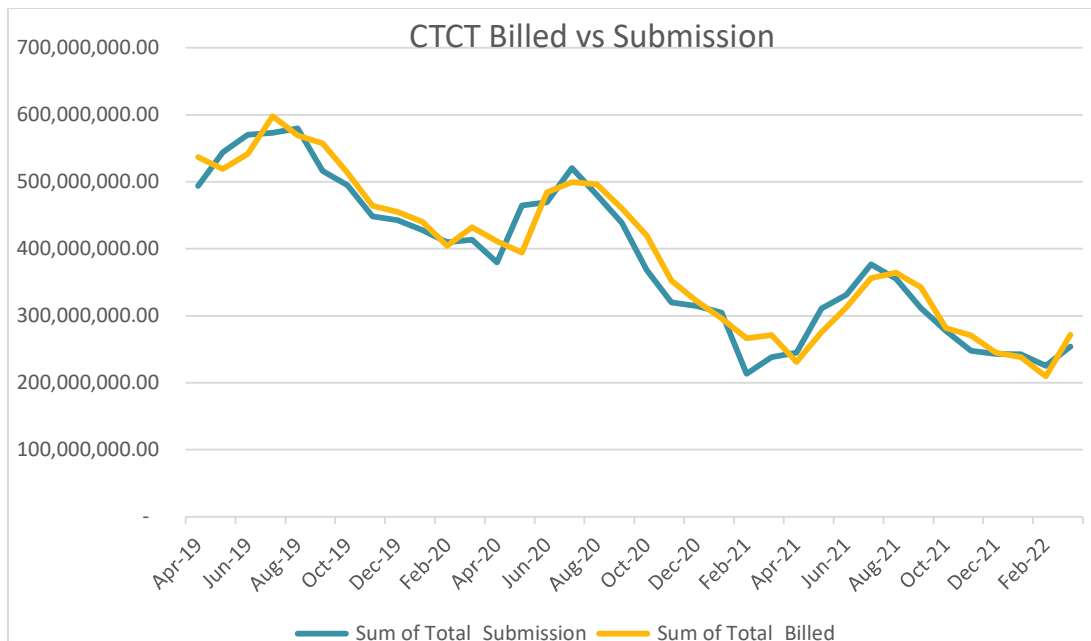
The chart below shows a comparison between submissions and electricity supplied information. At an aggregate level, submitted data is 0.6% higher than billed data for the 12-month period ending March 2022. Billed data is 1.7% higher than submitted data for the 24-month period ending March 2022 due to large numbers of ICPs switching from CTCT to CTCS.

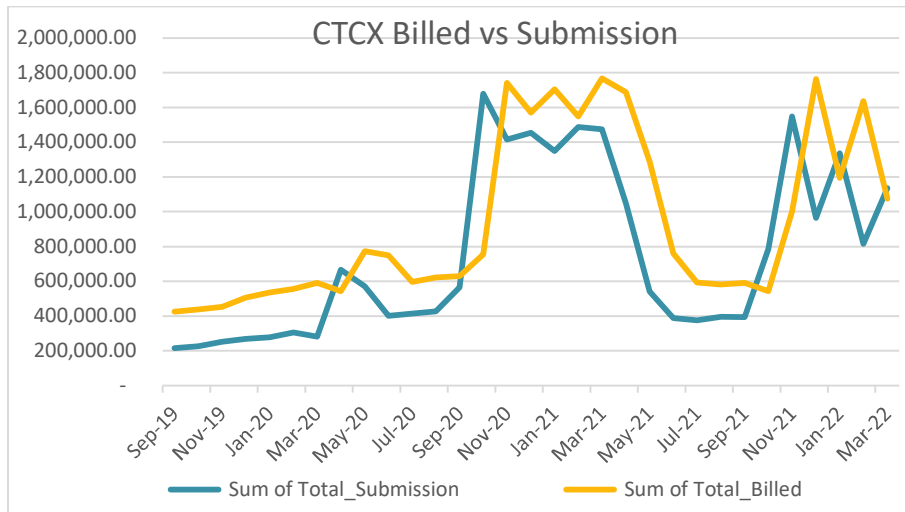
The chart below shows there is a significant difference between billed and submitted data. Analysis during the audit found CTCX billed volumes were 30.7% greater than submitted volumes for the year ended March 2022. The large differences are caused by residual load ICPs, which are included in the billed volumes but not the submitted volumes because the residual load is calculated by the reconciliation manager. The previous audit issue relating to incorrect submission in the HHR volumes and aggregates files for some FCLM meters with day/night registers have been resolved by clearing the data and reimporting the correct files.
