ELECTRICITY INDUSTRY PARTICIPATION CODE
DISTRIBUTED UNMETERED LOAD AUDIT REPORT

MATAMATA PIAKO DISTRICT COUNCIL AND
MERIDIAN ENERGY

Date audit commenced: 4 May 2022

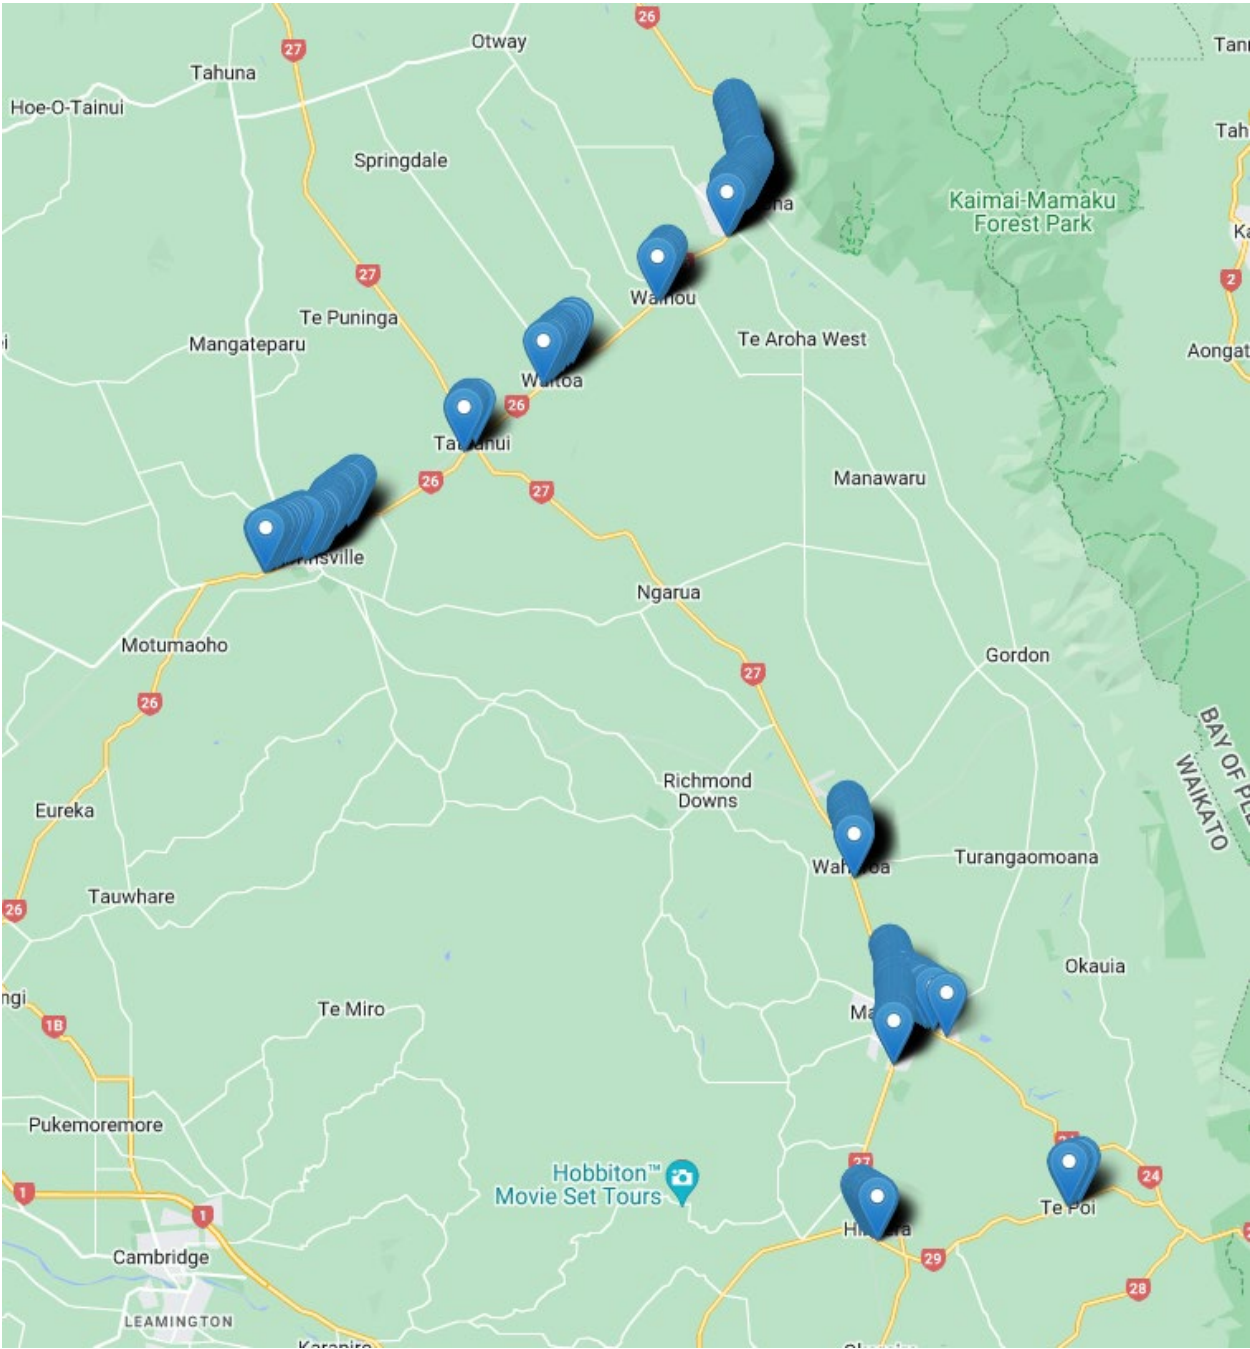
MPDC NZTA Urban lights

The 462 NZTA urban lights are being submitted by MPDC. NZTA are working to remove all NZTA lighting from council databases as these are being reconciled under other ICPs, so the NZTA urban load is being submitted twice by both NZTA (which is with another trader) and by MPDC. Power Solutions have compared the data in both databases and passed their findings onto NZTA. I recommend that Meridian liaise with Genesis (NZTA trader) to resolve the duplicate submission volumes.

This will be resulting in an estimated over submission of 303,735 kWh per annum, but I note that once agreed revisions are expected to be carried out to correct this over submission from the date that the NZTA urban load commenced being submitted by NZTA. This is recorded as non-compliance below.

Description	Recommendation	Audited party comment	Remedial action
Database accuracy	Liaise with Genesis (NZTA trader) to resolve the duplicate submission volumes.	Meridian will liaise with Genesis Energy regarding the duplicate lights and will have the database corrected. Once the database is corrected, Meridian will revise the historic submissions.	Identified
