**ELECTRICITY INDUSTRY PARTICIPATION CODE  
DISTRIBUTED UNMETERED LOAD AUDIT REPORT**

**NZTA TAUPO  
AND  
TRUSTPOWER LIMITED (CNIR)  
NZBN: 9429038917912**

Prepared by: Rebecca Elliot

Date audit commenced: 22 March 2022

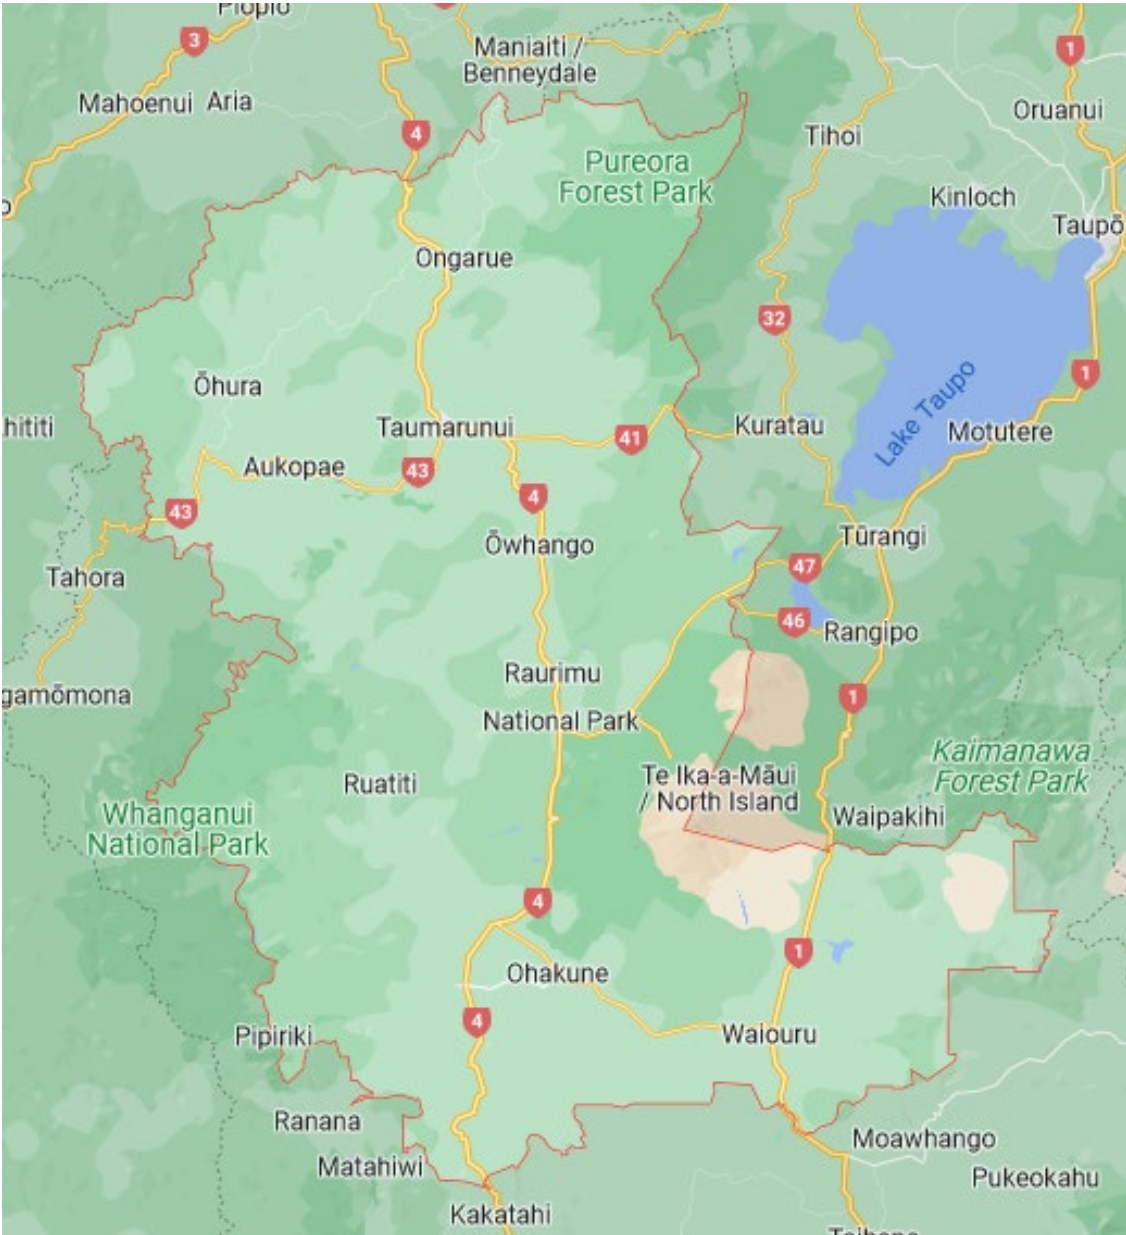
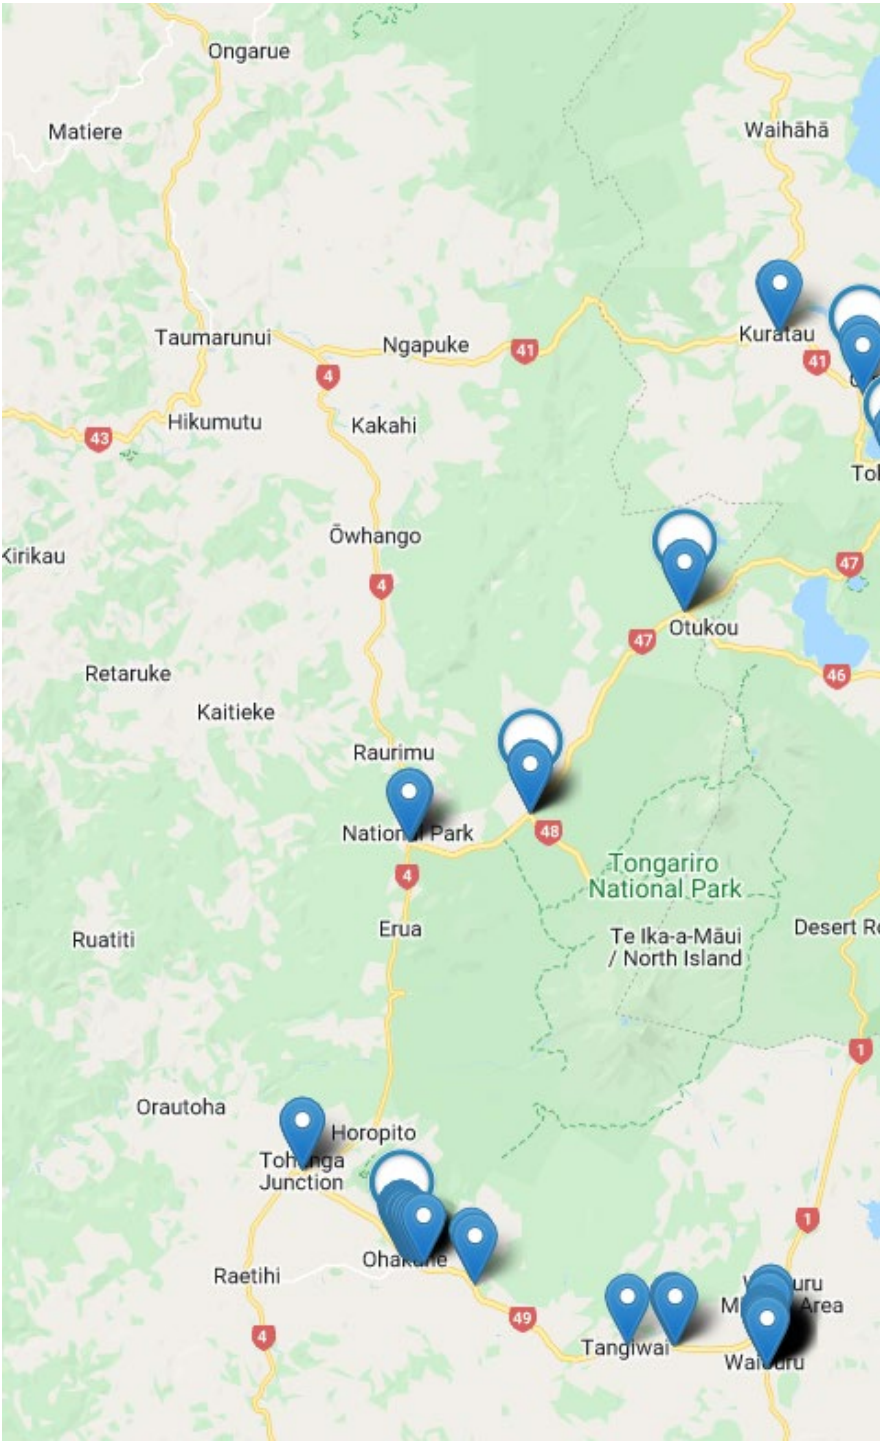
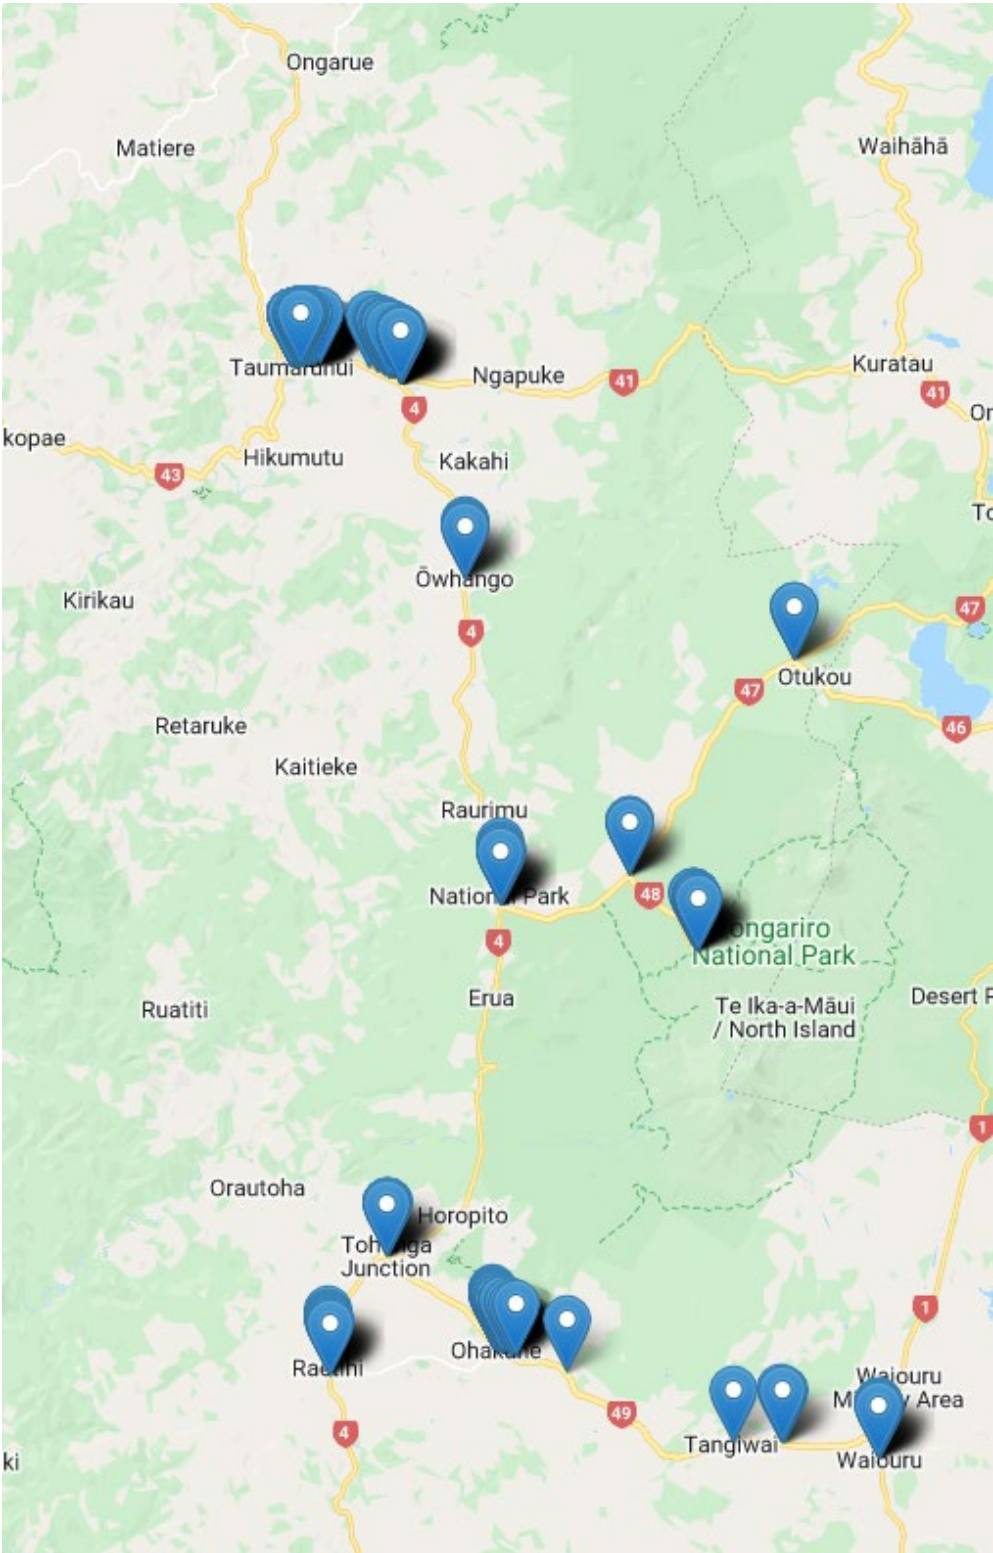
RDC Boundary

In addition to this it appears that there are 209 NZTA lights in the Ruapehu DC & Taupo DC areas that are being reconciled by both the councils and NZTA resulting in potentially 36.63 kW or 156,434 kWh per annum of load being submitted twice. The duplicated lights have been provided to WSP to investigate. I have included detailed pictures below showing the council boundaries, the NZTA RAMM database lights and the RDC SH lights:

I recommend that CNIR liaise with local councils and NZTA to determine the correct lights to be recorded in this database.
