ELECTRICITY INDUSTRY PARTICIPATION CODE
DISTRIBUTED UNMETERED LOAD AUDIT REPORT

PORIRUA CITY COUNCIL
AND MERIDIAN ENERGY LIMITED

Prepared by: Bernie Cross

Date audit commenced: 7 December 2022

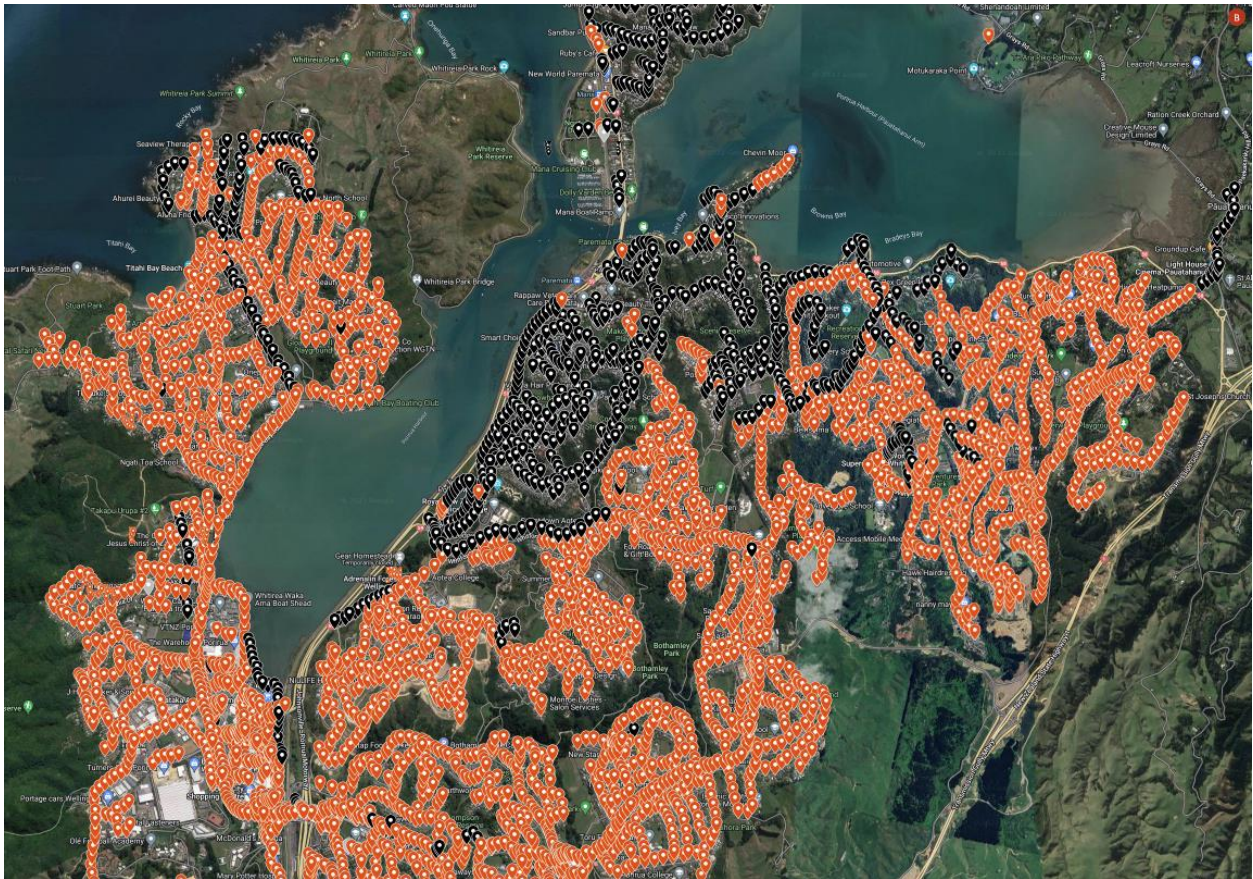
All items of load were plotted to ensure the correct network supply point (NSP) was allocated through the ICP assignment. In the map below the red plots are for NSP TKR0331 and the black plots are for PNI0331.

The map shows that the ICP/NSP assignment to the lights is not consistently applied resulting in some load being incorrectly assigned to ICPs and the associated NSP for reconciliation purposes. I recommend that Meridian works with Wellington Electricity to clearly define the boundaries between lights supplied by TKR0331 and PNI0331 NSPs.

Recommendation	Description	Audited party comment	Remedial action
<p>Improve accuracy of ICP assignment to each item of load.</p>	<p>Meridian to work with Wellington Electricity to clearly define the boundaries between lights supplied by TKR0331 and PNI0331 NSPs and ensure the database then correctly reflect these boundaries.</p>	<p>Meridian has advised PCC of the recommendation. There had been several staff changes at the council that have impacted progress on remedial work to the RAMM database. A new resource was assigned in November to start looking after the database and working on the corrections required.</p> <p>Meridian will be arranging a meeting with PCC and Veritek for early February to discuss the audit findings and recommendations.</p>	<p>Identified</p>
