# 4 September 2010 and 22 February 2011 Christchurch Earthquakes from a Transmission Grid Infrastructure Perspective

## Asset Structural Performance and Lessons Learned

By Craig McGhie and Christophe Tudo-Bornarel

TRANSPOWER

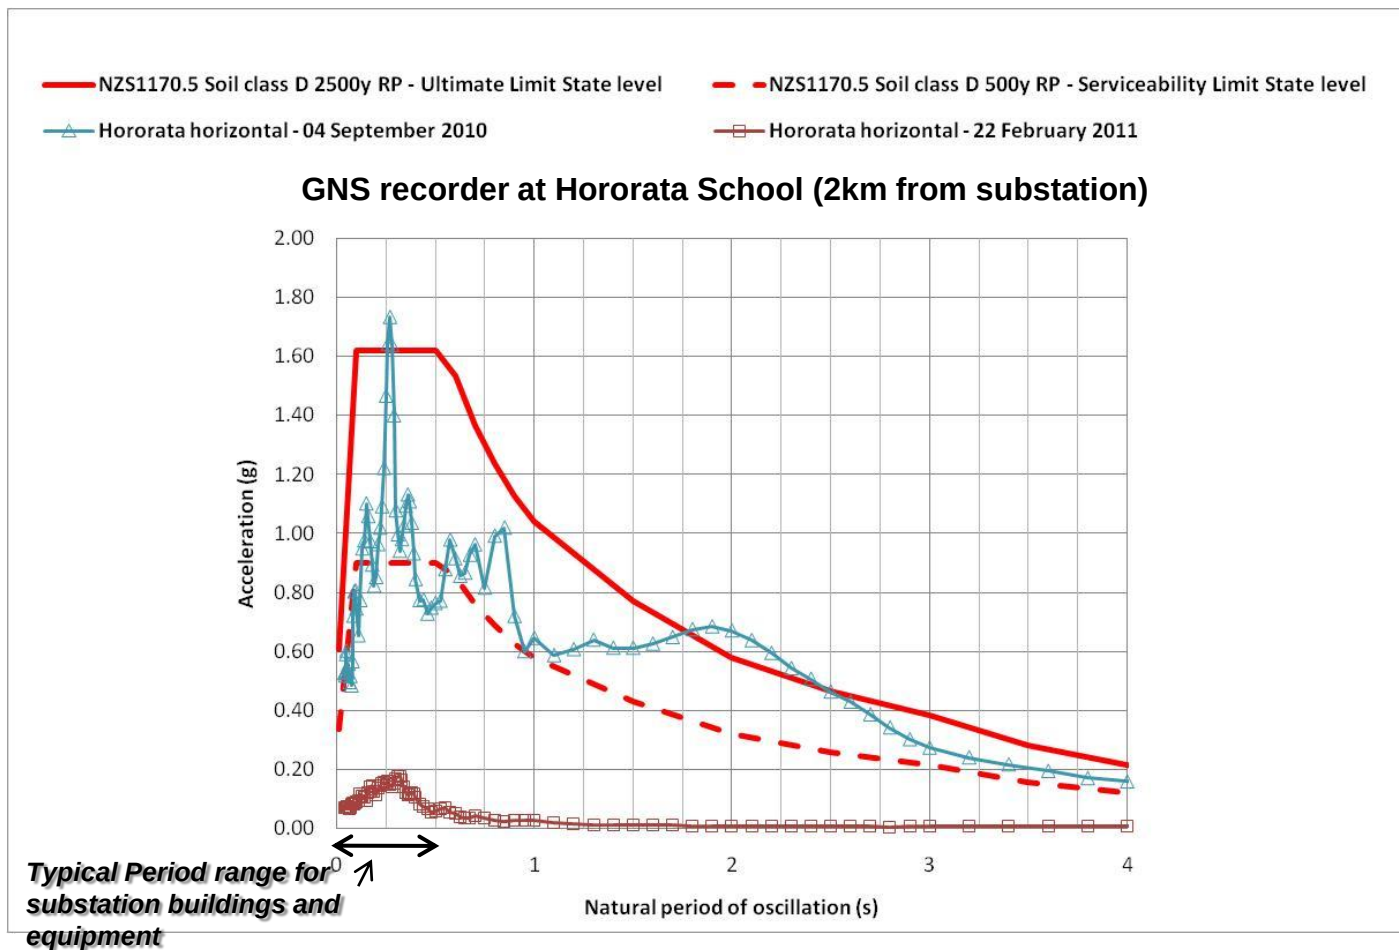
# Darfield vs Christchurch Earthquake Spectra Hororata Substation

- Earthquake response spectra was generally in the range from SLS (500 year RP) to ULS (2500 year RP).
- Some damage and disruption was to be expected, but there were notable exceptions (e.g. ISL 220kV Surge Arrestor).
- The performance of aged infrastructure (pre seismic standards) was above expectations.
- The length of time to put the grid back in service was as much a function of the time it took to undertake safety inspections, given the transport issues post earthquakes, than poor structural performance.

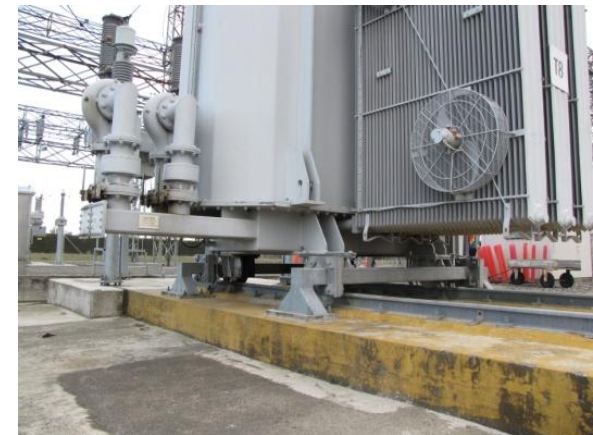
Transformer seismic restraints Hororata

- Priority - replace old mercury switches on transformers.
- The benefits of the seismic restraint programme undertaken in the 1990's following the Edgecumbe earthquake were realised in these events.
- Transpower is to continue to support the development of international seismic design standards for HV equipment.
- Further identification and mitigation of earthquake risk to the transmission network is required to provide resilience.
