# North Island AUFLS event Loss of Huntly Power Station

## December 13 2011

Presentation for the SRC  
February 2012

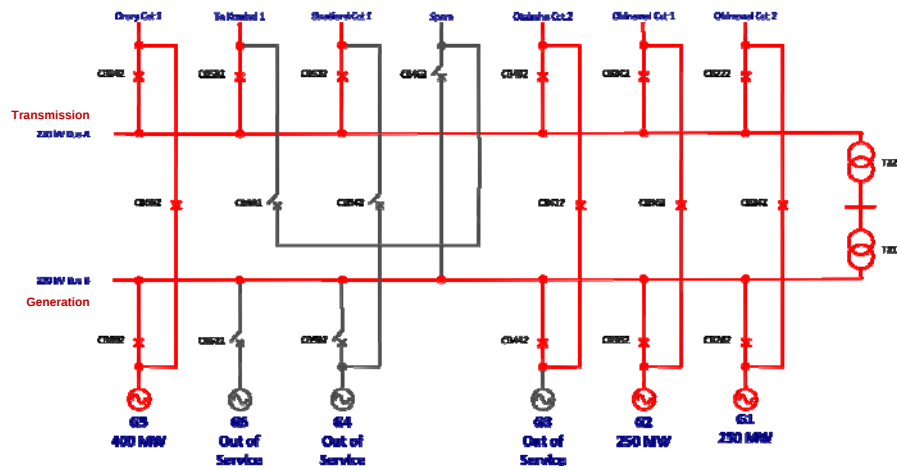
## Huntly – normal configuration

CB462 and CB602 are normally open.

Supply transformers T21 and T22 coupling Bus A and Bus B were both in service.

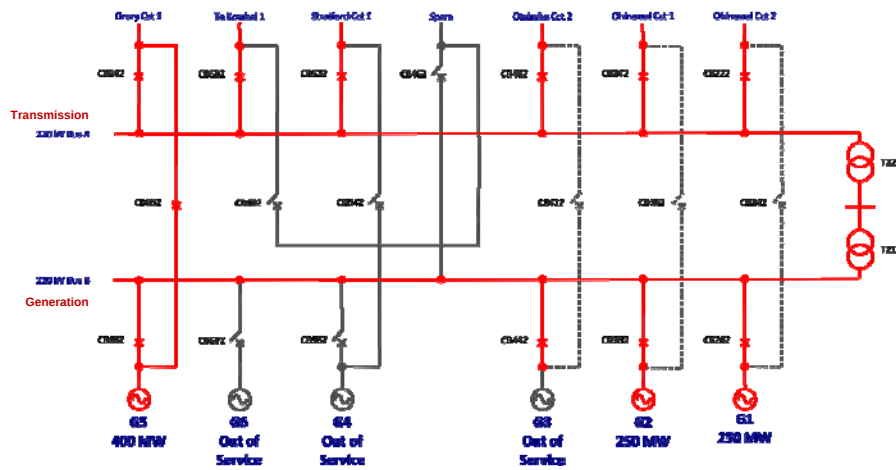
# Configuration immediately prior to generation loss

- With CB422, CB242 and CB362 open, all generating units remained connected to the grid via CB682, CB662 and CB642.
- Transpower assets remaining in service were operating within their capability
- Unit 5 tripping
  - Unit 1 and Unit 2 current (1430 A) combined with that of Unit 5 current (700 A) resulted in the Genesis protection tripping Unit 5 (CB52) on thermal overload.
- Unit 2 and 1 tripping events
  - 0.15 seconds after CB52 tripped, Genesis CB fail protection tripped CB662 and CB682, disconnecting Units 1 and 2 from the grid
  - 2 seconds later Unit 2 tripped
  - 20 seconds later Unit 1 tripped
