Report Title: Examination of cable joints from Penrose Substation

Client: Vector Ltd and Transpower NZ Ltd

Report Number: 2015-0356

2. Failed Heat Shrink PILC to XLPE Transition Joint 3-B-0, PN33

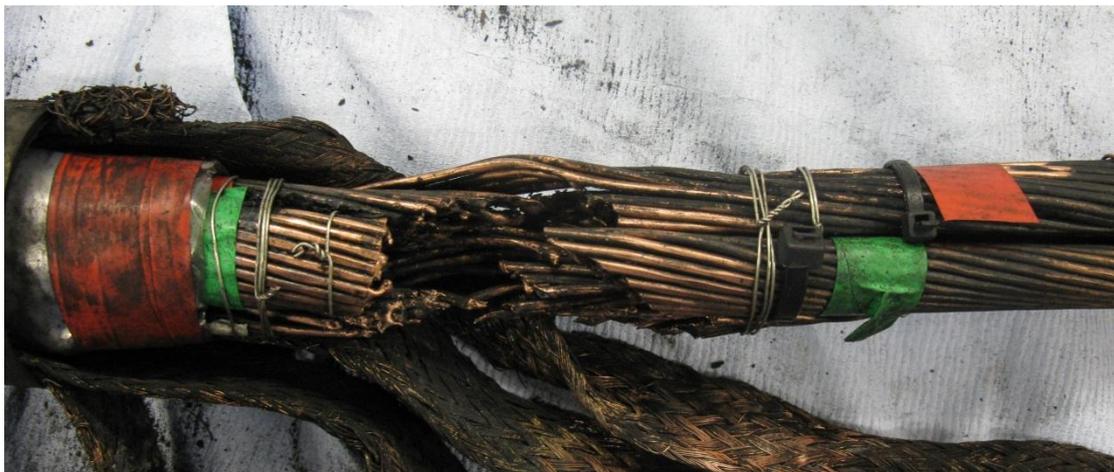
Figure 3: Fault area after cleaning conductors and clamping in position with binder wires

The arc eroded end of the green labelled core on the cable side of the fault had been cut by the arc in a relatively straight line almost perpendicular to the axis of the cable, Figure 3 and Figure 4.

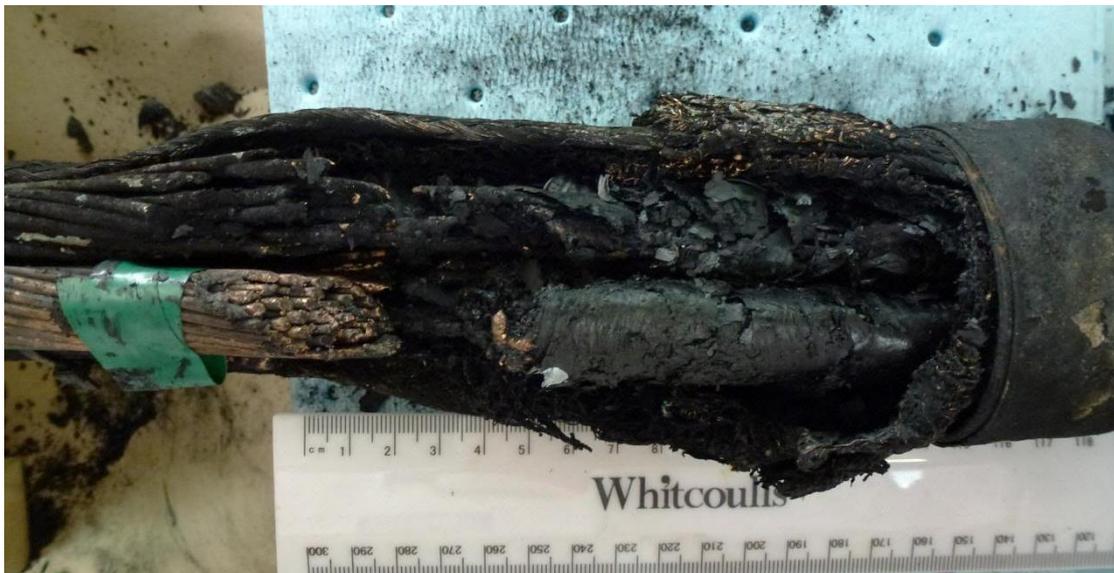
Figure 7: P1070019 from examination in New Zealand (brightness and contrast altered)

From photographs P01070015 and P01070019, taken during the partial strip down in New Zealand, the remains of the core insulating tapes were still present on the cable side of the fault position right up to the edge of the fault eroded region, Figure 6 and Figure 7.

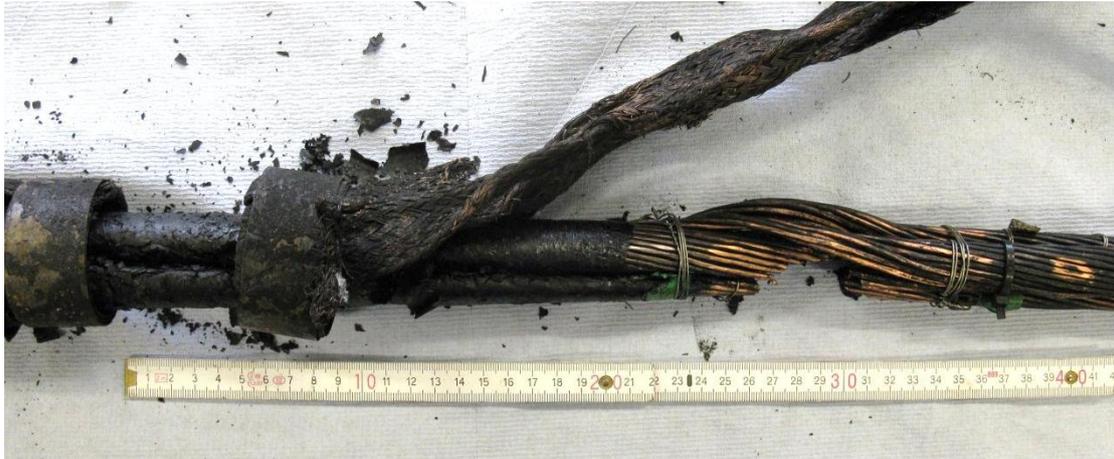
Figure 8: Faulted transition joint with core papers still present on cable side of fault

These insulating tapes next to the fault position were still partly present when the sample was received at ERA, Figure 8 and Figure 9. They were very fragile and tended to fall away as the cable was manhandled.

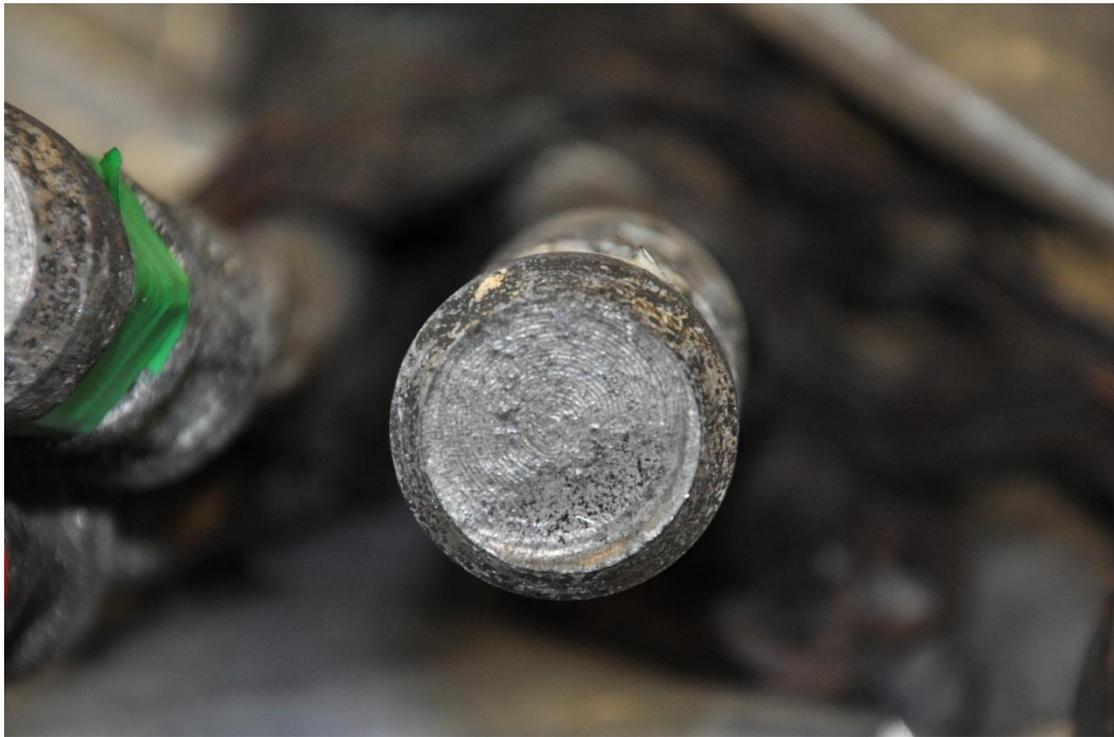
Figure 12: Aluminium weld surface from white taped core

There was little of the copper and aluminium material left adhering to the other side of the friction weld interfaces on the red and green taped cores. On the white taped core there was an indentation on the surface of the aluminium side and a raised area of what appeared to be aluminium on the copper side, Figure 11 to Figure 14.

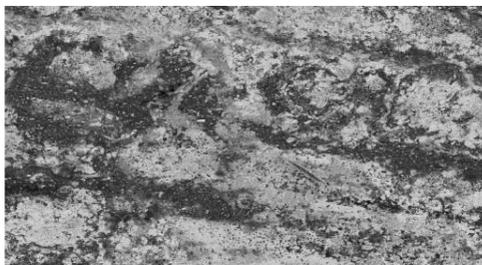
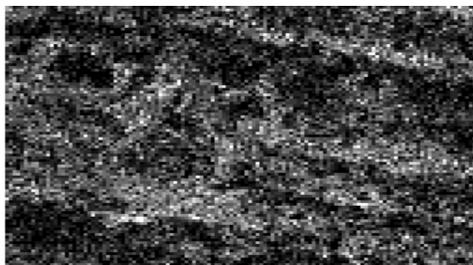
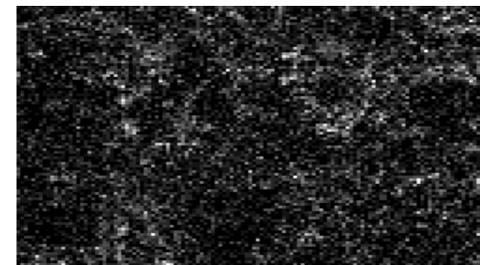
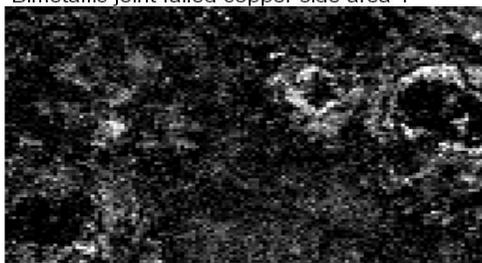
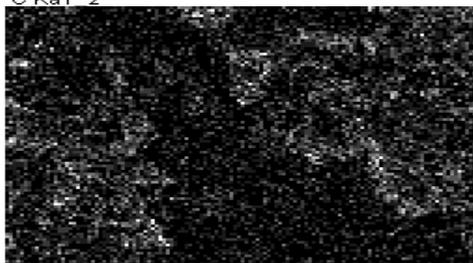
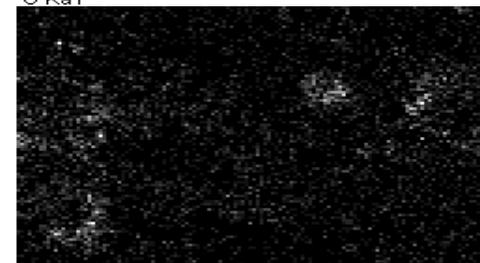
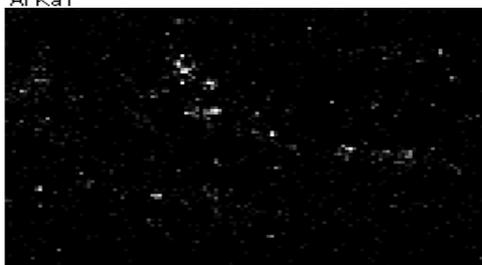
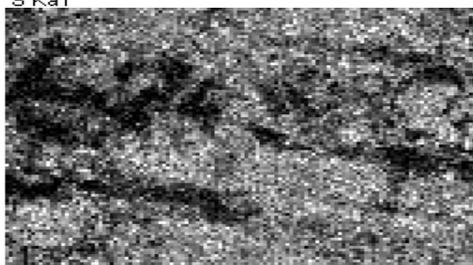
Bimetallic joint failed copper side area 1

There were localised lead deposits on both the copper and the aluminium bi-metallic weld surfaces. SEM images and EDX spectra are shown below:

Comment: EDX mapping of copper weld surface in an area where there was aluminium present, shows deposition of aluminium, sulphur,

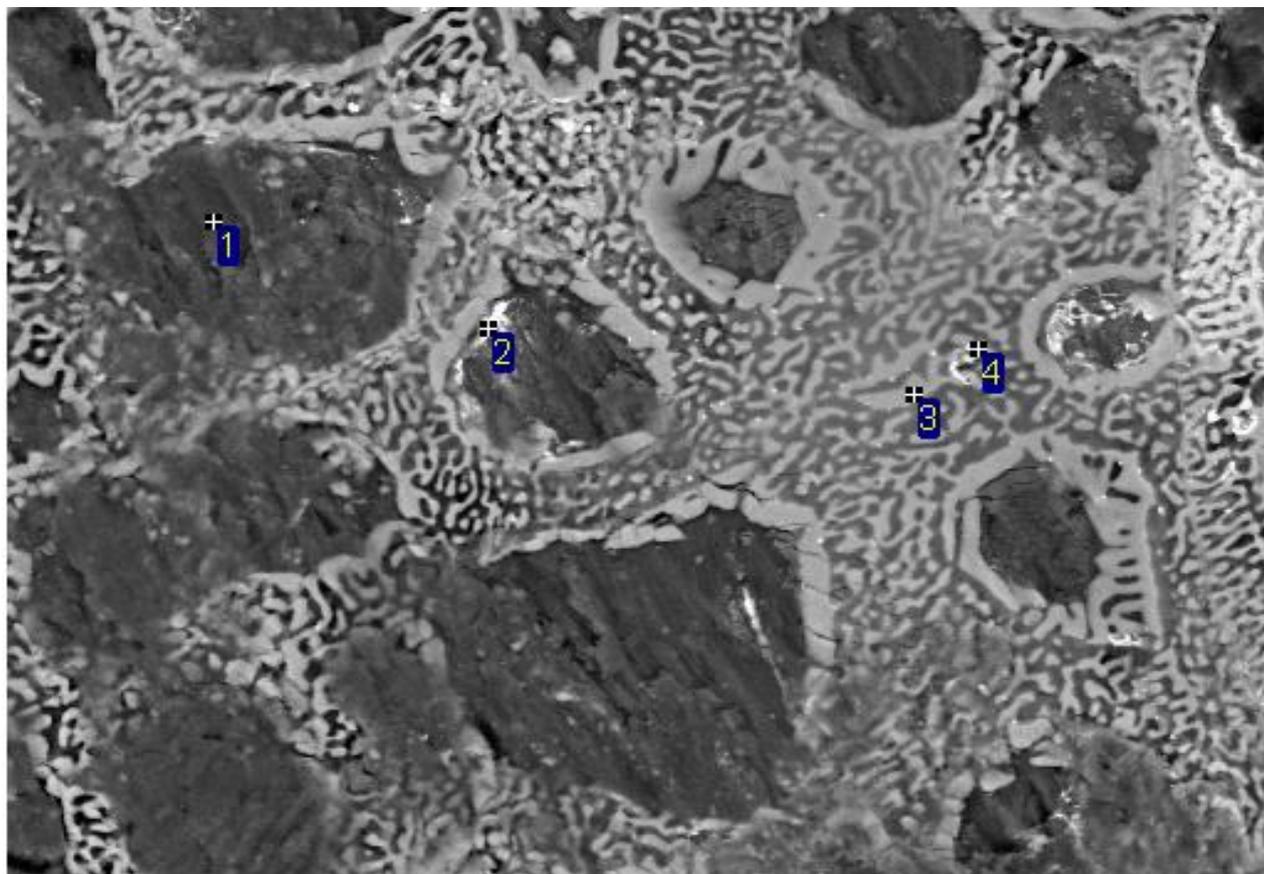
Bimetallic joint failed aluminium side area 1

All results in weight%. EDX spectrum indicates small quantities of lead on aluminium surface

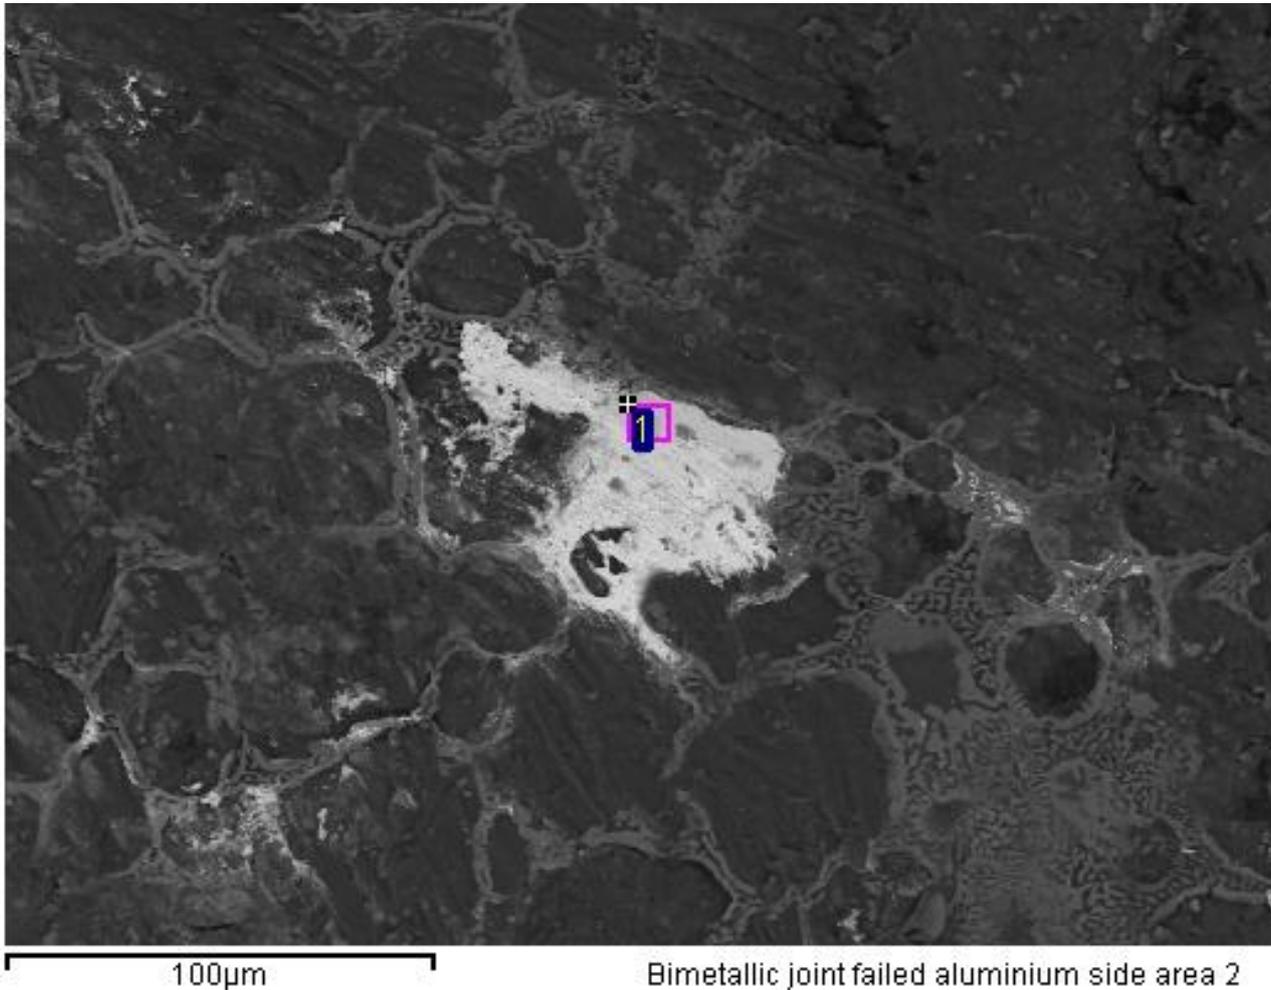
All results in weight%. EDX analysis indicated area of lead on aluminium surface

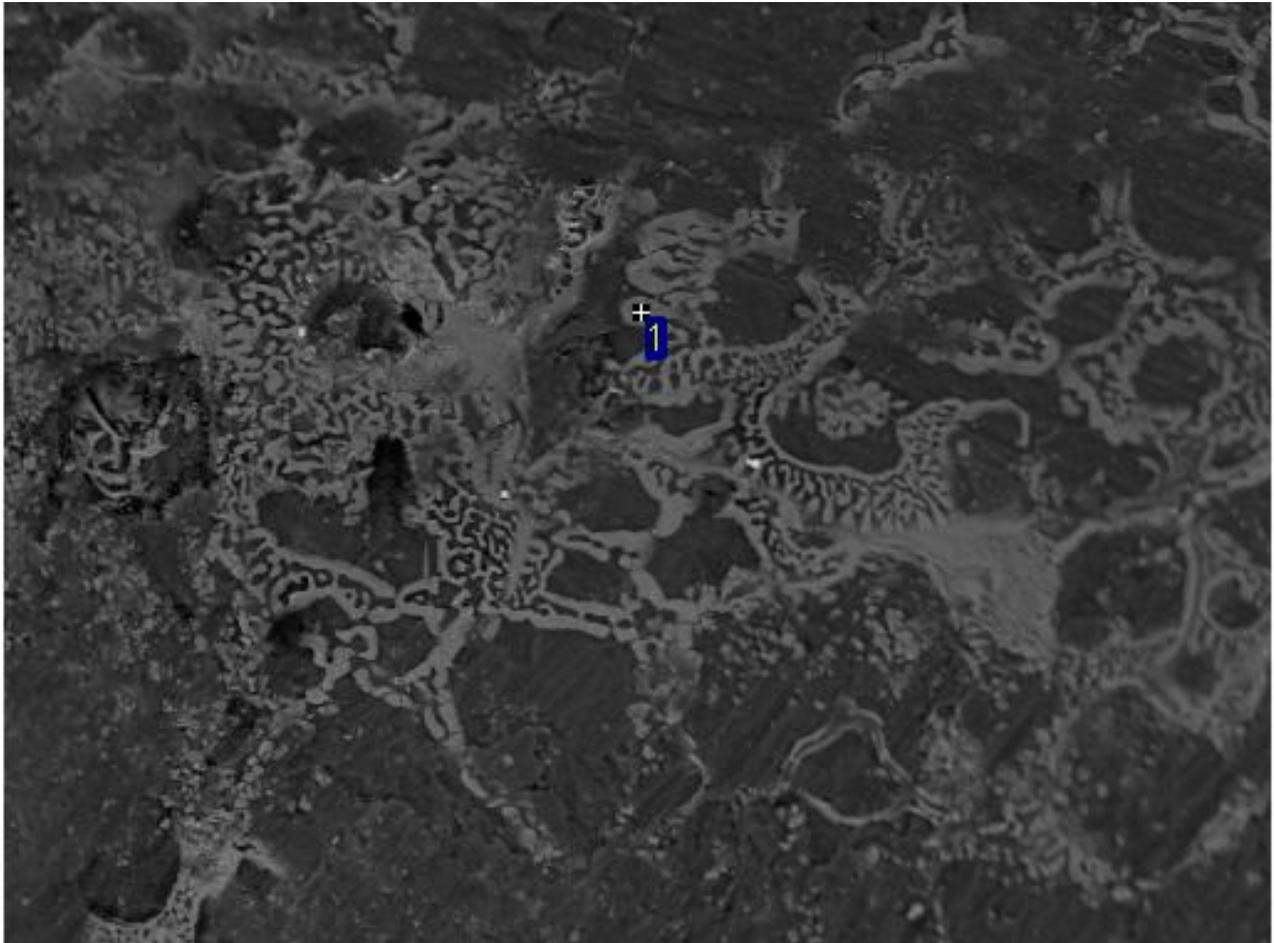
Bimetalllic joint failed aluminium side area 3

All results in atomic%. EDX analysis indicates grey areas are a combination of aluminium and copper

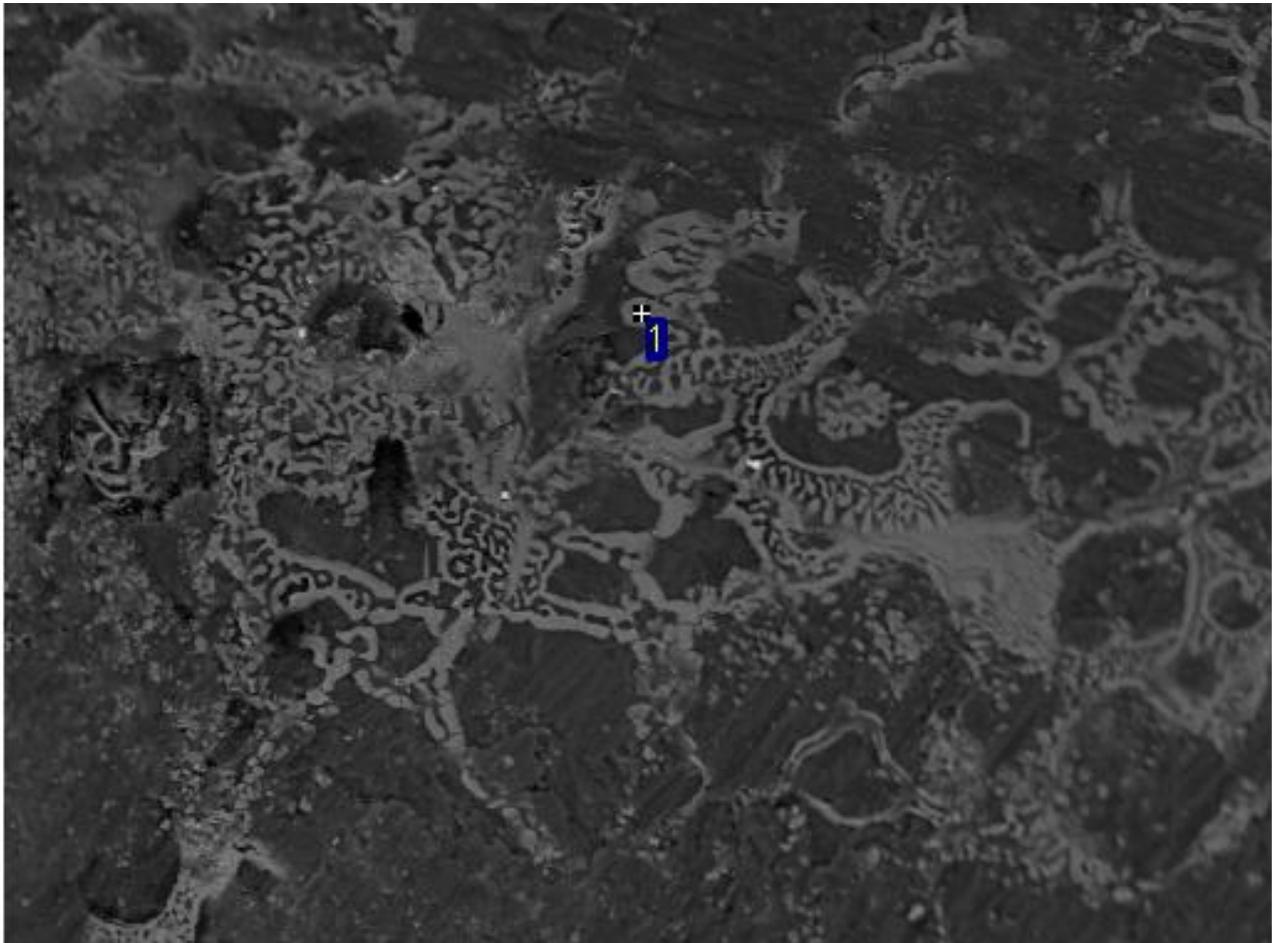
Bimetallic joint failed aluminium side area 3

All results in weight%. EDX analysis indicates the grey area on the aluminium side the aluminium side of the bimetallic connector contained copper and aluminium at close to the stoichiometric ratio.

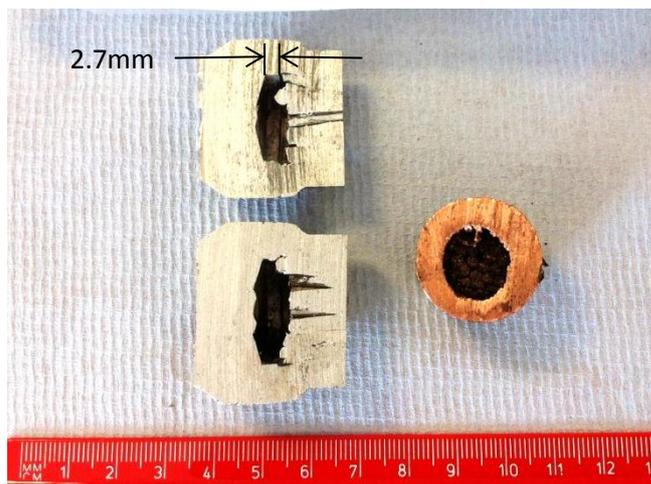
Figure 15: Sections through copper & aluminium ferrules, white phase connector

The aluminium and copper compression ferrules were cut longitudinally and transversely. All of the conductors had been inserted into the compression ferrules past the end of the final compression. The crimps had been applied uniformly over the combined thickness of stranded conductor and compression ferrule.

In Figure 15, the end of the stranded aluminium conductor was 2.7mm from the blind end of the bore of the aluminium ferrule and the end of the stranded copper conductor was 3mm from the blind end of the bore of the copper ferrule. In Figure 16, the end of the stranded aluminium conductor was 3mm from the blind end of the bore of the aluminium ferrule

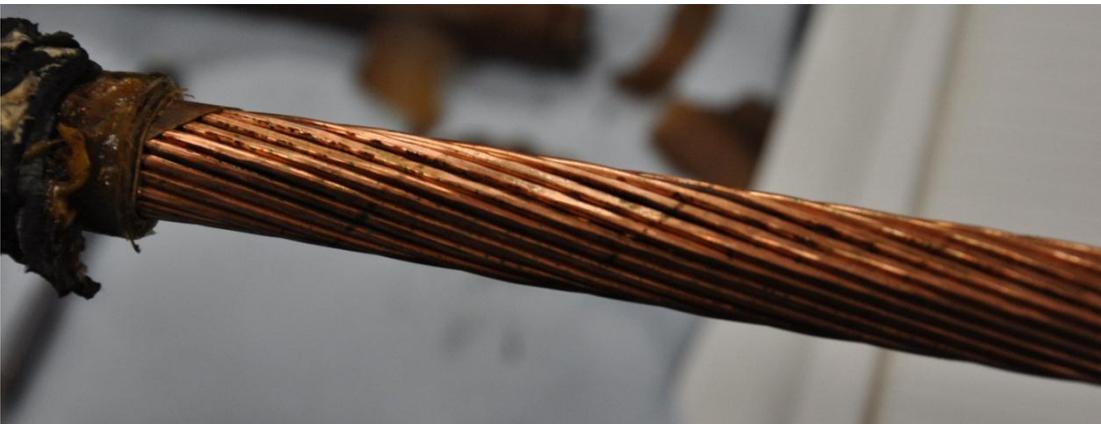
Figure 22: Localised "blotches" on conductor strands on core 1

On core 1 there was dark staining on the layer below the core identification tapes and in subsequent layers in the butt gaps. The conductor strands were generally dry with no evidence of compound but with small amounts of a relatively thin black liquid between the strands in places. There were dark brown "blotches" on the conductor strands near to the end of the translucent heat shrink sealing tube, Figure 22.

The SEM and EDX analysis of the blotches on core 1 showed them to be mainly carbon and oxygen with a small amount of copper. From this result and their visual appearance it is likely that these blotches were areas where the majority of the compound had evaporated due to the heat of the fire and the remaining less volatile components had been baked to the surface of the copper conductor strands.

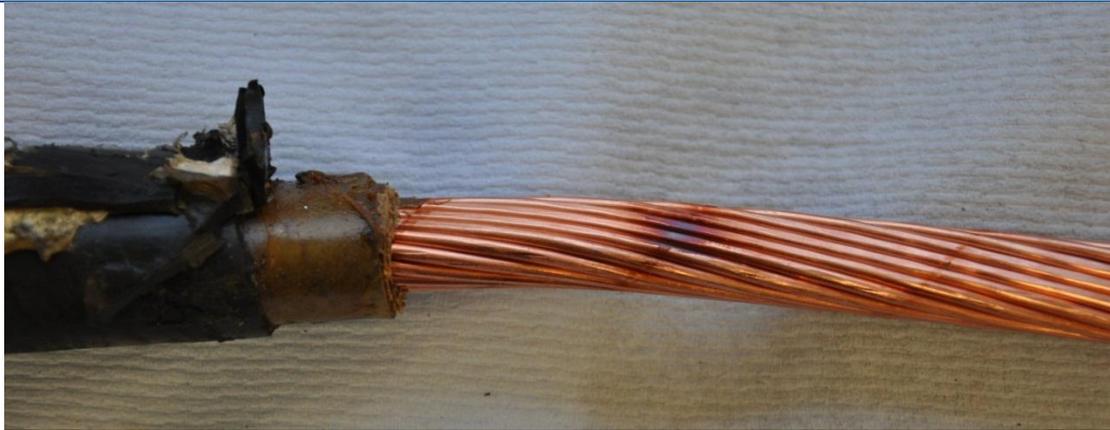
Figure 23: Localised apparent thermal effect on conductor, core 3

The core 3 papers had dark brown discolouration in the butt gaps beneath the lead sheath but close to the lead sheath cut back position. The papers were dry and brittle with a strong burnt sugar smell. The core 3 papers got darker towards the conductor. The conductor strands were dry with no compound or bitumen contamination. The conductor strands were discoloured with a range of colours from cherry red, through blue to black at a point close to the end of the lead sheath but under the lead sheath, Figure 23. From past experience this type of discolouration of copper is caused by localised overheating.

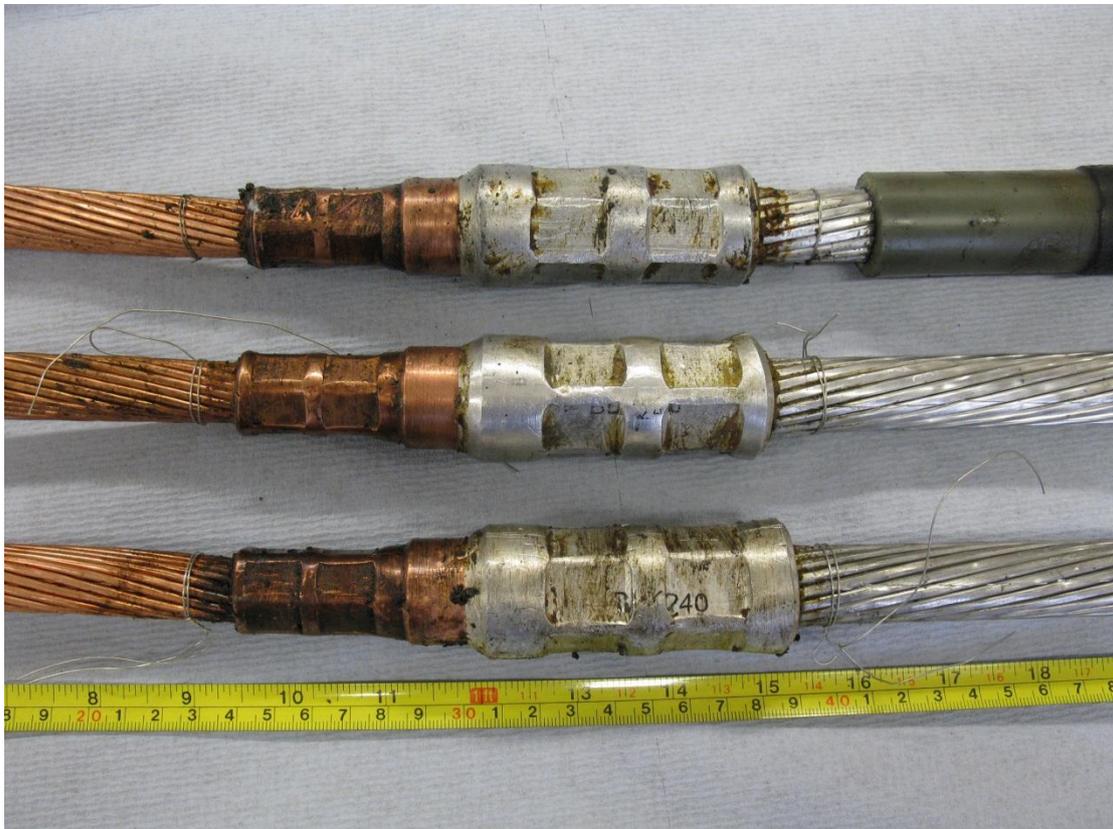
Figure 24: Bimetallic connectors after removing insulation

The compression ferrules on the bimetallic connectors had been uniformly compressed onto the conductors, Figure 24.

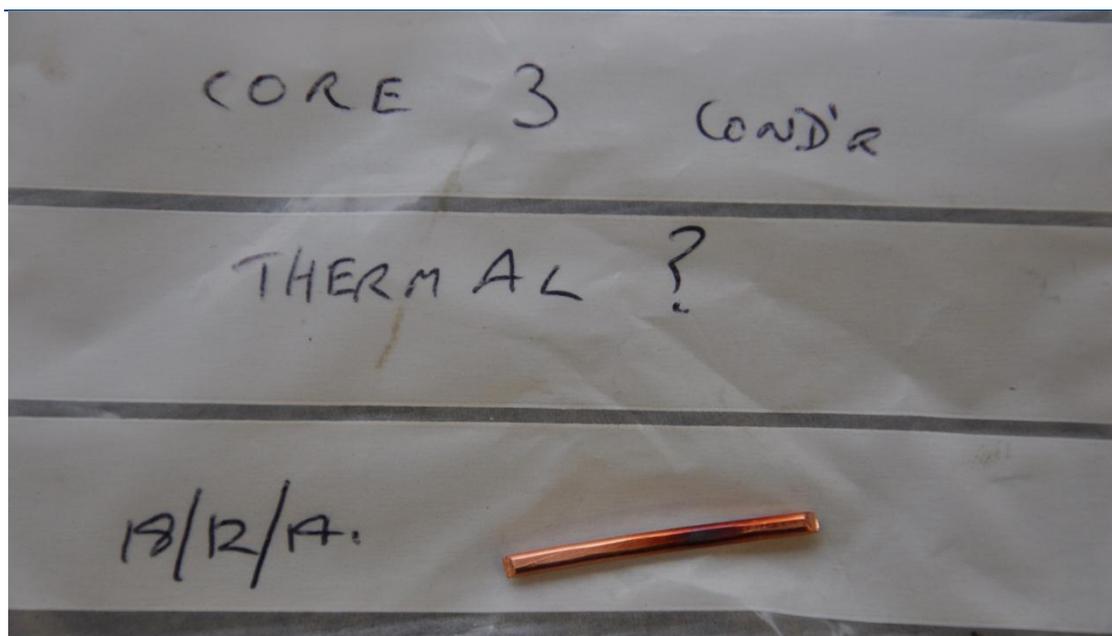
Figure 25: Discoloured conductor strand prior to SEM analysis

From the SEM EDX analysis of the discoloured area shown in Figure 25 the discolouration comprised carbon, oxygen and copper. Away from the discoloured region the surface was copper with less than 5% carbon. Considering the conditions this is effectively clean copper.

Where the copper was discoloured there was more than 80% carbon. This indicates that there was a carbon based substance over the top of the copper. The discolouration was not just due to heat causing the copper to oxidise.

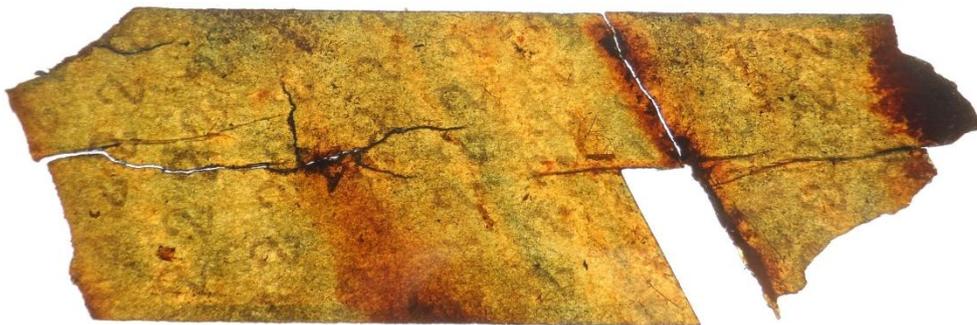
Figure 27: Stained paper with section cut out for SEM analysis

Close examination and staining of the outer papers on core 2 (taken from the area with the dark feature shown in Figure 19 and 20) indicated waxing, blackening and degradation, Figure 29, of the paper fibres in the butt gaps on core 2 as well as the more widespread blackening away from the butt gaps, Figure 26. The black deposits in the butt gaps could be bitumen from the original cast iron, bitumen filled, cable joint.

FTIR analysis of the stained area and the yellow mastic confirmed that the yellow mastic was present in the stained feature. The FTIR spectrum for the stained area was not the same as the spectrum for bitumen.

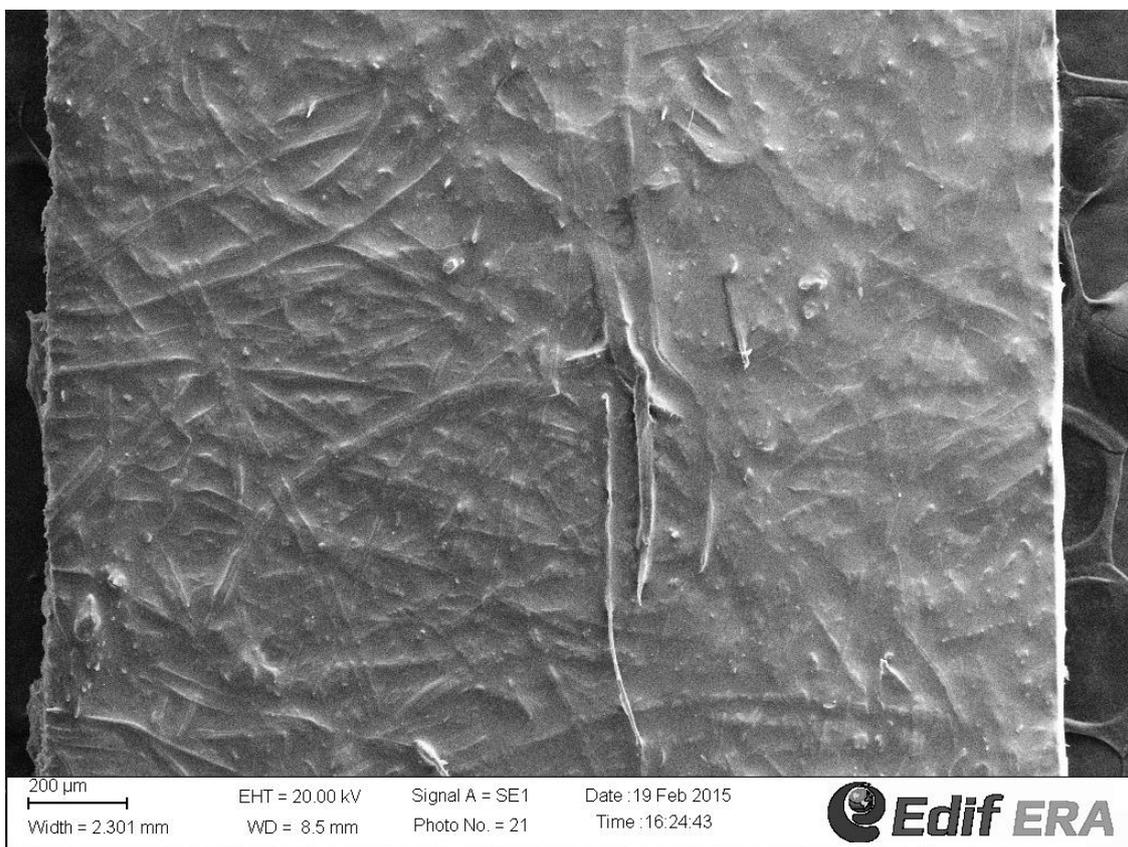
Figure 28: SEM image of paper in relatively good condition

- The un-blackened paper was carbon with some silica particles. The cellulose fibres could be seen as well as a smooth material between the fibres

- The blackened areas all had chlorine, carbon, silicate and oxygen present.
- Where the papers had badly deteriorated, Figure 29, and fractured, the smooth areas that bonded the fibres together, Figure 28, had mainly been lost. These areas also had chlorine, carbon, silicate and oxygen present.

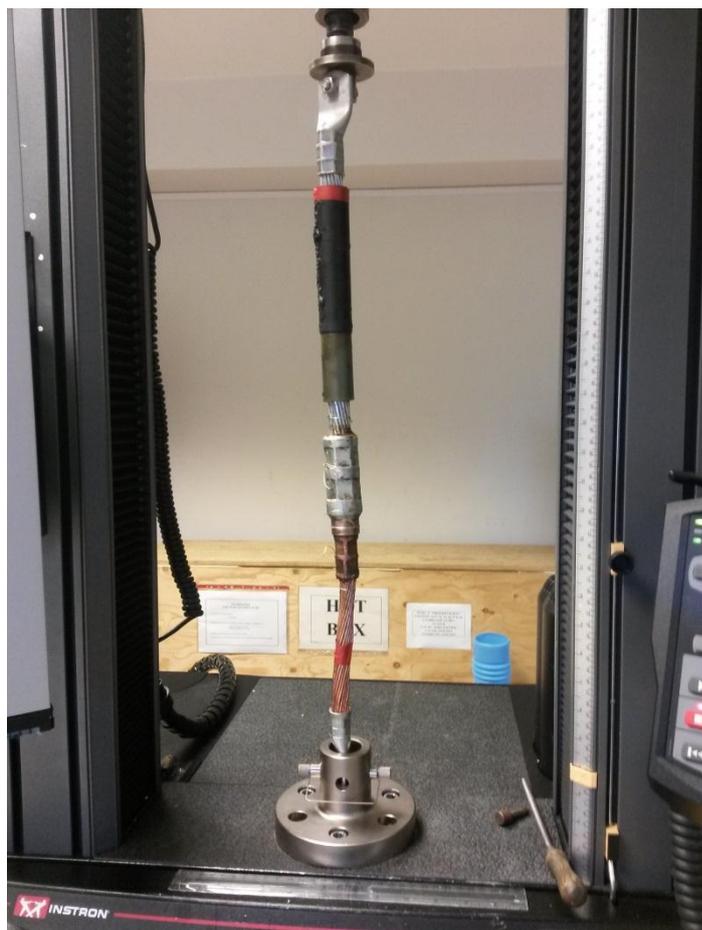
Figure 30: Tensile test on red phase bimetallic connector from PN53

Tensile tests were performed on the red and green labelled connectors by applying a tensile load to the aluminium and copper stranded conductors, Figure 30.

Connector	Time at 9.7kN (s)	Time at 12kN (s)	Failure load (kN)	Comments
Red	60	60	N/A	No failure occurred
Green	60	N/A	10,918	Aluminium conductor pulled out of connector ferrule

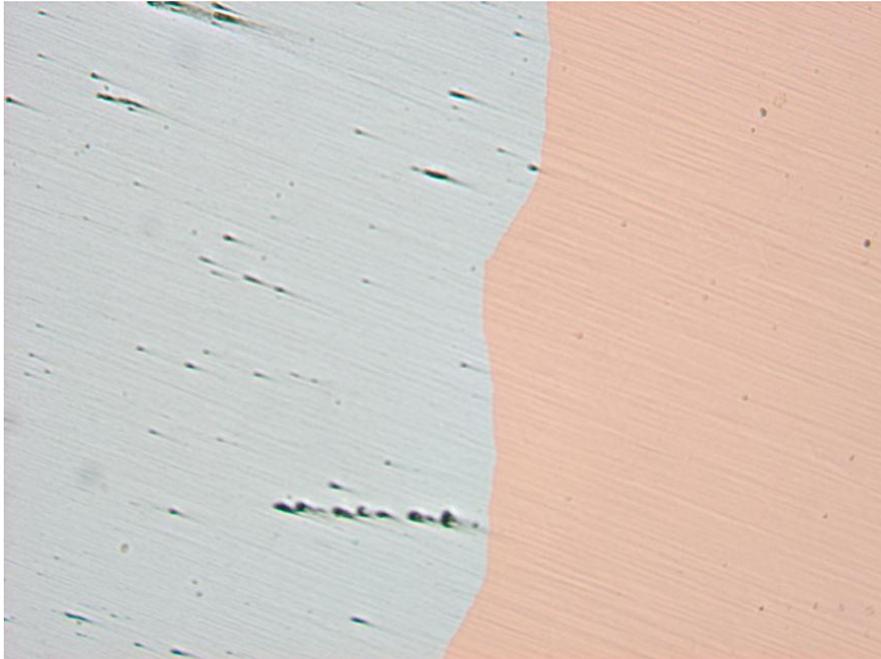
Figure 31: Red connector aluminium/copper interface (scale approx. 1mm from top to bottom)

There was no evidence of any separation at the aluminium/copper interface and no evidence of a heat affected zone where the two elements were combined, Figure 31.

The apparent voids and scratches in Figure 31 were due to the cutting process used to separate the connector longitudinally. One half of the green connector was polished to obtain a smooth surface and examined in the SEM. From the SEM results:

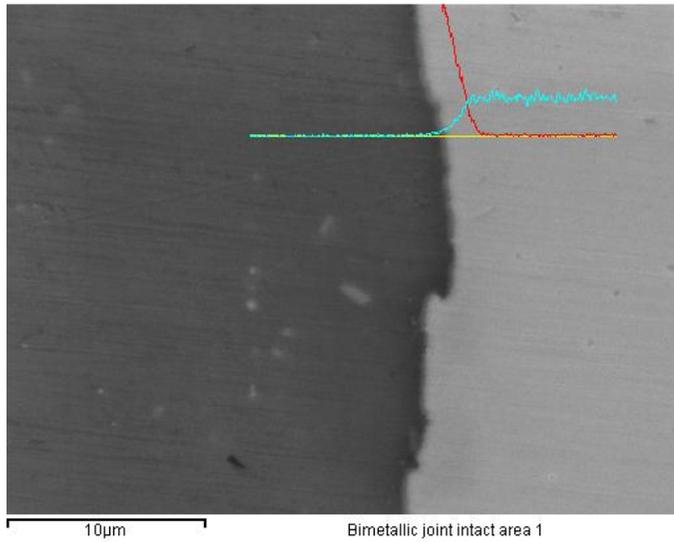
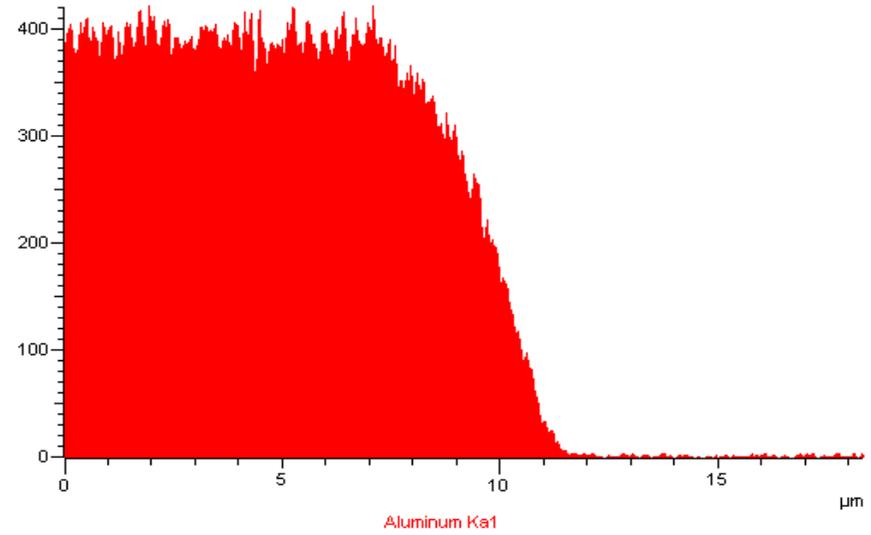
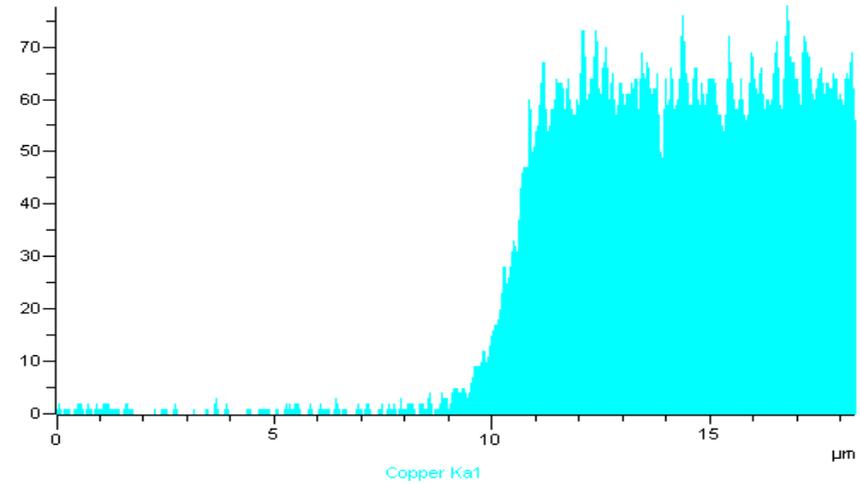
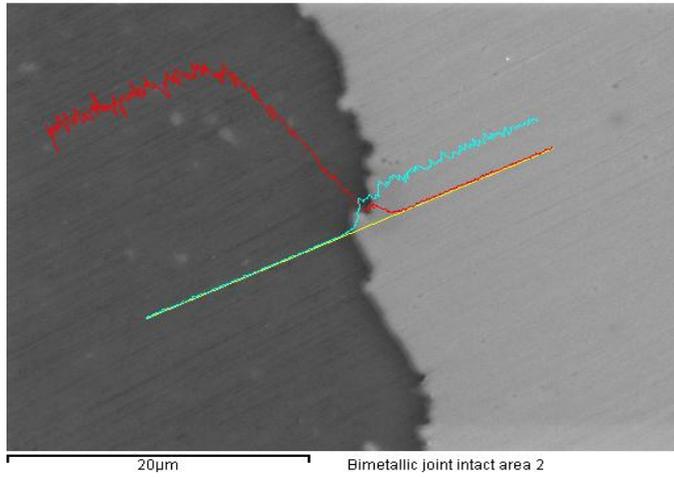
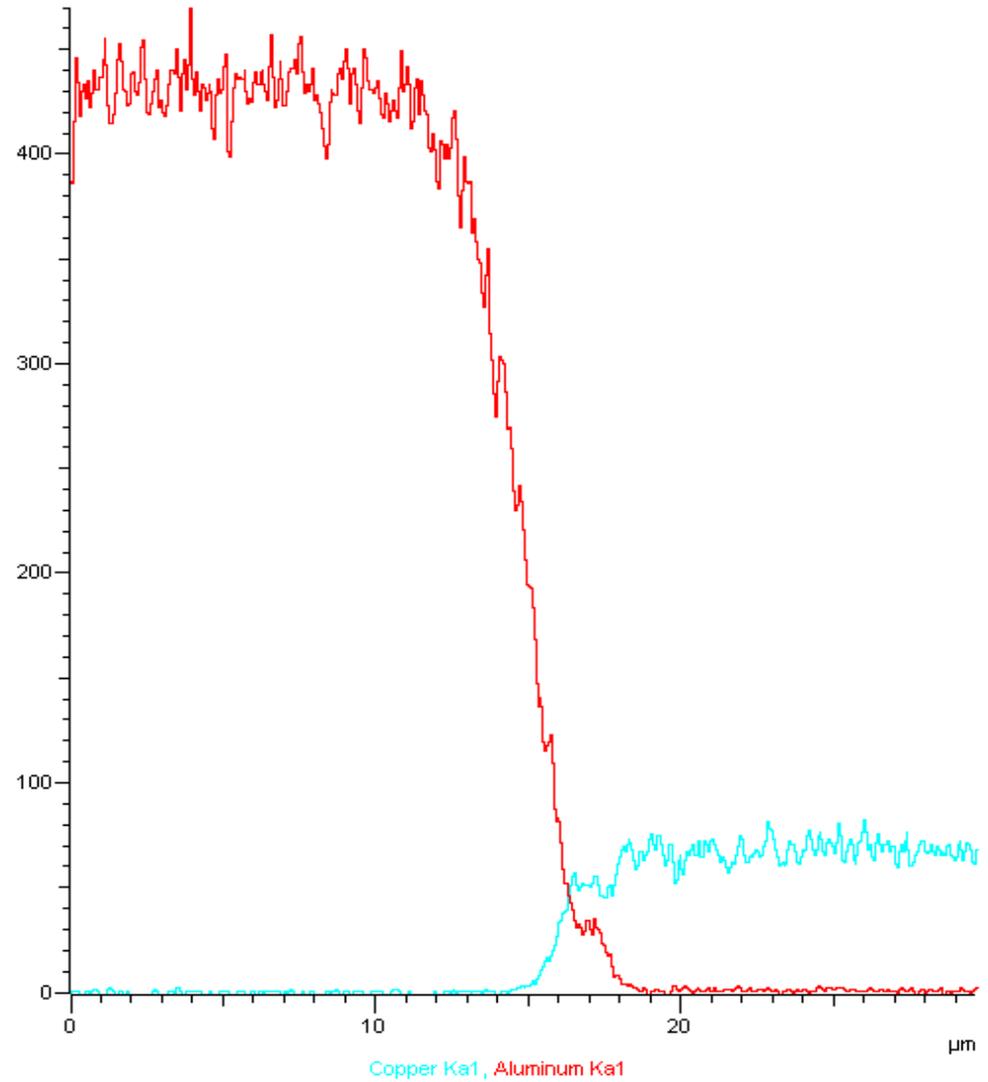
- The distance between the helical ridges in the copper half of the connector was 0.6mm. The ridges were visible along the welded interface.
- At the interface there was a very thin (2 μ m thick) zone where aluminium occurred in the copper. However this could be a result of the polishing process used by ERA rather than a result of the welding process.
- There was no evidence of copper in the aluminium.
- There were some areas where the copper and aluminium had become locked together mechanically as a result of the way the surfaces had deformed, see following SEM images.

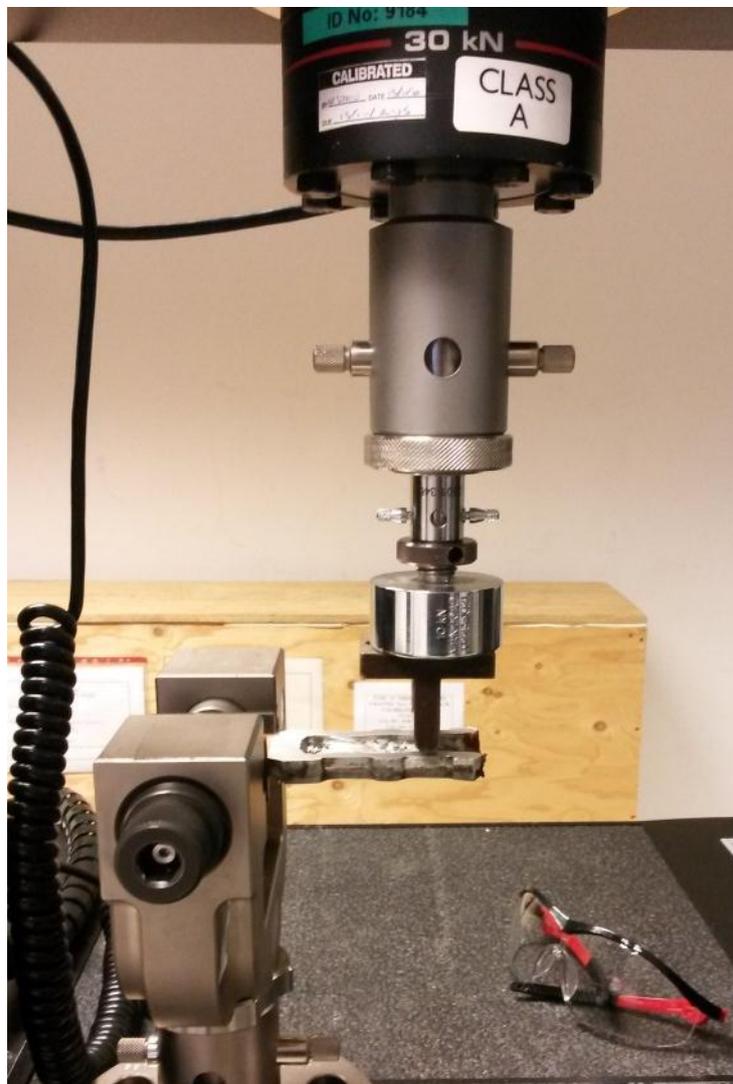
Figure 32: Initial arrangement for testing bi-metallic weld on PN 53 connector

The connector was held horizontally with the copper half clamped on the base of the tensile test machine. A vertical load was applied to the aluminium side 75 to 80mm from the copper/aluminium interface, Figure 32 and Figure 33. In both cases the aluminium ferrule bent without the aluminium/copper interface separating.

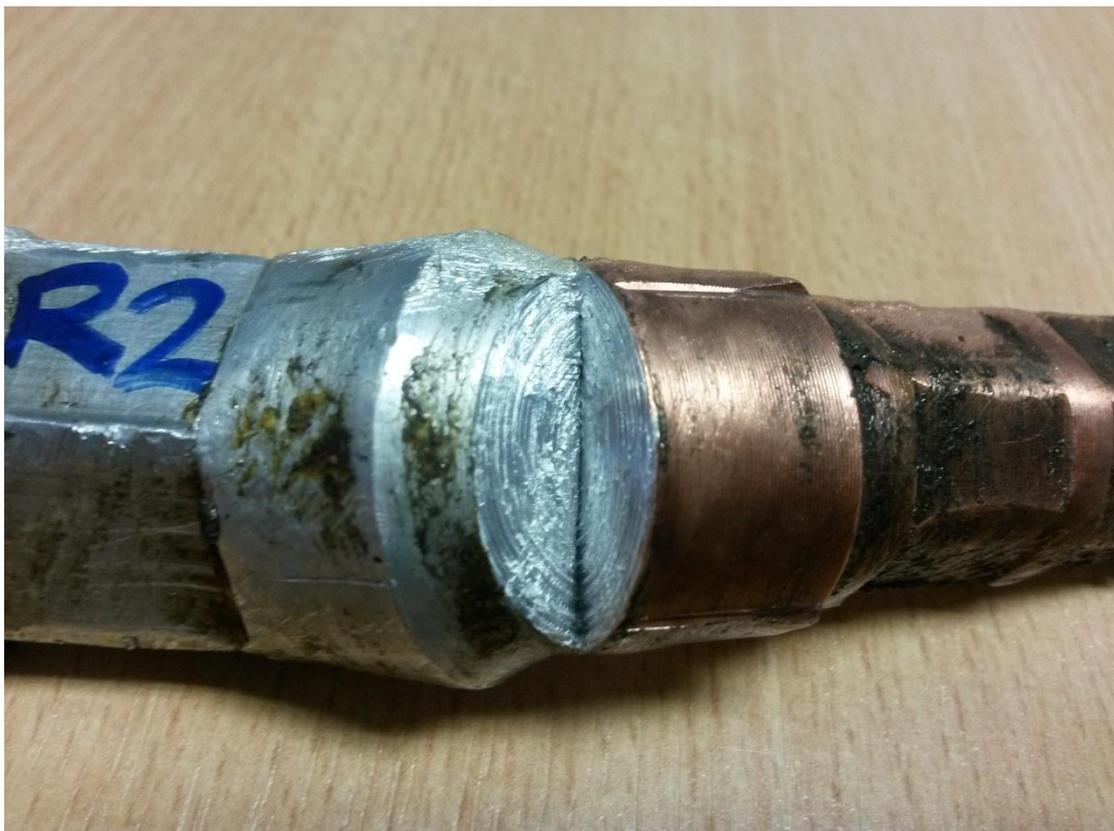
Figure 34: Weld interface surfaces showing aluminium adhering to copper surface

The connector halves were then turned over and the load applied at the same distance from the interface from the other side causing the weld to separate. In both cases there was aluminium visible on the copper side of the interface, see Figure 34.

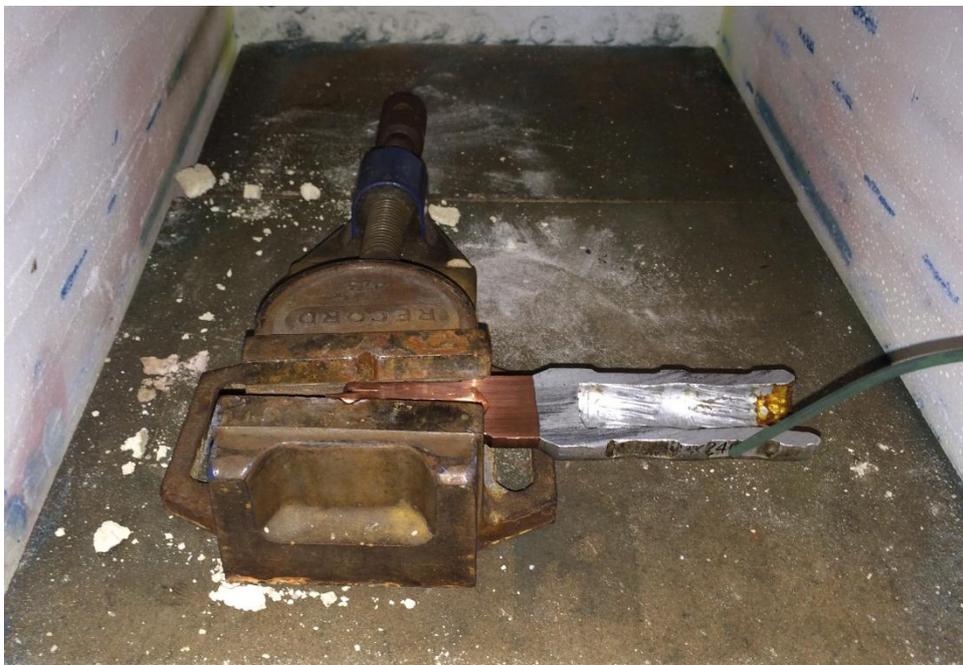
One half of the green phase connector from PN53 was held horizontally in a vice in an oven, Figure 35, and the oven heated to 600°C.

**Figure 35: Half of connector from PN53 mounted in oven**

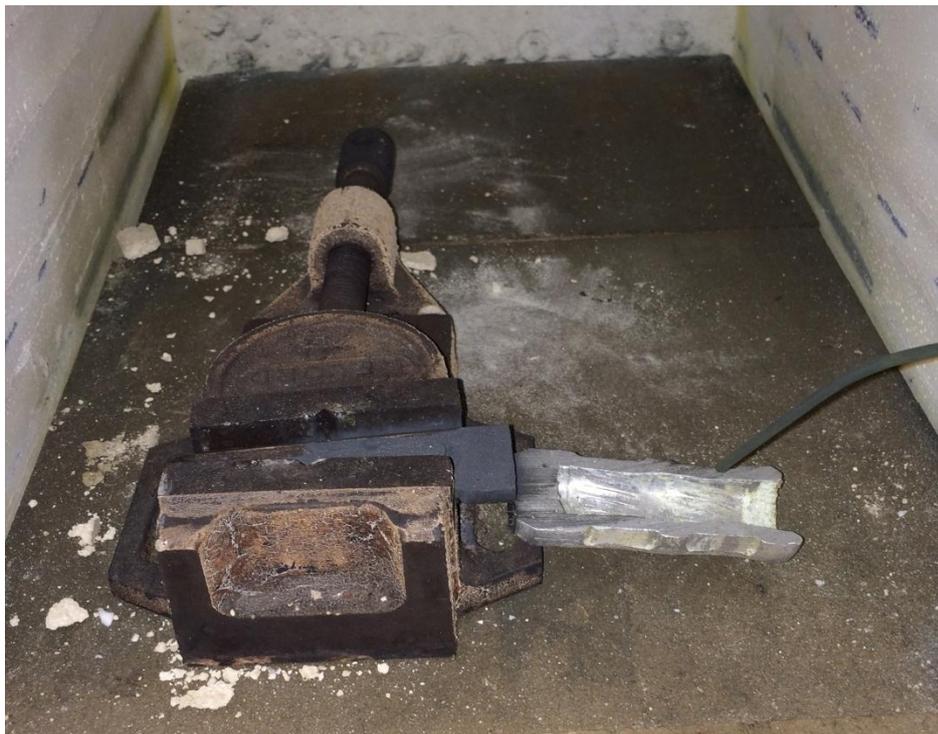
After 15 minutes at 600°C the oven door was opened and it was observed that the aluminium half of the connector had separated from the copper half and fallen onto the floor of the oven,

Figure 36: Half of connector from PN53 after 15 minutes at 600°C

The exposed bi-metallic weld surfaces were examined. There was no visible copper on the surface of the aluminium but there was a thin layer of aluminium on the weld surface of the copper side of the connector.

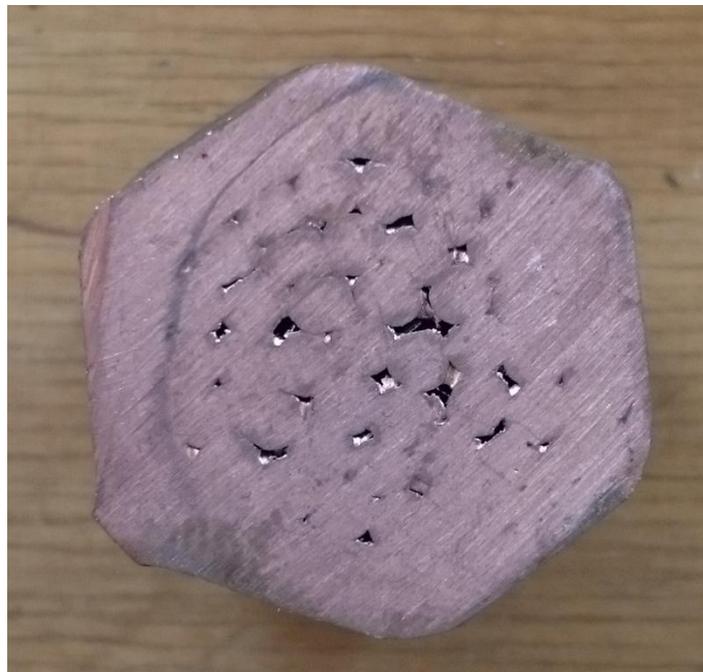
Larger gaps were observed between the strands of the PN33 green connector copper section and the PN53 white connector copper section, Figure 41 and Figure 42.

Figure 42: PN 33 green, copper, crimped section

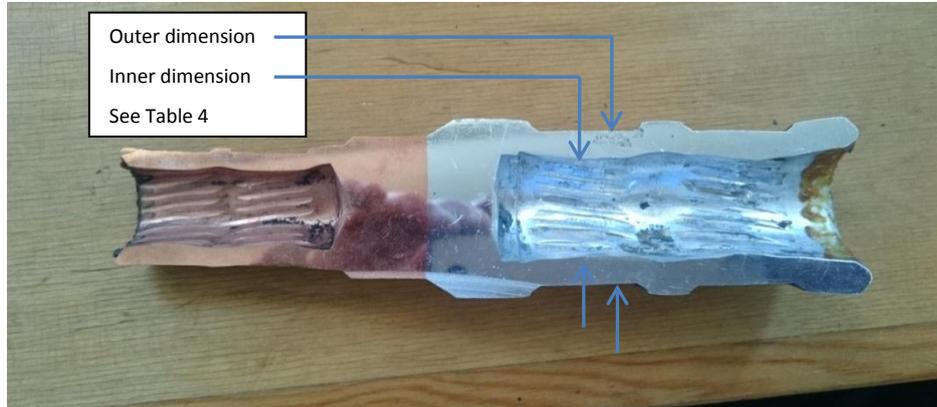
Figure 43: PN53 Green connector with good conductor insertion and compaction
