Report Title: Examination of cable joints from Penrose Substation

Client: Vector Ltd and Transpower NZ Ltd

Report Number: 2015-0356

2. Failed Heat Shrink PILC to XLPE Transition Joint 3-B-0, PN33

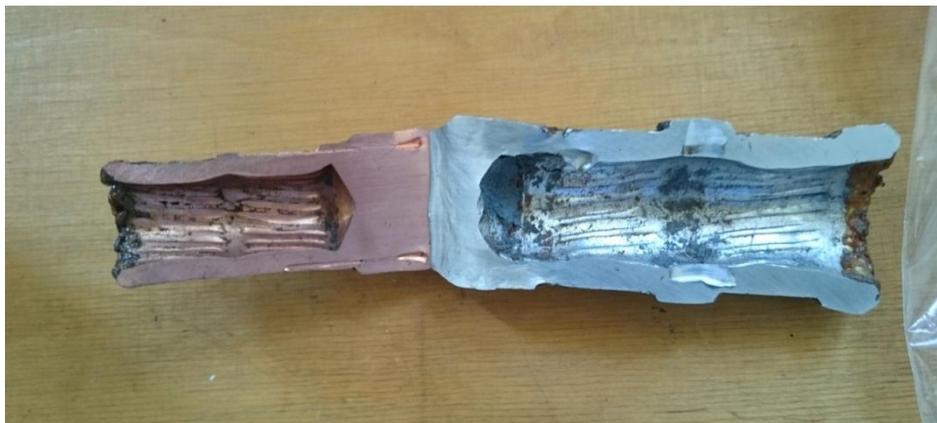
Figure 44: PN53 Red connector with good conductor insertion and compaction

The longitudinal impressions on the cut copper surface in Figure 44 were due to the way the sample had been clamped after it was cut open.

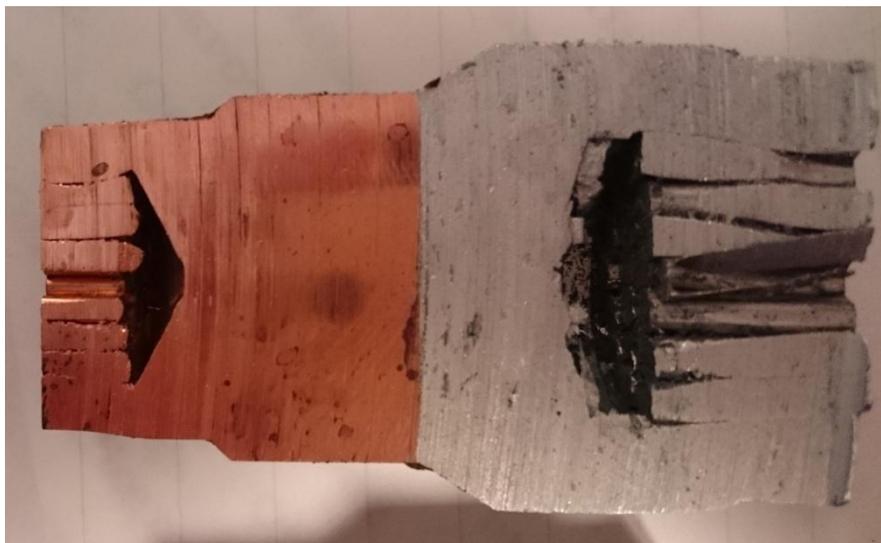
Figure 45: PN53 White connector with conductor strands fully inserted into ferrules

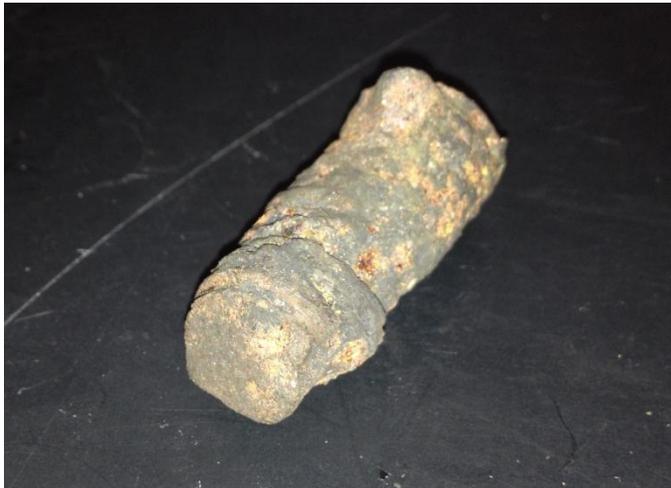
Figure 46: PN64 top bolt 69.5m (Failed Support Position)

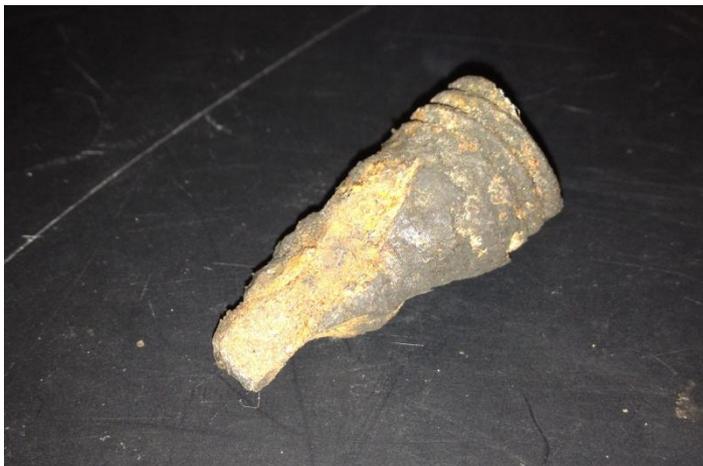
Figure 47: PN65 bottom bolt 69.5m (Failed Support Position)

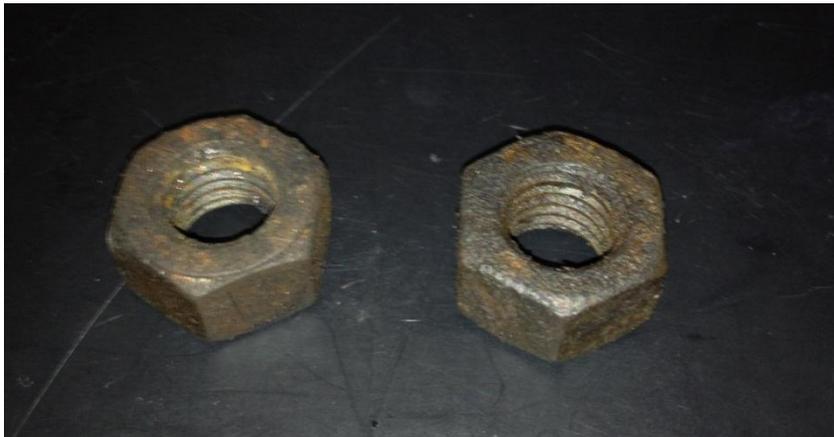
Figure 48: PN66 two nuts 69.5m (Failed Support Position)

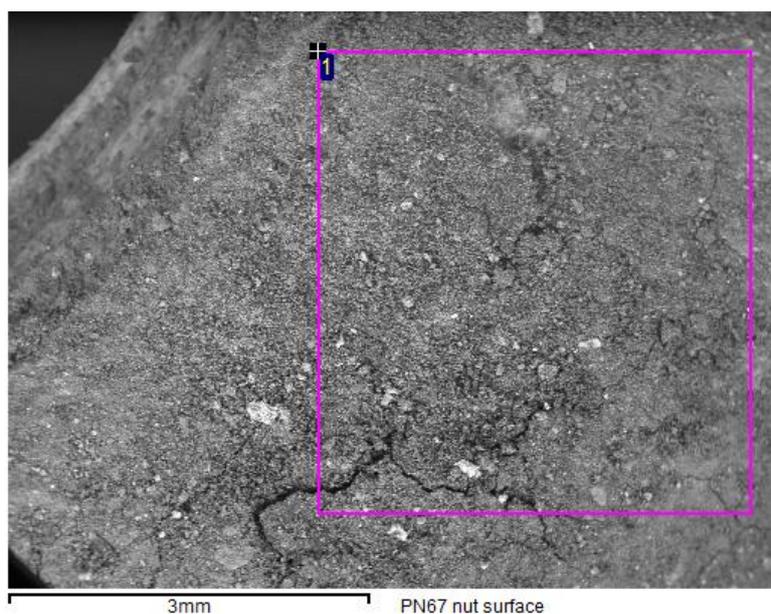
Figure 51: PN67 Nut surface

The stud and nut samples had a mixed zinc and iron oxide layer also containing mineral debris and chlorine. This layer would be consistent with the parts having been exposed to a fire and any subsequent water used to suppress the fire. The high chlorine content is most likely associated with burning of PVC or other chlorinated polymer. Copper was also detected on the surface. Copper would not be expected to be present as an alloying addition in the steel of the nut or bolt at the concentration seen. It is therefore likely that the copper contamination originated from arcing by-products from the cables.

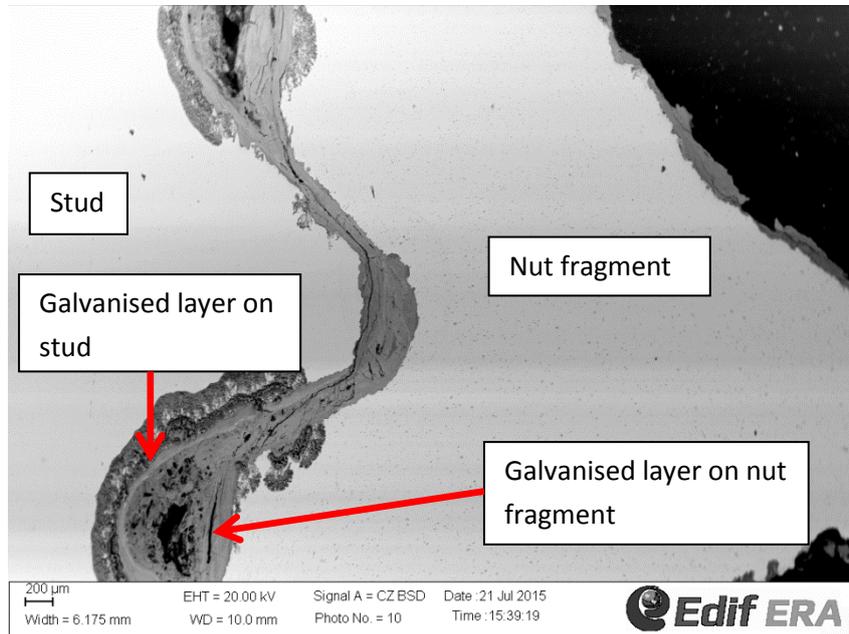
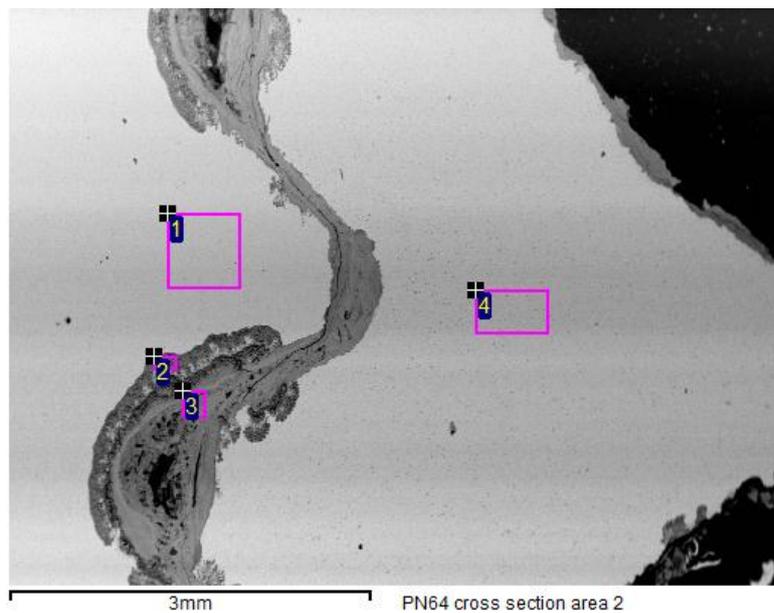
A fragment of nut was confirmed to be present on the top stud as shown in Figure 54. A nodule was also present on the top stud indicative of arcing and local melting Figure 59.

A polished cross-section through PN64 showed evidence of a nut fragment on the stud thread, .

Figure 54: PN64 SEM images and chemical analysis

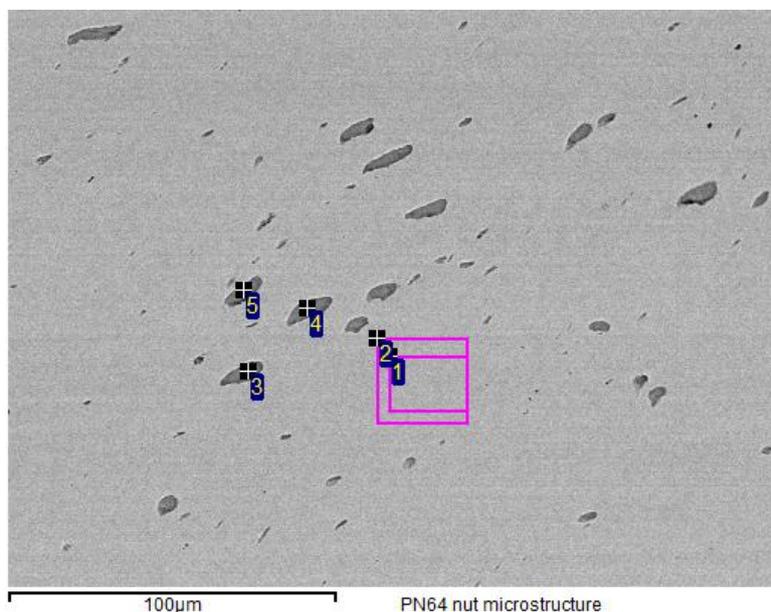
Standard carbon manganese steel had been used on the studs. Free cutting steel (with sulphur addition) had been used for the nut (see Figure 55 below showing backscattered electron image of microstructure, including spherical manganese sulphide particles associated with additions of sulphur to the alloy to improve its machinability).

Figure 55: PN64 nut microstructure

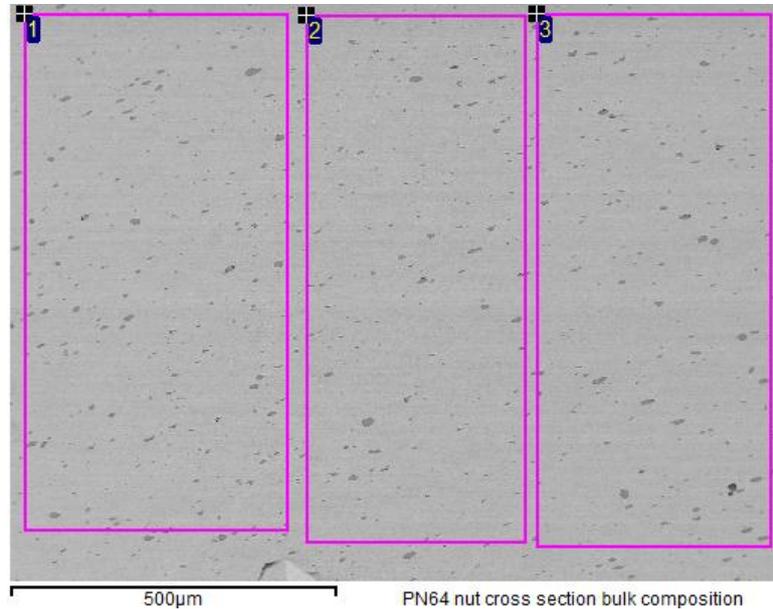
0.34wt%. The measured composition of the nut is shown below, Figure 56. The sulphur content of this nut exceeded the permitted level for grades within ISO 898-1.

Figure 56: PN64 nut SEM image and bulk composition

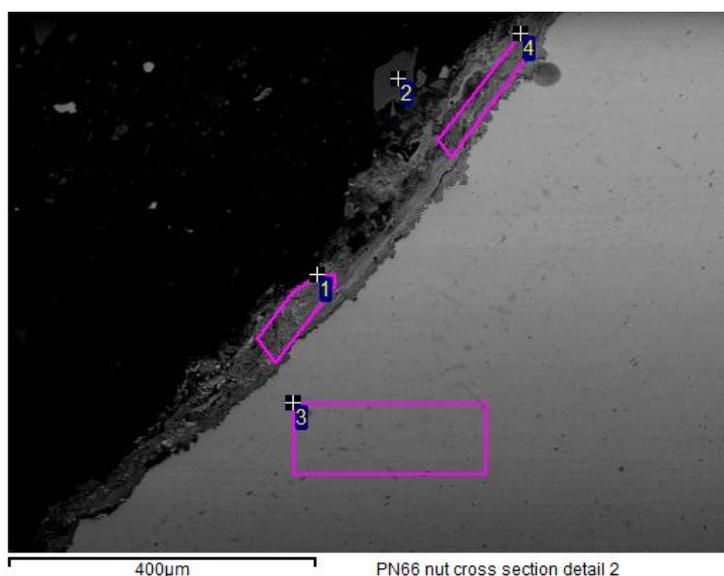
Chlorine was detected at high concentration on both the outer galvanising surfaces and the thread surfaces. It is expected that this chlorine is a contamination from the cable fire event (caused by the burning of a chlorinated polymer cable sleeve). The presence of chlorine on all nut surfaces would therefore suggest that the nut was not attached to a stud at the time of the fire.

Figure 61: PN66 nut cross section and SEM analysis

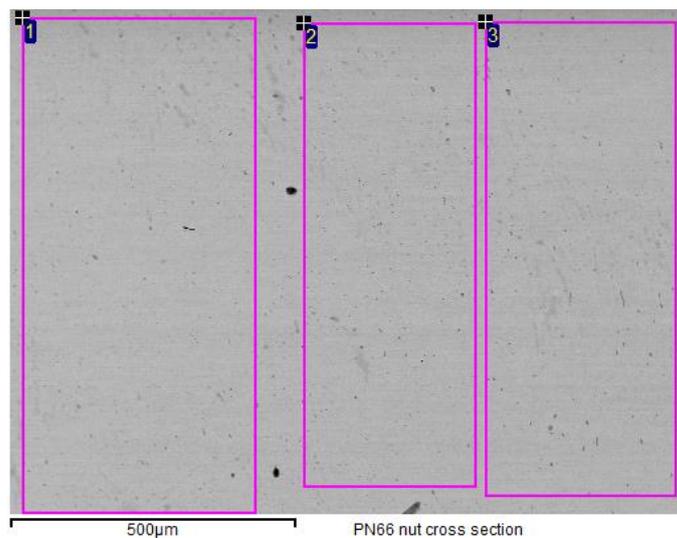
The sulphur content of this PN66 nut was within the specification for ISO898-1 (see Figure 63, below). This may indicate that these nuts are from a different batch/supplier to the other nut fragment found on bolt PN64.

Figure 63: PN66 SEM cross section and material analysis

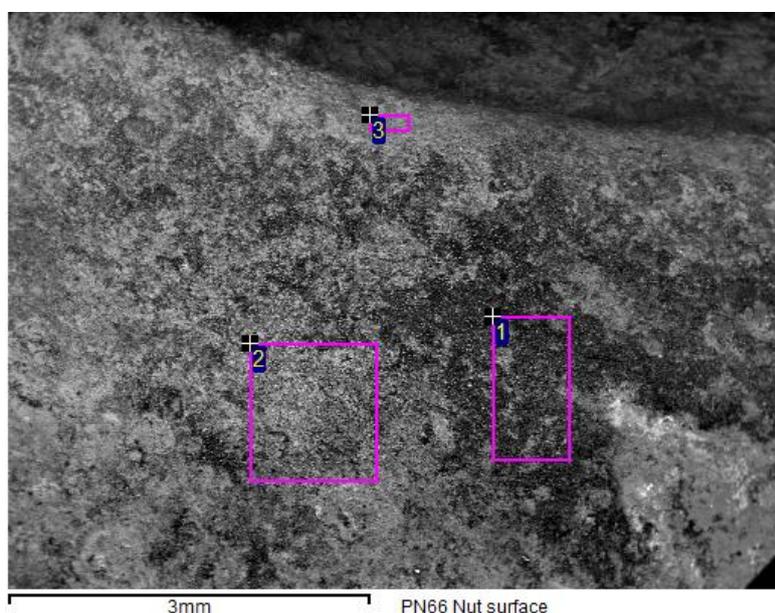
The PN66 nuts were found on the floor of the trench. They may have been assembled onto the studs at some time but the evidence suggests that these nuts were not assembled onto studs at the time of the fire. Chlorine was present on the inner thread surfaces of the nut that could not have reached this region if the galvanising layer had been in contact with the galvanising layer of the stud thread, Figure 64. The pattern of the thread deposit indicates that this would not have been transferred to the thread if it had been undone after the event. The presence of a fragment of nut on the top stud indicates that the support frame had been correctly assembled and the above finding indicates that the two nuts found on the floor had not been associated with the frame.

Figure 64: PN66 nut surface, SEM image and analysis

The studs show both oxidation/corrosion and arc damage. The nuts show some oxidation and deposition of a carbon/chlorine rich residue, probably associated with the fire. The evidence suggests the nuts were not in place on the studs at the time of the fire.

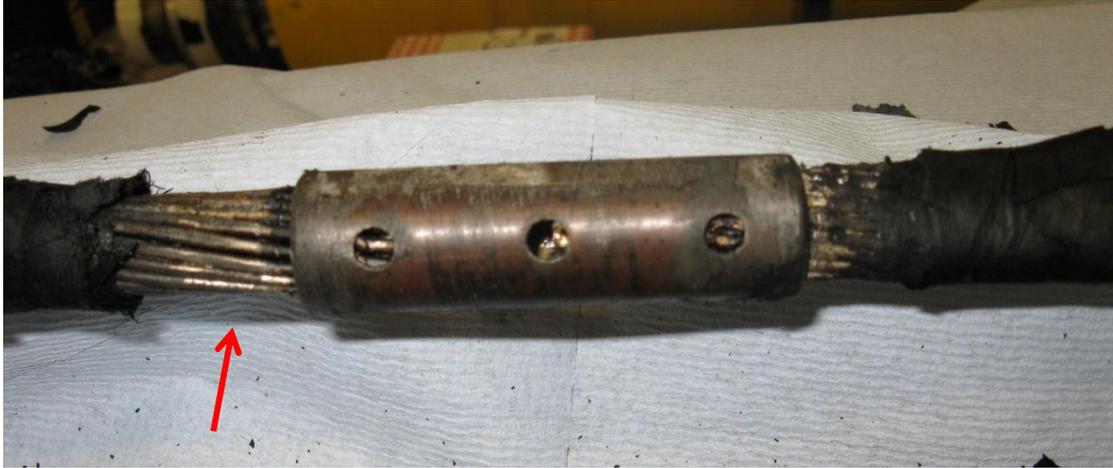
There was little if any solder left in the ferrules and one conductor had pulled out of the ferrule by 2.5mm on the switch room side of the joint.

Figure 69: Conductor partly pulled out of ferrule

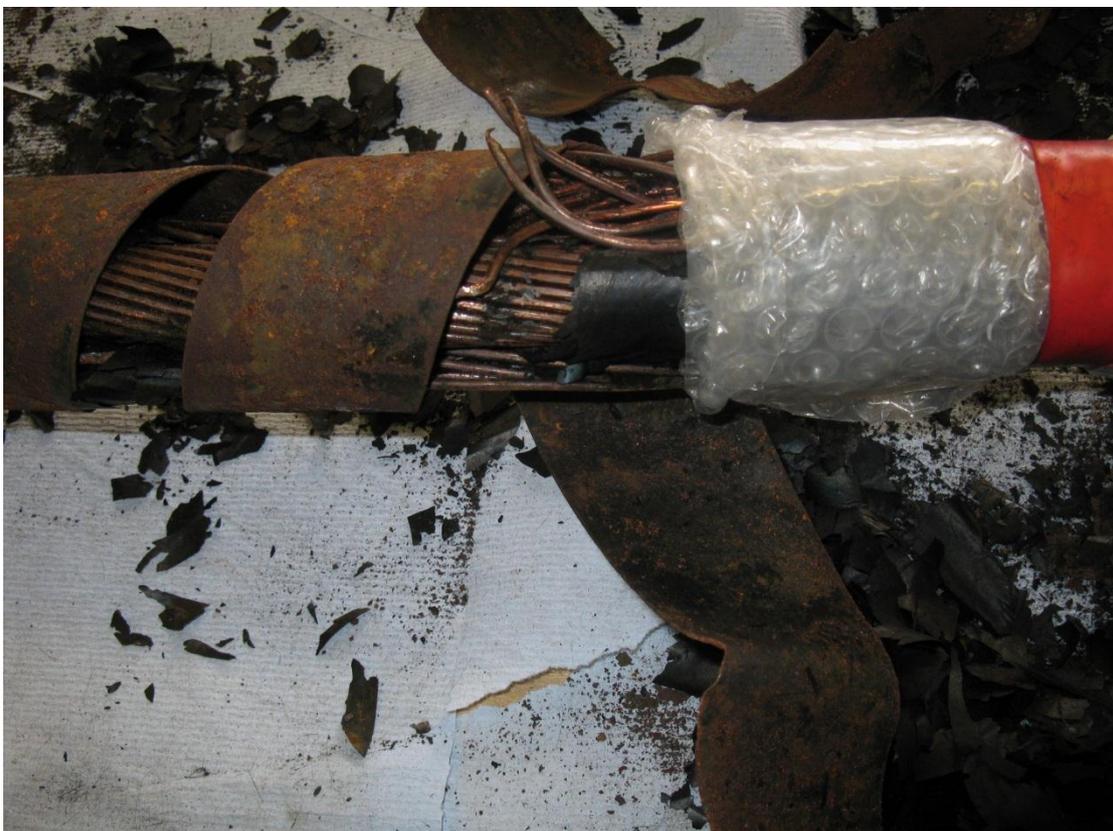
There was a phase to earth fault in the cable on the Gavin Street side of the joint 280mm away from the end of the joint shell. The phase conductor was eroded over a distance of approximately 10mm. The eroded conductor strands had been displaced outwards through gaps in the armour and there was localised arc erosion on the steel tape armour.

Figure 70: Cable fault position on Gavin St side of joint, PN57

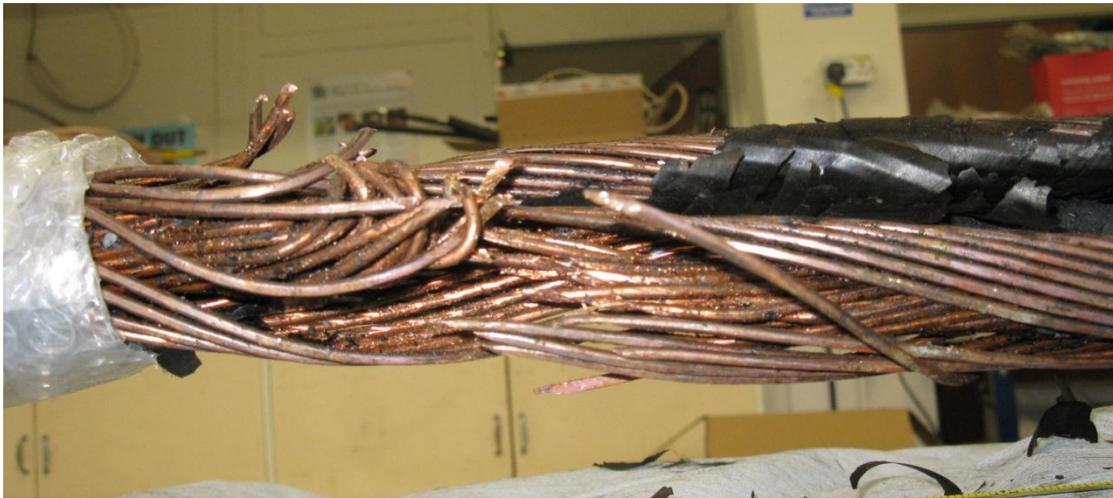
Figure 71: Fault position after removing armour, PN57

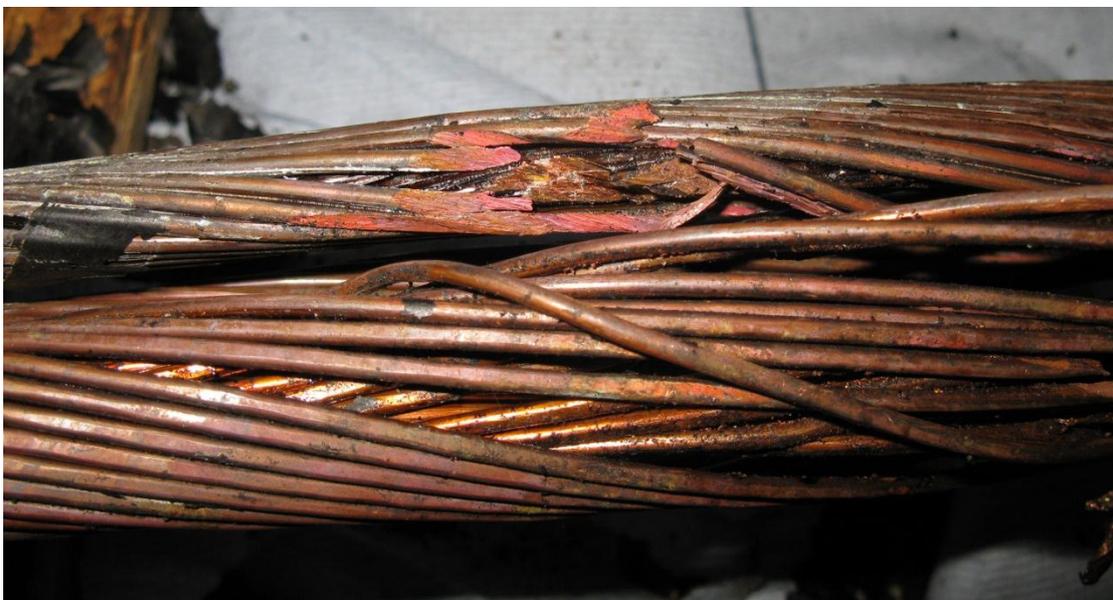
There was what appeared to be a second phase to earth fault in another core on the Gavin Street side of the joint 350mm away from the end of the joint shell. The ends of some of the eroded conductor strands had an abraded appearance, Figure 72. The cores may have moved relative to each other and it is therefore possible that there was one phase to phase to earth fault rather than two separate phase to earth faults.

Figure 72: Abraded appearance of conductor strands on Gavin Street side of joint, PN57

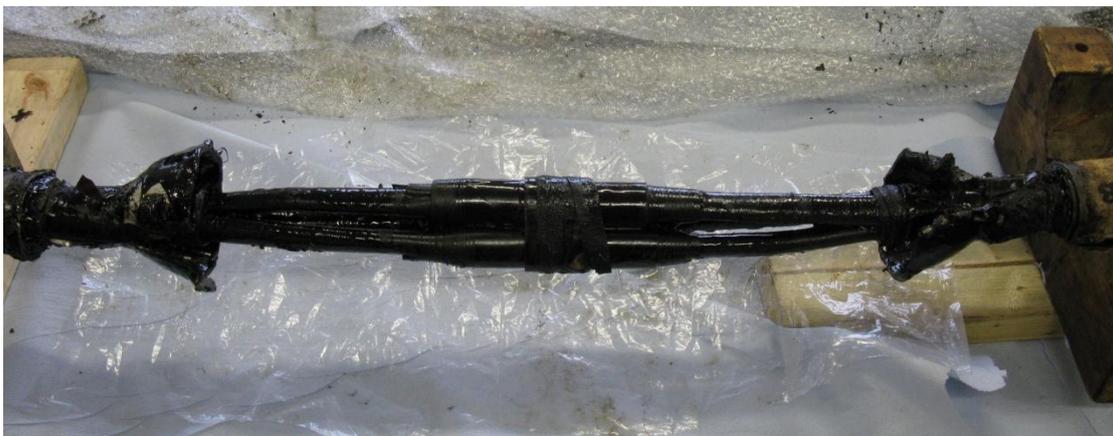
The joint shell was heated, drained of bitumen and the two joint shell halves removed. The inner lead sleeve was still intact. It was heated, cut open and drained of bitumen. The core, insulation papers and binders inside the joint all appeared to be in good condition prior to further strip down, Figure 74.

Figure 74: PILC cable joint after removing joint shell, inner lead sleeve and bitumen, PN60

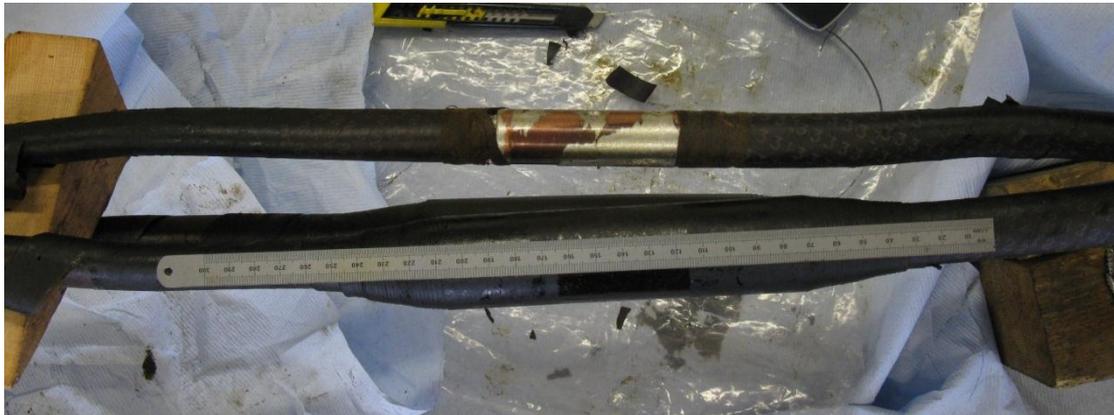
The core papers had also been degraded, presumably by heat from the fire as there was no evidence of any electrical breakdown activity. The central insulating tapes over the ferrules had been correctly applied and were in relatively good condition. Cloth tape had been applied between the ferrules and the tapered end of the core insulation, Figure 79.

Figure 79: Central taped insulation over ferrule PN28

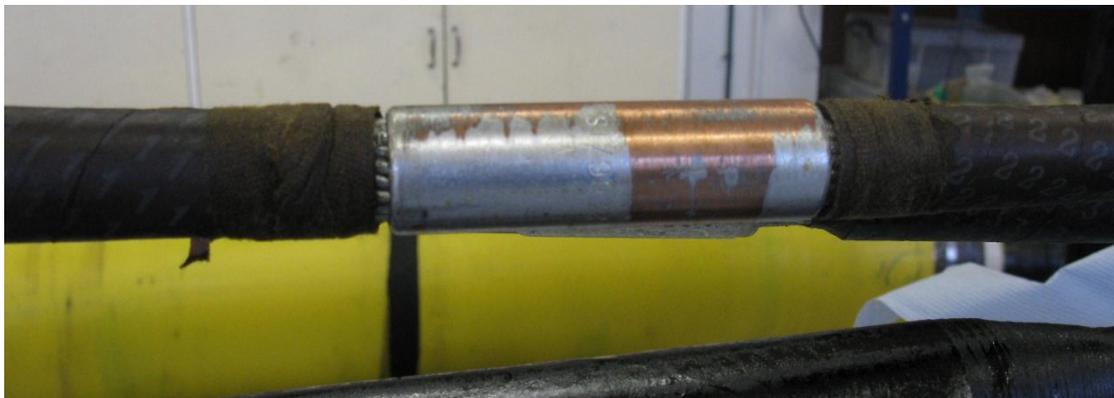
Most of the solder had melted out of the ferrules. There was a 3mm gap between the Gavin Street end of the ferrule and the cloth tape on core 1 where the conductor had started to pull out of the ferrule, Figure 80.

Figure 80: Core 1 ferrule, PN28

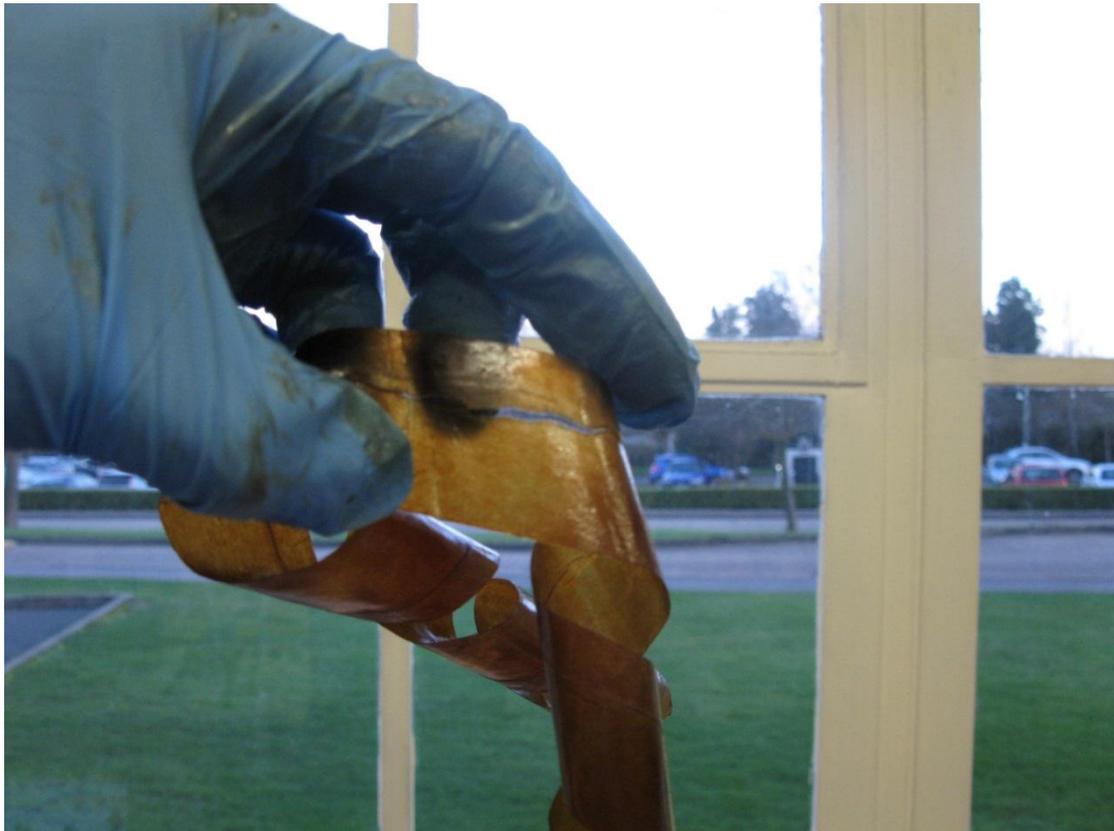
The core papers showed signs of localised mechanical damage, creasing and butt gap separation where the temporary spreaders had been fitted during the jointing operation. The lead solder from the ferules had travelled up to 345mm along the conductor strands, Figure 82. The papers had a tendency to split at the extended butt gap positions, Figure 83.

Figure 83: Split in insulation paper at butt gap position, PN28

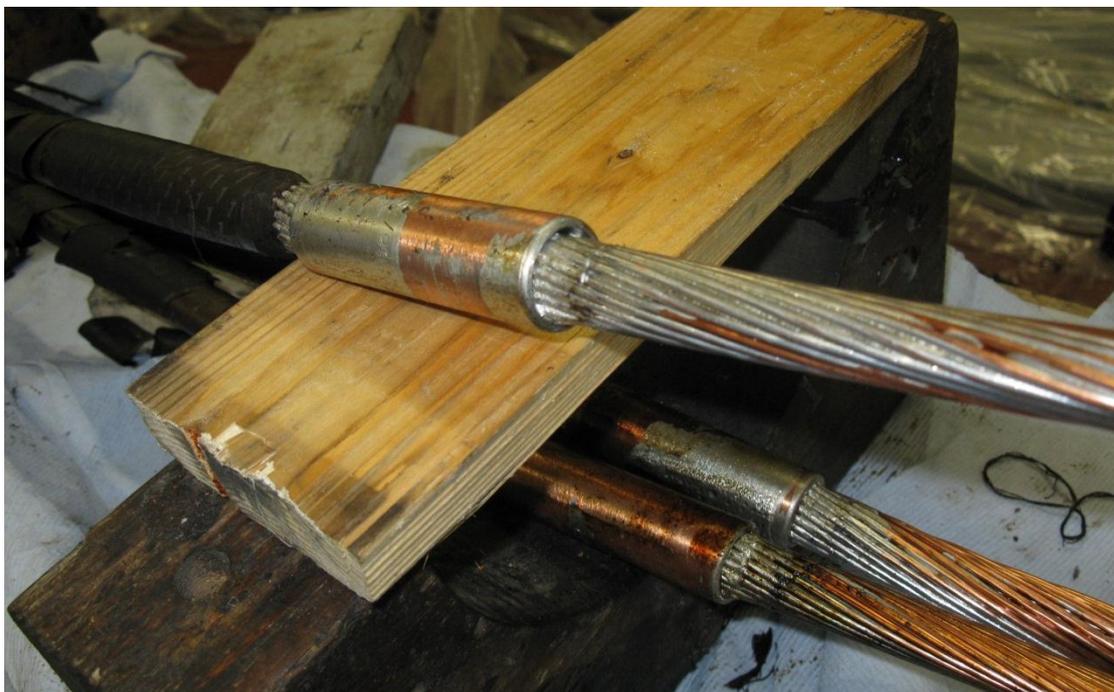
There were gaps of between 1.5 and 1.8mm between the conductors and the bore of the ferrules, Figure 84.

Figure 84: Gap visible between conductor and bore of ferrule

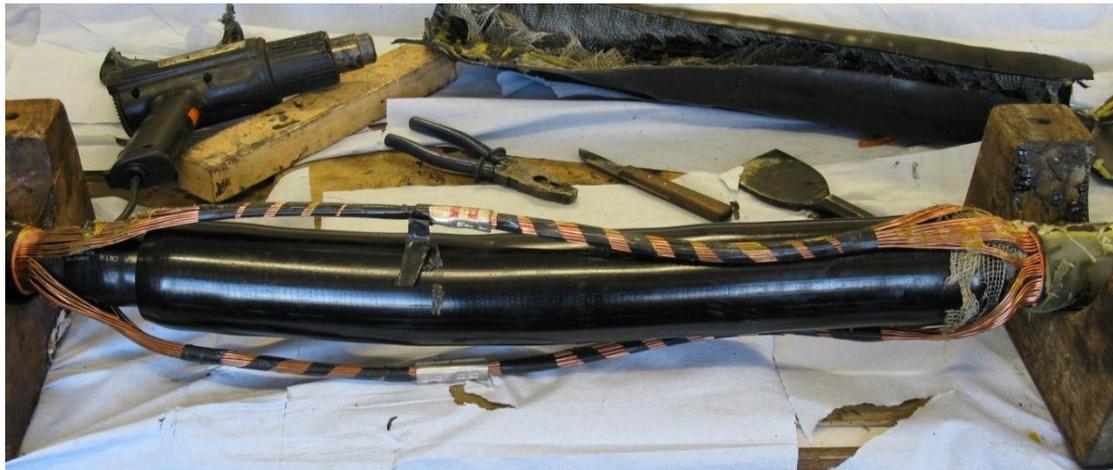
There was no evidence of any damage to the black outer heat shrink tube. The outer heat-shrink tube and knitmesh copper braid screen were removed to expose the central insulator and earth bond connections, Figure 85.

Figure 85: 33kV XLPE s/c joint after removing outer HS tube and earth screen, PN54

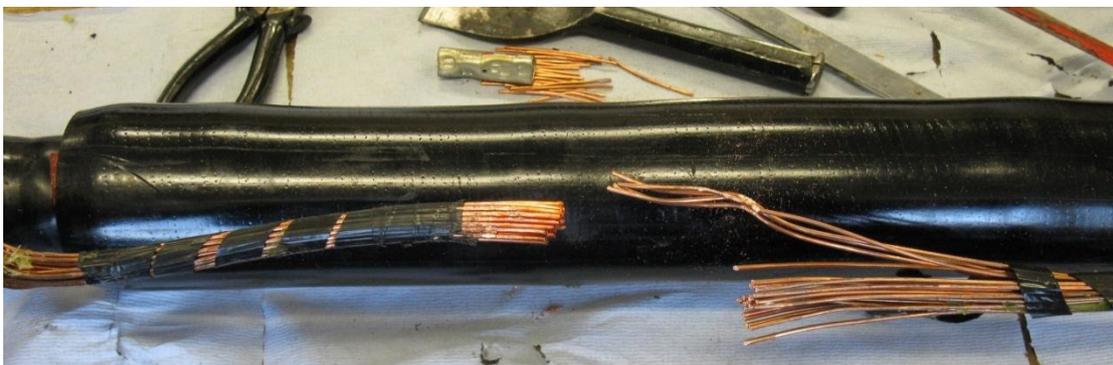
The central insulating tube was 620mm long and was marked "Top layer conducting EB62611 21:50 ECIC 95/42 Raychem". The compression ferrules joining the screen wires from the two cables together were not adequately compressed onto the screen wires. When a cable cutter was used to cut through one of the bunches of screen wires, the ends of the wires fell out of the compression ferrule, Figure 86.

Figure 86: Screen wires fell out of compression ferrule

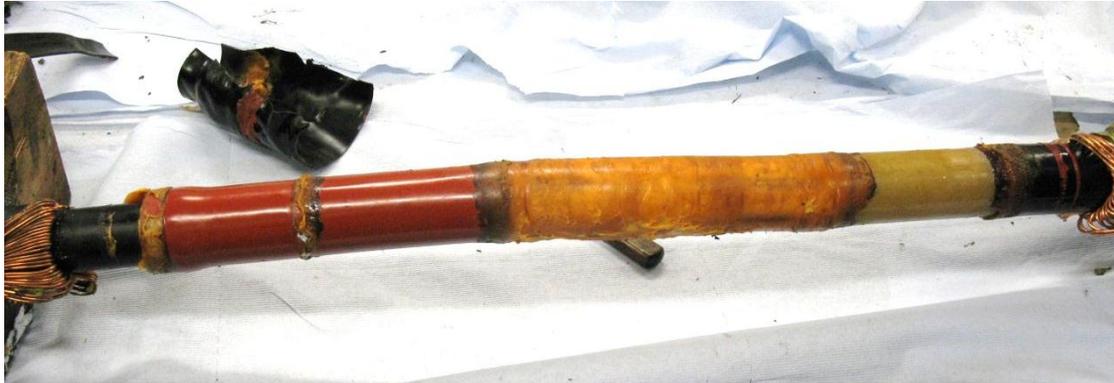
The central insulation tube and stress control tubes were cut open and removed. A layer of red heat-shrink insulation had been applied over the 400mm² XLPE core to increase its diameter to that of the larger 800mm² cable, Figure 87.

Figure 87: XLPE joint after removing outer heat shrink and stress control tubes PN54

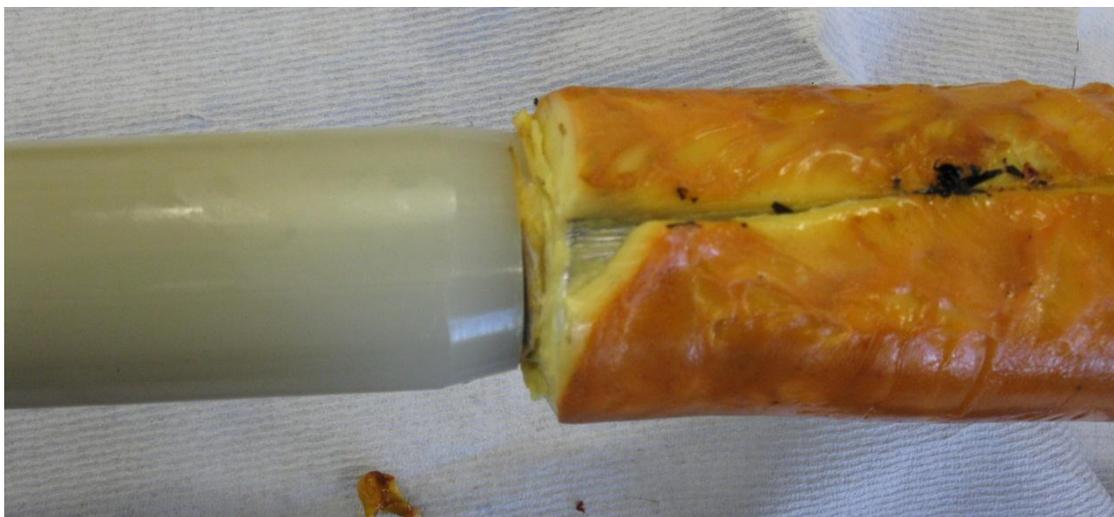
Yellow mastic had been applied over the end of the extruded cores screens, in the gaps between the compression ferrule and the XLPE core insulation and over the compression ferrule. The surface of the yellow mastic was discoloured, particularly at the core screen terminations on both cables. The ends of the XLPE insulation had been tapered, Figure 88.

Figure 88: XLPE core on 400mm² cable and ferrule coated with mastic, PN54

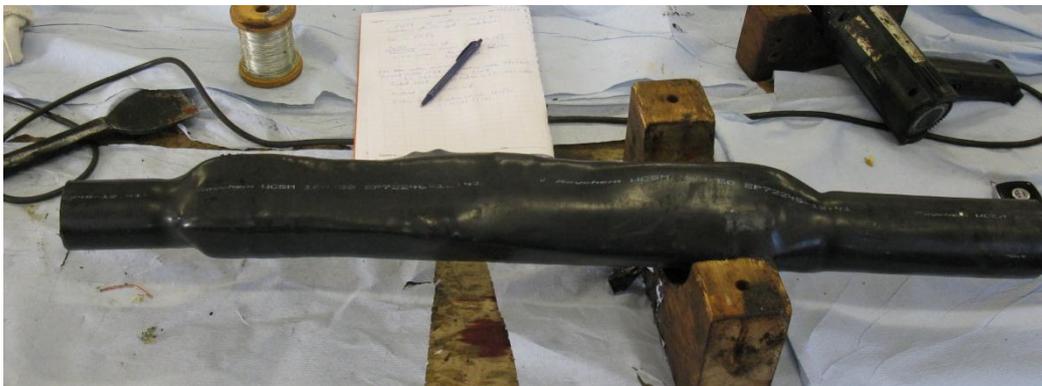
There was no cable sheath on the other end of the joint as the sample had been cut off at the end of the joint, Figure 89. The outer heat shrink tube was cut open and removed. The outer tube was coated with hot melt adhesive on the inside. The ends of the cable sheath had not been abraded.

Figure 89: 400/630mm² XLPE transition joint PN59

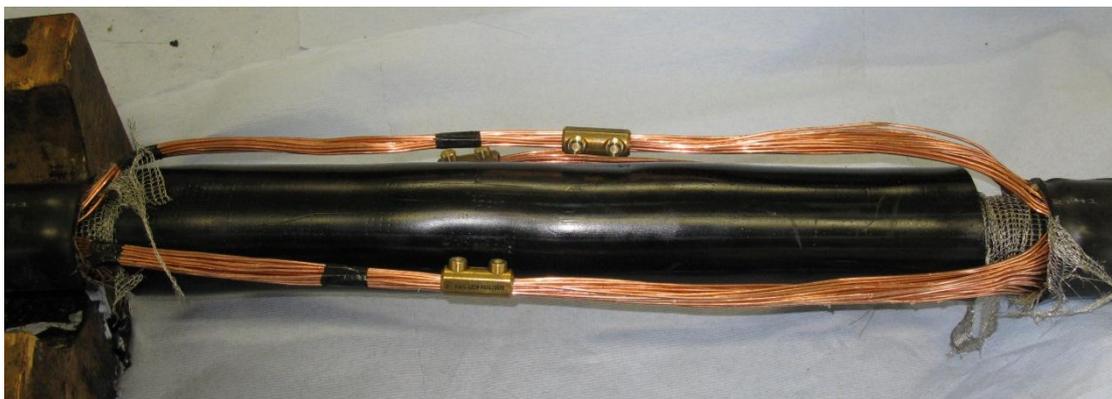
The screen wires were connected across the joint with three shear-head bolt connectors, Figure 90.

Figure 90: Screen wire connections across joint, PN59

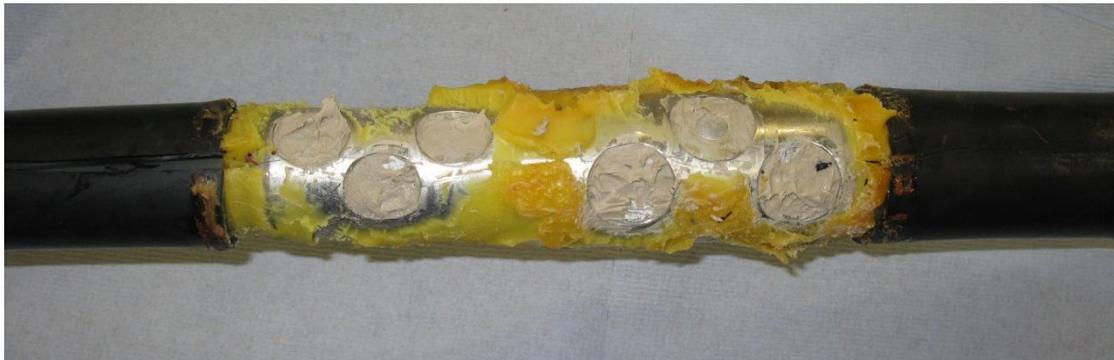
Yellow mastic had been applied over the shear-head bolt connector and in the gaps between the core insulation and the ends of the shear-head bolt connector. The gaps above the ends of the shear-head bolts had been filled with a cream coloured putty, Figure 91.

Figure 91: Shear head bolt connector, PN59

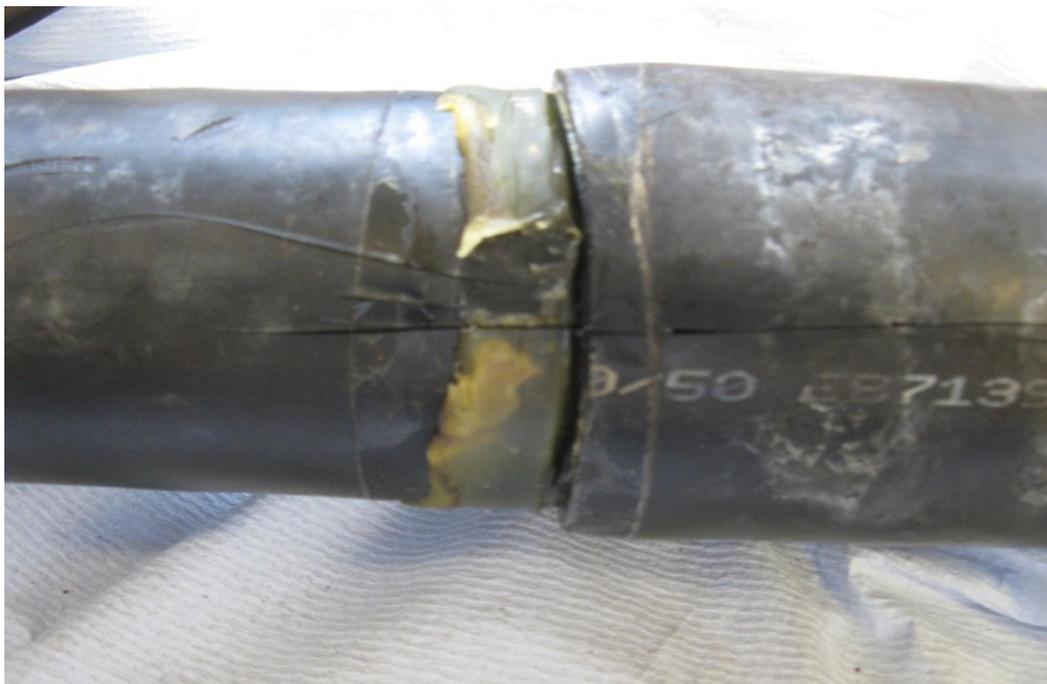
The Raychem WCSM 160/50 outer tube was uniformly shrunk down onto the joint with hot melt adhesive visible at either end, Figure 92. The WCSM outer tube and the semi-conducting CNTM stress control tubes were cut open and removed. The ends of the cable sheaths had not been abraded.

Figure 92: Hot melt adhesive visible at end of WCSM outer tubing, PN55

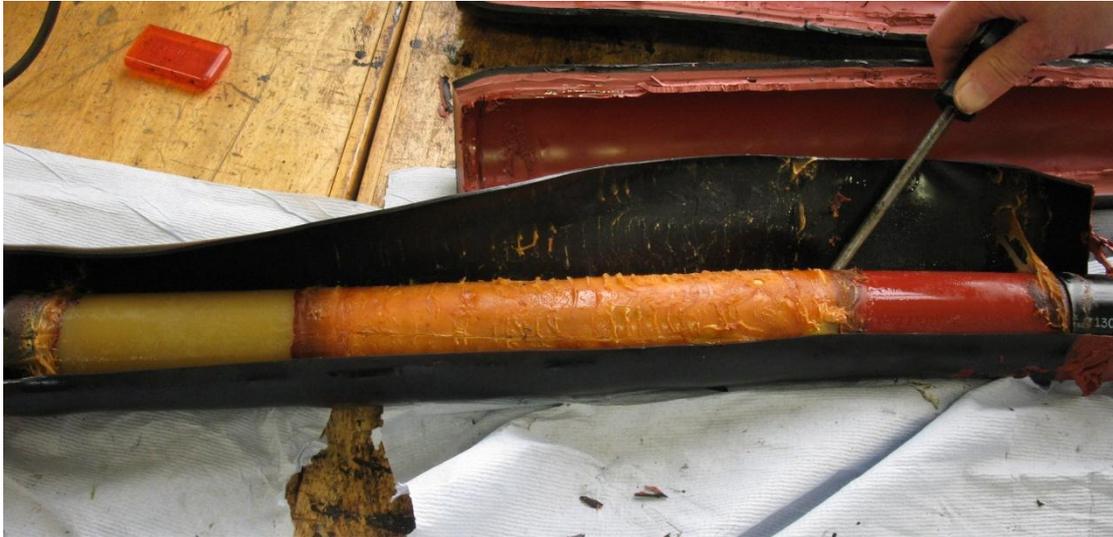
build up the diameter. There was a thin layer of oil over the red heat shrink tubing. Yellow mastic had been applied over the ferrule and screen terminations. The yellow mastic was discoloured at the ends of the ferrule and at the screen terminations, Figure 93.

Figure 93: Yellow mastic applied over ferrule and screen terminations, PN55

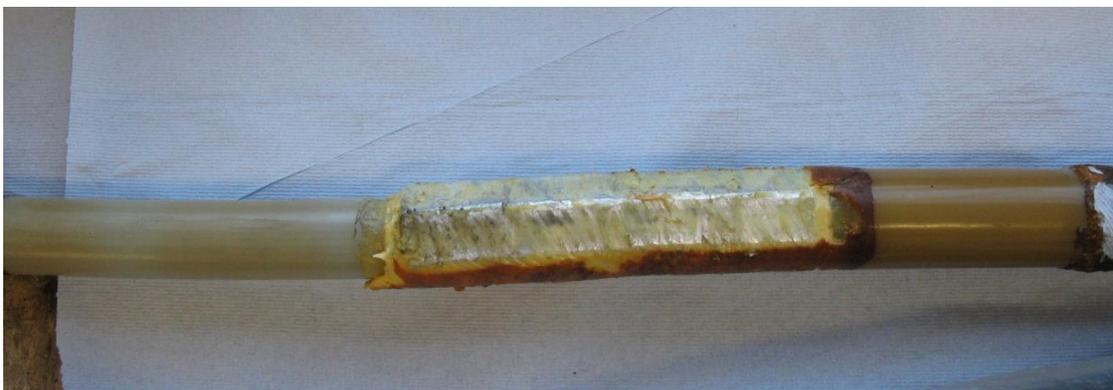
The XLPE insulation was close to the original colour on the 400mm² side of the joint but darker on the 800mm² side, Figure 94.

Figure 94: XLPE insulation and compression ferrule, PN55

The distance from the screen cut back position to the ferrule was 226mm on the 400mm² side of the joint and 145mm on the 800mm² side of the joint.

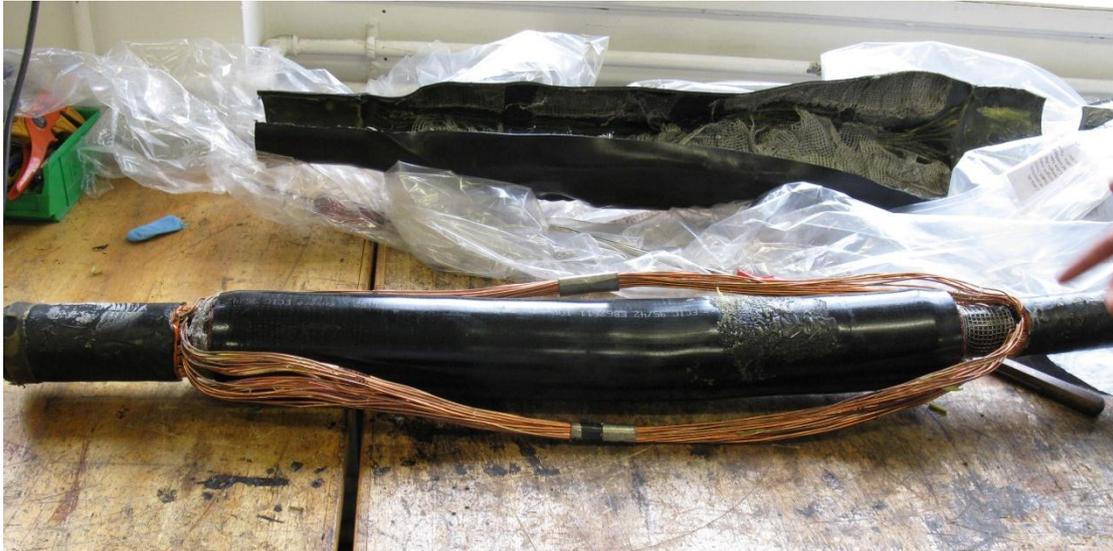
The 960mm long WCSM outer heat shrink tube was uniformly shrunk down onto the joint. The outer heat shrink tube and knitmesh braid was cut open and removed from the joint, Figure 95.

Figure 95: XLPE transition joint after removing outer WCSM tube, PM58

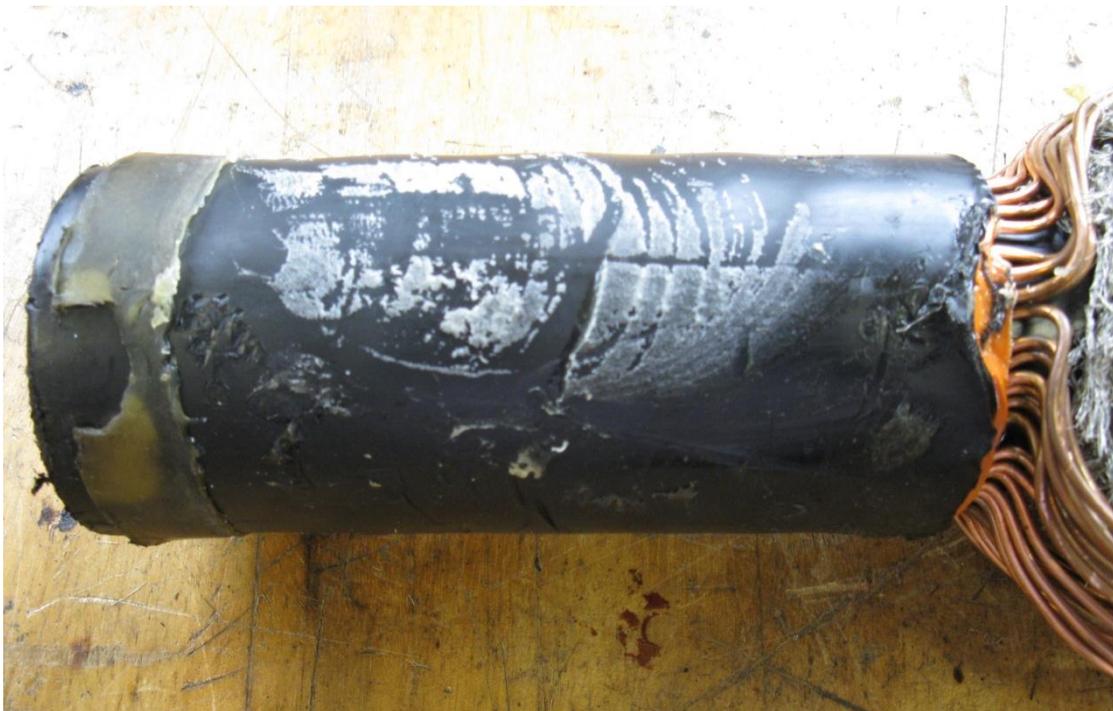
The outer heat shrink tube was coated on the inside with hot melt adhesive. The ends of the cable sheaths had not been abraded, Figure 96.

Figure 96: End of cable sheath and remains of hot melt adhesive, PN58

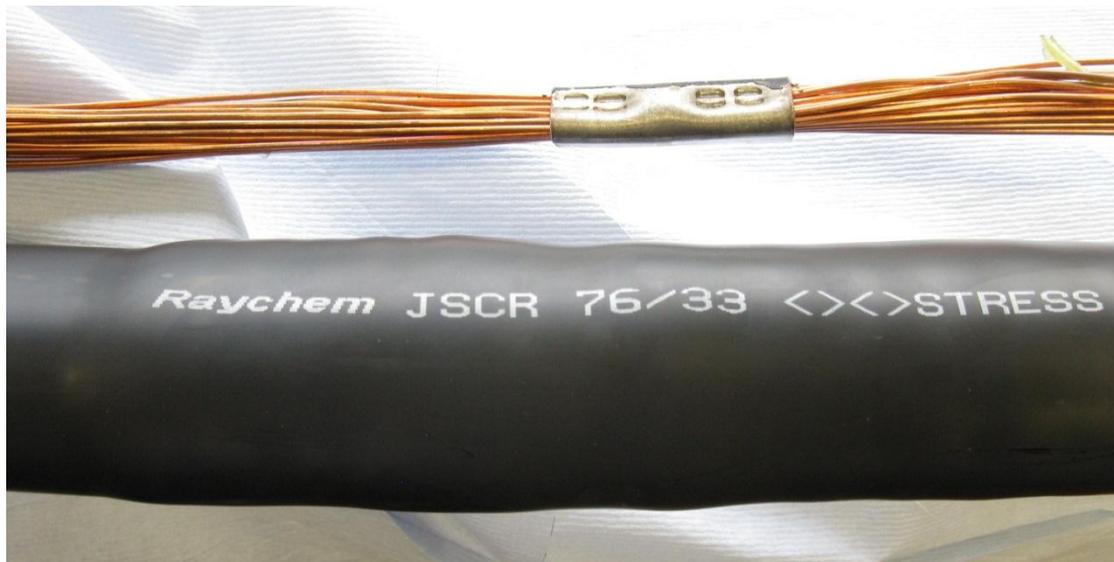
There was a layer of stress control tube over the phase conductor compression ferrule, Figure 97.

Figure 97: Stress control tube over phase conductor ferrule and screen wires connection, PN58

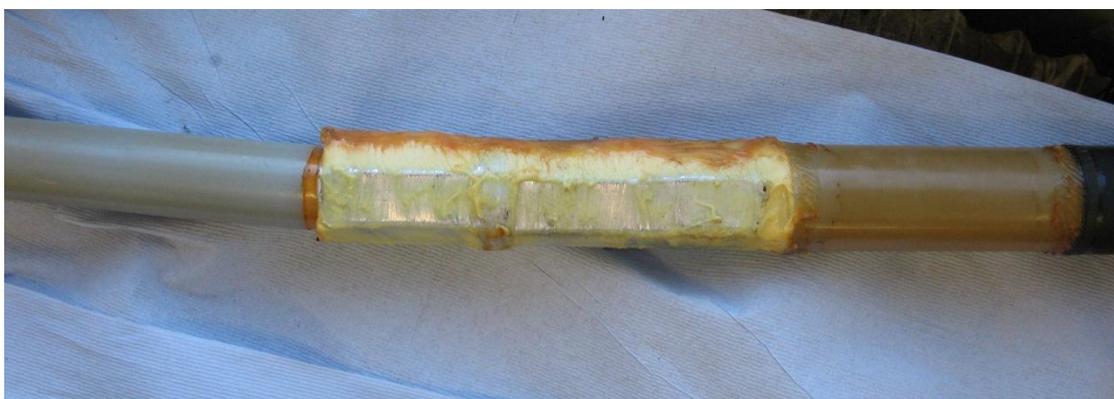
The XLPE insulation was close to the original colour on the 400mm² side of the joint but darker on the 800mm² side, Figure 98.

Figure 98: XLPE insulation and compression ferrule, PN58

The distance from the screen cut back position to the ferrule was 226mm on the 400mm² side of the joint and 145mm on the 800mm² side of the joint.

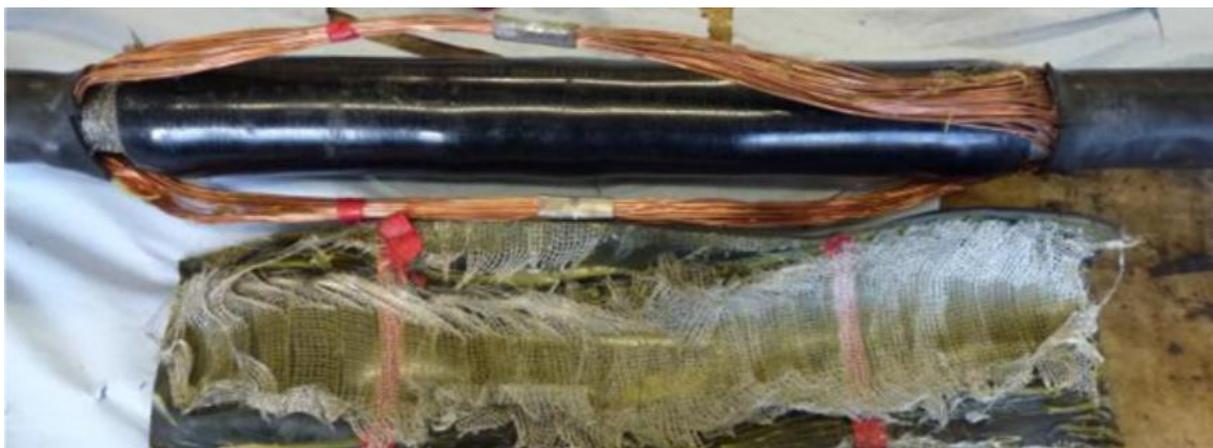
There was no evidence of any damage to the protective outer black heat shrink sleeve. The heat shrink sleeve and knit-mesh copper braid screen were removed to expose the two earth bond connections and the central insulation package, Figure 99.

Figure 99: 33kV XLPE s/c joint after removing outer HS tube and earth screen, PN56

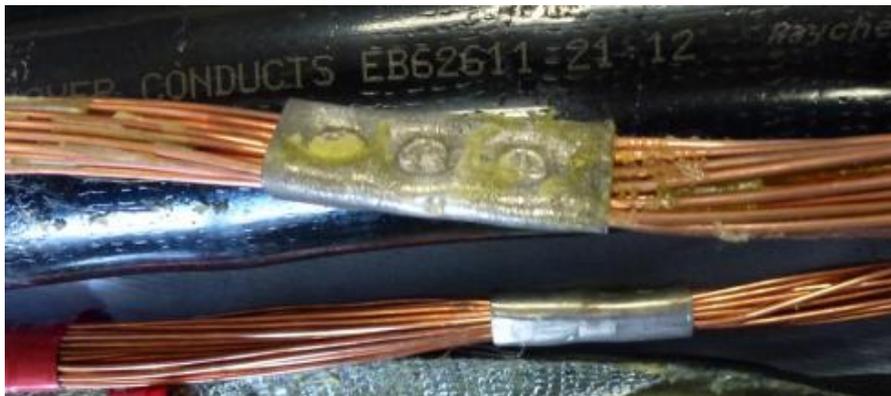
The ferrule length appeared to have been too short to accommodate the indent widths. On one ferrule, Figure 100, two of the indents were ineffective: one was compressed at the centre of the ferrule and another overlapped the end of the ferrule.

Figure 100: Ferrule connecting cable screen wires across the joint PN 56

- The five XLPE straight joints examined were generally found to be in sound condition. In one joint one of the two compression ferrules connecting the cable earth return conductors had not satisfactorily gripped the conductor wires.
