Report Title: Examination of cable joints from Penrose Substation

Client: Vector Ltd and Transpower NZ Ltd

Report Number: 2015-0356

2. Failed Heat Shrink PILC to XLPE Transition Joint 3-B-0, PN33

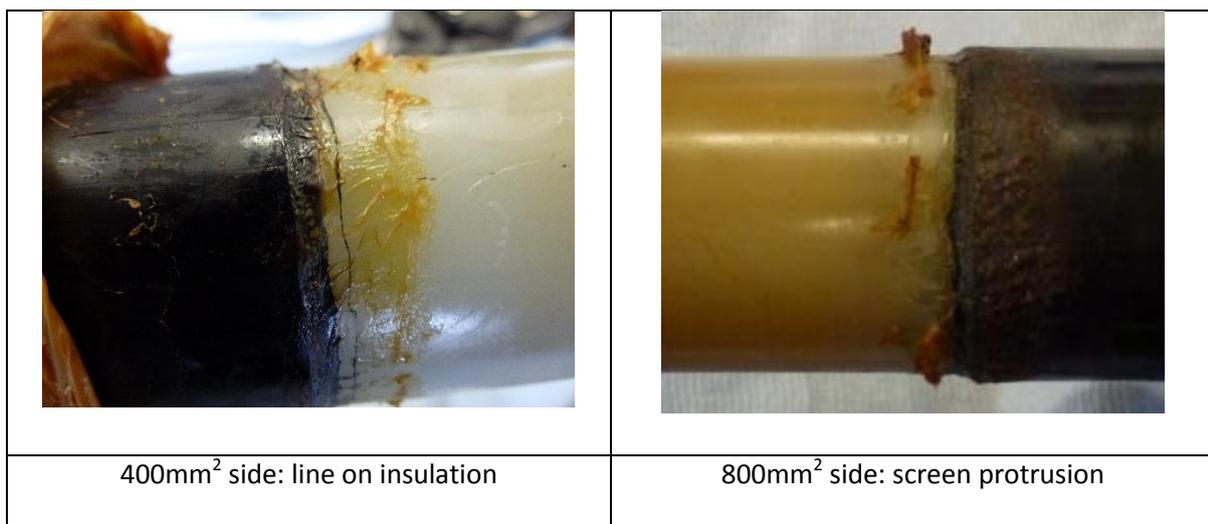
Figure 102: Screen termination features PN 56

The red sleeves were removed from the 400mm² side. The local covering of yellow void filling mastic was removed to reveal the termination of the cable's extruded core screen, Figure 102 left hand side. The screen had been chamfered to approximately 45°. A circumferential black line was present

The void filling mastic applied over the screen termination on the 800mm² cable side had discoloured from yellow to both dark red and to black, indicative of ageing and chemical activity between the materials present. The yellow mastic was removed from the 800mm² cable side, Figure 102 right hand side, to reveal a small stress raising protrusion present on the edge of the core screen termination where it had not been uniformly removed.

A marked difference in colour of the two cable XLPE insulations was apparent, Figure 102, that was attributed to difference in the types of the anti-oxidants. The colour of the insulation on the 400mm² side was white-light grey and on the 800mm² side was a darker light-brown colour. There was no evidence of any electrical activity on the XLPE insulation surfaces.

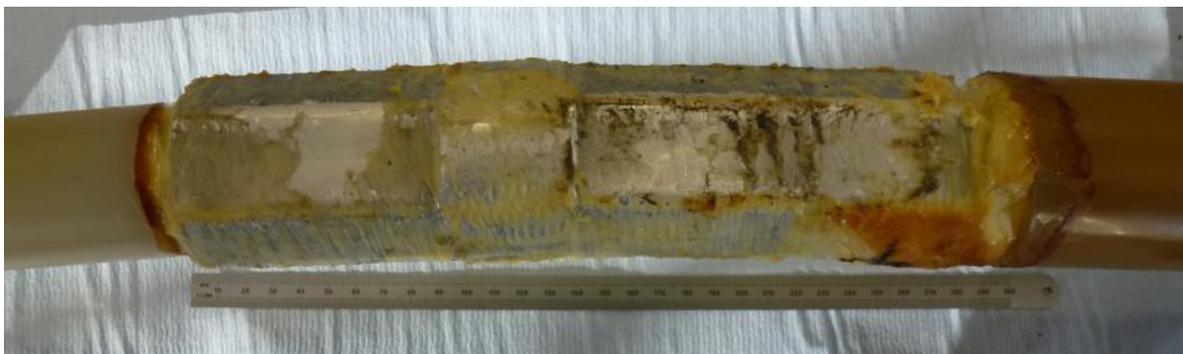
The yellow mastic was removed from the ferrule and found to be well adhered, Figure 103. The ferrule was asymmetrically positioned in length on the conductors having a small gap to the insulation cut on the 400 mm² side and a larger 12mm wide gap on the 800 mm² side, Figure 103. Wide gaps are undesirable as they risk void formation and mechanical instability.

Figure 103: Compression transition ferrule PN56

A lateral bend of 4mm offset was present over the ferrule length. A possible cause of bending is the use of a two-part compression die in a press having a single hydraulic ram. Curvature is undesirable as it increases the risk of void formation at the interface between the joint insulation and the cable XLPE insulation.
