Penrose substation fire 5 October 2014

Report on the inquiry conducted by the
Electricity Authority under section 18 of the
Electricity Industry Act 2010

20 November 2015

Inquiry into the Penrose substation fire and power outage 5-7 October 2014

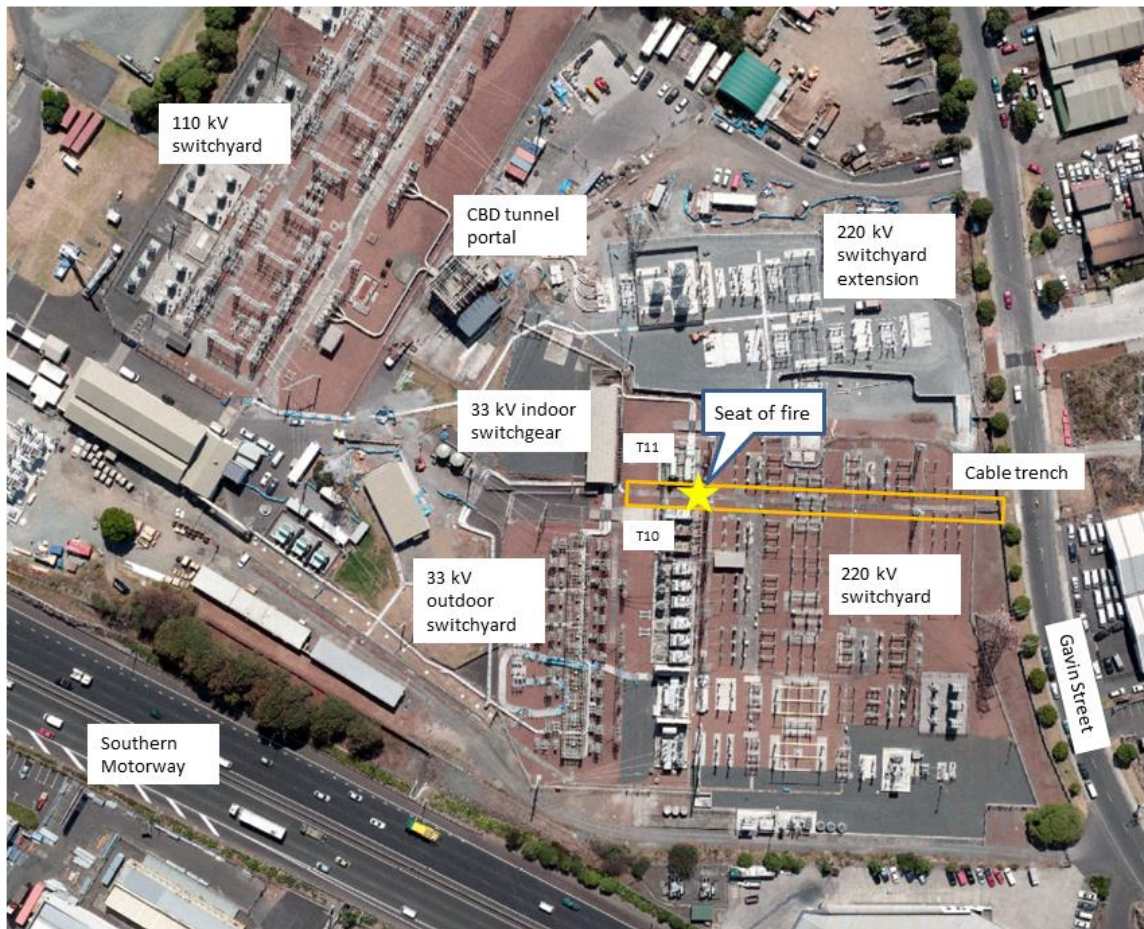
Figure 1 – Penrose substation layout

²¹ There are several cable trenches and above ground cable-racks installed at Penrose substation. The covered, concrete-lined cable trench in which the fire started runs west to east through the 220 kV switchyard, and is highlighted with a yellow border in figure 1. At the time of the initial firefighting by NZFS, it was not clear that the fire had actually started inside the cable trench.

- 4.13 From 2:04 am on 5 October 2014, Transpower's remote monitoring and control system recorded a series of unusual alarms from equipment at Penrose substation. The initial alarms were associated with the 220/33 kV supply transformer T11 (refer to figure 1 and note the proximity of T11 to the indicated seat of the fire).

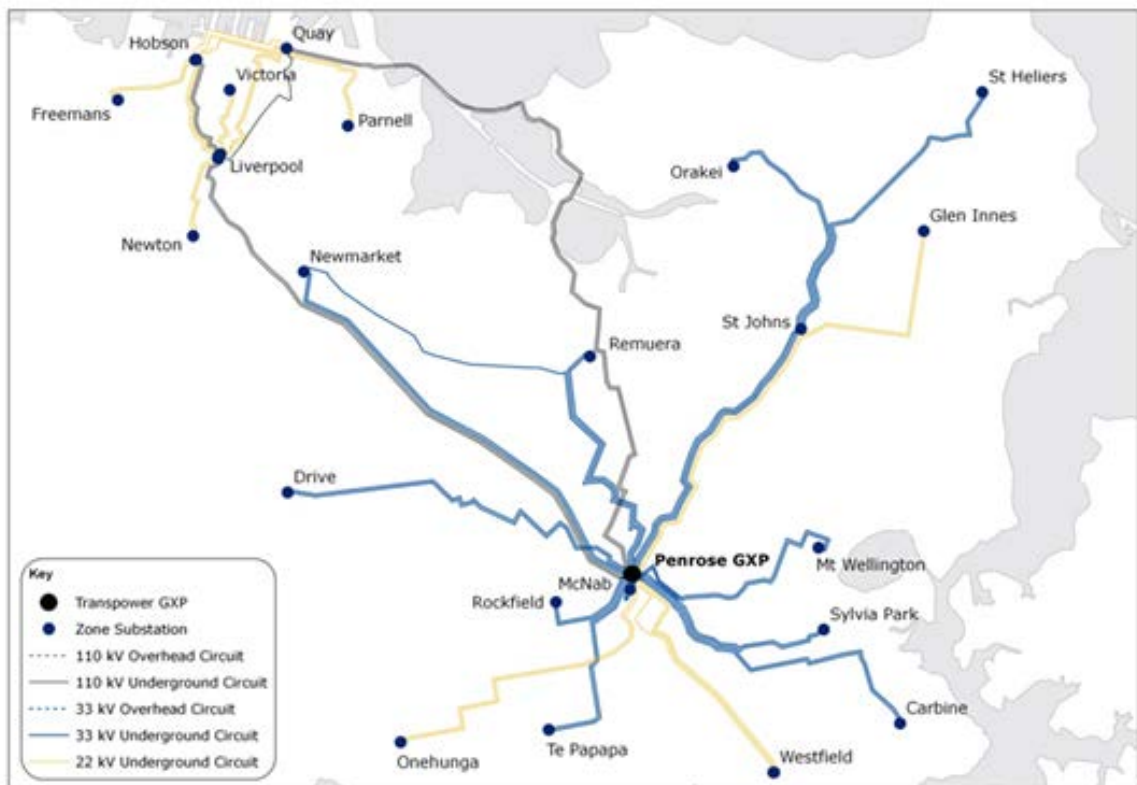
Figure 3 – Vector network area and zone substations supplied at various voltages from Penrose GXP

- 3.1 Penrose substation is a major electricity grid exit point (GXP) on the national grid owned and operated by Transpower. The extra high-voltage (EHV) transmission network into Auckland and across the Auckland isthmus provides connections through Penrose substation at 220 kV and 110 kV.
- 3.2 The national grid also supplies electricity into Vector's distribution network at Penrose, servicing a wide area of south-central Auckland starting at the south-eastern perimeter of the central business district (CBD) and running south and east as far as Westfield and Onehunga.²⁵
- 3.3 A large part of Vector's distribution network is supplied from Penrose substation at 110 kV, 33 kV and 22 kV to supply electricity customers throughout its south-central Auckland network (see figure 3).

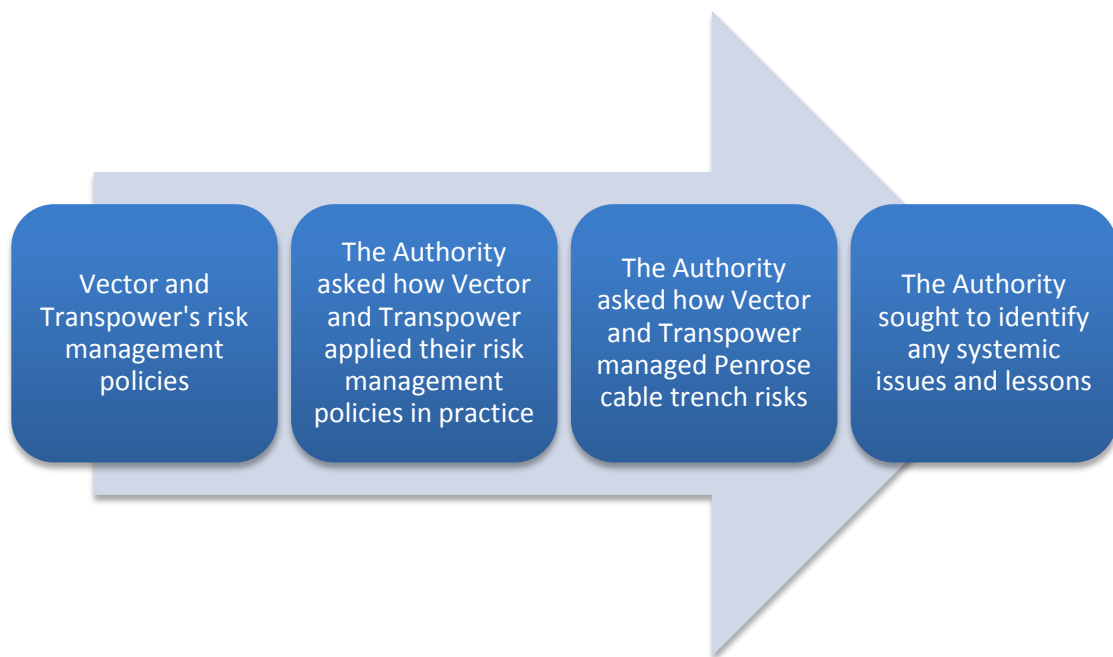
Figure 9 – The Authority’s top-down review process

- 5.36 The inquiry took the initial step of establishing whether Vector and/or Transpower had identified the risks associated with the cable trench at Penrose substation. As Vector and Transpower told the Authority that neither had identified the risks, the Authority moved on to consider why the risks had not been identified.
- 5.37 In order to answer the question as to why the cable trench risks had not been identified the Authority used a 'top-down' review of governance and management to establish what the businesses say they do and then compare this with what was seen to have been applied in practice. This approach is described in figure 9.

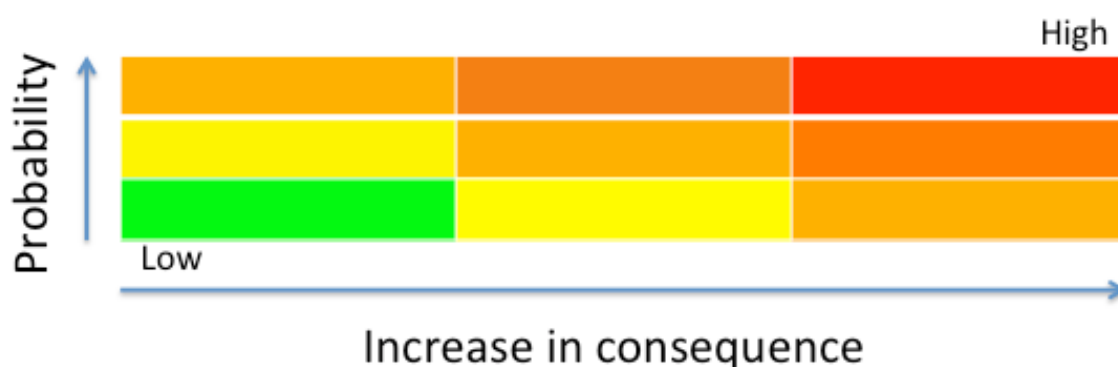
Figure 10 – Risk priority assessment matrix

5.44 Figure 10 shows how, at a high level, risks can be considered on the basis of probability and consequence.

- 5.45 Had the above approach been applied to the risk to electricity supplies resulting from the co-located power cables within the Penrose cable trench, the Authority considers it likely that the ignition risk would have been assessed as:

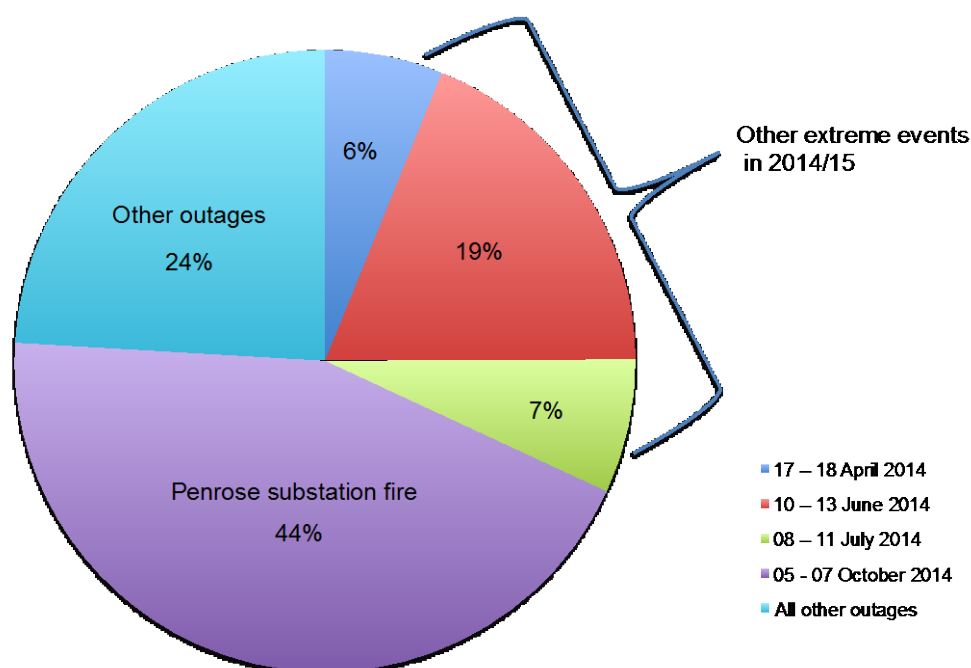
Figure 11 – Contributions to Vector’s SAIDI for the year ended 31 March 2015

- 8.8 Figure 10 highlights the proportion of the supply interruptions on Vector's network caused by the four major events in the year to 31 March 2015. The impact of the Penrose fire in terms of loss of supply to customers can be clearly seen.
