Penrose Substation Fire

05 October 2014

Investigation Report

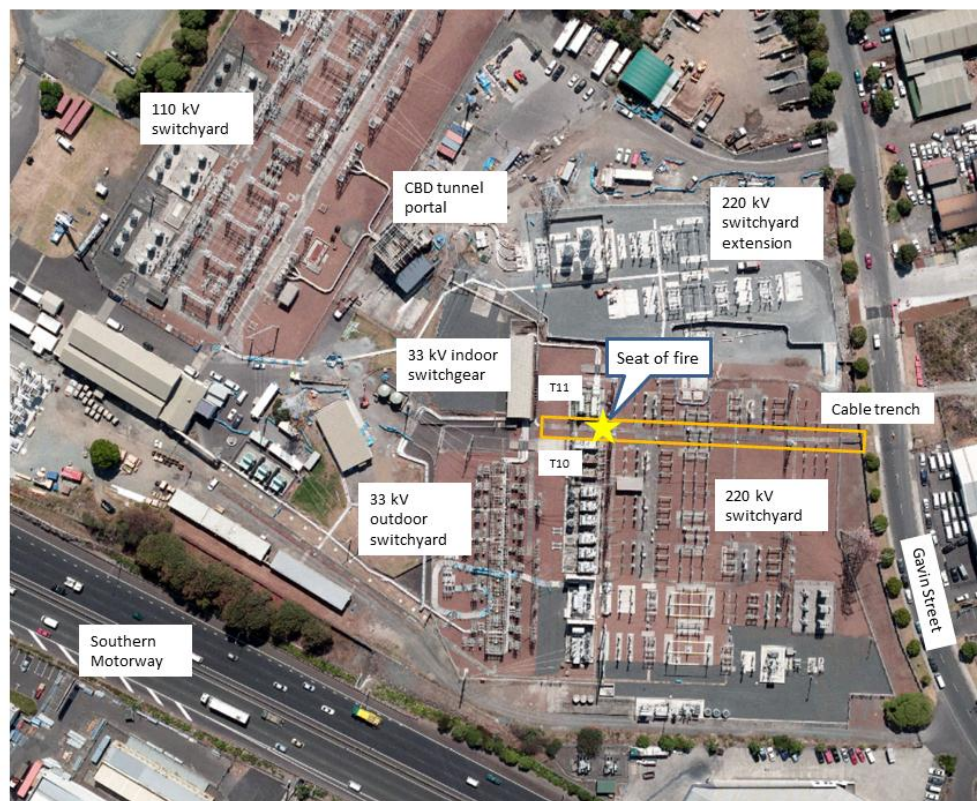
Figure 6 Penrose Site

Figure 6 gives an aerial view of the Penrose substation.

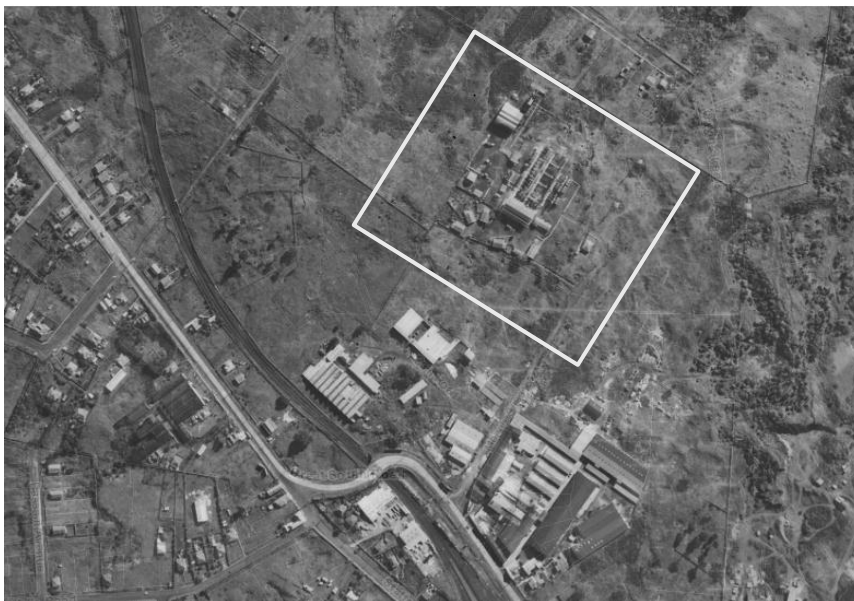
Figure 8 Penrose in 1949

Penrose was one of a number of substations established to supply power to Auckland. These substations were established on the outskirts of the city at the time. Figure 8 is an aerial photo of the Penrose substation in 1949 showing the substation in open land, with both the southern motorway and Gavin St yet to be constructed. The current site is shown in Figure 6.
