TITLE: Investigation into a Fire in a Cable Trench in Penrose Substation

REPORT: ER 763

CUSTOMER: Vector Ltd and Transpower New Zealand Ltd

DATE: 3rd November 2015

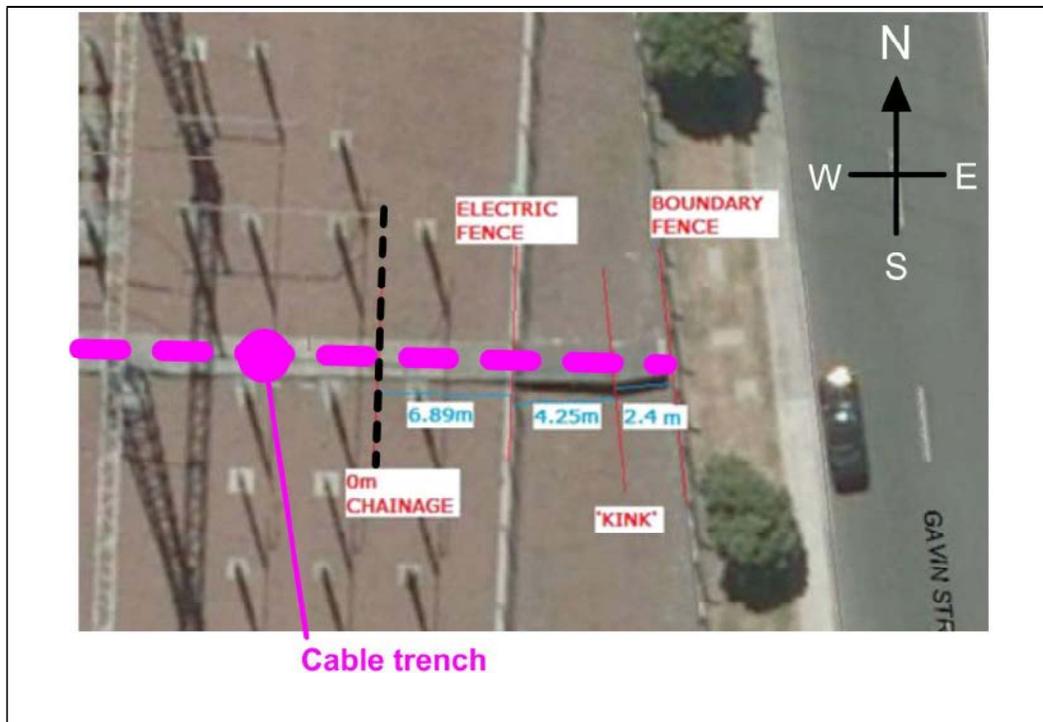
Figure 2 Zero metre chainage at east end of cable trench near Gavin Street

The cable trench runs across the 220 kV switchyard from the east at Gavin Street to the west at the 33 kV Switchroom, Figure 1. A plan of the location of the east end of the trench showing the zero 'chainage' reference position is given in Figure 2. This was close to the position at which the cable circuits had been judged to be clear of fire damage and where they were cut and jointed onto new diverted cables as part of the immediate remedial works. The zero position is 13.5 m from where the cable emerges from the laid-direct section at Gavin Street.

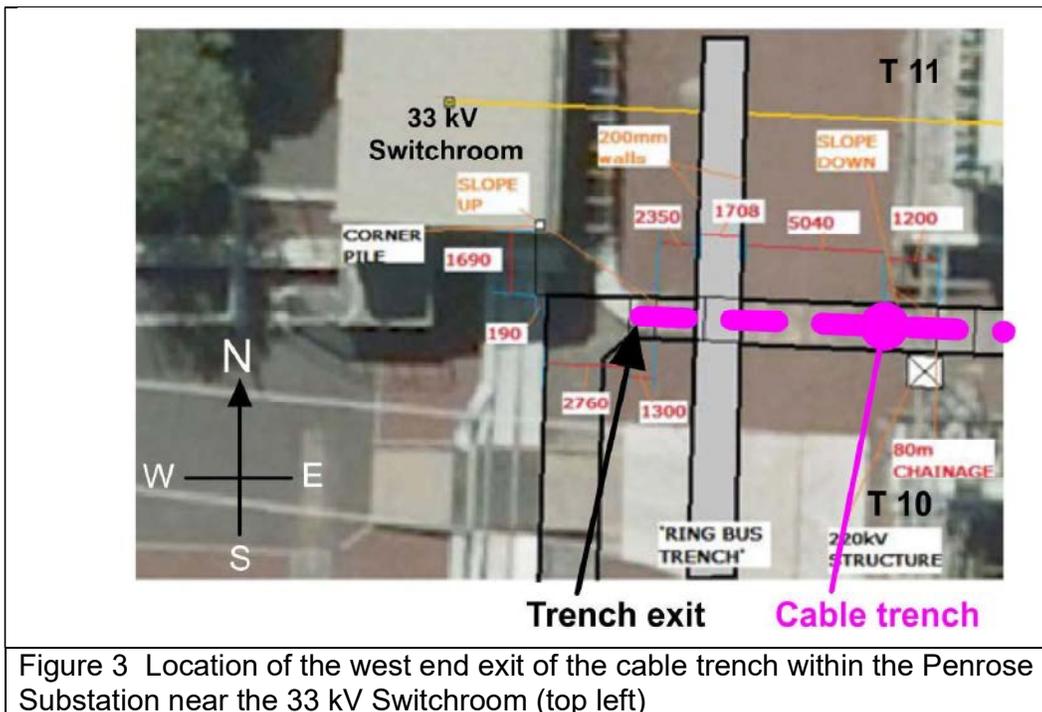
Figure 3 Location of the west end exit of the cable trench within the Penrose Substation near the 33 kV Switchroom (top left)

The west end is shown in Figure 3. The chainage measurements in this report refer to the distance to the west from the zero chainage reference position. The chainage to the point where some of the cables exit to above ground near the 33 kV Switchroom is 91.5 m and the total cable trench length to this point from Gavin Street is 105 m. A CCTV camera was present in the northwest corner as shown in Figure 1 that looks southwards over this area. Figure 58 in Section 16, Appendix A, shows the CCTV photographs that were recorded before, during and after the fire.

A larger concrete 220 kV Ring Bus trench seen in Figure 3 passes below the cable trench. At the time of the fire this trench was under construction with an open top and did not contain 220 kV cables. A temporary timber bridge was present near the 33 kV cable exit that provided access for personnel to the Switchyard.

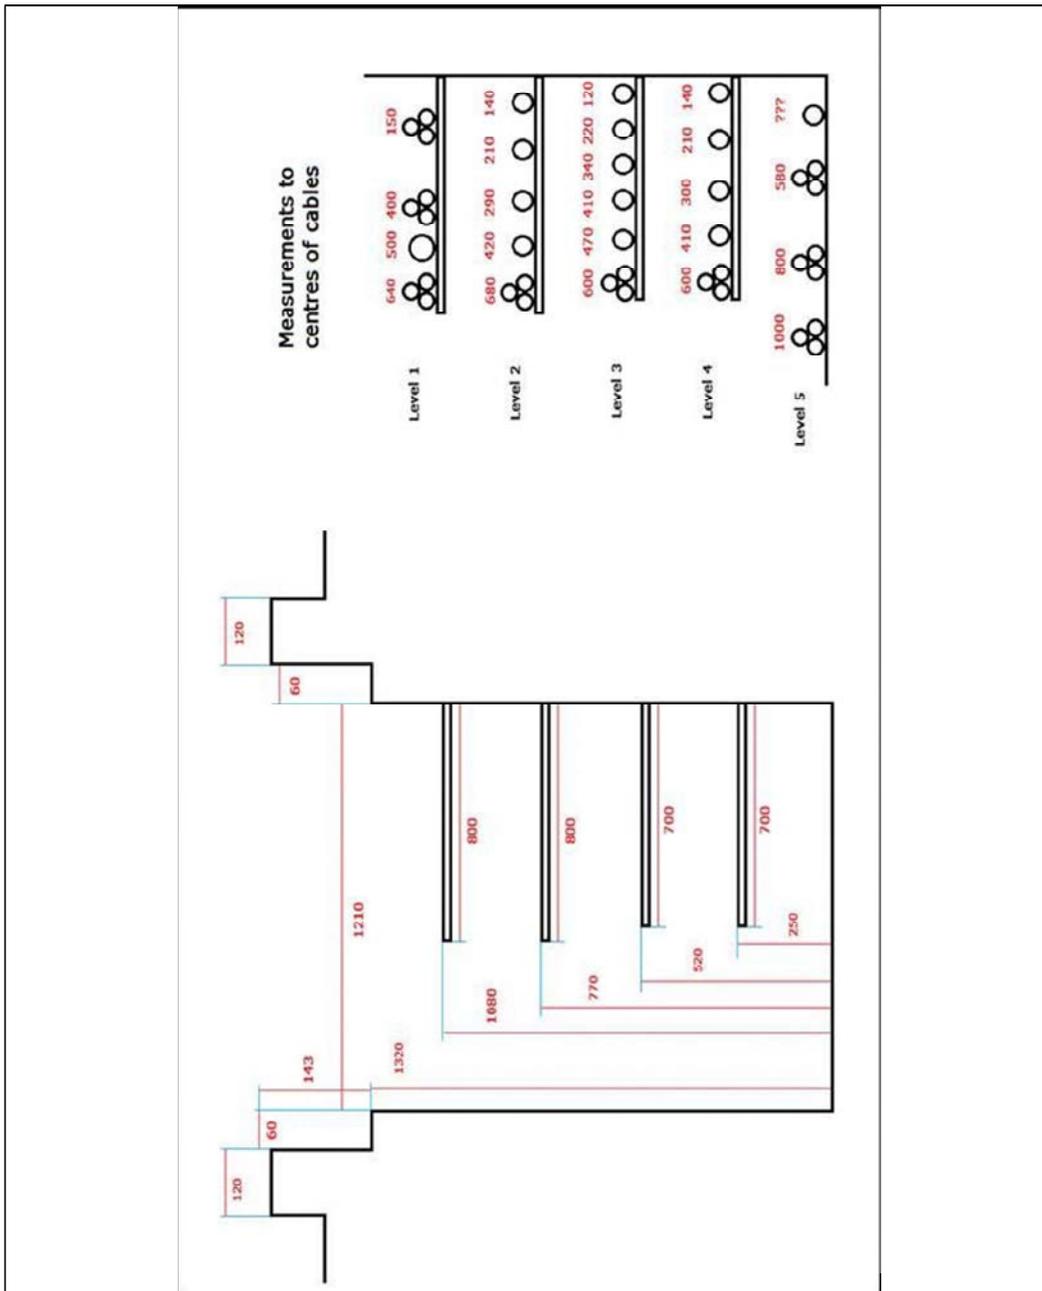
Figure 4 Trench dimensions and cable centre-line spacings at 65 m

The trench cross-sectional dimensions, the support arm lengths and the centre-line spacings are given in Figure 4; the view is looking westwards.

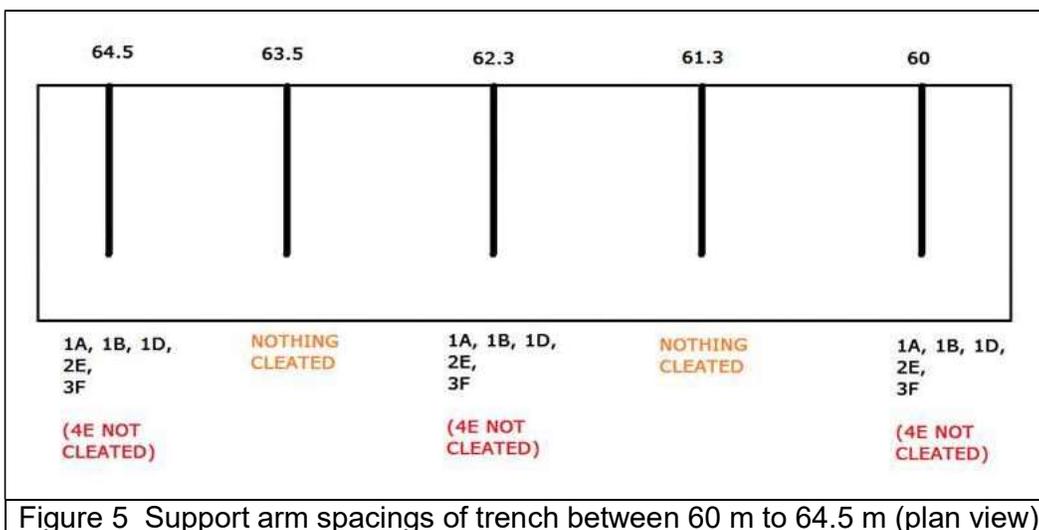
Figure 5 Support arm spacings of trench between 60 m to 64.5 m (plan view)

An example of the spacings between the cable support arms is shown in Figure 5 for the chainage distances 60 m to 64.5 m. The average spacing is 1.125 m.

Figure 5 also shows which of the 33 kV XLPE circuits in trefoil formation were cleated to the cross arm supports. It is shown that the five trefoil circuits were cleated to every second support arm on Levels 1, 2 and 3, but that the three cables forming the 33 kV Mt Wellington 2 circuit at the end of the arm on Level 4 were not cleated.

The Remuera K10 cable had been installed in straight alignment in an informal 'semi-flexible' thermo-mechanical system that rested uncleaned on supports at 1.125 m spacings, Figure 5. The cable had neither been 'rigidly close-cleated' nor 'flexibly sagged' as described in CIGRE TB 194⁷ (i.e. it was not formed into lateral sags between the support arms). Thus the prospective axial thermal expansion in Remuera K10 (and the other cables in the trench) would not have been relieved by uniformly distributed lateral deflection, but would have generated axial compressive forces that tended to move residual thermal strain into randomly occurring geometric lateral perturbations. The six metre long loop of 11 kV three core XLPE cable adjacent to the failed transition joint at 73 m, Figure 44 and Figure 45, is a perturbation that is likely to have cyclically flexed to absorb and release axial thermal strain from the PILC cable and in so doing to disturb the transition joint insulation.

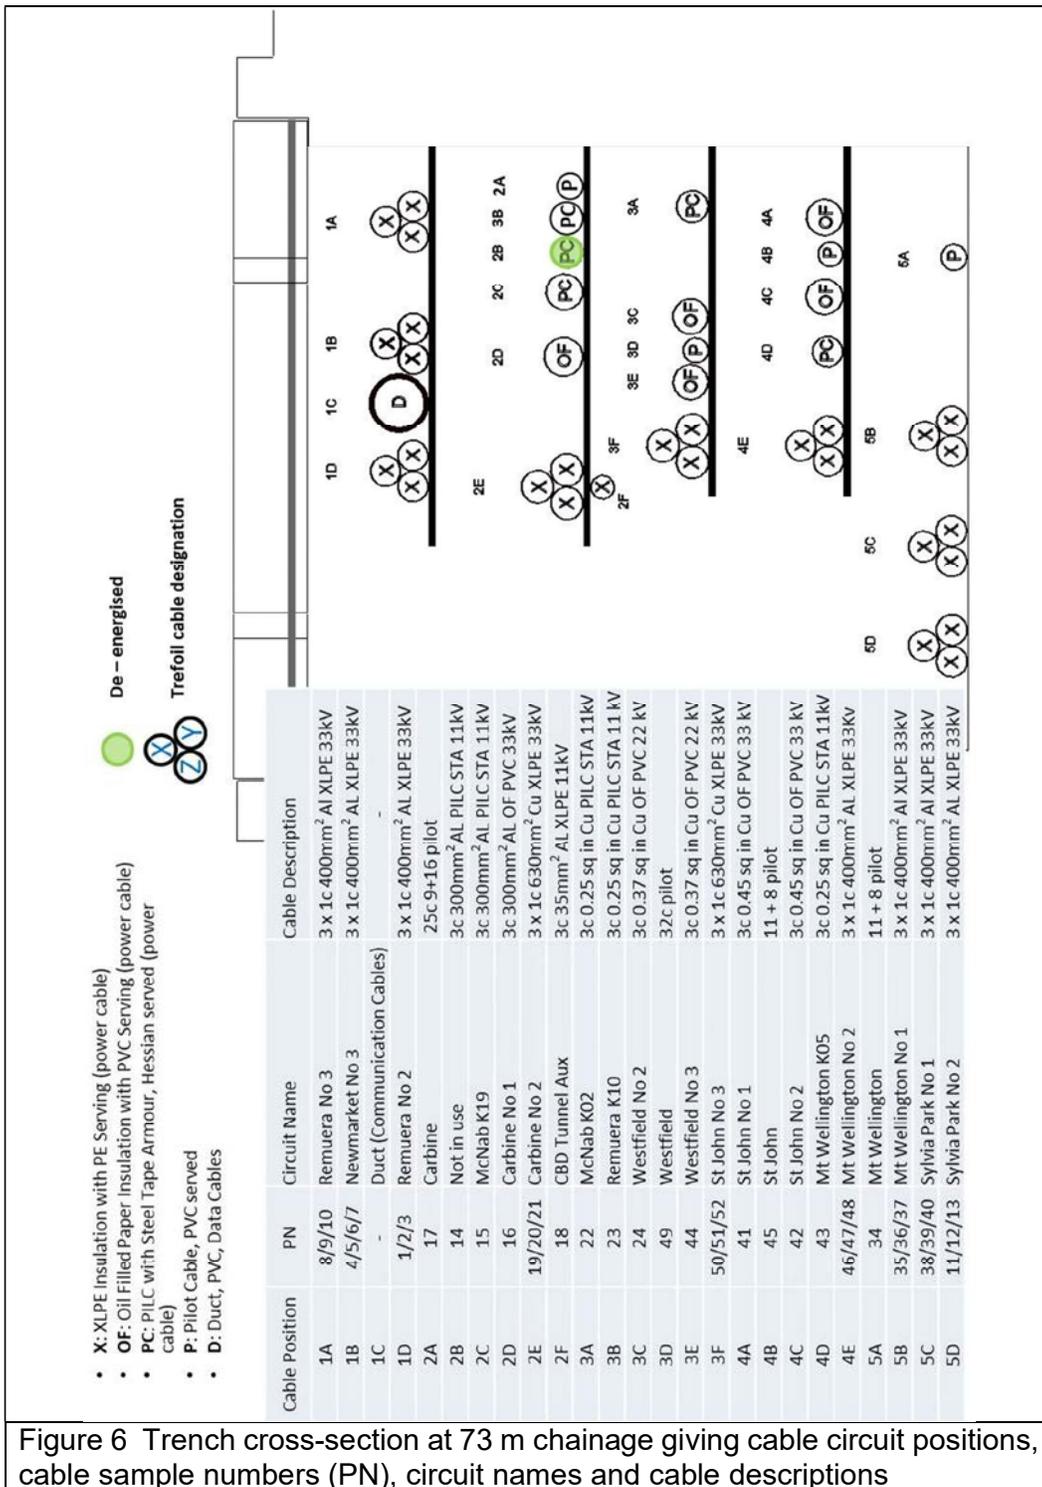
Figure 6 Trench cross-section at 73 m chainage giving cable circuit positions, cable sample numbers (PN), circuit names and cable descriptions

Figure 6 shows the circuit locations in the trench cross section at the 73 m chainage position and the alpha-numeric reference designations that they were given for the purpose of the investigation. The cross-section designation relates to the support arm level that the cable occupies for the majority of its position in the trench length.

For example, '3A0' at 73 -74 m chainage is the designation for the position of an 11 kV PILC cable. Figure 6 shows the circuit to be 11 kV PILC McNab K02. This cable circuit runs throughout the length of the trench at the same cross-section position:

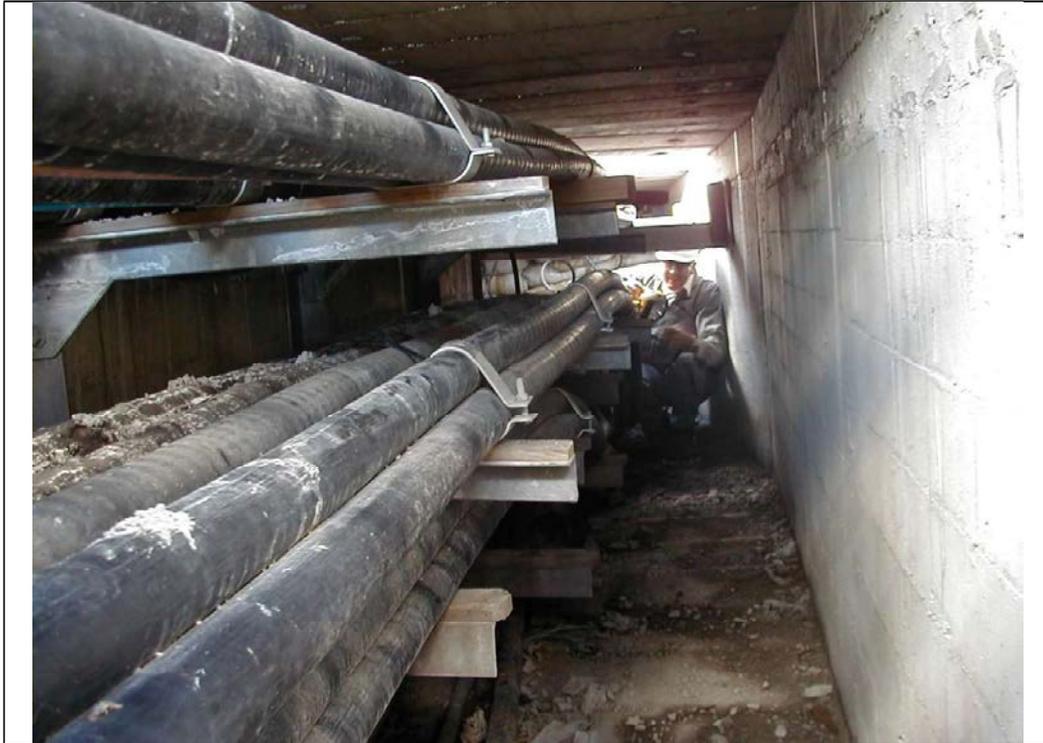
Figure 7 Photograph of the cable trench in 2001, near zero m, before the fire

Four power cable circuits are seen to be present on Level 2. A smaller pilot cable is out of view against the north wall (left hand side). As explained in Section 10 the first electrical fault occurred on Level 2, but further westwards at chainage position 73 m.

In Figure 7 the cables can be seen to be supported on timber battens bolted to a horizontal arm of galvanised angle-iron. The arm is bolted to a galvanised vertical angle-iron with gusset strengthening pieces. The steel vertical is bolted to two studs that are fixed into the north wall (left hand side). The trench access-way is on the south wall (right hand side).

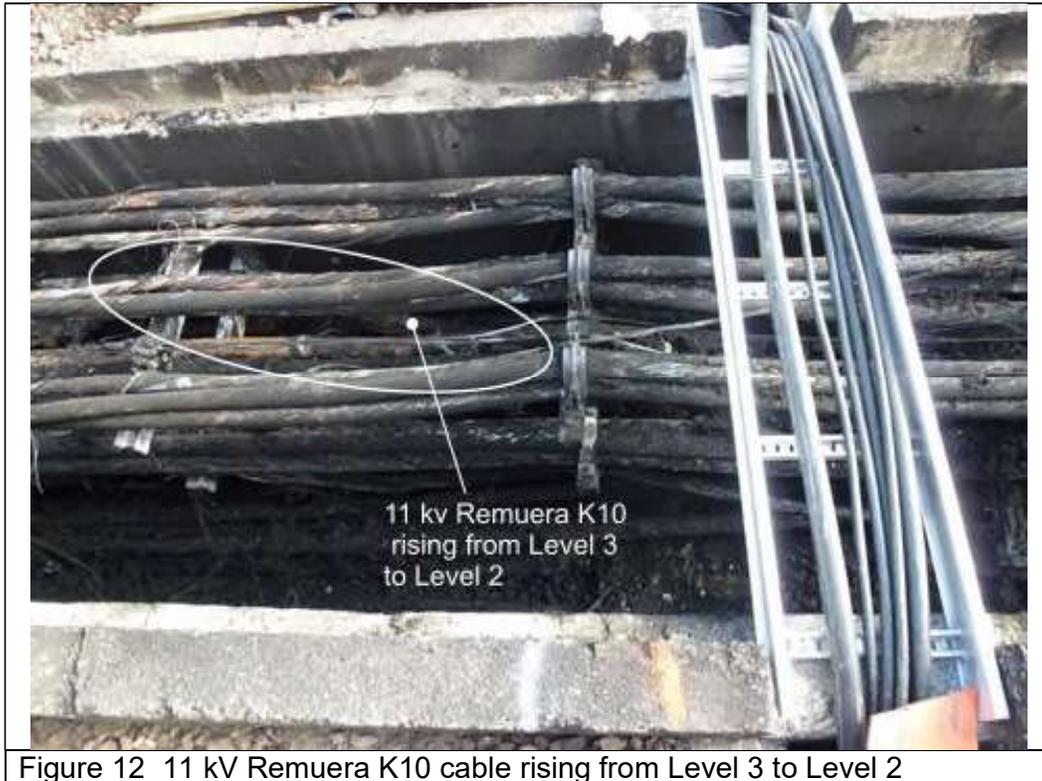
Figure 12 11 kV Remuera K10 cable rising from Level 3 to Level 2

A longitudinal braided copper strap is present, this being the earth continuity conductor that connects the lead sheath of the PILC cable (out of view on the left) to the copper screening wires of the XLPE cable cores (out of view on the right). A small crimped compression ferrule can be seen in the centre of the photograph that connects the braid conductor to the screen wires, this connector was the only surviving component that held the two halves of the joint together. The 3B0 cable was seen to have been raised to Level 2 at 71.5 m and descended again at 81 m, in which length two transition joints had been inserted;

the faulted joint at 73 m and an unfaulted joint at 79 m. The cable is seen to be ascending from Level 3 to 2 in Figure 12. (The cable bridge and control cables are new and replace those that suffered fire damage, their location is at 70.5 m). A diagrammatic plan view of the layout is given in Figure 44.

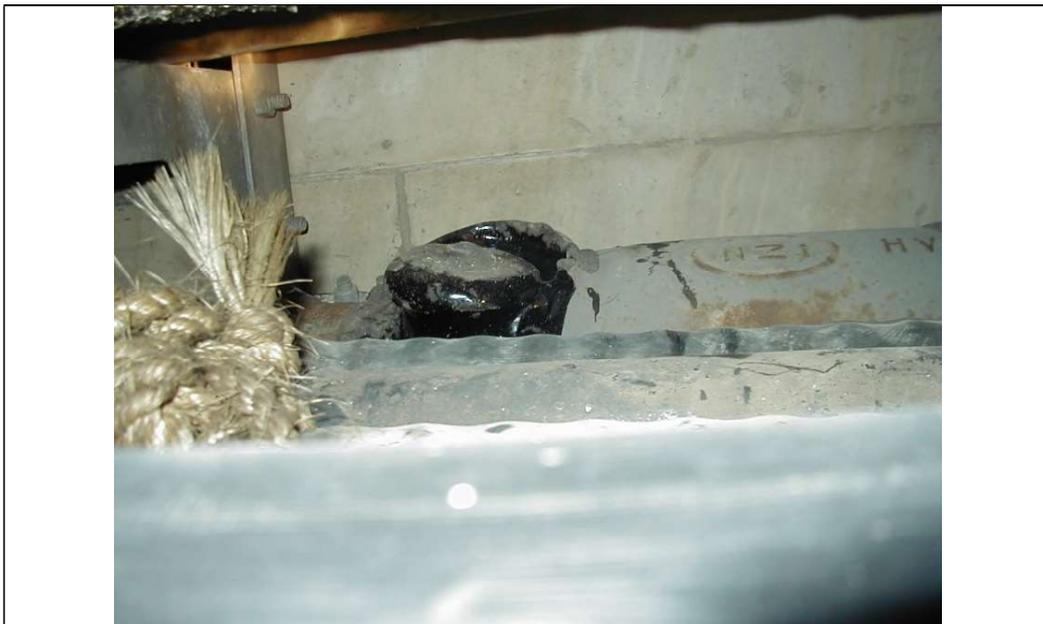
Figure 18 Straight joint in Remuera K10 at 79 m: Photo taken in 2001

It was a reasonable assumption that both joints were of the same design and had been installed at the same time, by the same jointing team and using the same tooling. The background to this assumption is that an email dating from 2001 indicated that remedial action was needed concerning a conventional cast iron joint that was found to be leaking bitumen from the filling port of the cast iron shell. The email and photograph, Figure 18, showed that the joint was in the 11 kV Remuera K10 cable at, or close to, the top of the slope in the trench, this being at 79 m chainage, Figure 44. It was thus taken that the cast iron joint had been cut out c.2001 and had been replaced by two transition joints and the six metre length of 11 kV three core XLPE cable.

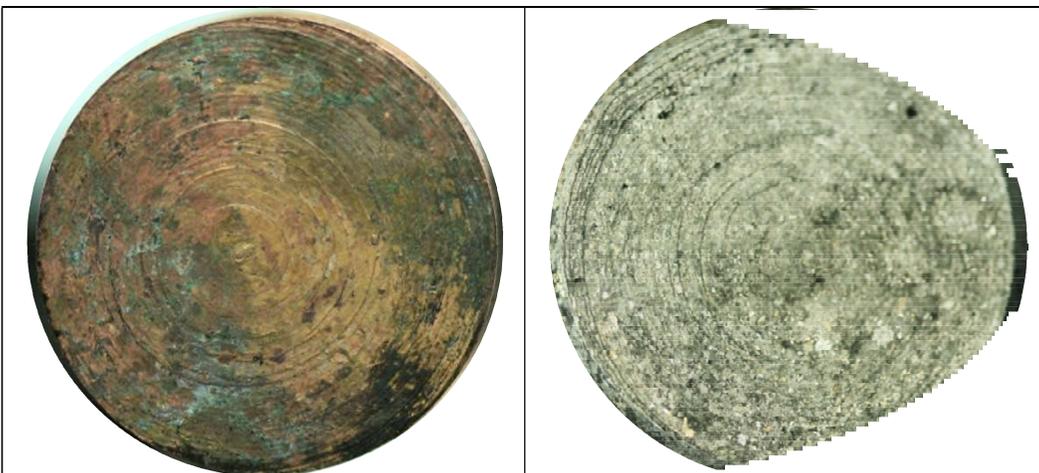
Connector C: Friction weld copper face

Connector C: Friction weld aluminium face

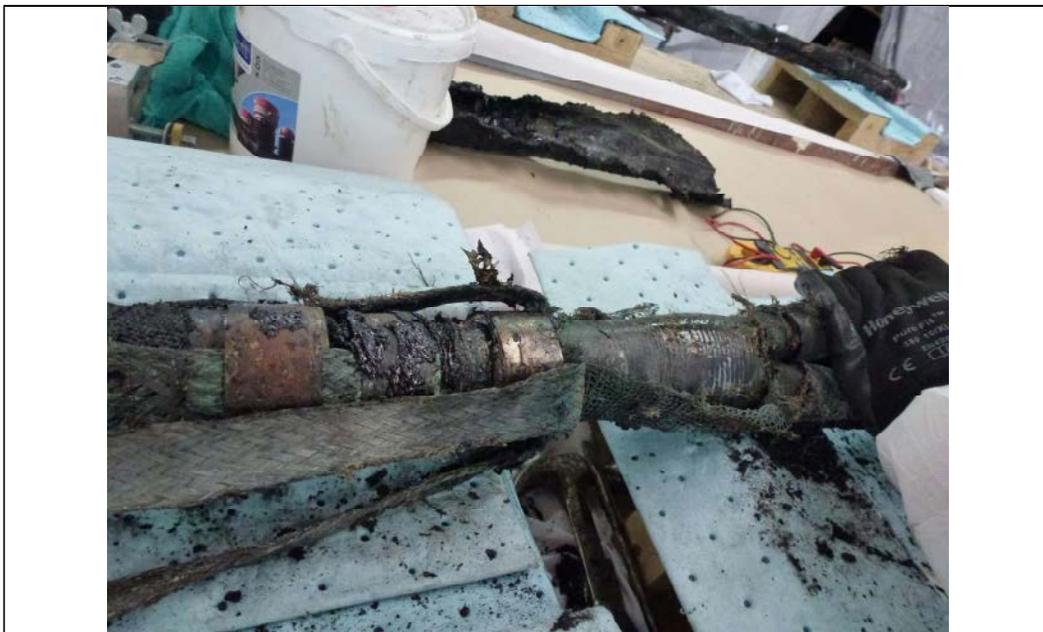
Figure 27 Unfailed joint: Outer heat shrink sleeve and copper mesh removed

The outer protective heat shrink sleeve was removed to reveal the internal joint components, Figure 27.

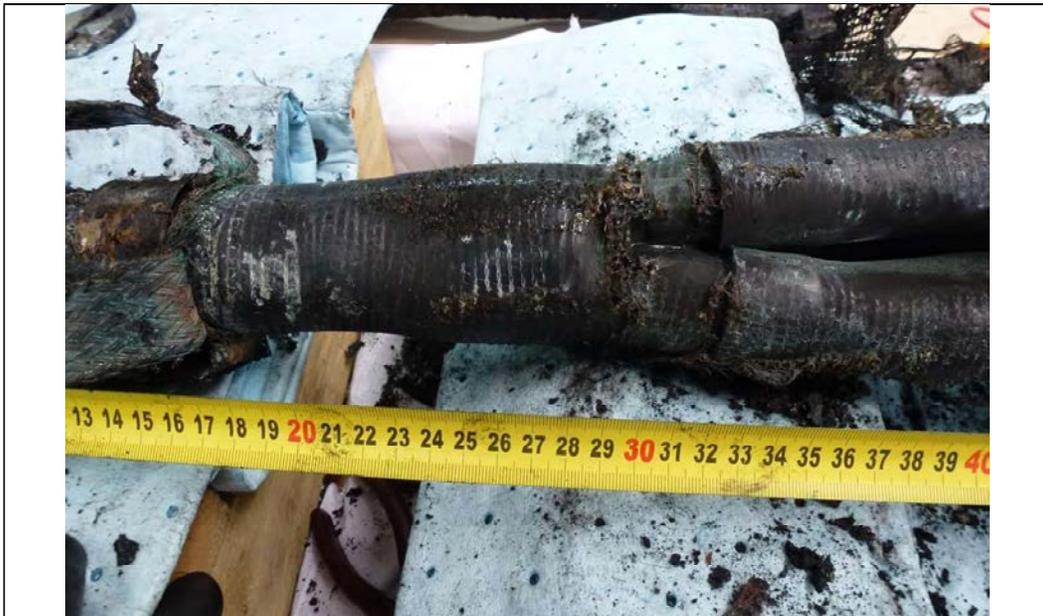
Figure 28 Unfailed joint: The heat shrink 'break-out' glove covering the PILC crutch

The arc centre-line measurement was transferred to the heat shrink 'break-out' (glove) in the unfailed joint, Figure 28.

The arc centre-line was denoted by a red pointer and was found to be within the 'break-out' glove and close to the internal exit of the core spouts, Figure 29.

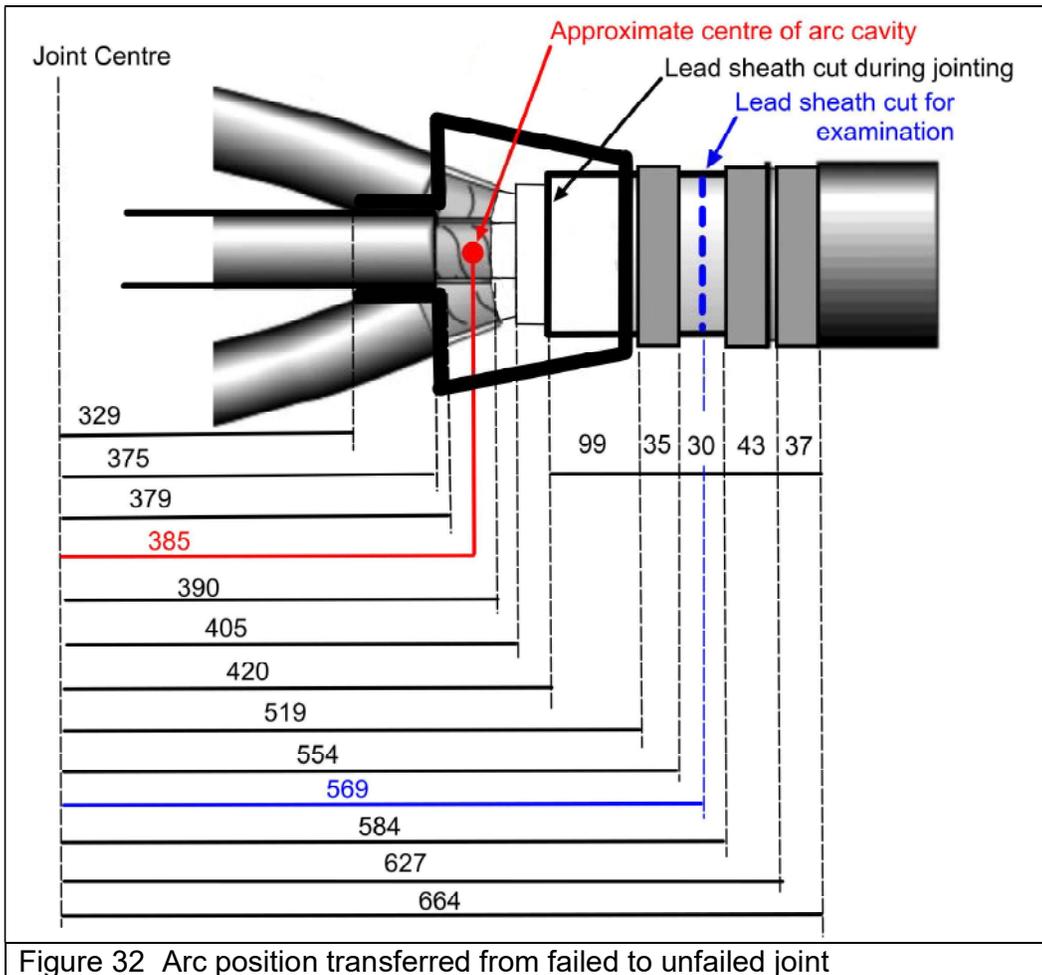
Figure 32 also indicates the position of the arc crater centreline (marked in red) in the failed joint as being 5 mm from the end of the oil barrier/insulation tube. However, there are significant uncertainties in the measurement tolerances. Additionally the arc crater had a length of 62 mm and so it is not possible to know exactly where the electrical fault path that had preceded the arc was. Arc

damage tends to move away from the direction of the current feed, impelled by electromagnetic forces and so it is probable that the fault path was closer to the belt paper termination at 405 mm or, in the extreme, towards the termination of the lead cut. The lead sheath in the failed joint had been completely melted away so that the position of the arc in relation to the lead cut could not be verified.

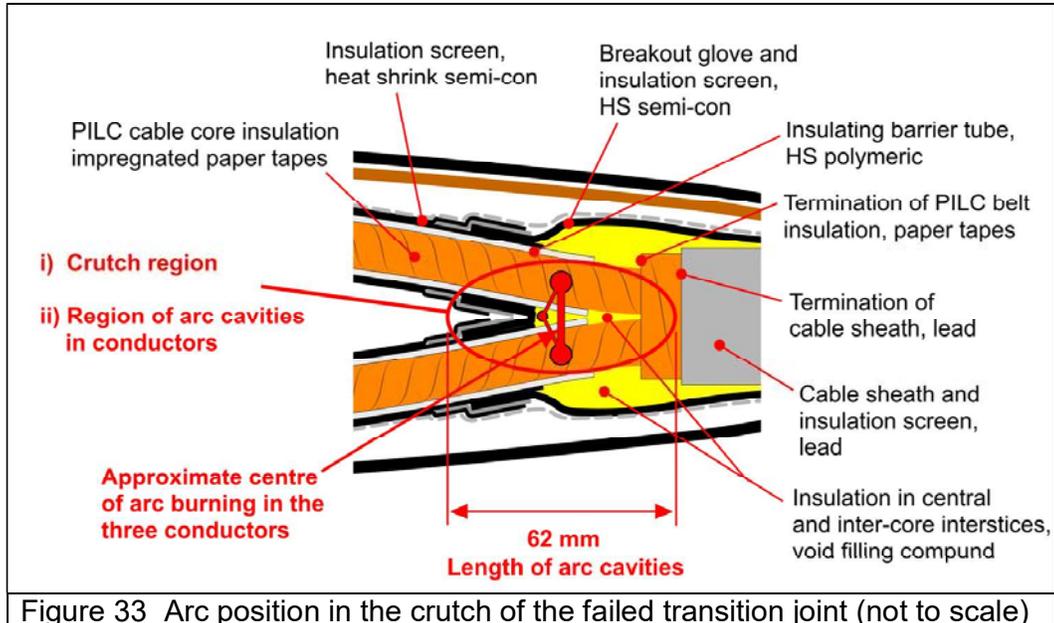
The location of the arc and fault positions is shown in Figure 33. A general view is shown in Figure 114.

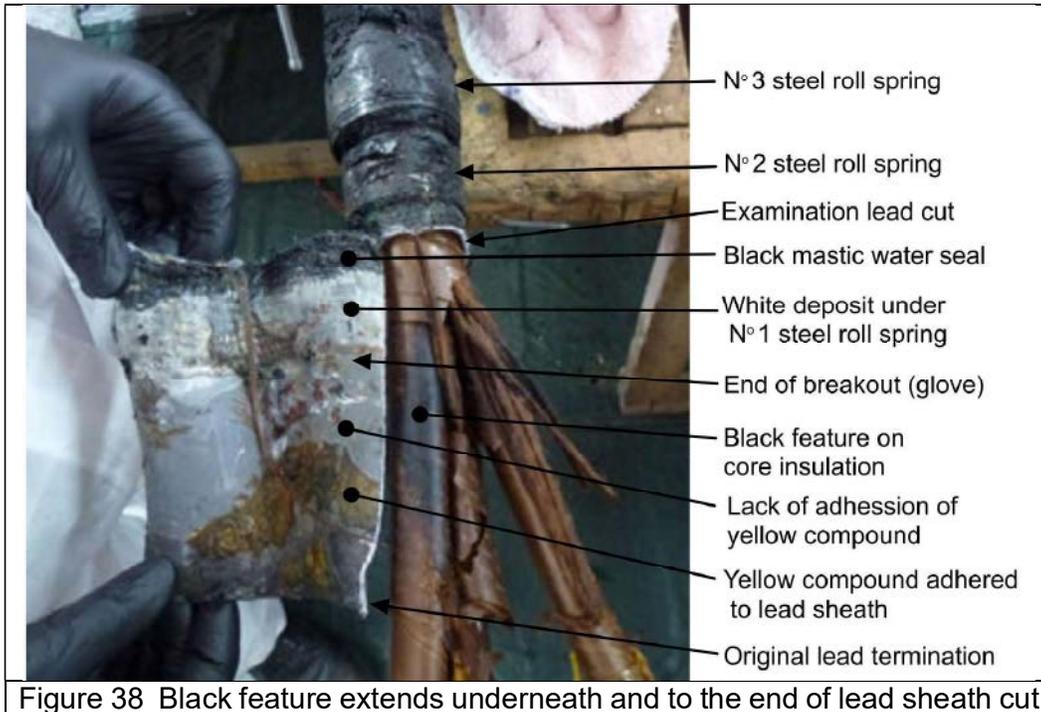
Figure 38 shows the removed lead sheath being held back in place. The black feature is underneath the lead sheath and is neither centred on the roll spring position (white region) or on the tip of the lead sheath cut (foreground). The black feature does however extend to within 3 mm of the lead cut.

The cores were opened out. The black feature was not present in the jute string filled central interstice, or between the contacting flat faces between the core insulation.

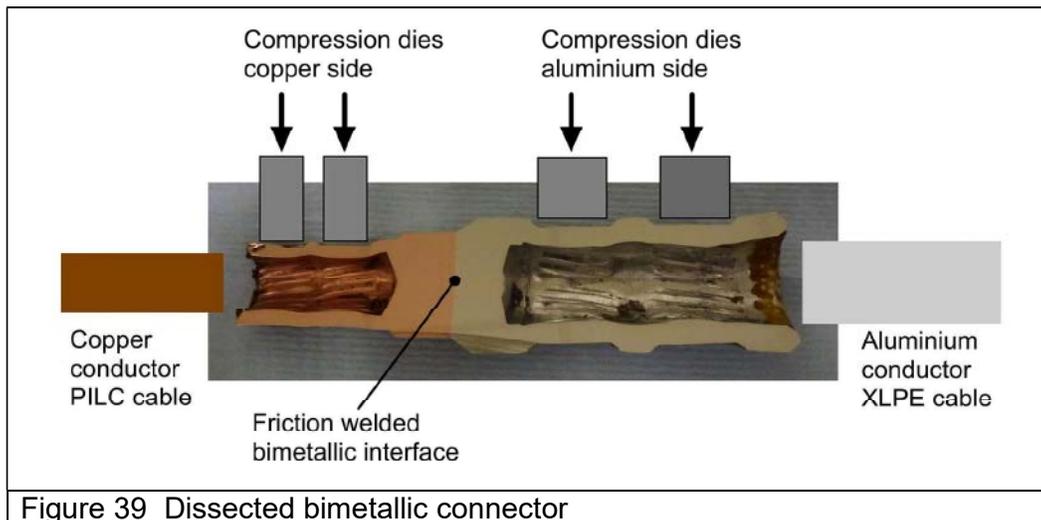
Figure 39 Dissected bimetallic connector

Two aspects of the bimetallic connection were examined i) the bimetallic friction weld and ii) the compression ferrule region. A dissected bimetallic connector is shown in Figure 39.

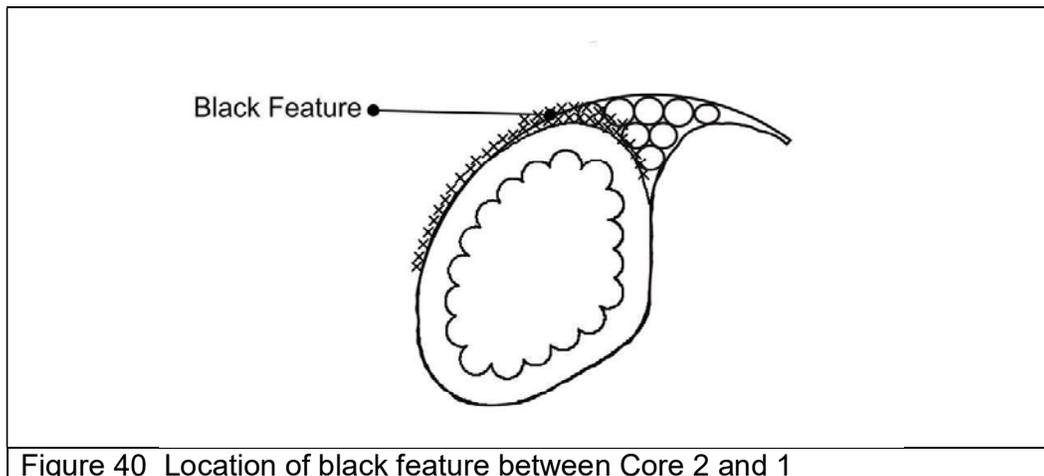
Figure 40 Location of black feature between Core 2 and 1

A photograph of the black feature is shown in Figure 37 and its location in Figure 40. The 11 kV PILC cable is described and is shown diagrammatically in cross-section in Section 18, Appendix C.

The black feature is centred on the shoulder of the core, this being its major axis.

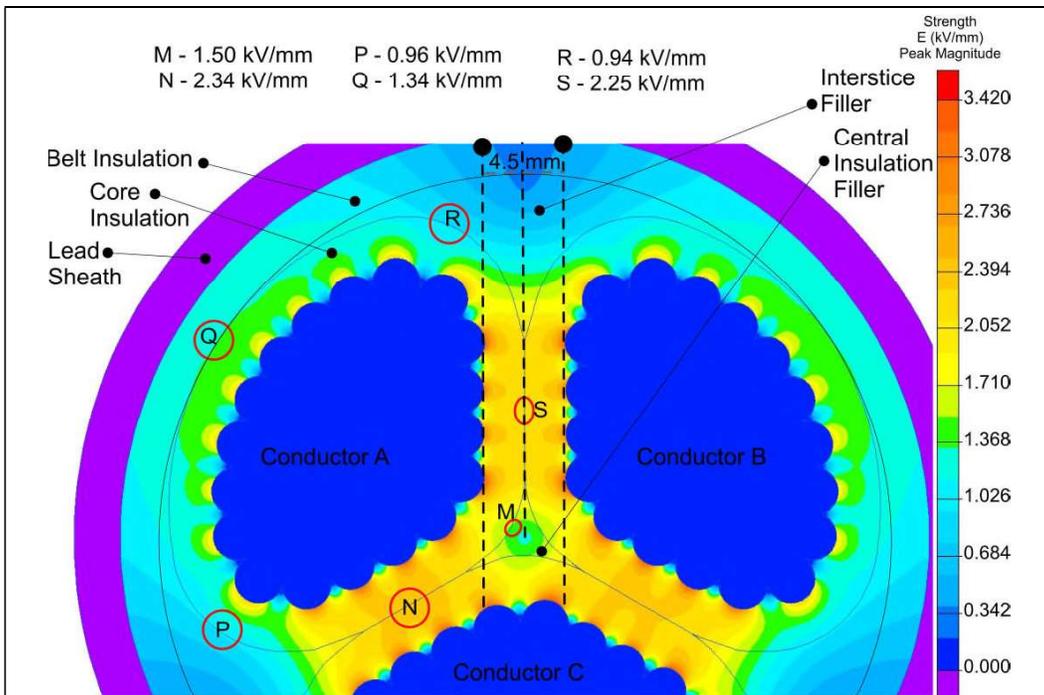
Figure 42 Magnitudes of maximum stress on a PILC core through a 360° cycle

To produce Figure 42:

- The stress at every point and every moment in time through the 360° cycle is calculated.
- The maximum values at any moment irrespective of time are selected and plotted. The maximum value at each individual location is shown. The units of stress are displayed as 10^6 V/m, which are equivalent to MV/m, or kV/mm. The voltage and the stress are the RMS (root mean square) values (i.e. peak value divided by $\sqrt{2}$), which is the usual form for cable engineering.

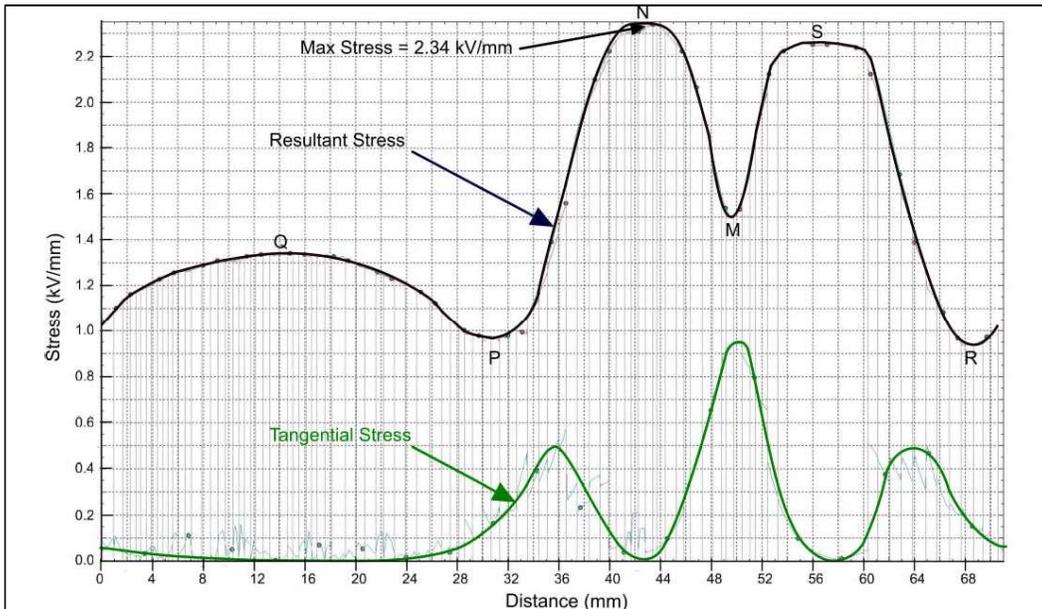
Figure 43 Resultant and tangential stresses around the core surface

Values of the resultant stress around the circumference of the core insulation and of the stress tangential to the surface are given in Figure 43. The peaks of electrical stress are denoted by letters and their geometric positions are shown in Figure 42.

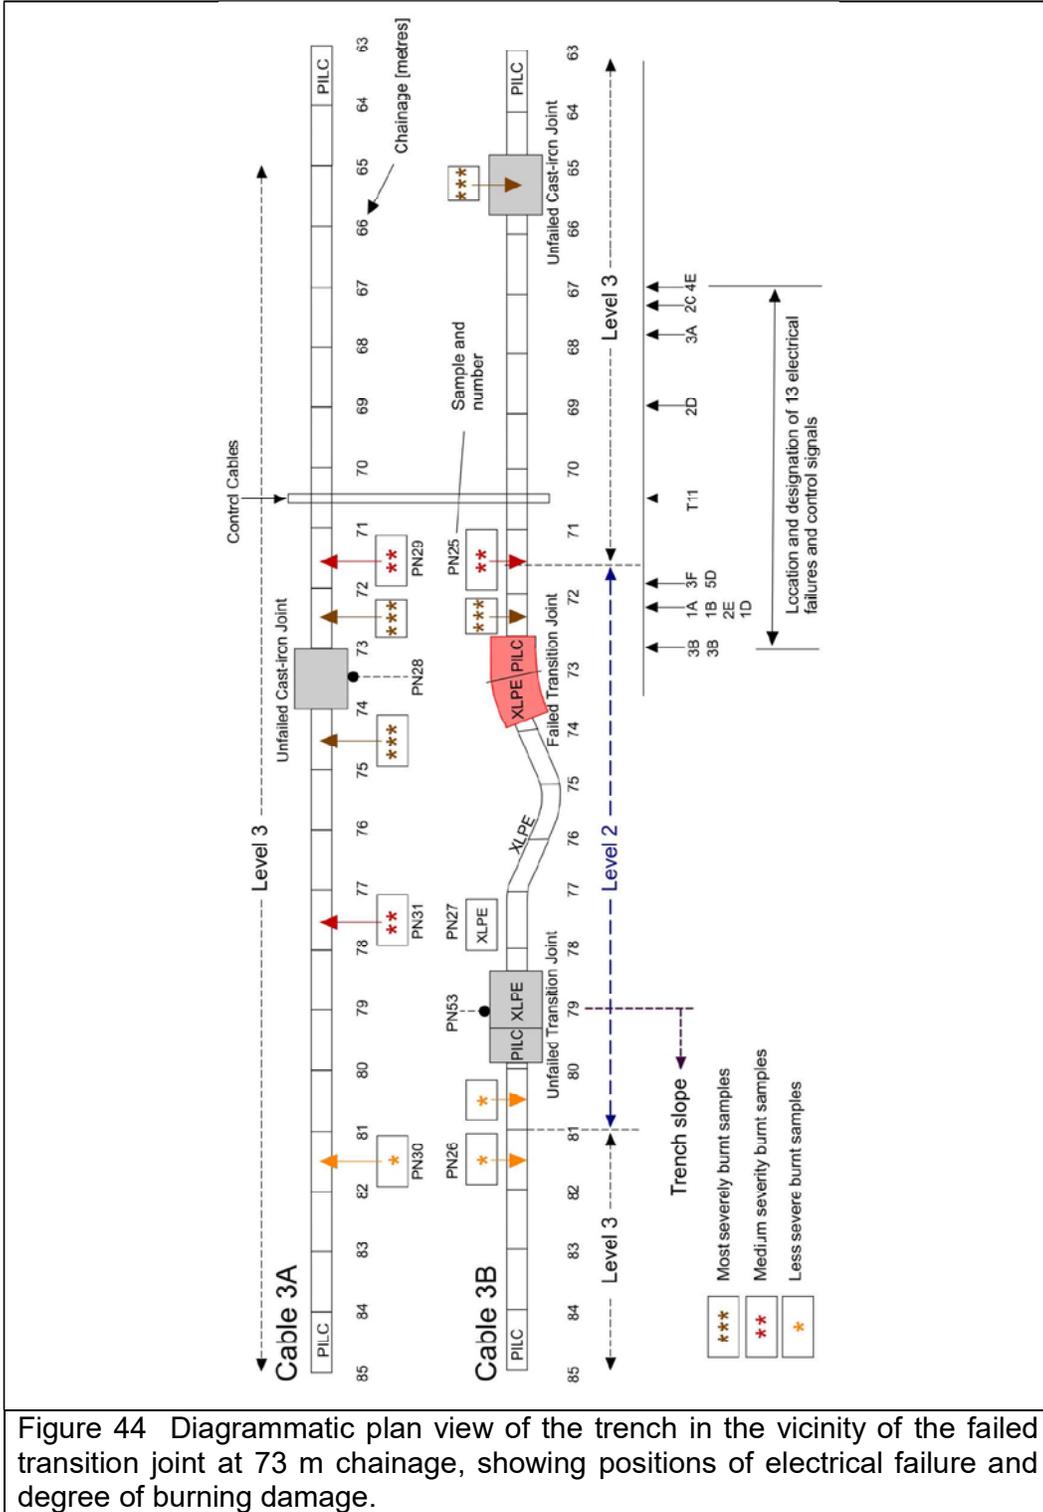
The evidence from the examinations of the joints and cables performed in Penrose and in the UK permitted a plan view of the trench in the vicinity of the failure to be constructed, Figure 44. The view is of the two 11 kV PILC cables Remuera K10 3B0 and McNab K02 3A0.

All but one of the electrical fault holes are located between 67 m and 73 m; the exception is a failure in 4D0 at 50 m. Figure 44 shows the length of trench from 63 m to 85 m:

- McNab K02, 11 kV PILC cable, which remains in its position, 3A0, on Level 3 next to the north wall throughout the length of the trench.
- Remuera K10, 11 kV PILC cable, which, from zero metre chainage, runs on Level 3 immediately adjacent to 3A0. At 71.5 m chainage it rises from Level 2 to Level 3, (note that its designation '3B0' is not changed). At 73 m (centre-line) the failed transition joint was located on Level 2 between cables 2A0 and 2B0. At this position the failed transition joint connected the three core PILC cable to a three core XLPE cable.

The three core XLPE cable and joint were installed in the shape of a lateral bow, Figure 45, that passed over circuits 2B0, 2C0, 2D0 and 2E- and overhung the trench access way, reaching its peak amplitude at 75 m. The loop rejoined its in-line position on Level 2 at 77 m. A second nominally identical transition joint was centred at 79 m on Level 2, which coincided with a change from a horizontal trench run to a downward slope for the trench to pass under the Transformer Way. This joint converted the 6 m length of 11 kV three core XLPE cable back to the main run of 11 kV PILC cable. At 81 m the PILC cable descended back to its original position, 3B0, on Level 3. Dissection of samples of the 3B0 11 kV PILC cable from 0 m to 73 m and from 79 m onwards revealed that they were of the oil-rosin type and nominally identical in size and construction having been manufactured by Scottish Cables in 1965. It was not possible to determine if they were originally part of the same drum length.

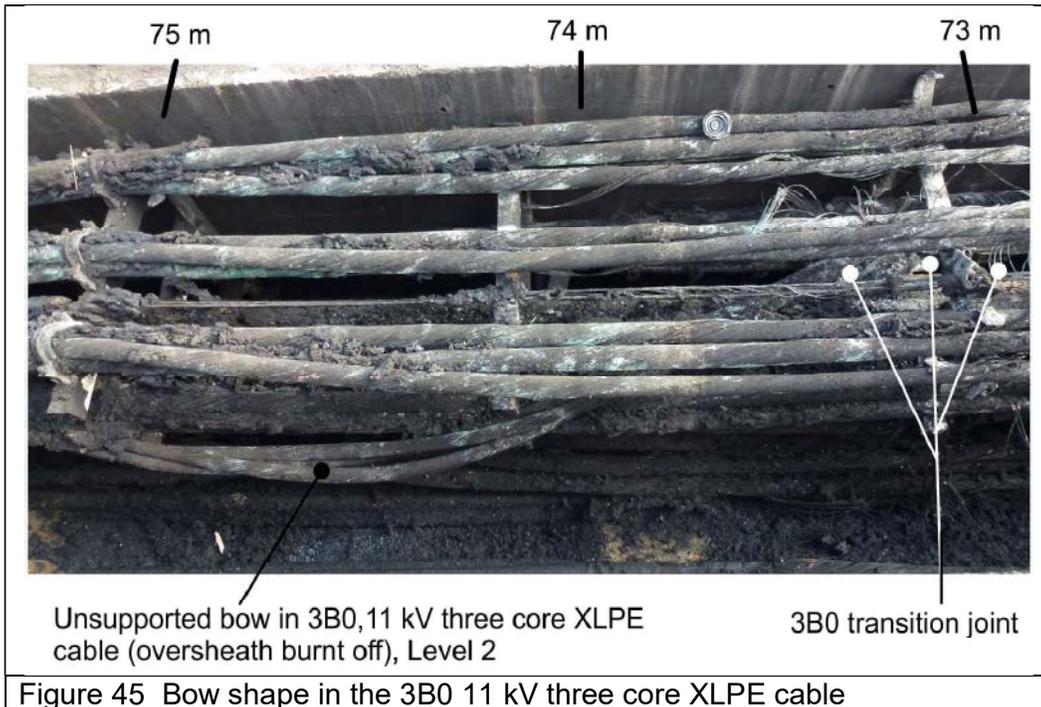
Figure 44 also shows:

- The location of two original PILC to PILC straight joints, having outer cast iron protective joint shells, one in 3A0 at 73.5 m and one in 3B0 at 65 m. A historical record, text and photographs, refer to a pre-existing cast iron straight joint, which was determined to be in Remuera K10 on Level 3 at the top of the slope. This is assumed to have been in the horizontal region between 77 m and 79 m. Evidence for the joint was confirmed by the finding of bituminous compound within cable sample PN26 at 81-82 m. It is possible that cables 3A0 and 3B0 may each have had one planned joint to connect laid cable drum lengths together.

The finding of two straight joints comparatively close together in cable 3B0 at a spacing of 13 m (65 m and 77-79 m) indicates that an unidentified event had occurred earlier in its life, for example damage/deterioration /failure of i) an original straight joint that may have required replacement by 'two joints and a cable piece', or ii) the original PILC cable that may have required to be replaced by 'one cable joint and a cable piece'.

- The comparative severity of burning in cable samples in 3A0 and 3B0 adjacent to, or in, the joints as indicated by the following symbols:
 - ***. The most severe burning with cables having lost their outer servings, the steel tape armour having lost its protective finish and being recently oxidised with red rust, its lead sheath melted, its paper insulation charred and carbonised and dried impregnating compound is present in some insulation interstitial creases and butt gaps.

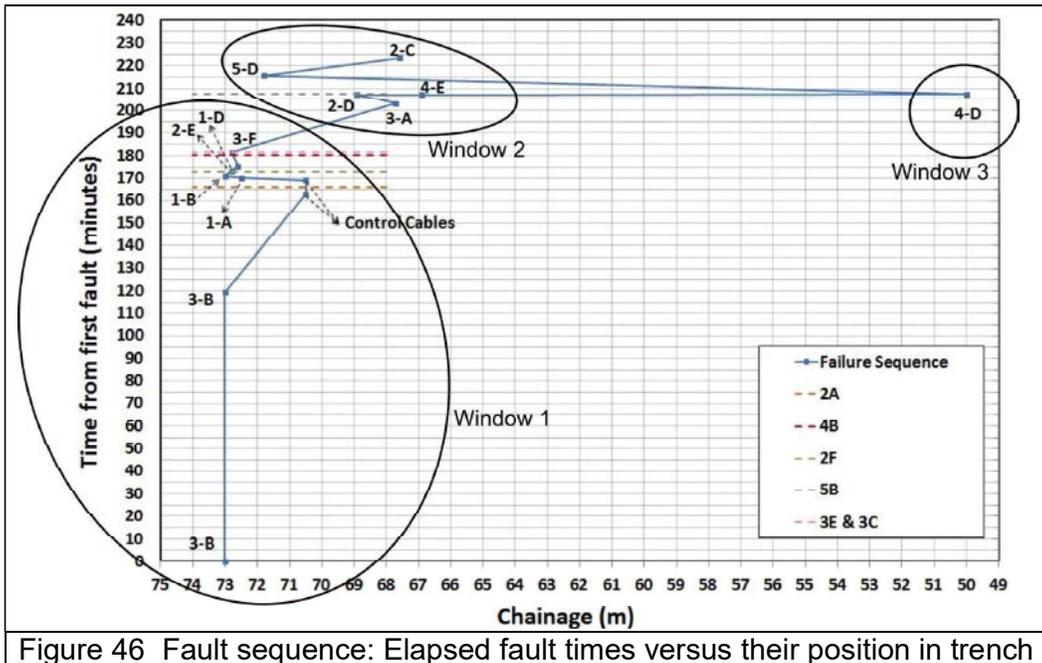
Figure 46 Fault sequence: Elapsed fault times versus their position in trench

This group of incidents is defined by being immediately adjacent to the failed transition joint in 11 kV Remuera K10, 3B0, at 73m. Two of the early incidents were the T11 control cables on the cable bridge that crossed the cable trench at 70.5m. Fault holes were discovered in five cables and were coincident in location with the failed transition joint 3B0. These cables were above and adjacent to the failed transition joint. This provided clear evidence that the cause of their failure was spread of fire from the electrical failure of the 11 kV Remuera K10, 3B0 transition joint.

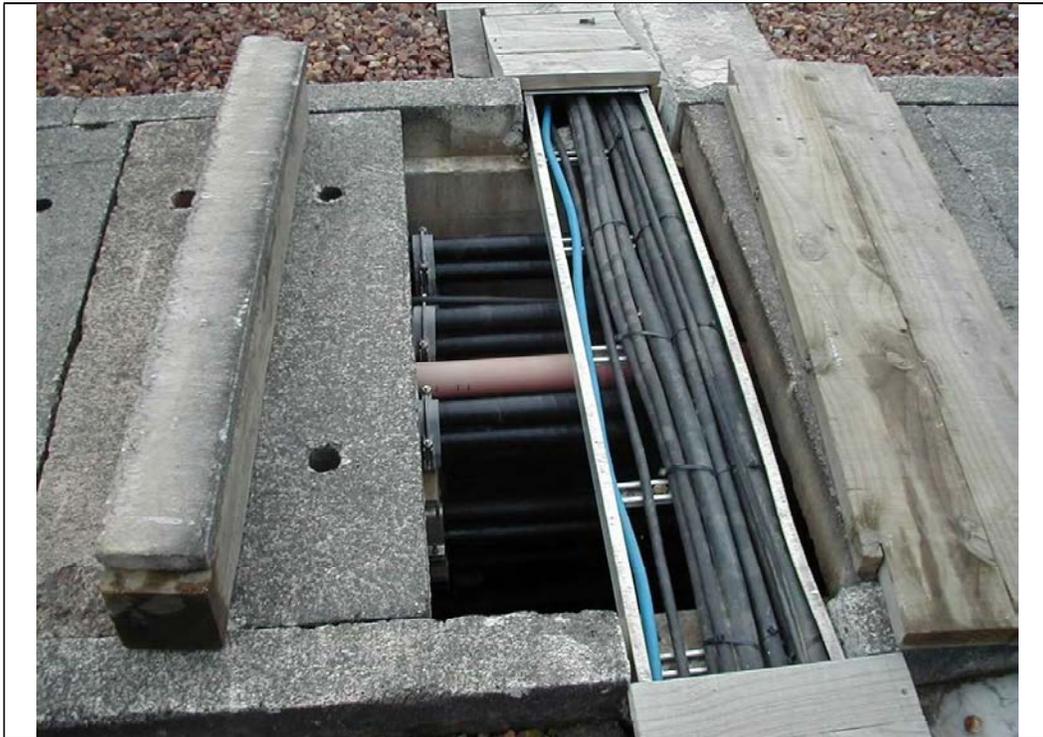
Figure 47 Control cable bridge at 70.5 m (photograph taken in 2001)

Occurred 43.67 min after the second trip. An alarm signal was received from the low voltage control cables for transformer T11 that crossed a cable bridge between the concrete cover tiles that passed over the trench at 70.5 m; 1.5 m to the east of the centre of the failed joint 3B0 and 650 mm from its end. The timber covered metal bridge had no floor, Figure 47, and supported the control cables on lateral metal hangers. Thus the control cables were exposed and their insulation would have been degraded and melted by the hot air and flames from the transition joint and surrounding cables. It is possible that the increased supply of air through the bridge drew the fire into an eastwards direction.

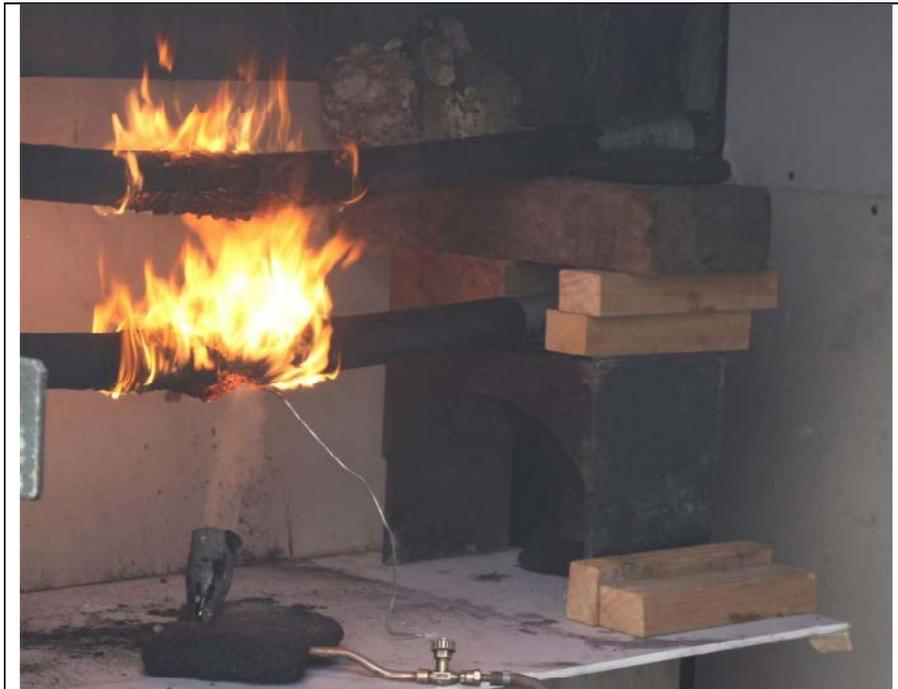
- b. In the cable trench the fire transferred progressively to all the cables except some of those located on the floor. Figure 48 simulates how flames and radiated heat transfer fire to a parallel cable. Significant heat input was required to reach a condition which would sustain this fire.

Figure 48 33 kV XLPE cables: Ignition of two cables with gas torch
