TITLE: Investigation into a Fire in a Cable Trench in Penrose Substation

REPORT: ER 763

CUSTOMER: Vector Ltd and Transpower New Zealand Ltd

DATE: 3rd November 2015

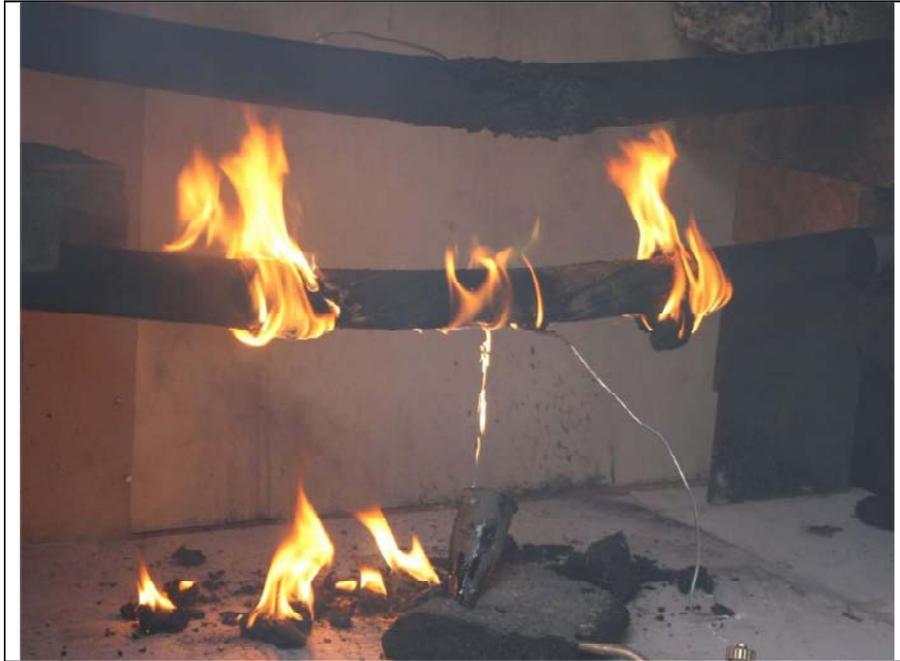
- c. In the cable trench the flames propagated long distances in both directions. Figure 49 shows flame starting to propagate along the PE/PVC oversheath of a single core 33 kV XLPE cable after the heat source in Figure 48 had been removed.

It is seen that the flames on the parallel cable had not self-sustained and have extinguished.

Portions of burning, partially combusted oversheath have dripped and dropped off the cable onto the floor. Evidence was found in the cable trench that this mechanism had spread fire to the cable circuits below. 'Curtains' of i) dripping PE/XLPE were found underneath some of the less severely combusted oversheaths and ii) dripping hydrocarbon compound was found underneath some of the PILC cables from which the lead sheath had melted, but which were still mechanically contained within their double steel armour tapes.

Figure 49 33 kV XLPE cable: Flame propagating and PE dropping

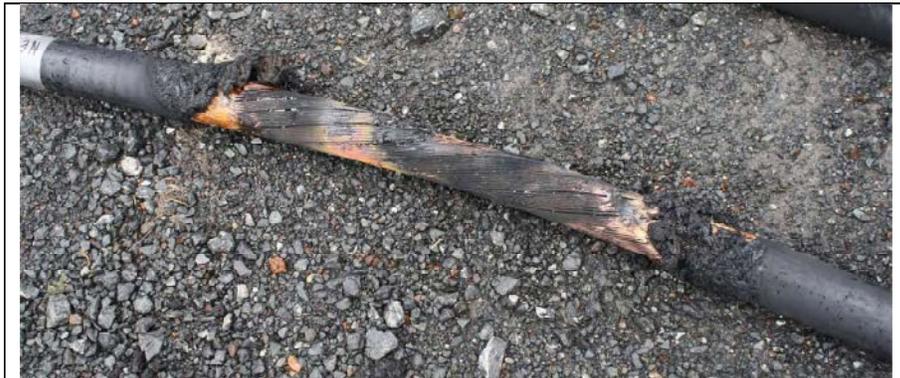
Figure 50 shows that the oversheath of the Figure 49 sample had been combusted to expose the copper wire screen. The extruded XLPE core, also combustible, is visible between the wires.

Figure 50 33 kV XLPE cable: Oversheath combusted

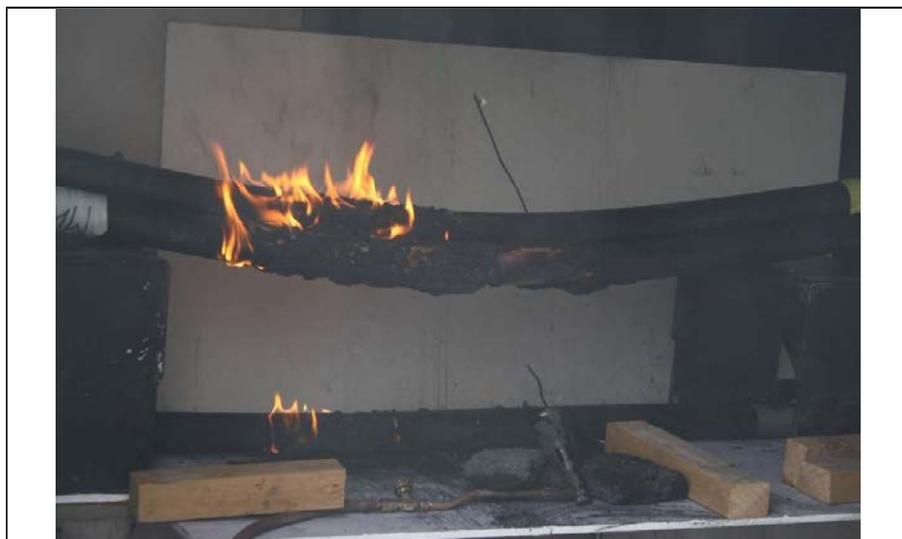
- e. In the cable trench the circuit 1A- of 33 kV XLPE single core cables in trefoil formation was present above the failed transition joint. The trefoil formation geometrically concentrates both an increased volume of combustible material and an increased surface area to absorb heat and to contribute flammable gasses. The volume of combustible material in one trefoil group of 33 kV 400 mm² XLPE cable was calculated to be 4.7 L/m. Figure 51 simulates the ignition and flame propagation of a trefoil cable group after the heat source had been removed.

Figure 51 33 kV XLPE trefoil group: Flame is sustained

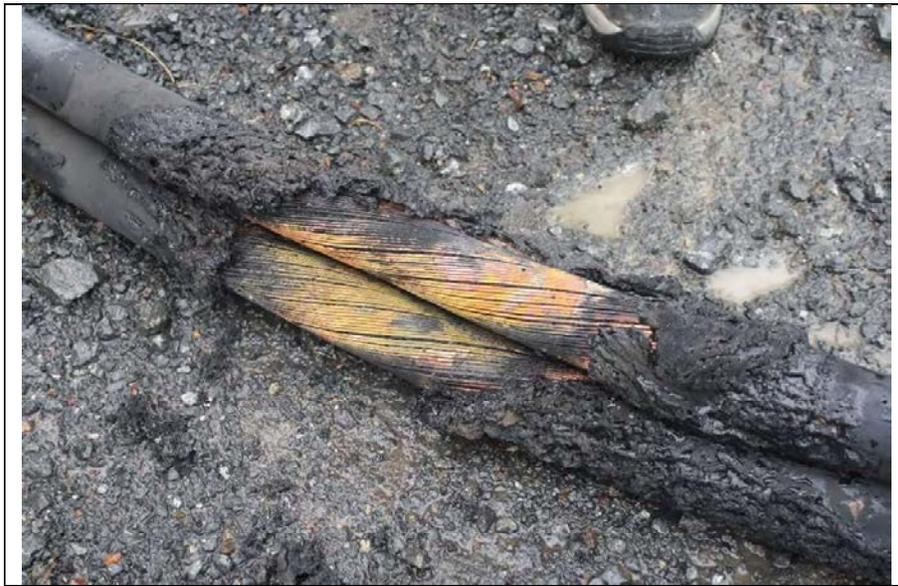
Figure 52 shows the trefoil group after the flames were extinguished. The oversheath comprising an outer layer of PE and an inner layer of PVC had been combusted to expose the copper screen wires. On the extreme left of the photograph the oversheath has a matt appearance indicative of char. The presence of char is specified in the IEC type approval test as a measure for the distance flame has propagated when assessing the performance of a fire performance oversheath. It was used in the investigation to assess how far the fire had propagated along the trench.

Figure 52 33 kV XLPE trefoil group: Oversheath combusted

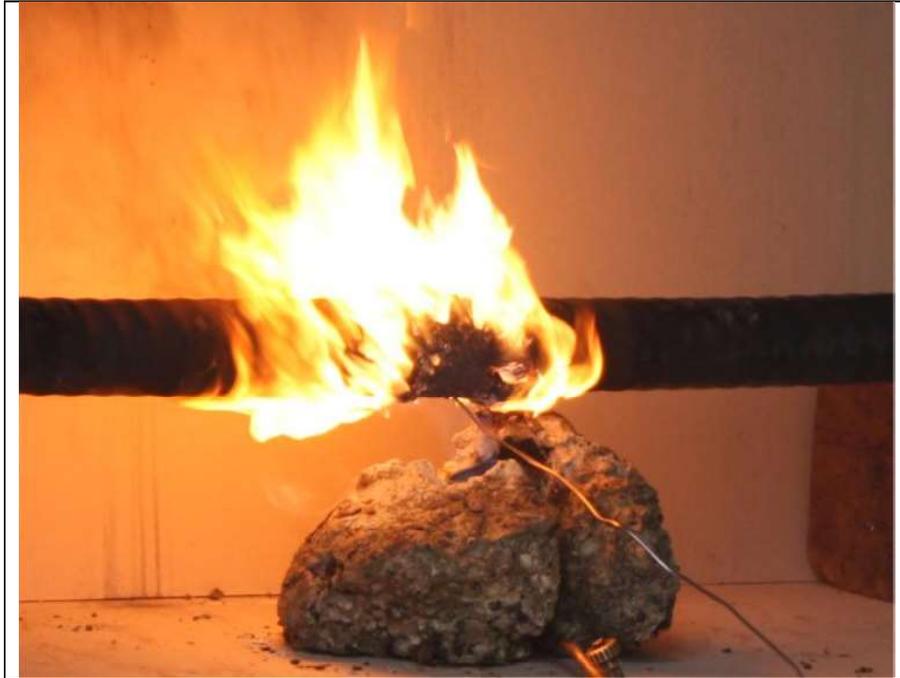
- f. Qualitative fire trials performed on a PVC oversheathed 33 kV OF cable, Figure 53, demonstrated that a significant level of heat was required to ignite the PVC sheath. However, this level also melted the aluminium sheath. It is probable that i) in the early fire stage bitumen leaked from the interface between the oversheath and aluminium sheath and sustained flame ii) in the later fire stage cable oil leaked from the ruptured aluminium sheath and contributed to the size of the flame. In the cable trench the aluminium sheaths along the majority of their lengths had remained intact. This trial simulated those locations of intense fire in the trench where the aluminium sheath was seen to have been melted and ruptured. Figure 54 shows the burnt PVC oversheath, the anti-corrosive bitumen layer and the aluminium sheath, exposed and melted.

Figure 53 33 kV OF cable: PVC sheath burning with gas torch

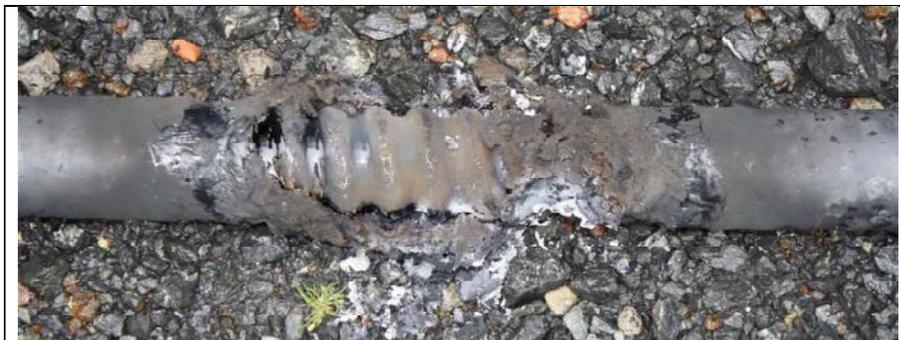
Figure 54 33 kV OF cable: Oversheath burnt and aluminium sheath melted

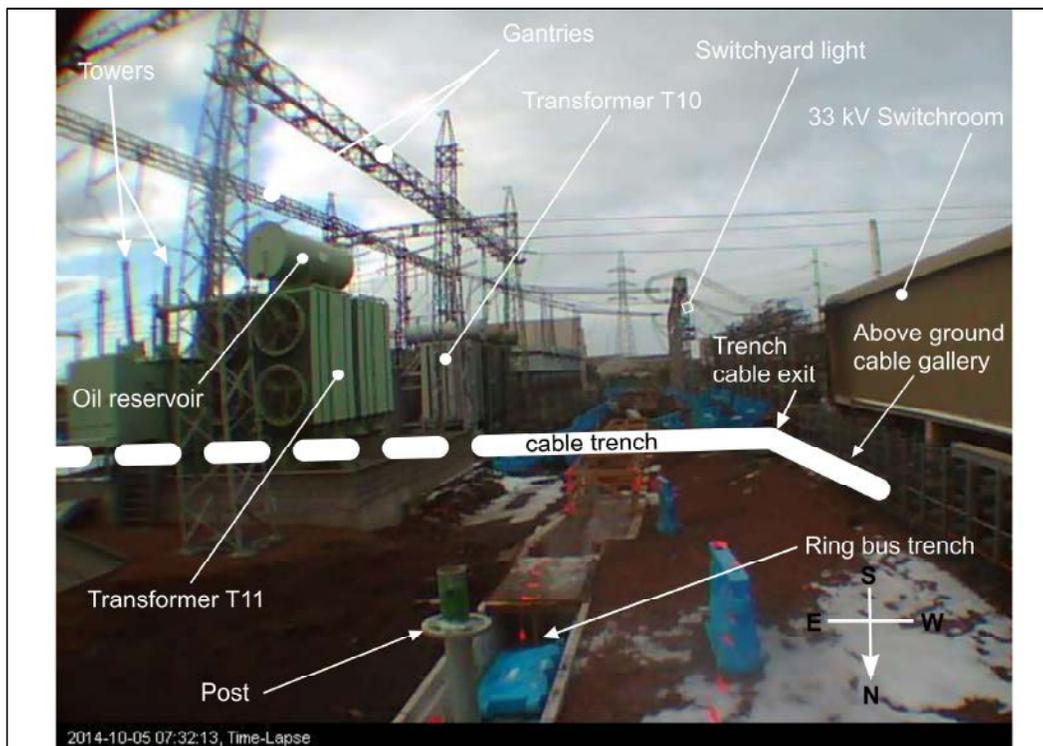
Figure 58 CCTV at 08:32:13, after the fire had been extinguished

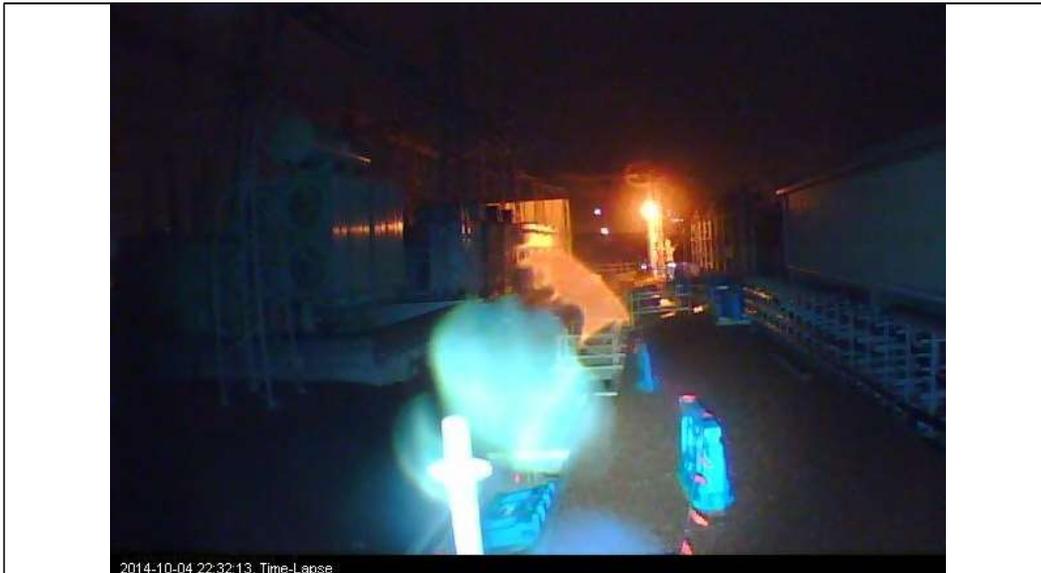
In Figure 59, 10.72 minutes after the first fault, there are clear reflections of the substation lights from the sides of transformers T10 and T11, the T11 oil reservoir, the 33 kV Switchyard building and the gantries. There is no sign of loss of vision due to smoke. The feature in the centre of the lens is believed to be an insect. A residual smudge from the feature is present in the later photographs

Figure 59 CCTV at 23:32:13, 10.72 min, after 1st fault: sharp reflections off T11 side and expansion tank and off side of T10.

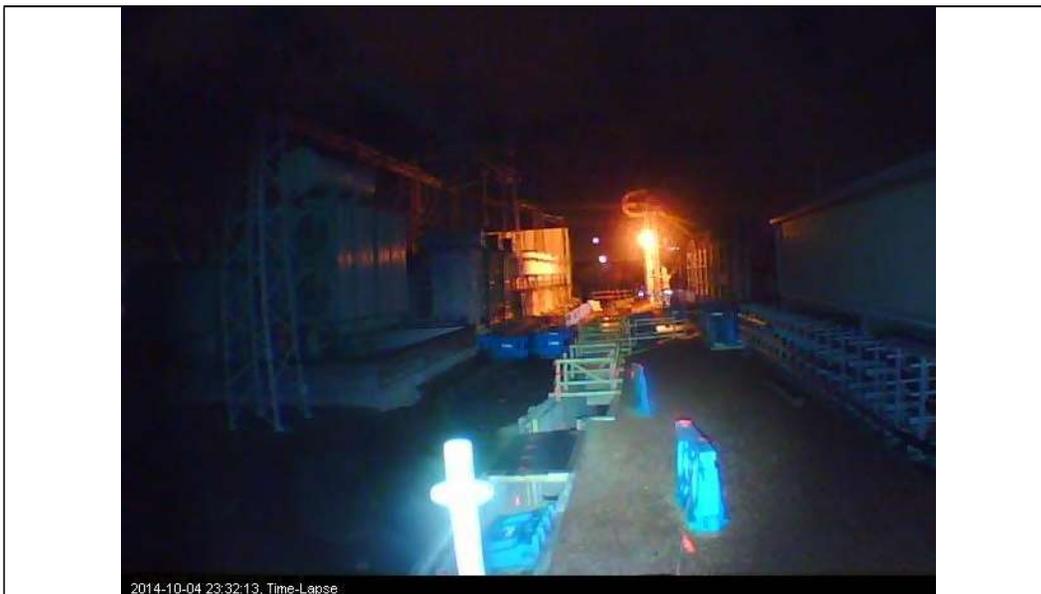
- Figure 60. Vision started to be obscured and light reflections dimmed by a light smoke haze 70.72 minutes after the first fault and 48.6 minutes before the second fault, indicating that i) a fire had been ignited by the first fault and ii) its progression was slow.
- Figure 61. Vision was further obscured by light smoke forming a general green haze 130.72 minutes after the first fault and 11.40 minutes after the second fault. This further indicated that progression of the fire from the first fault and acceleration of the fire from the second fault had continued to be slow.

The observations in Table 9 for Figure 60 record that smoke had obscured both clarity of view and some of the reflections from the Switchyard lights on the sides of the T10 and T11 transformers. This indicates that at 70.72 minutes after the first fault and 48.60 minutes before the second fault occurred i) some degree of combustion had occurred after the first fault and ii) that fire was in progress.

Figure 60 CCTV at 00:32:13, 70.72 min after 1st fault: View of T11 and T10 become obscured. Reflection on T10 obscured. Reflection off T11 is dull.

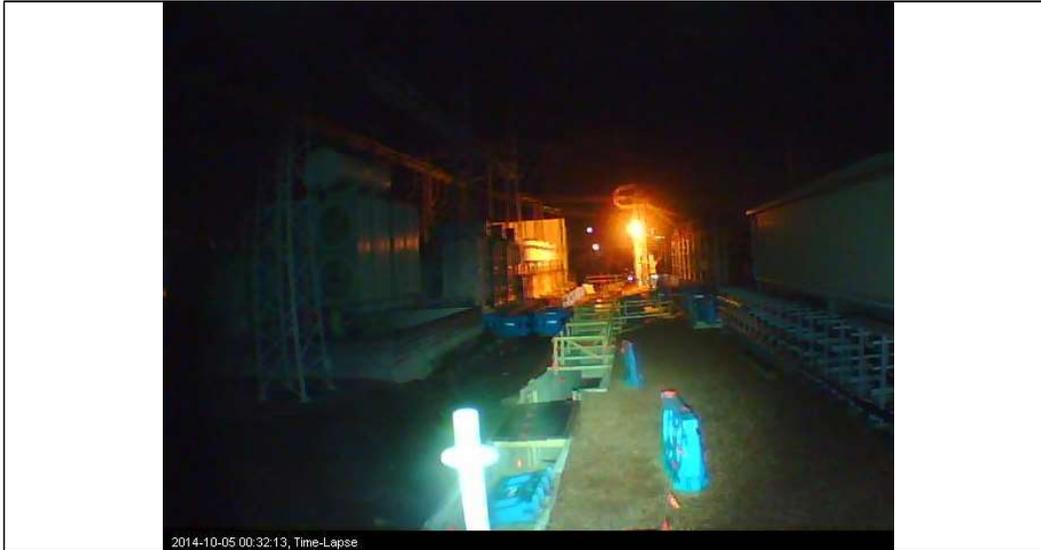
There was further loss of light transmission at 130.72 minutes, Figure 61, some 11.40 minutes after the reclose onto the fault. A green haze had dulled the light and the reflections. No evidence of light from the fire or of dense smoke could yet be seen.

Figure 61 CCTV at 01:32:13, 130.72 m, after 1st fault, 11.4 m after 2nd: general green haze.

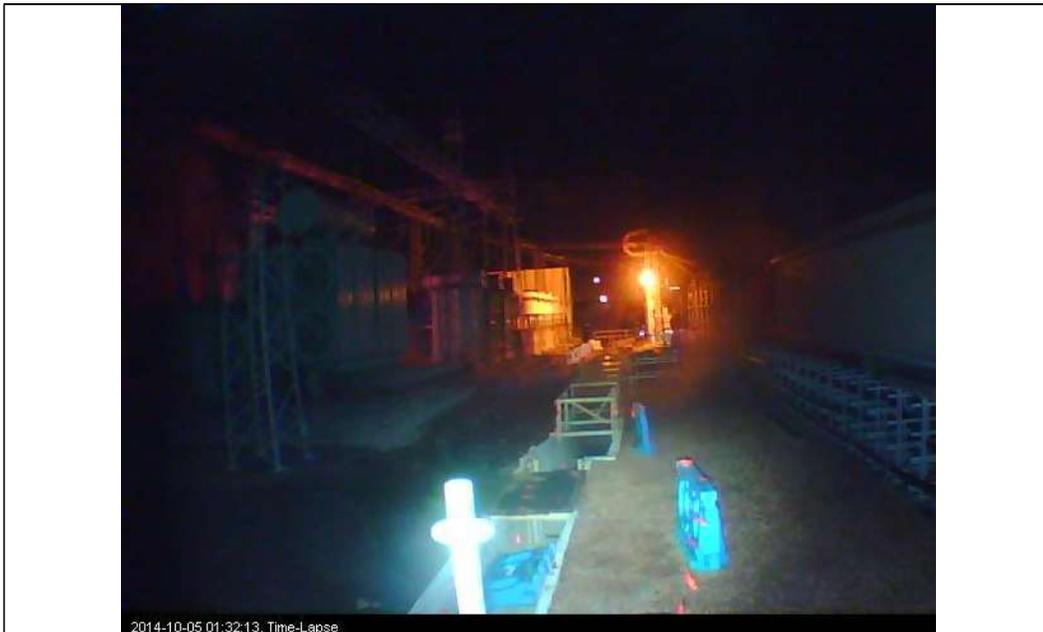
- Figure 62. Clear signs of reflected light are present from the fire deduced to be in the trench between transformers T10 and T11 and swirls of thicker smoke are present at 190.72 minutes after the first fault and 71.40 minutes after the second fault on the transition joint. This confirms that the fire had become established and accelerated between 11.40 minutes and 71.40 minutes after the second fault.

Figure 62 CCTV at 02:32:13, 190.72 min after 1st fault, 71.4 min after 2nd: mauve light reflections of fire between and above T11 and T10. Halo of smoke.

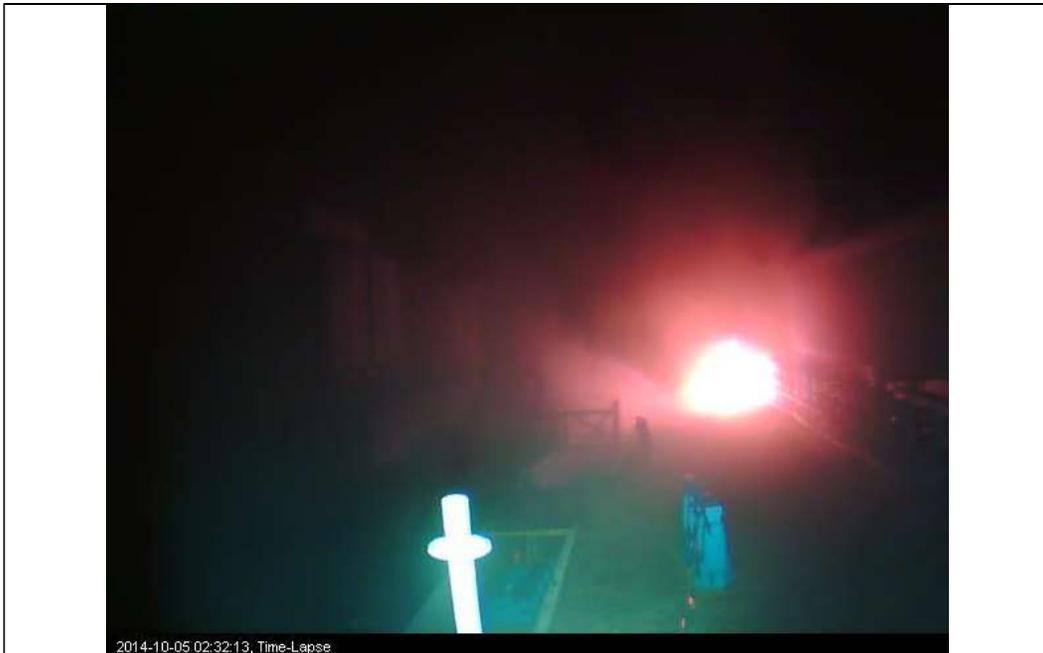
- Figure 63. The fire, accompanied by dense smoke can be seen to have emerged from the exit of the trench adjacent to the 33 kV Switchroom at 250.72 minutes after the first fault and 131.40 minutes after the second fault. This confirms that the fire had progressed from the 73 m chainage position to the trench exit at 91.5 m within the one hour period. The dense smoke is to be expected from cables having non fire performance designs; i.e. having the following combustible materials:

Figure 63 shows that at 250.72 minutes after the first fault and 131.40 minutes after the second, the fire had emerged out of the west end exit of the trench and was close to reaching the corner of the 33 kV Switchroom. The field of view contains dense smoke. Additionally the fire had already travelled from the faulted transition joint at 73 m a distance of 23 m to the east towards Gavin Street. The last cable to fault, 11 kV PILC McNab K19, 2C0, had already faulted at 223.48 minutes after the first fault.

Figure 63 CCTV at 03:32:13, 250.72 min after 1st fault and 131.4 min after 2nd: Free fire from trench exit close to 33 kV Switchroom corner. Dense smoke.

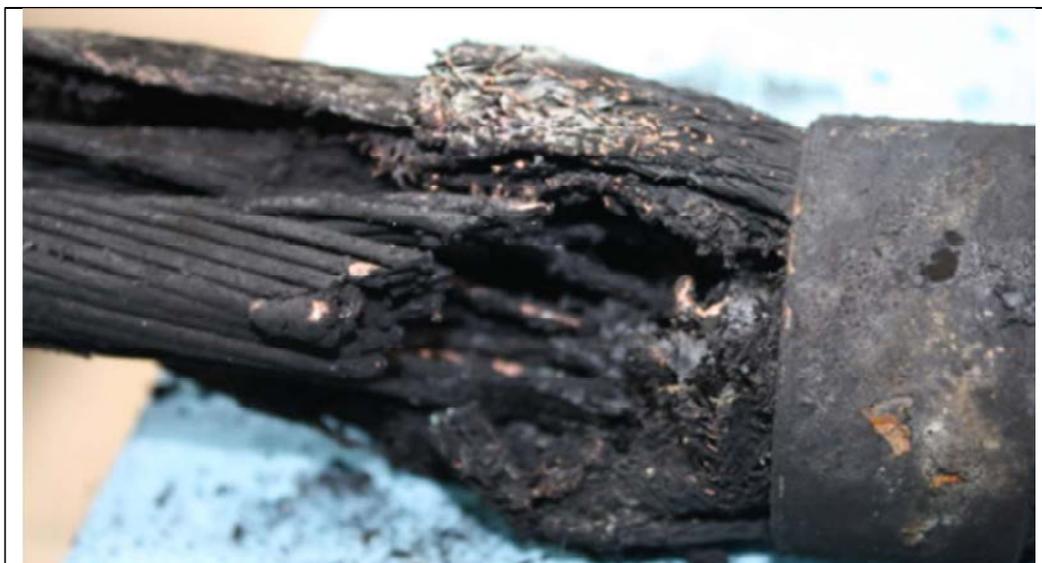
Figure 83 Arc crater: 11 kV PILC, Remuera K10, 3B0, 73 m

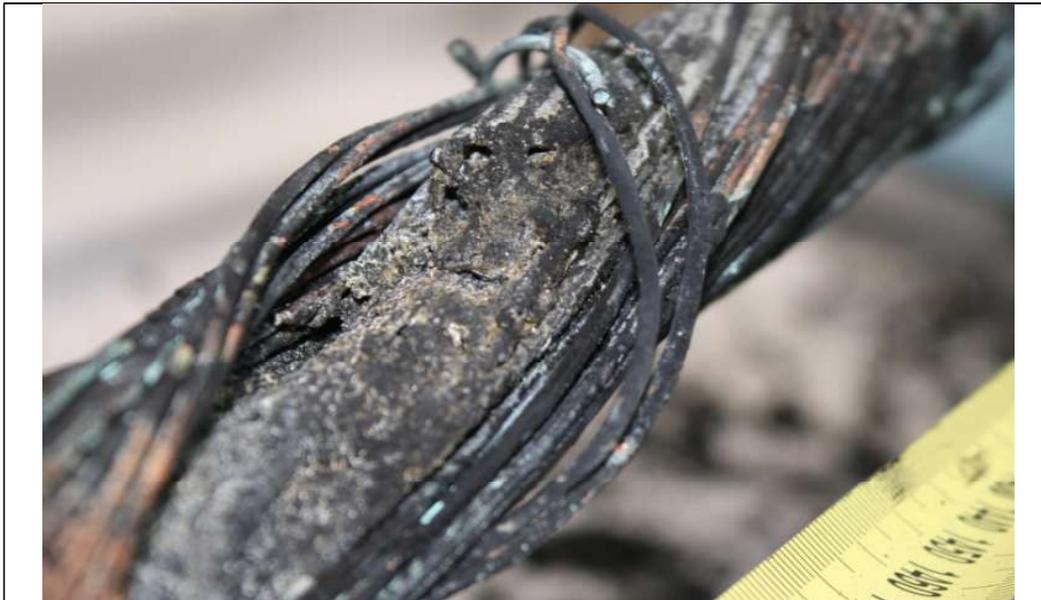
Figure 88 Arc crater: 33 kV XLPE, Remuera 3, 1AZ, at 72.5 m

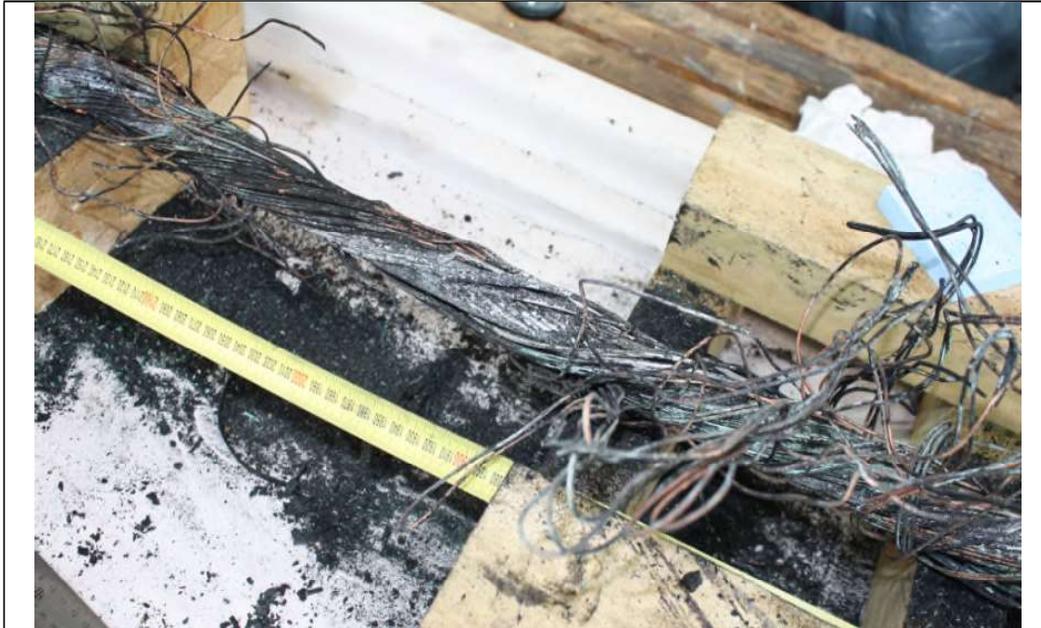
Figure 90 Arc crater: 33 kV XLPE, Newmarket 3, 1B-, 73 m, Y Phase

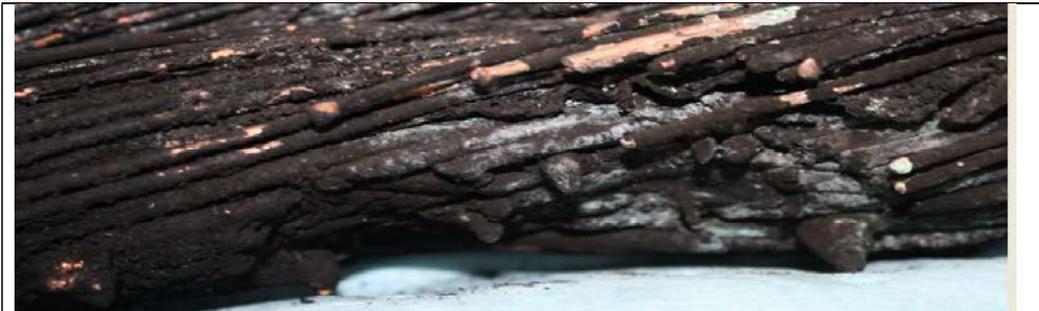
Occurred 0.27 minutes later. 33 kV XLPE Carbine Road 2, 2EY, at 72.8 m, faulted and tripped. The arc crater is shown in Figure 93. It is likely that the PVC duct 1C and XLPE cable 1D were alight and that burning polymer had fallen below them onto 2E in Level 2.

Figure 93 Arc crater: 33 kV XLPE, Carbine Road 2, 2EY, 72.8 m

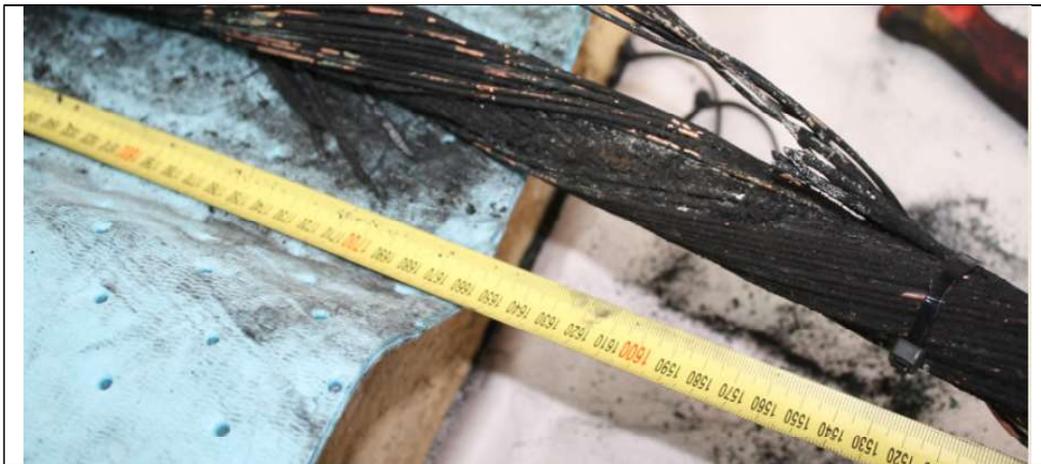
Occurred 1.97 minutes later. 33 kV XLPE Remuera 2, 1DY, at 72.6 m, faulted and tripped. The arc crater is shown in Figure 95. It is likely that fire had spread across the top row from 1A to 1B to 1C and then 1D. 2E below had faulted 2 minutes before and the energy from the power arc would have accelerated the demise of 1DY.

Figure 95 Arc crater: 33 kV XLPE, Remuera 2, 1DY, 72.6 m

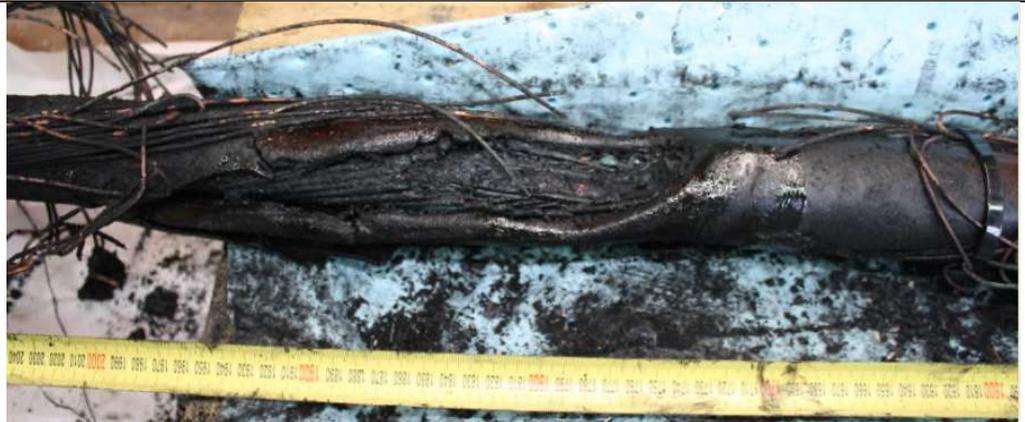
Occurred 1.17 minutes later. 33kV XLPE St Johns 3, 3F- circuit faulted and tripped at 72.3 m. The first fault was recorded as blue phase to earth for 0.061 s and red and blue phases to earth for 0.979 s. It was deduced that the power arc from the blue phase cable had emerged from between the screen wires and had burnt into the adjacent red phase cable causing it to fault to the earthed screen wires. The arc burning was found in two of the single core cables, Y and Z, which had been cut out separately for examination. The arc burning in cable 3FY is shown in Figure 98 and was recorded to be at 72.8 m. A closely similar arc burn was present in 3FZ at 72.35 m. The difference in position of 450 mm was taken to be a measuring/cutting error and so a common position of 72.3 m was taken. It is likely that burning polyethylene had fallen from 2E-, which had faulted 8 minutes before.

Figure 98 Arc crater: 33 kV XLPE, St John 3, 3FY, 72.3 m

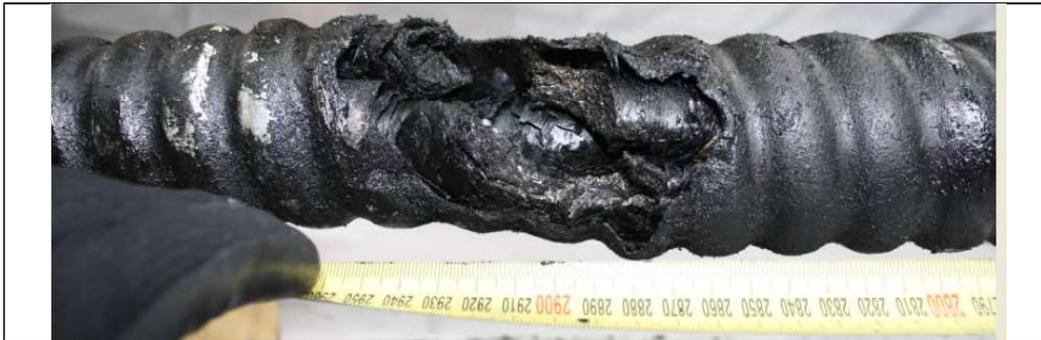
Occurred 4.0 m minutes later. 33 kV OF Carbine N° 1, 2D0, at 68.9 m, faulted and tripped. This was the first oil-filled cable to fail in the cable trench. The arc crater is shown in Figure 102. The fault position is 4.1 m eastwards from the centre of the failed transition joint and 207.2 minutes after it. The long survival duration of the OF cable is significant as this cable was on the same Level 2 as the failed transition joint and had burning cables above, below and on either side. The oil would have expanded until it exceeded the storage capacity of the oil storage tanks. The pressure would then have risen to a value capable of bursting the aluminium sheath. The sheath would become plastic and its hoop strength reduce before the temperature approached the melting point of 660°C (aluminium sheaths are typically extruded at 425°C). The sheath is therefore likely to burst at a mechanically weakened point somewhere within the fire region. The paper insulation would have been thermally degraded by the high temperature. The drop in pressure and the admittance of air and hot gas into the insulation would cause electrical failure. The addition of hot cable oil and vapour into the fire would spread the fire along the trench and underneath the cables and so significantly increase the fire intensity.

Eventually either the external fire or an internal cable fault and arc breached the aluminium sheath of the OF cable as shown in Figure 102. The increased intensity of the fire damage seen in this trench region is attributed to the release of cable oil and spread of fire. Smaller holes were found to have been melted in the aluminium sheath of 2D0 close to the fault hole as shown in Figure 56.

Figure 102 Arc crater: 33 kV OF, Carbine No1, 2D0, 68.9 m

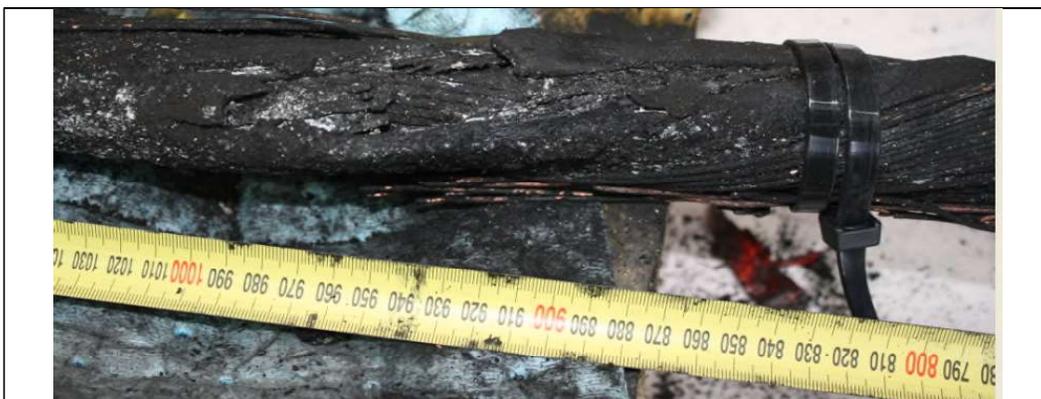
Occurred 0.07minutes later than 2D0 above. 33 kV Mt Wellington No 2, 4EY, XLPE cable at 66.9 m, faulted and tripped. The arc crater is shown in Figure 104. This cable would have experienced burning PE from 3F above it, which had faulted 26 minutes before.

Figure 104 Arc crater: 33 kV XLPE, Mt Wellington No2, 4EY, 66.9 m

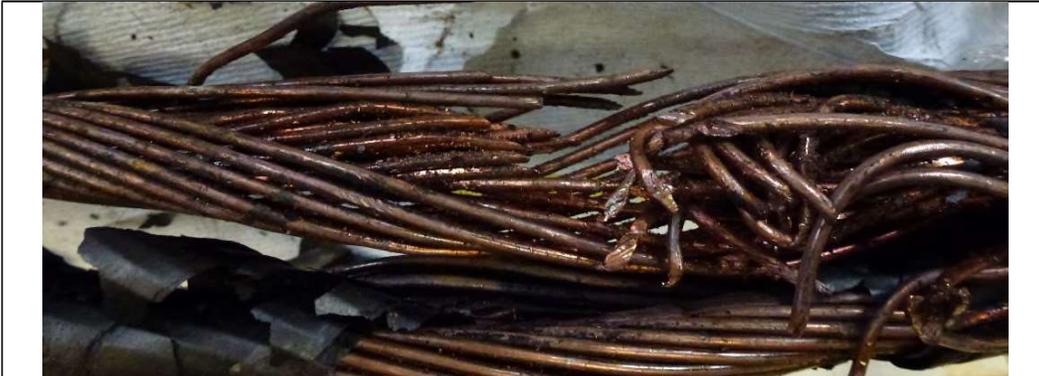
Occurred 0 minutes later (at 207.40 minutes), at the same time as the previous incident, 5B, 11 kV PILC Mt Wellington K05, 4D0, at 50 m faulted, as shown by the arc crater in the conductor in Figure 107. However there is no record of this circuit having electrically tripped. It has therefore been taken for the purpose of this report that it faulted at the time of Mt Wellington Substation losing power when Mt Wellington No 1 tripped.

Figure 107 Arc crater: 11 kV PILC, Mt Wellington K05, 4D0, 50 m

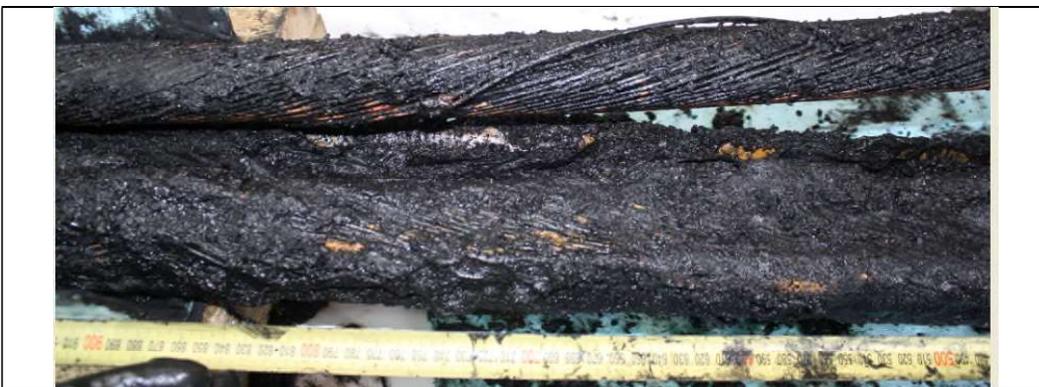
Figure 109 Arc crater: 33 kV XLPE, Sylvia Park No 2, 5DX, 71.8 m

Occurred 8.32 minutes later. 33 kV XLPE Sylvia Park No 2, 5DX at 71.8 m, faulted and tripped. The arc crater is shown in Figure 109. This cable had been laid in the access way. It failed close to the fault in the OF cable 2D0 at 68.9 m, which had faulted 9 minutes before.

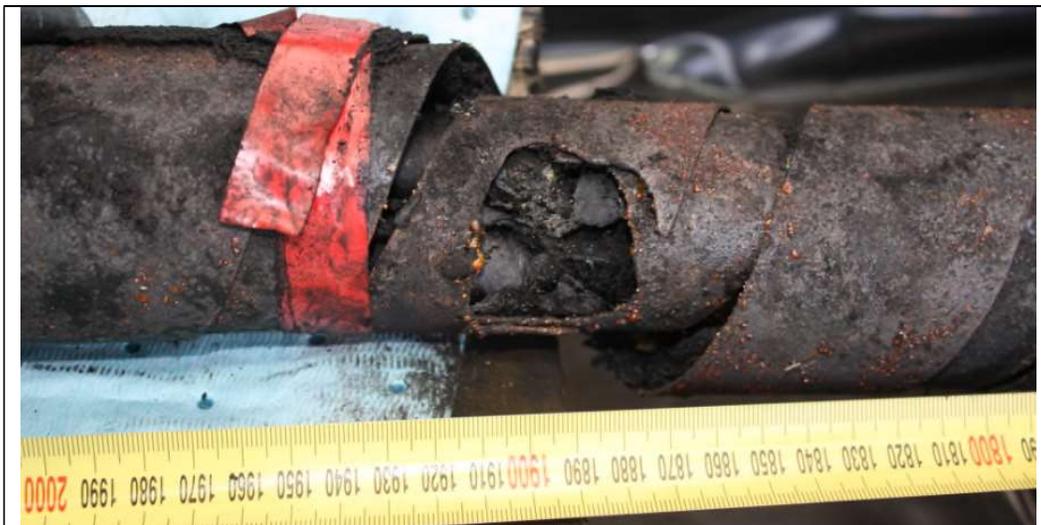
Figure 111 Arc hole in armour: 11 kV PILC, McNab K19, 2C0, 67.4 to 67.9 m

Occurred 7.77 minutes later. 11 kV PILC McNab K19, 2C0, at 67.9 m, faulted and tripped. The arc crater in the armour tape is shown in Figure 111 and in the conductor in Figure 112. The long survival duration of this PILC cable of 223.48 minutes is significant as this cable was on the same Level 2 as the failed transition joint and had burning cables above, below and on either side. The cable is effectively adjacent to (1 m to the east) the faulted OF cable 2D0 at 68.9 m. It failed 16.28 minutes after cable 2D0. 2C0 was next to the faulted transition joint and survived 104.17 minutes after its failure. It is possible that burning oil accelerated its failure.

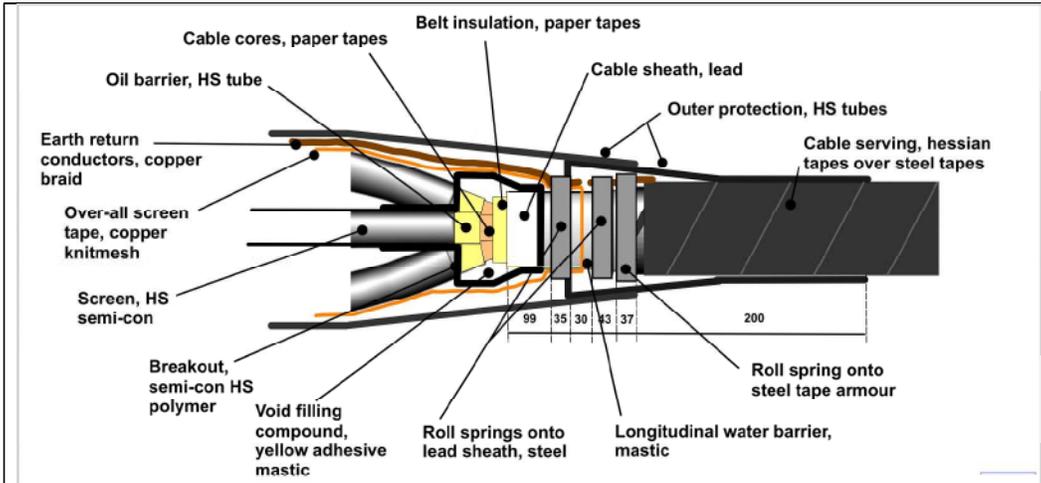
Figure 115 Unfailed 11 kV transition joint: PILC end of joint

A water protective mastic/adhesive lined 'adaptor' heat shrink tube had been applied over the roll springs and over the hessian tape served PILC cable for a distance of 200 mm, Figure 115. It was observed that the length of the overlap of the heat shrink tube onto the cable serving could not form a watertight seal as the hessian tape serving had a water permeable open weave and the armour tapes below it had been factory applied with a gap between turns that provided a water permeable helical channel.

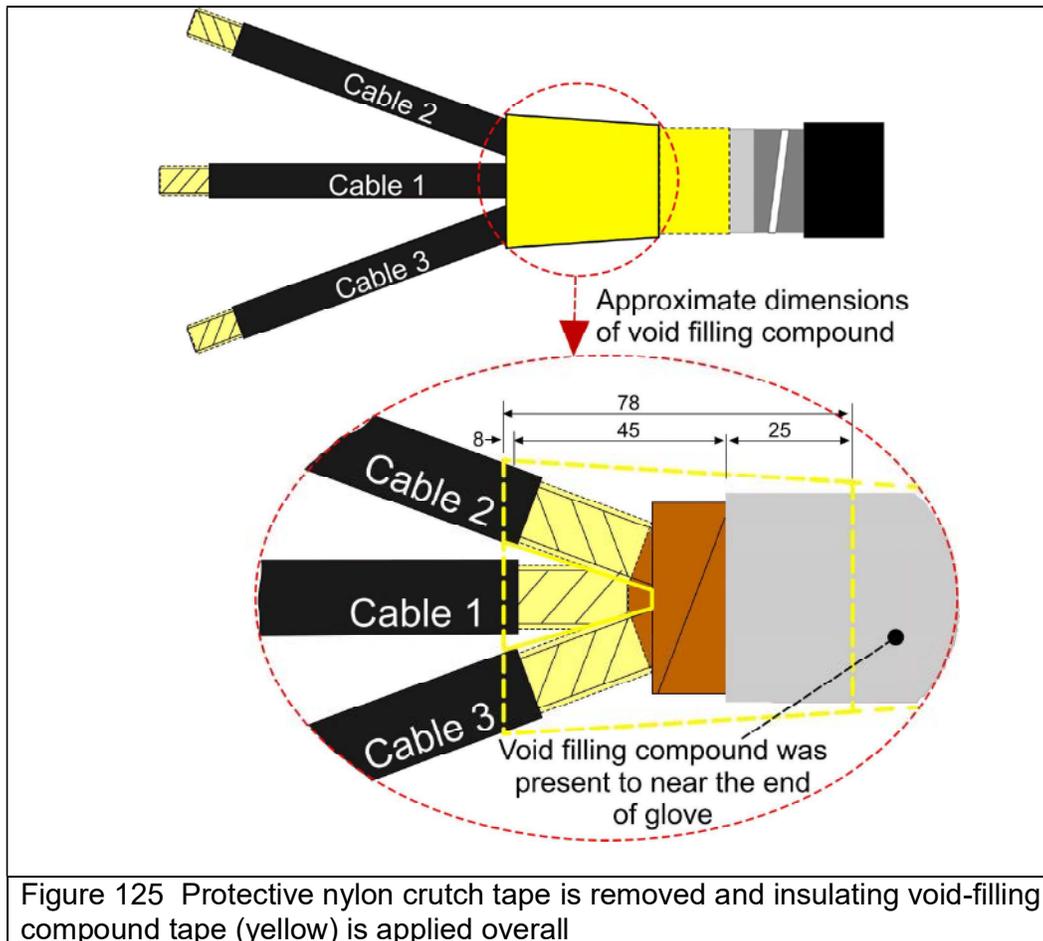
Having inserted the wedge of compound into the crutch between the three PILC paper insulated cores the protective nylon tape is removed. Yellow void filling compound is then applied to form an insulating layer over and between the paper insulated cores. The adhesive compound is supplied in tape form interleaved between layers of disposable separating tape to prevent it from adhering to itself prior to use. Figure 125 records the overall length of the compound that was measured when the unfailed transition joint was dismantled. The yellow compound overlapped the lead sheath by 25 mm as shown by a stained area on the lead. The yellow compound was also present in the region from 25 mm up to the end of the breakout glove. In this region the compound had adhered to the lead sheath in some places and to the inside of the breakout sleeve in others. The surfaces of the compound had discoloured from yellow to a dark brown colour and gave the impression that this surface had deteriorated with age.

Similar discolouration was seen on the surfaces of the yellow void filling compound present in the XLPE to XLPE cable straight joints when they were dismantled.

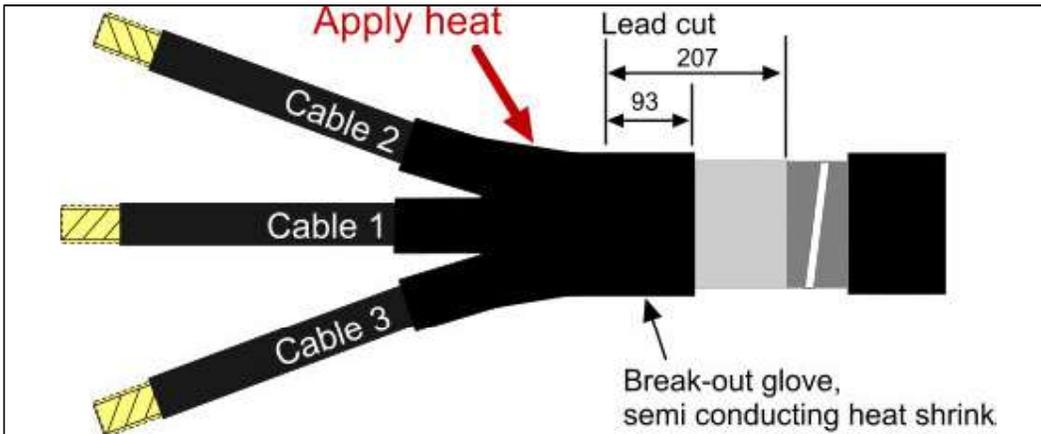
Figure 126 The break-out glove (conducting earth screen) is fitted and shrunk-down

A heat shrink breakout glove had been fitted over the heat shrink semi-con sleeves present over each of the three screened cores and then shrunk down onto the lead sheath, the taped yellow compound insulation and the semi-con conductive sleeves. The overlap onto the lead sheath was 93 mm as shown diagrammatically in Figure 126 of which the first 23 mm appeared to have adhered and formed a possible water seal. The overlap onto each of the semi-con core sleeves was approximately 50 mm, as shown in Figure 128. This overlap did not appear to be sealed to prevent water entry.

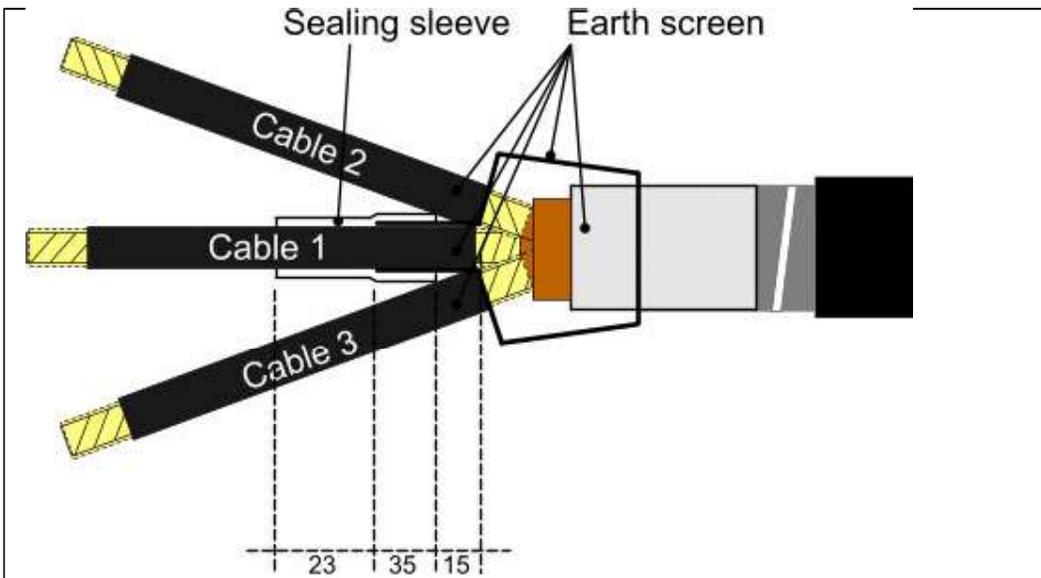
Figure 127 Sealing sleeves are fitted over the break-out glove spouts and shrunk down

Adhesive lined sealing sleeves of approximately 60 mm length had been heat shrunk down over the ends of the spouts on the breakout glove as shown in Figure 127. The length of the overlaps were typically 23 to 25 mm. White adhesive appeared to have been applied inside the sleeves in thin longitudinal lines. The adhesive had not been uniform spaced around the circumference and had not spread to form an annular sealing layer. The impression was given that this would not have formed an effective water seal.

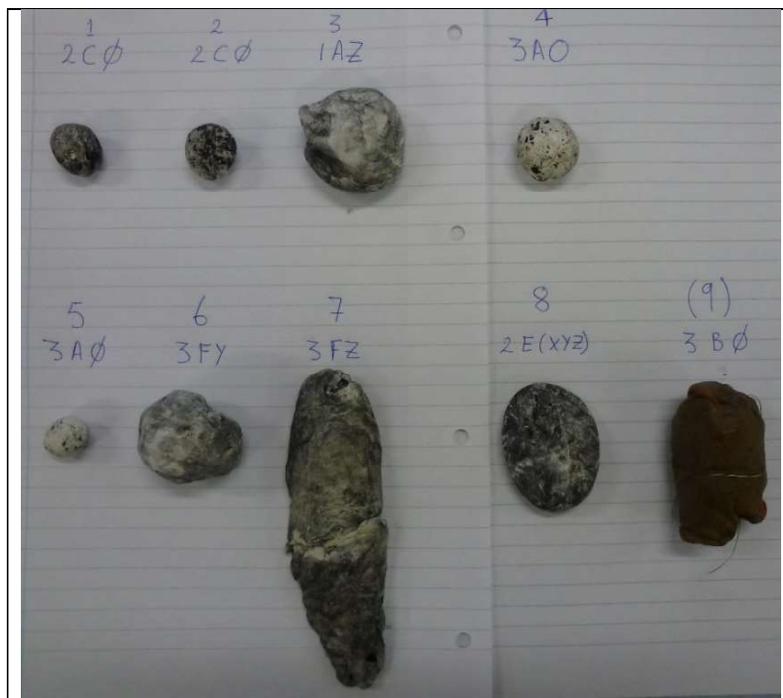
Figure 141 Clay volumes from the conductor arc cavities

- The measured arc erosion volume in the failed 11 kV PILC transition joint 3B0 to be 27.3 mL, this being produced by the passage of 4,200 A fault current on two occasions both of two 0.55 s duration.
- The 3B0 transition joint crater volume to have been very significantly larger than those in the other 11 kV PILC faults; i.e. 3A0 has 4.9 mL and 2C0 has 1.6 mL and 3 mL.
- The failed 3B0 transition joint is one of the three faults to have large arc crater volumes, the other two being 33 kV XLPE cables; 1A has a volume of 25.8 mL and 3F has 24.4 mL.

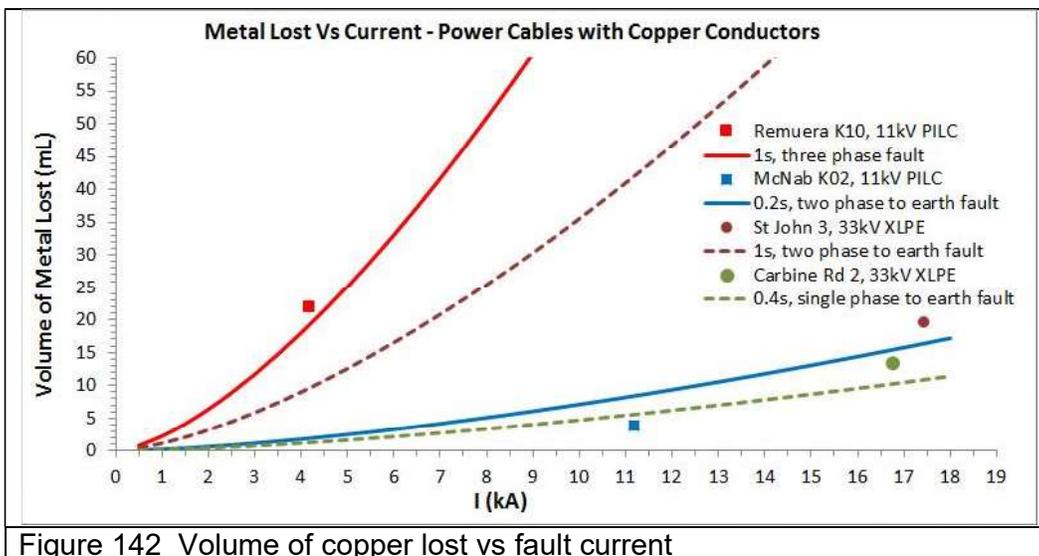
Figure 142 Volume of copper lost vs fault current

The curves in the graph in Figure 142, Figure 143 and Figure 144 were drawn to illustrate the dependence of lost copper volume on fault time and current according to the Stanback relationship. For the purpose of the illustration each line represents a constant fault duration together with a multiplying factor to represent i) the number of power arcs present during the fault between the phase conductors and ii) the number of ends of power arcs that contributed to the erosion. The co-ordinates of measured metal lost and fault duration were then plotted in Figure 142 for four faults that had copper conductors and in Figure 143 for three faults that had aluminium conductors.

The CCI Author concludes that the fault coordinates were sufficiently close to the empirical 'Stanback expression' curves to have confidence that:

- The volumes of the metal lost had a logical dependence on the magnitude of fault current and duration.
- The two cumulative faults did inject high arc energy into the Remuera K10 transition joint.

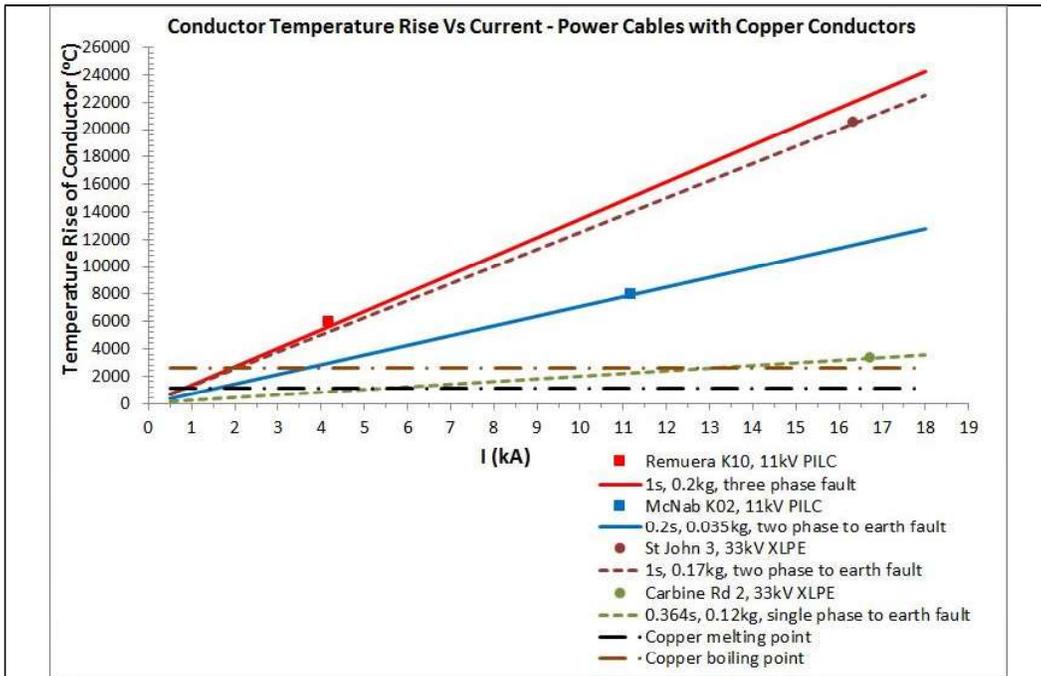
Figure 144 Temperature rise vs fault current for set fault durations

Figure 144 plots the calculated temperature rise against the fault current for different fault times for the measured mass of metal lost from four faulted copper conductor circuits.

Figure 144 shows that:

1. Taking 100% efficiency for the conversion of fault into thermal energy the temperature rises were significantly greater than i) the melting point of copper of 1,085°C and ii) of the fire ignition temperatures of the insulating and protective layers surrounding the joints and cables, Table 7.
2. Taking a 50% efficiency for conversion of fault into thermal energy the temperature rise in the vicinity of the arc for the Remuera K10 transition joint of approximately 3,000°C is still greater than the melting point of copper and the ignition temperature of the materials.

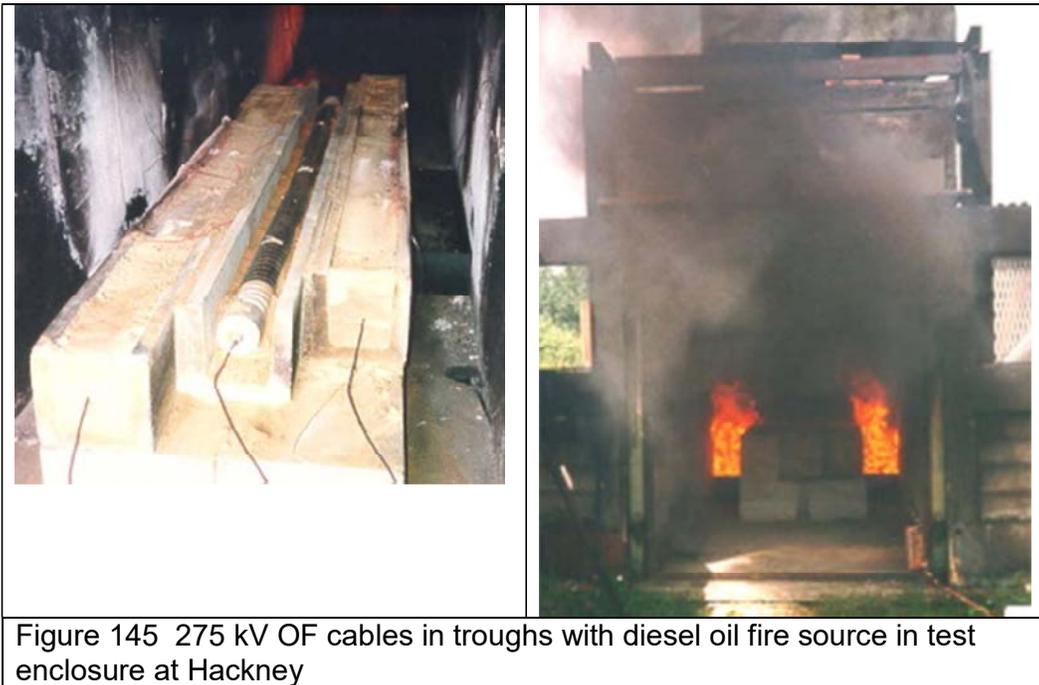
Figure 145 275 kV OF cables in troughs with diesel oil fire source in test enclosure at Hackney

Three conventional 275 kV single core oil-filled cables were then laid in CBS (cement bound sand) filled concrete troughs, as shown in Figure 145. The protected cables satisfactorily withstood the fire test without damage or oil leakage. This installation method had previously been used by the CEGB for oil-filled cables installed in the Wimbledon tunnel, Figure 146. The method was later used in the first installations of 132 kV XLPE cable in London Electricity's new cable tunnels. The method was eventually discontinued in favour of fire retardant cable oversheaths as the method increased the risk of damage to the cable oversheath during installation, occupied too much of the usable space in the tunnel and significantly reduced the current rating compared to in-air cables.
