# Penrose substation fire inquiry report

9 November 2015

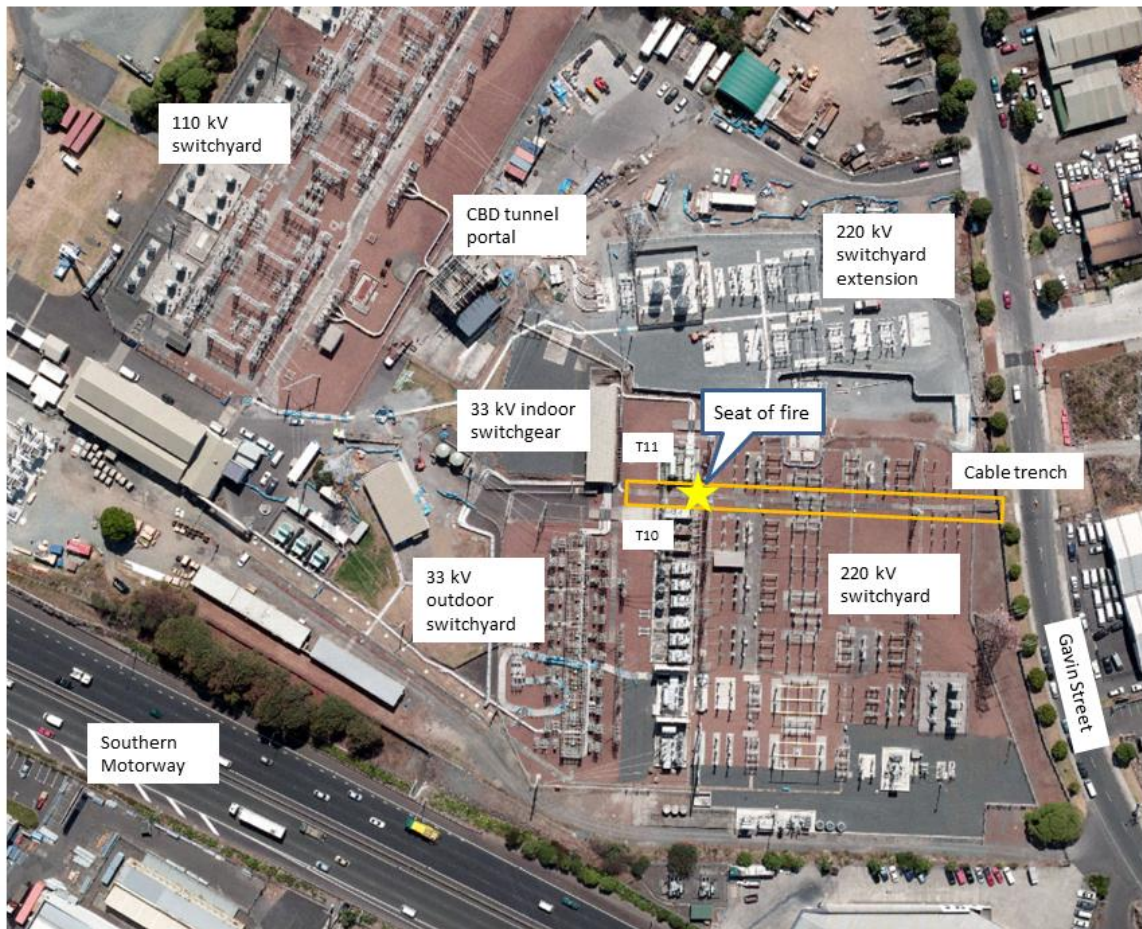
**Figure 1 – Penrose substation layout**

<sup>20</sup> There are several cable trenches and above ground cable-racks installed at Penrose substation. The covered, concrete-lined cable trench in which the fire started runs west to east through the 220 kV switchyard, and is highlighted with a yellow border in Figure 1. At the time of the initial firefighting by NZFS, it was not clear that the fire had actually started inside the cable trench.

- 4.13 From 2:04 am on 5 October 2014, Transpower's remote monitoring and control system recorded a series of unusual alarms from equipment at Penrose substation. The initial alarms were associated with the 220/33 kV supply transformer T11 (refer to Figure 1 and note the proximity of T11 to the indicated seat of the fire).

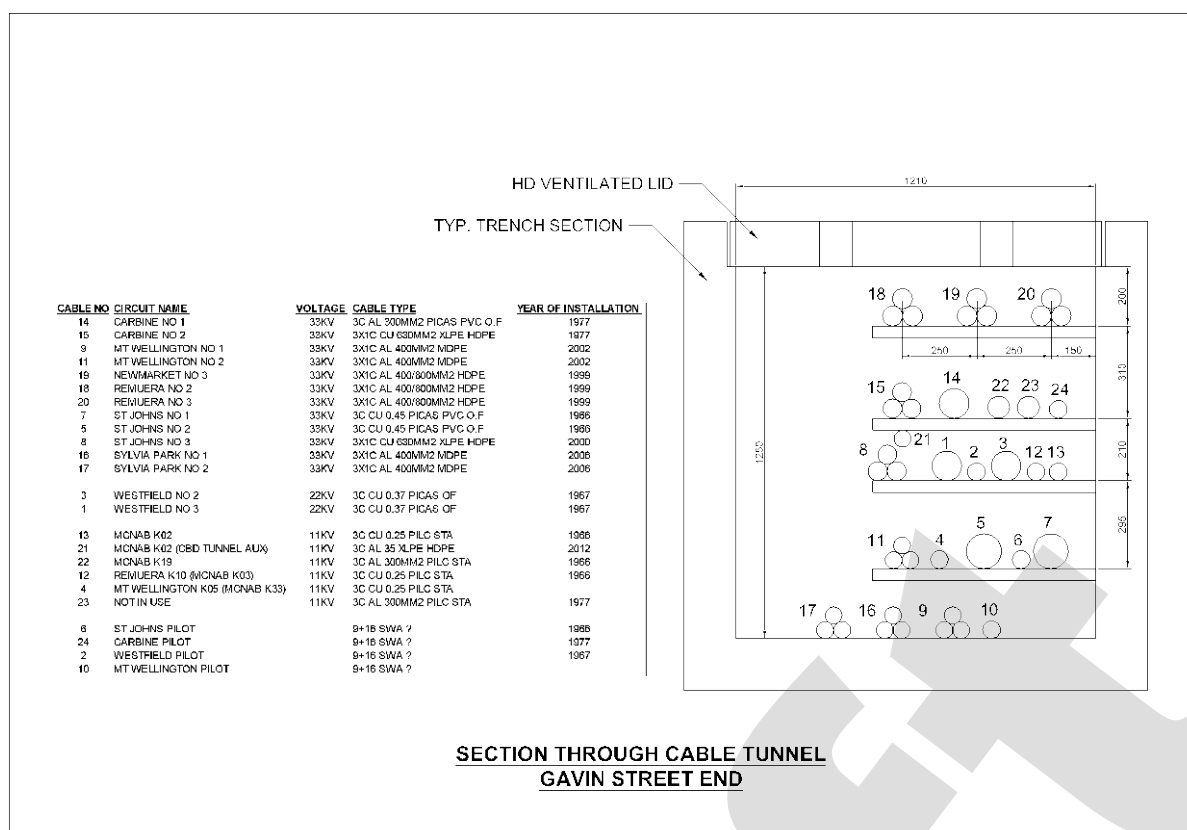
**Figure 4 – Cable trench cross-section as at October 2014**

- 3.15 At the time of the fire, the cable trench contained:
- twelve 33 kV circuits, two 22 kV circuits
  - six 11 kV circuits<sup>27</sup>
  - several communications, control, and pilot (communication cables associated with specific cables) cables
  - a switchyard lighting power supply cable.
- 3.16 Figure 4 shows the Vector power and pilot cables only.
- 3.17 The combined equivalent single length of all the power cables in the cable trench was found by CCI to be 3.99 km.<sup>28</sup> The power cables in the cable trench had 15 in-air cable joints installed in their length.
- Transpower is the owner and operator of land and facilities at Penrose substation**
- 3.18 Transpower is the owner and operator of Penrose substation. In that capacity, and of particular relevance to the October 2014 fire, Transpower is responsible for:

<sup>27</sup> Five of which were in service and one (cable 23 in Figure 4) marked as 'not in use'.

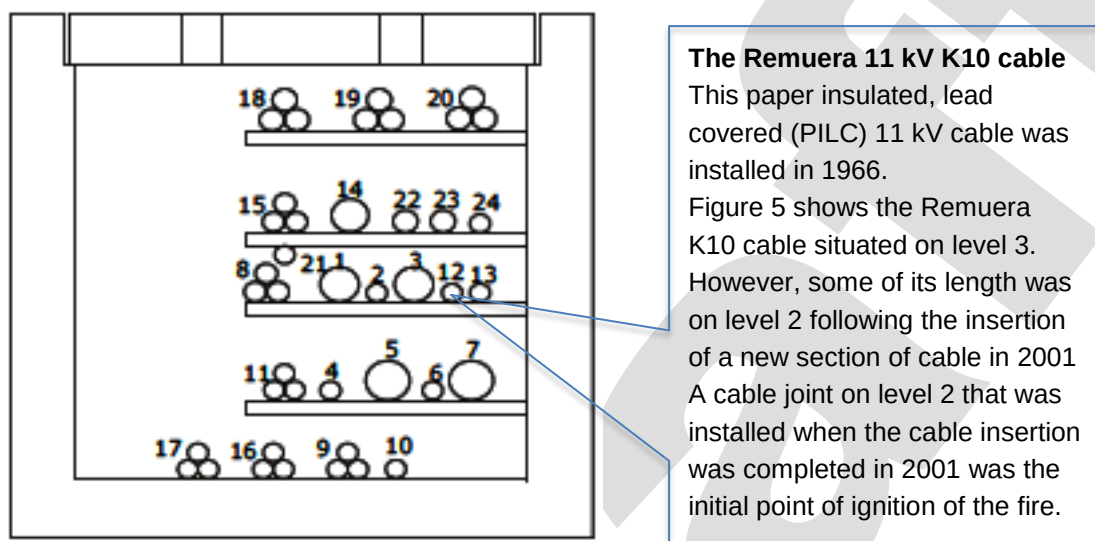
**Figure 5 – Cross-section of the Penrose substation trench Gavin Street end**

5.9 Figure 5 shows the cables in the cable trench in 2014, and the location of the cable that contained the joint that failed. The material used in the cables provided the fuel for the fire.

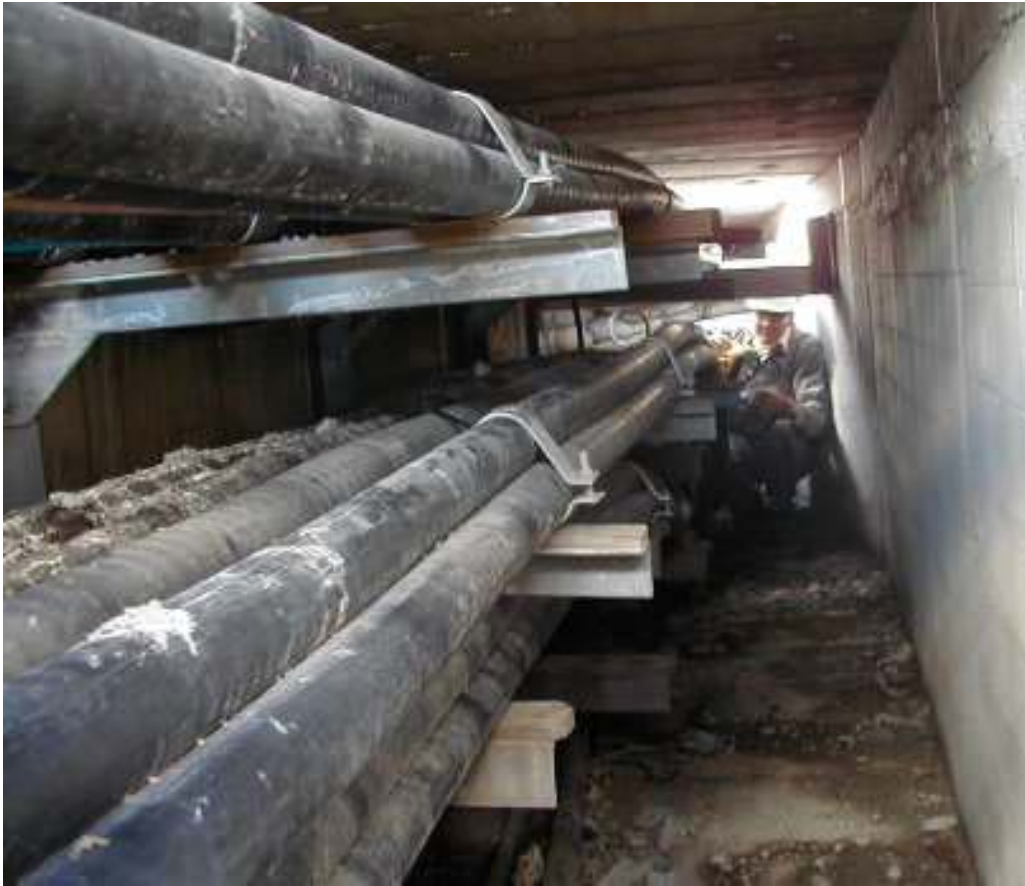
**Figure 6 – Penrose cable trench in 2001**

5.10 The cable trench is covered with ground-level removable concrete lids. At the time of the fire, the cable trench had no fire barriers or fire, heat or smoke detectors. No fire suppressant systems had been installed. Figure 6 is a photograph of the cable trench taken in 2001. Note that more cables were added to the trench after this photograph was taken.

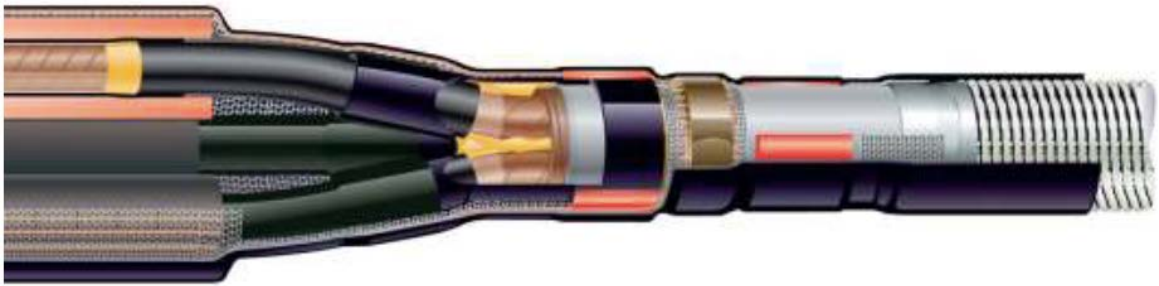
**Figure 7 – PILC to XLPE transition joint example**

- 5.15 Figure 7 is a cutaway diagram of an 11 kV, three-core, heat-shrink sleeve PILC to XLPE transition joint.

- 5.16 CCI's detailed examination identified that a power arc occurred in the 'crutch' of the transition joint at the location shown in Figure 8.<sup>53</sup> CCI concludes that the fire is likely to have ignited from the 11 kV power arc that would have resulted as the insulation material in the joint failed.

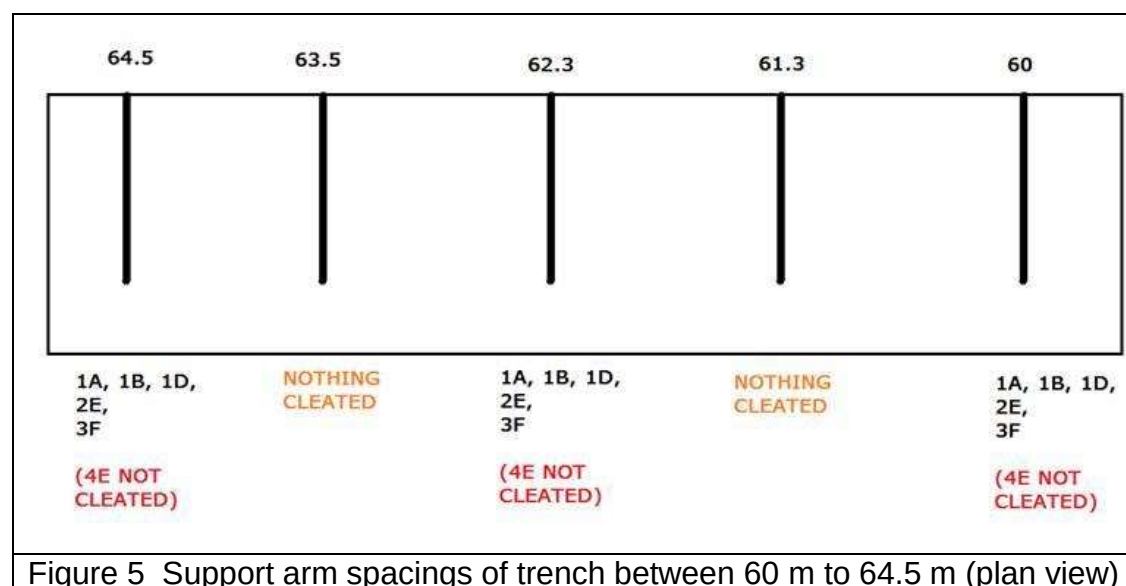
Figure 5 Support arm spacings of trench between 60 m to 64.5 m (plan view)

Figure 5 also shows which of the 33 kV XLPE circuits in trefoil formation were cleated to the cross arm supports. It is shown that the five trefoil circuits are cleated to every second support arm on Levels 1, 2 and 3, but that the three cables forming the 33 kV Mt Wellington 2 circuit at the end of the arm on level 4 is not cleated.

The Remuera K10 cable had been installed in straight alignment in an informal 'semi-flexible' thermo-mechanical system that rested uncleated on supports at ~1.125 m spacings, Figure 5. The cable had neither been 'rigidly close-cleated' nor 'flexibly sagged' as described in CIGRE TB 194<sup>6</sup> (i.e. it was not formed into lateral sags between the support arms). Thus the prospective axial thermal expansion in Remuera K10 (and the other cables in the trench) would not have been relieved by uniformly distributed lateral deflection, but would have generated axial compressive forces that tended to move residual thermal strain into randomly occurring geometric lateral perturbations. The six metre long loop of 11 kV three core XLPE cable adjacent to the failed transition joint at 73 m, Figure 41 and Figure 42, is a perturbation that is likely to have cyclically flexed

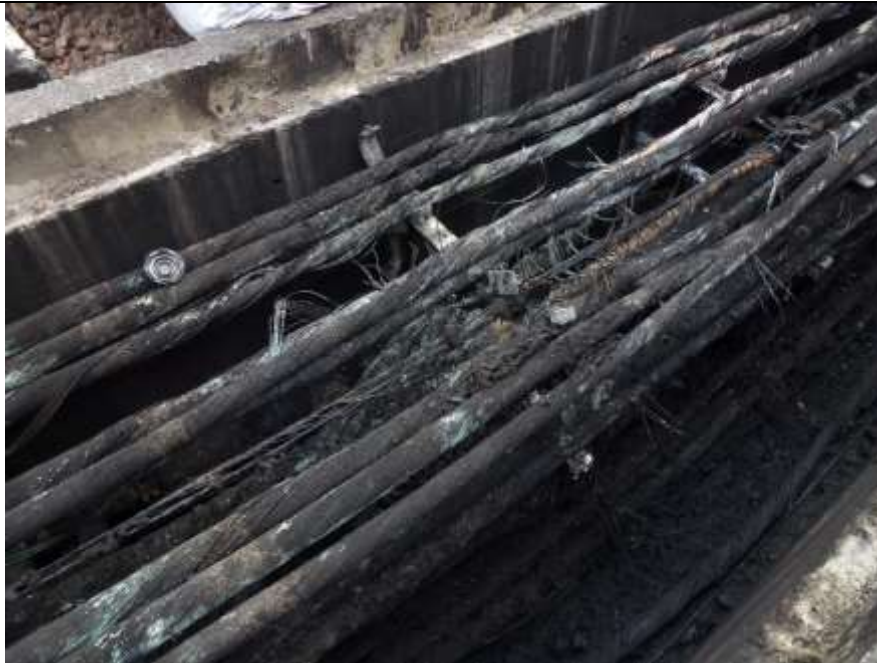
Figure 8 Photograph of cable trench at 73 m taken after the fire in October 2014

A photograph of the cable trench after the electrical failure on the 4<sup>th</sup> October 2014 is shown in Figure 8. The photograph is at the position of the first electrical fault at 73 m chainage. The view is of the cable circuits on the top layer. Starting from the left hand wall end of the support arm the cables are:

The trefoil cleats on Level 1 can be seen to have been i) broken open as a consequence of the fault current electromagnetic forces and ii) melted from the heat of the fire. The cables in three of the groups on Level 1 have been laterally displaced from their trefoil formation by the electromagnetic force.

Two cable circuits can be seen on Level 5, the floor of the access way, amongst the carbonised debris, these being Sylvia Park No 1 and 2: 3 x 33 kV, S/C XLPE cables.

One phase of a 33 kV S/C XLPE cable had fallen from a higher level onto the cable circuit on the floor.

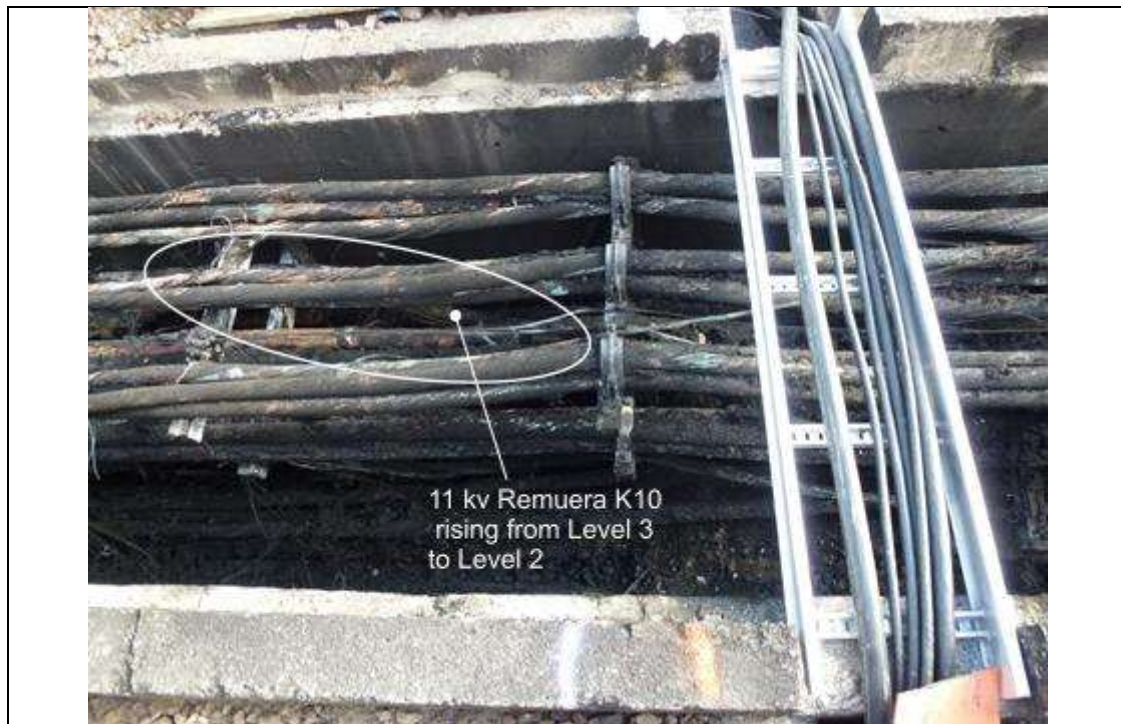
Figure 11 11 kV Remuera K10 cable rising from Level 3 to Level 2

The failed transition joint in Level 2 was confirmed to be in the 11 kV Remuera K10 circuit and connected the three core PILC cable to a three core XLPE cable. The normal position of the cable for the main run through the trench was on Level 3 and for the investigation is designated 3B. The cable was seen to have been raised to Level 2 at 71.5 m and descended again at 81 m, in which length two transition joints had been inserted: the faulted joint at 73 m and an unfaulted joint at 79 m. The cable is seen to be ascending from Level 3 to 2 in Figure 11. (The cable bridge and control cables are new and replace those that suffered fire damage, their location is at 70.5m).

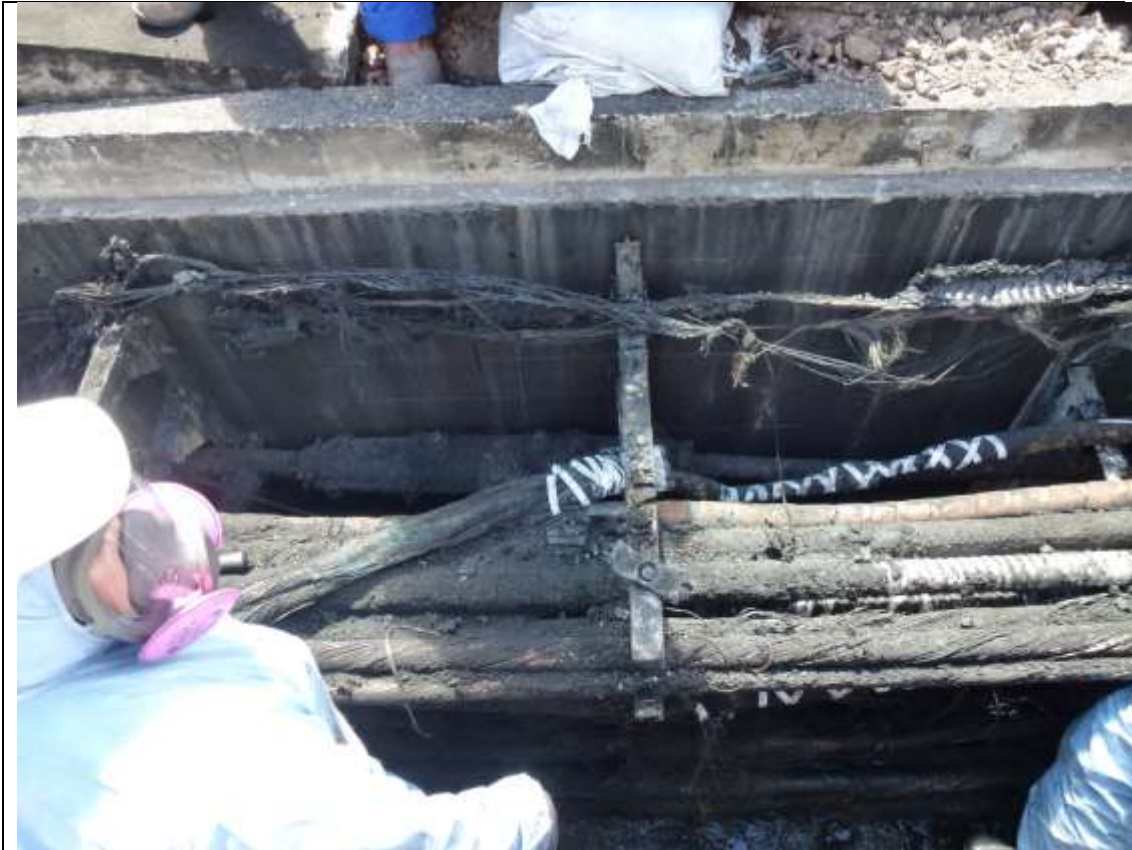
Figure 14 Level 1 cables removed to reveal the failed transition joint on Level 2 and a conventional cast-iron joint below it on Level 3

This revealed the two 2 m long samples containing the failed transition joint at 73 m (Figure 14) and the unfailed joint at 79 m, which were then cut out for dissection in the examination room.

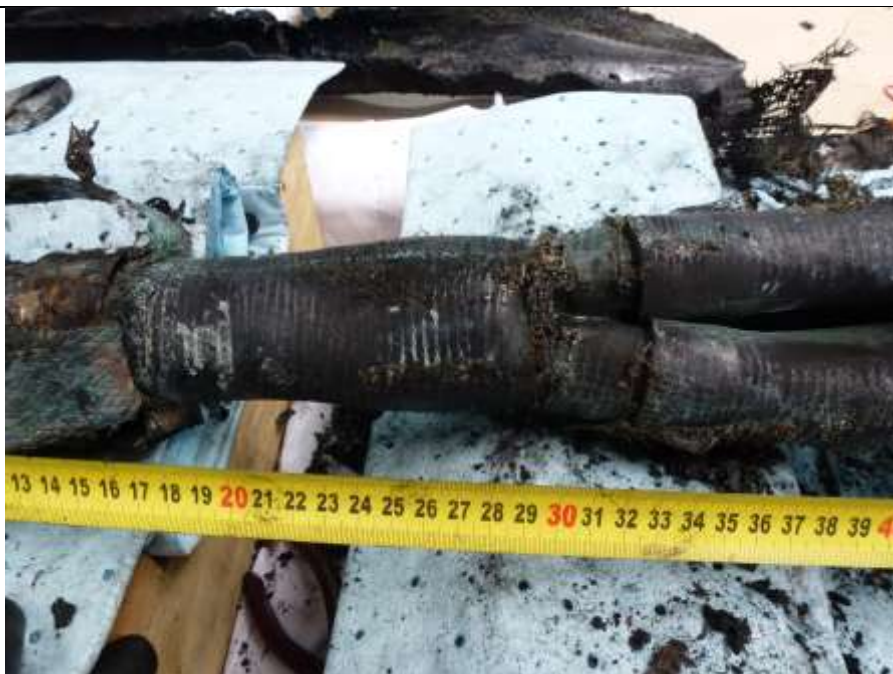
Figure 26 Unfailed joint. The heat shrink 'break-out' covering the PILC crutch

The arc centre-line measurement was transferred to the heat shrink 'break-out' (glove) in the unfailed joint, Figure 26.

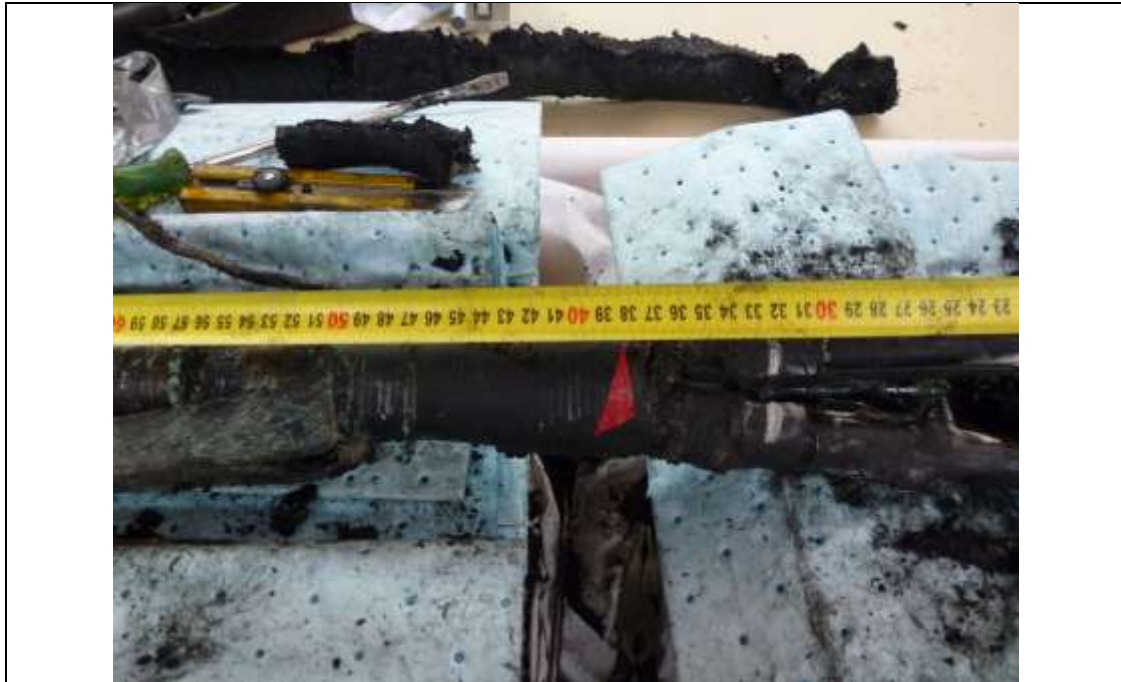
Figure 27 Unfailed joint. Arc centre transferred from failed joint

The arc centre-line was denoted by a red pointer and was found to be within the 'break-out' and close to the exit of the core spouts, Figure 27.

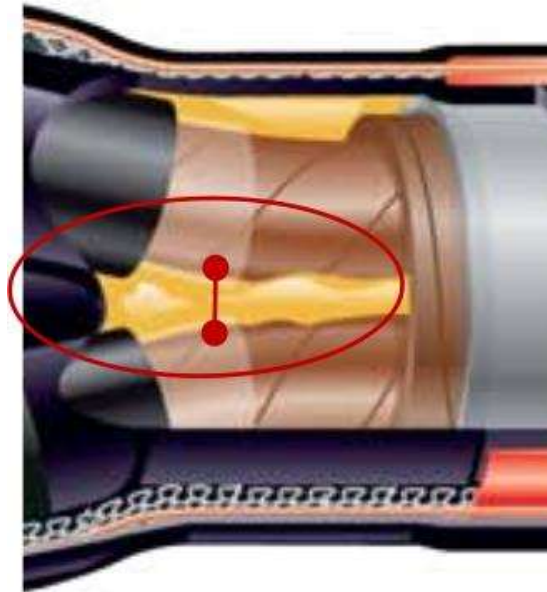
Figure 31 Arc position in the failed transition joint (joint not to scale)

This figure also indicates the position of the arc crater centreline (marked in red) in the failed joint as being 5 mm from the end of the oil barrier tube. However, there are significant uncertainties in the measurement tolerances. Additionally the arc crater had a length of ~62 mm and so it is not possible to know exactly where the electrical fault path that preceded the arc had been. Arc damage tends to move away from the direction of the current feed impelled by electromagnetic forces and so it is probable that the fault path was closer to the belt paper termination at 405 mm or, in the extreme, towards the termination of the lead cut. The lead sheath in the failed joint had been completely melted away so that the position of the arc in relation to the lead cut could not be verified.

The location of the arc and fault positions are shown in Figure 31.

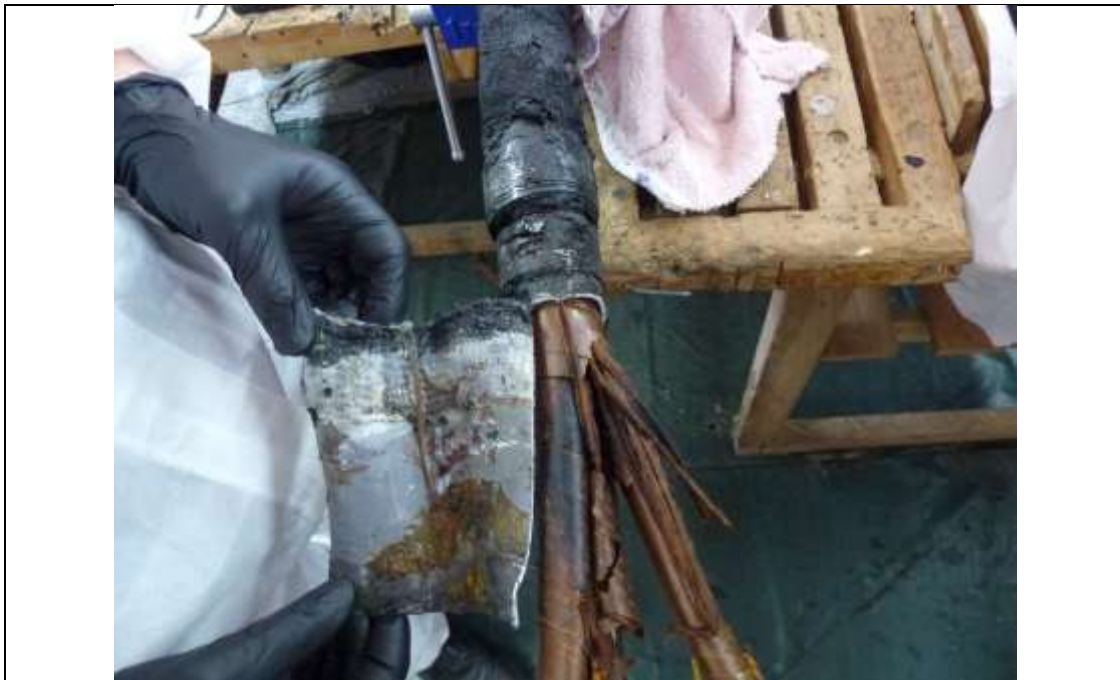
Figure 36 Black feature extends underneath and to the end of lead sheath cut

Figure 36 shows the removed lead sheath being held back in place. The black feature is underneath the lead sheath and is neither centred on the roll spring position (white region) or on the tip of the lead sheath cut (foreground). The black feature does extend however to within 3 mm of the lead cut.

The cores were opened out. The black feature was not present in the jute string filled central interstice or between the contacting flat faces between the core insulation.

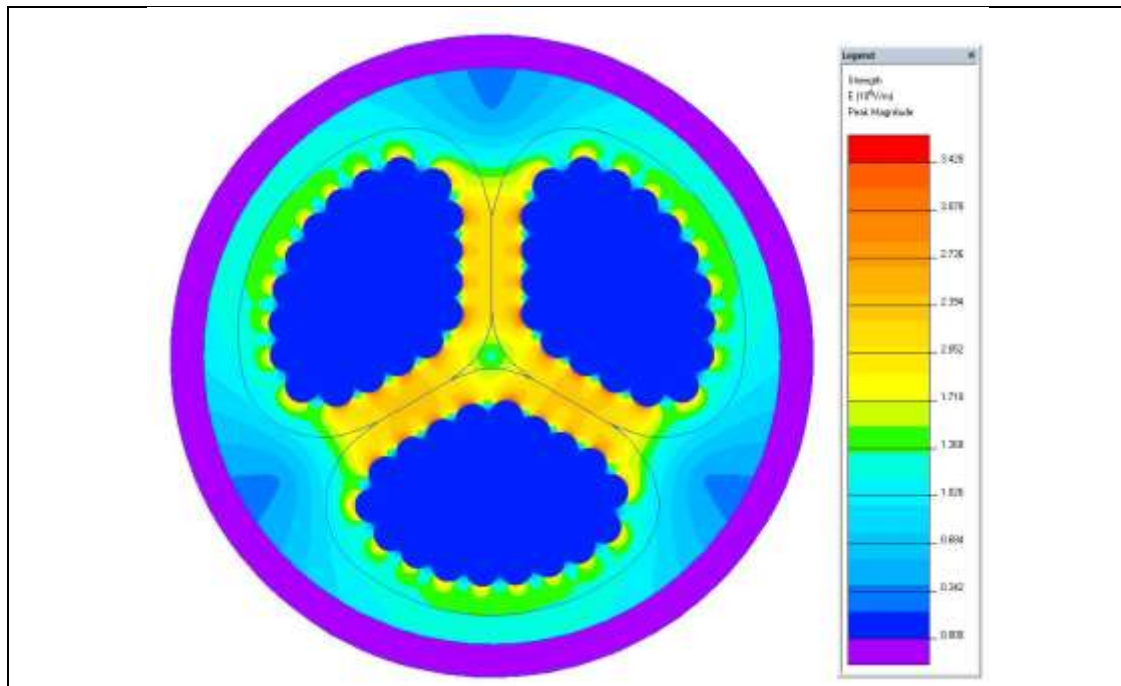
Figure 38 Contour plot of points of maximum stress through a 360° cycle

The stress at every point and every moment in time through the  $360^\circ$  cycle is calculated and displayed and only the maximum values plotted, Figure 38. The values at individual locations are given in Figure 39. The units of stress are

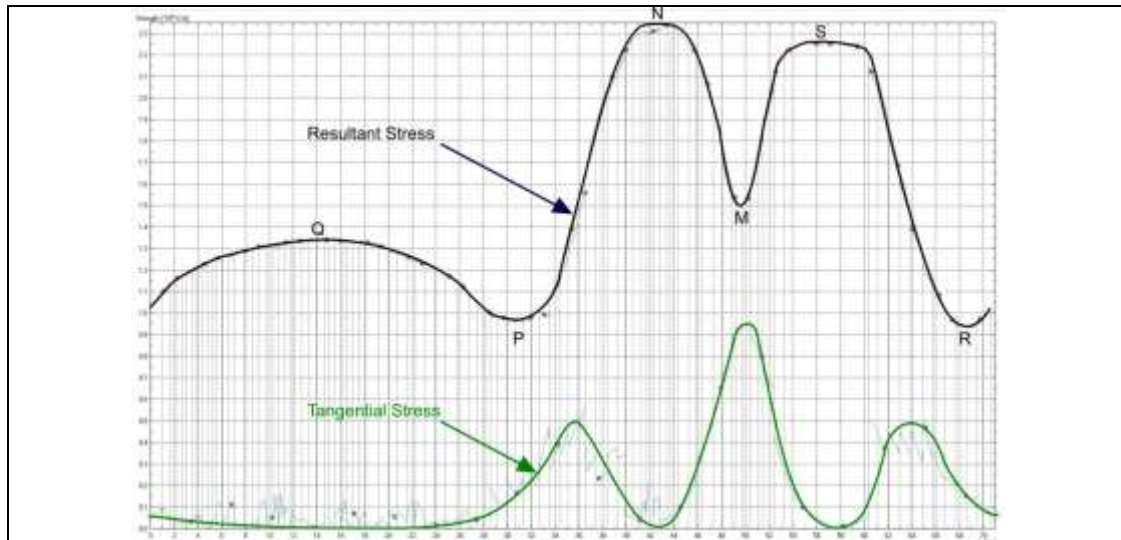
**Figure 40** Resultant and tangential stress around the core surface

Values of the resultant stress around the circumference of the core insulation and of the stress tangential to the surface are given in Figure 40. The peaks of electrical stress are denoted by letters and their geometric positions are shown Figure 39.

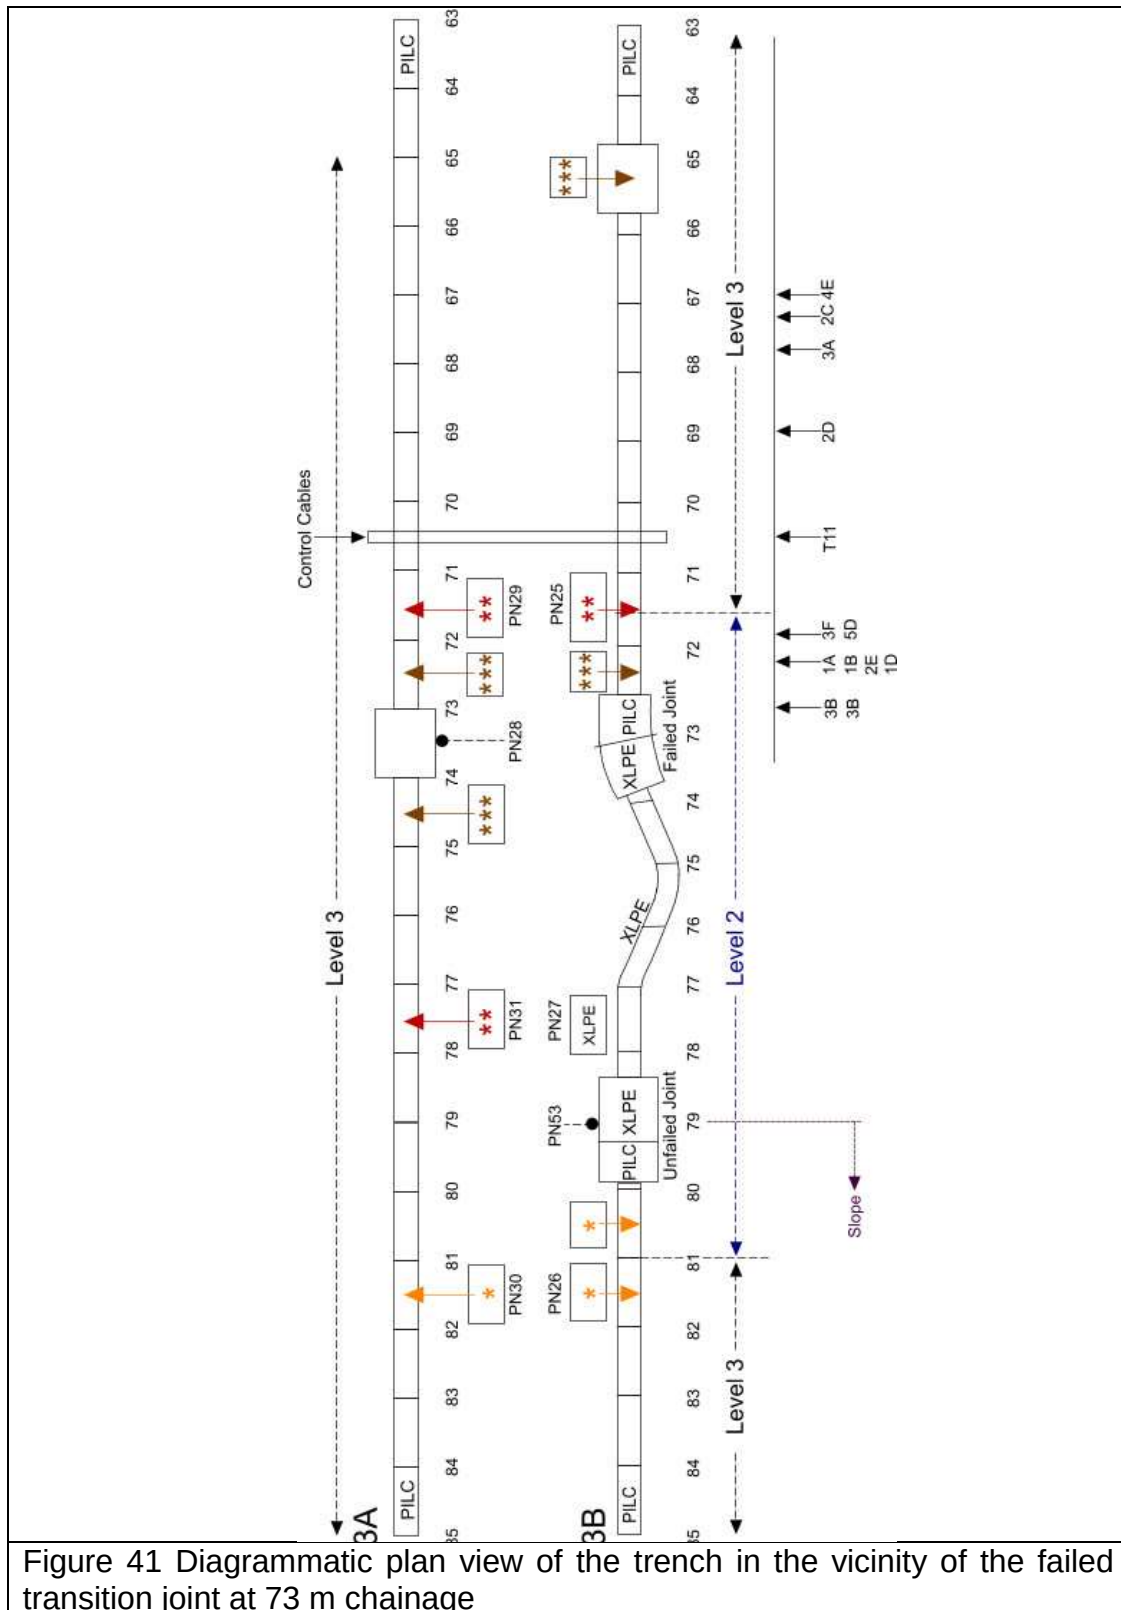
The evidence from the examinations of the joints and cables performed in Penrose and in the UK permitted a plan view to be constructed, Figure 41. The view is of the Remuera K10 3B0 and McNab 3A0 11 kV PILC cables.

Figure 41 shows the length of trench from 63 m to 85 m. All but one of the electrical fault holes are located between 67 m and 73 m:

- McNab K02, 11 kV PILC cable, which remains in its position, 3A0, on Level 3 next to the North wall throughout the length of the trench.
- 11 kV Remuera K10, 11 kV PILC cable, which, from zero metre chainage, runs on Level 3 immediately adjacent to 3A0. At 71.5 m chainage it rises from Level 2 to Level 3, (note that its designation is not changed). At 73 m (centre-line) the failed transition joint was located on Level 3 between cables 2A and 2B. At this position the failed transition joint connected the three core PILC cable to a three core XLPE cable.

It was interpreted that the bowed shape in Remuera K10, Figure 41 and Figure 42 had resulted from the replacement in 2001 of the cast iron joint at ~ 78-79 m in 3B0, which involved:

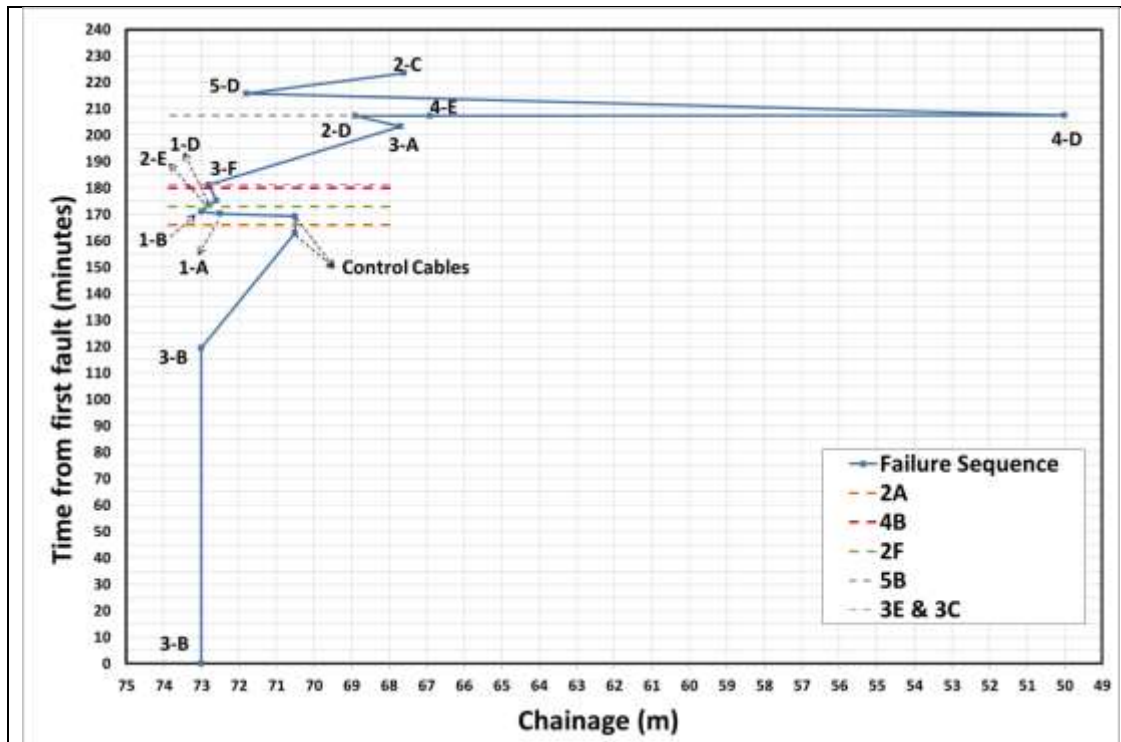
Figure 43 Fault sequence: Elapsed fault times versus their position in trench

The time sequence of each cable incident is shown in the graph in Figure 43, which plots elapsed time in minutes after the first fault at 23:21:30 versus the chainage position in the cable trench.

Nineteen cable incidents (faults and alarm/pilot signals) occurred over a length from 73 m to 50 m by the time the last tripping occurred at 223.48 minutes after the first fault when 11 kV PILC McNab K19 tripped. This was 104.17 minutes after the reclosure onto the first fault. The incidents occurred in three overlapping 'windows' as defined by the following 'length-time' co-ordinates:

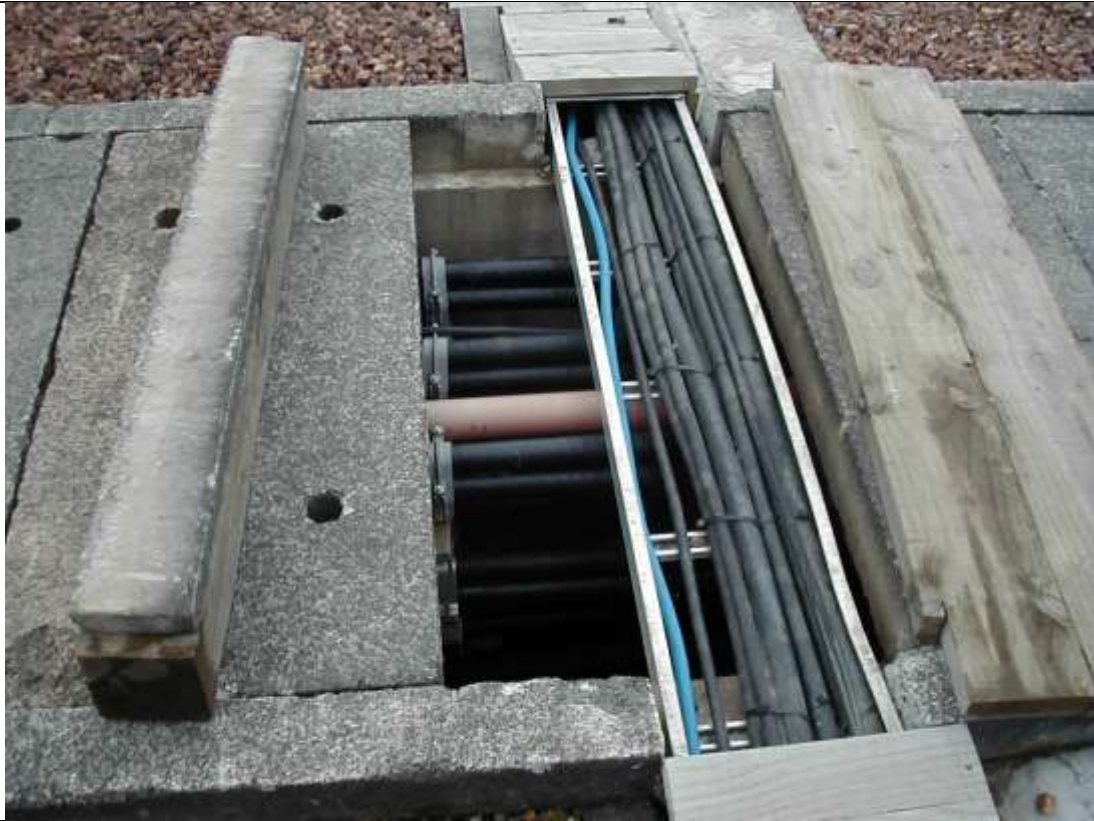
Figure 44 Control cable bridge at 70.5 m (photo taken in 2001)

Occurred 43.67 min after the second trip. An alarm signal was received from the low voltage control cables for transformer T11 that crossed a cable bridge between the concrete cover tiles that passed over the trench at 70.5 m; 1.5 m to the East of the centre of the failed joint 3B0 and 650 mm from its end. The timber covered metal bridge had no floor, Figure 44, and supported the control cables on lateral metal hangers. Thus the control cables were exposed to the heat and their insulation would have been degraded and melted by the hot air and flames from the transition joint and surrounding cables. It is possible that the increased supply of air through the bridge drew the fire into an eastwards direction.

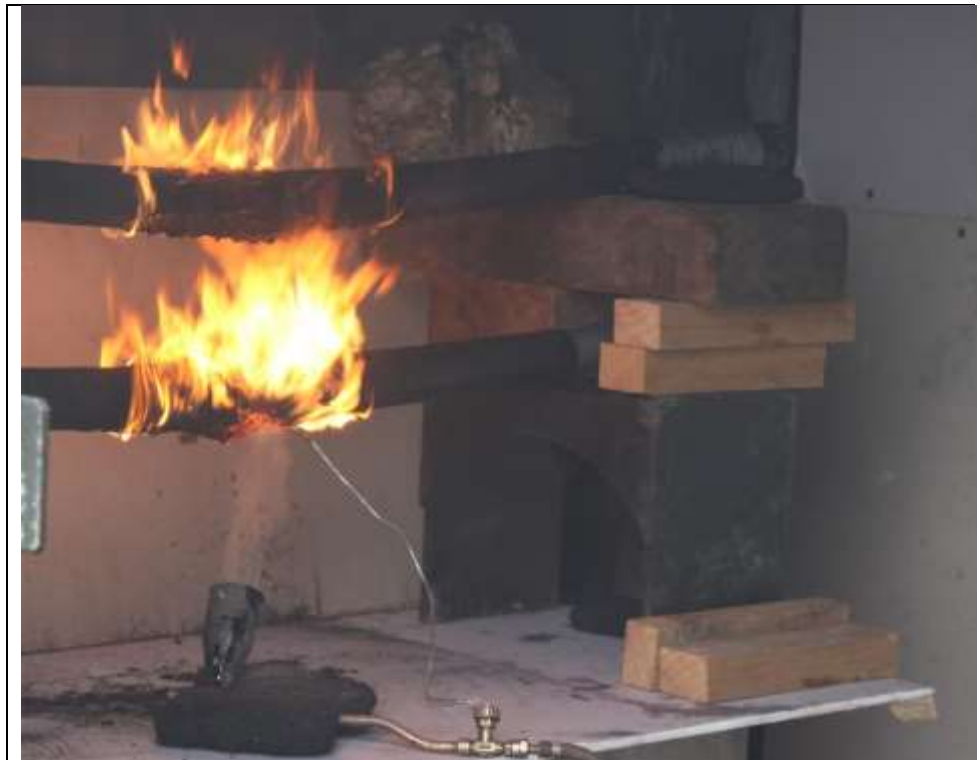
Figure 45 33 kV XLPE cables: ignition of two cables

- b. In the cable trench the fire transferred progressively to all the cables except some of those on the floor. Figure 45 visualises how flames and radiated heat transfer fire to a parallel cable. Significant heat input was required to reach a condition which would sustain this fire.

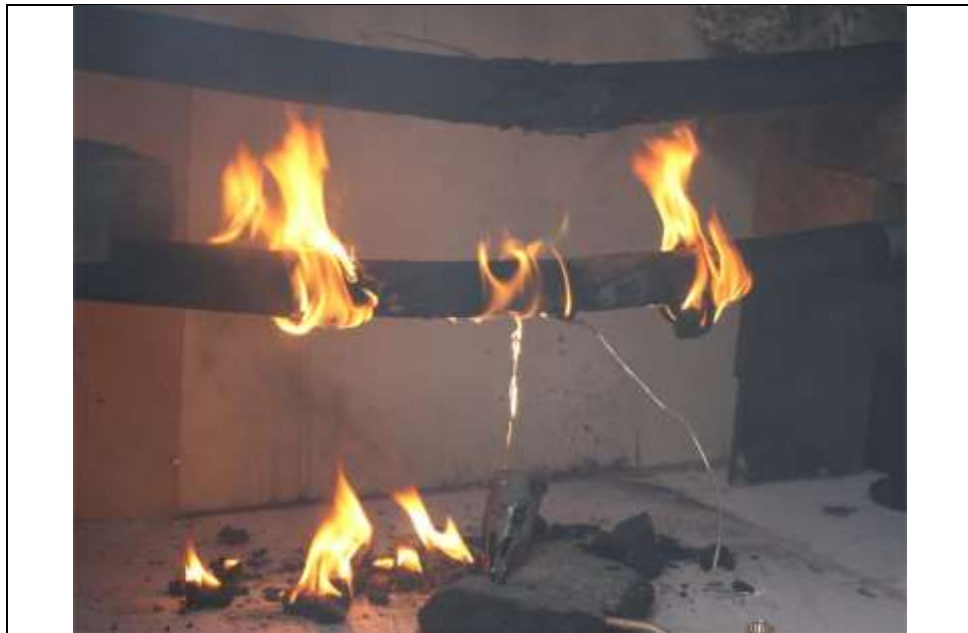
Figure 46 33 kV XLPE cable: flame propagating and PE dropping

- c. In the cable trench the flames propagated long distances in both directions. Figure 46 shows flame starting to propagate along the PE/PVC oversheath of a single core 33 kV XLPE cable after the heat source in Figure 45 had been removed.

It is seen that the flames on the parallel cable had not self-sustained and have extinguished.

Portions of burning, partially combusted oversheath have dripped and dropped off the cable onto the floor. Evidence was found in the cable trench that this had spread fire to the cable circuits below. Curtains of i) dripping PE/XLPE were found underneath some of the less severely combusted oversheaths and ii) dripping hydrocarbon compound was found underneath some of the PILC cables from which the lead sheath had melted, but which were still mechanically contained within their double steel armour tapes.

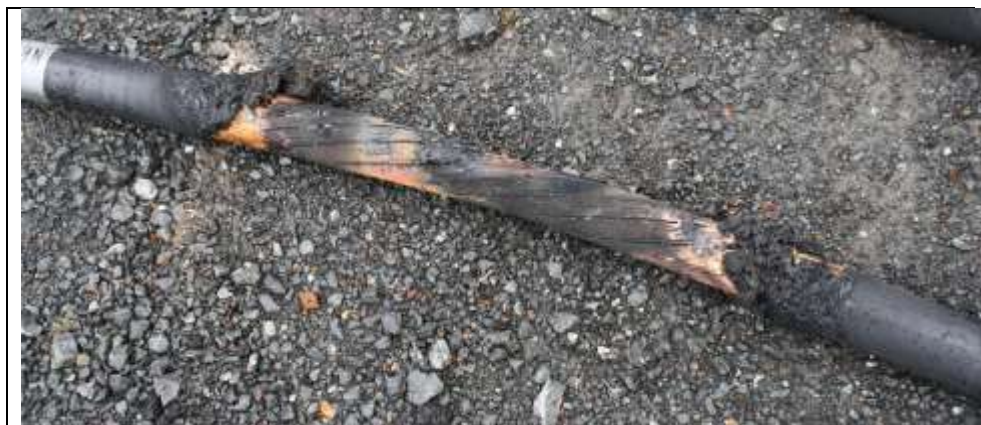
Figure 47 33 kV XLPE cable: oversheath combusted

Figure 47 shows that the oversheath of the Figure 46 sample had been combusted to expose the copper wire screen. The extruded XLPE core, also combustible, is visible between the wires.

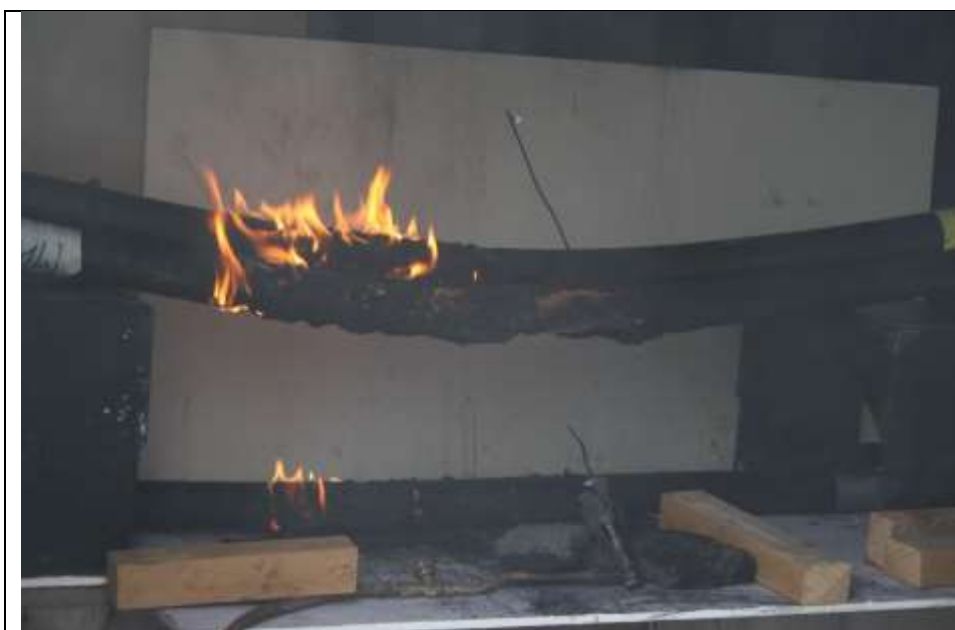
Figure 48 33 kV XLPE trefoil group: flame is sustained

- e. In the cable trench a circuit of 33 kV XLPE single core cables in trefoil formation was present above the failed transition joint. This standard configuration geometrically concentrates both a volume of combustible material and an increased surface area available to absorb heat and to contribute flammable gasses. The volume of combustible material in a trefoil group of 33 kV 400 mm<sup>2</sup> XLPE cable was measured to be 4.7 L/m. Figure 48 visualises the ignition and flame propagation of a trefoil cable group after the heat source has been removed.

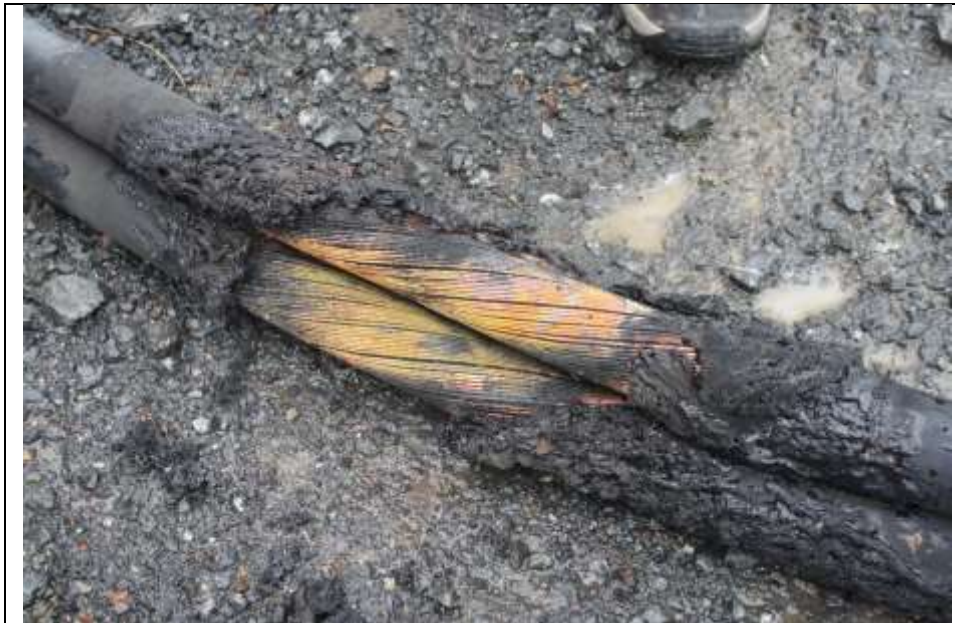
Figure 49 33 kV XLPE trefoil group: oversheath combusted

Figure 49 shows the trefoil group after the flame was extinguished. The oversheath comprising an outer layer of PE and inner layer of PVC had been combusted to expose the copper wire screen. On the extreme left of the photograph the oversheath has a matt appearance

indicative of char. The presence of char is specified in the IEC type approval test as a measure for the distance flame has propagated when assessing the performance of a fire performance oversheath. It was used in the investigation to assess how far the fire had propagated along the trench.

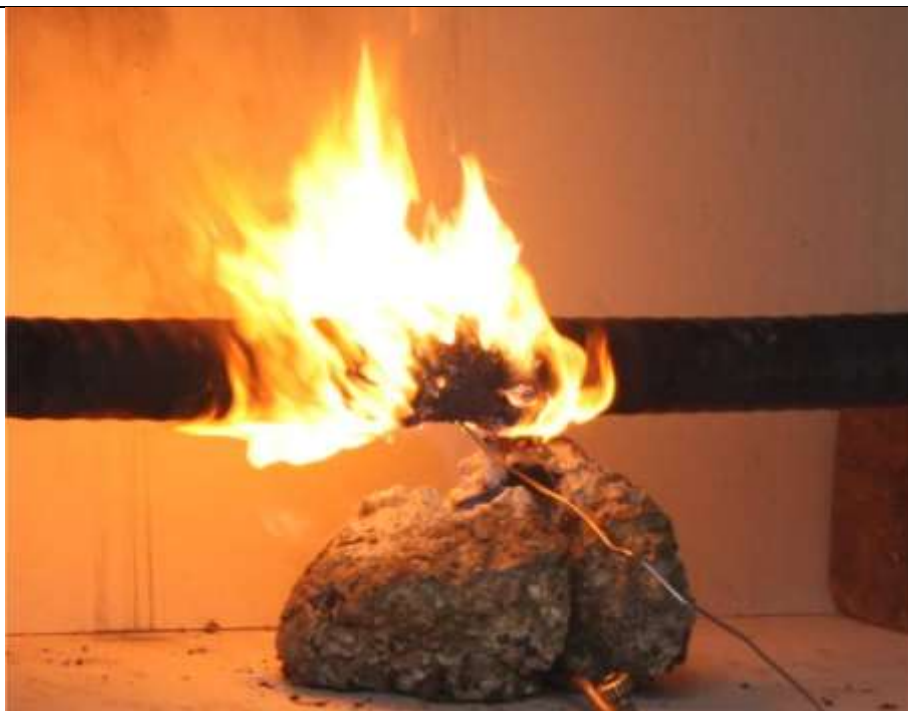
Figure 50 33 kV OF cable: PVC sheath and oil burning

- f. Qualitative fire trials performed on a PVC oversheathed 33 kV OF cable, Figure 50, demonstrated that a significant level of heat was required to ignite the PVC sheath. However, this level also melted the aluminium sheath. It is probable that cable oil leaked from the non-pressurised sample and contributed to the size of the flame. In the cable trench the aluminium sheaths along the majority of their lengths had remained intact. This trial visualised those locations of intense fire in the trench where the aluminium sheath had been melted and ruptured. Figure 51 shows the burnt PVC oversheath, the anti-corrosive bitumen layer and the aluminium sheath, exposed and melted.

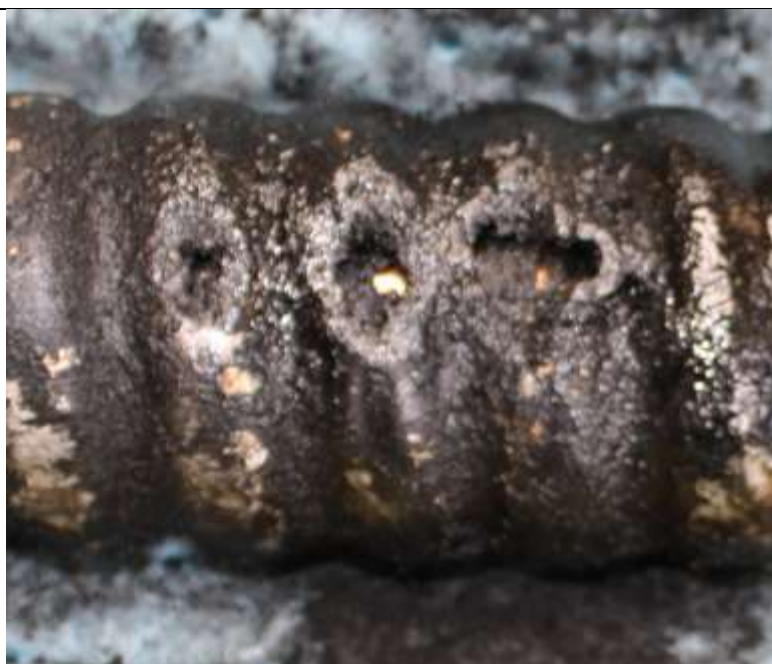
Eventually either the external fire or an internal cable fault and arc breached the aluminium sheath of the OF cable as shown in Figure 87. The increased intensity of the fire damage seen in this trench region is attributed to the release of cable oil and spread of fire. Smaller holes were found to have been melted in the aluminium sheath of 2D0 close to the fault hole as shown in Figure 53.

Figure 53 Holes in OF cable aluminium sheath, cable 2D0 at 66-71m
