# Penrose substation fire inquiry report

9 November 2015

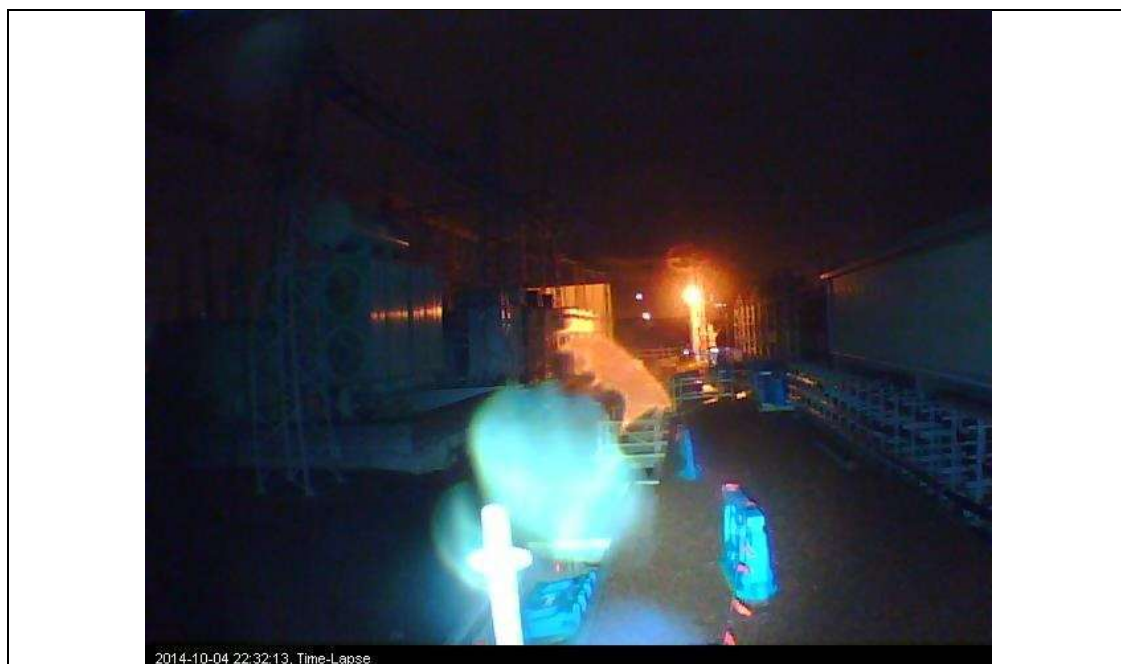
Figure 55 CCTV at 23:32:13, 10.72 m after 1<sup>st</sup> fault: sharp reflections off T11 side and expansion tank and off side of T10

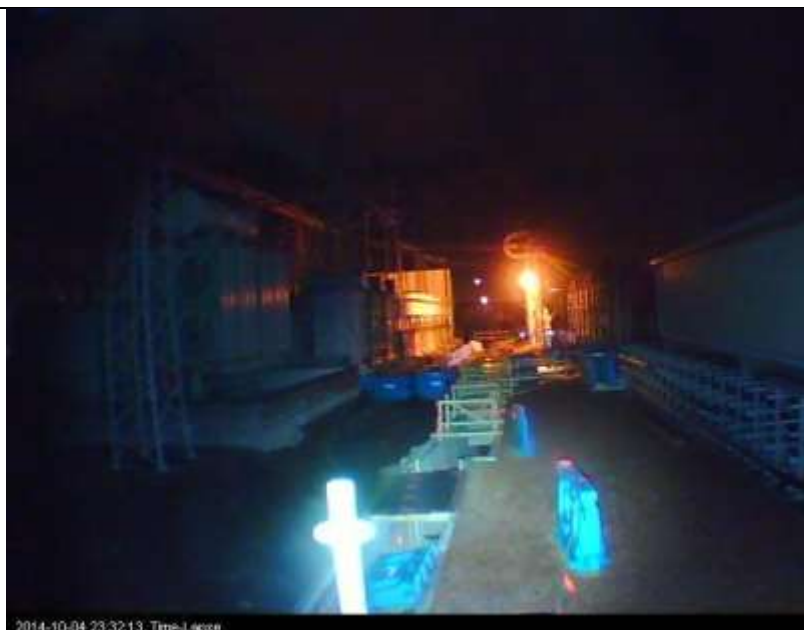
The observations in Table 9 for Figure 56 show that smoke had obscured both clarity of view and some of the reflections from the Switchyard lights on the sides of the T11 and T10 transformers at 70.72 minutes after the first fault and 48.60 minutes before the second fault occurred. This indicates that some degree of combustion had occurred after the first fault and that fire was in progress.

Figure 56 CCTV at 00:32:13, 70.72 m after 1<sup>st</sup> fault: view of T11 and T10 become obscured. Reflection on T10 obscured view of reflection obscured dull reflection off T11

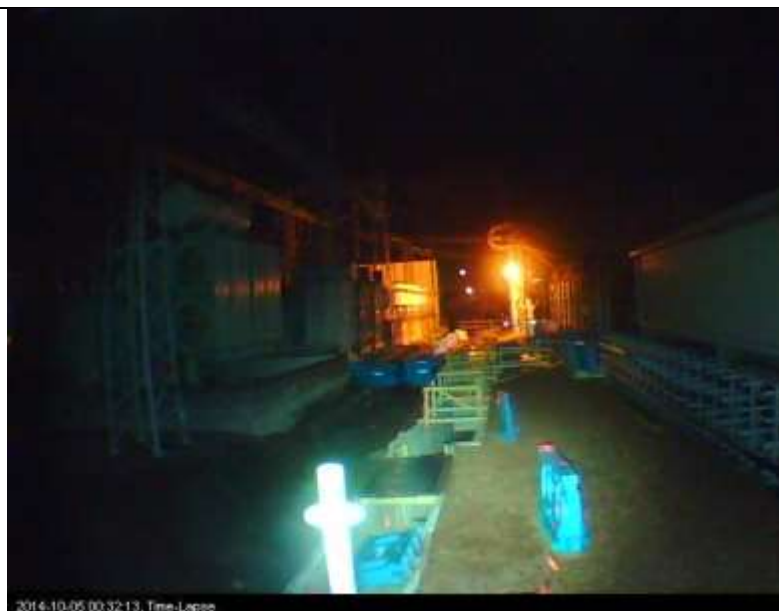
There was further loss of light transmission at 130.72 minutes, Figure 57, some 11.40 minutes after the reclose onto the fault. No evidence of light from the fire or of dense smoke could yet be seen.

Figure 57 CCTV at 01:32:13, 130.72 m after 1<sup>st</sup> fault, 11.4m after 2<sup>nd</sup>: general green haze

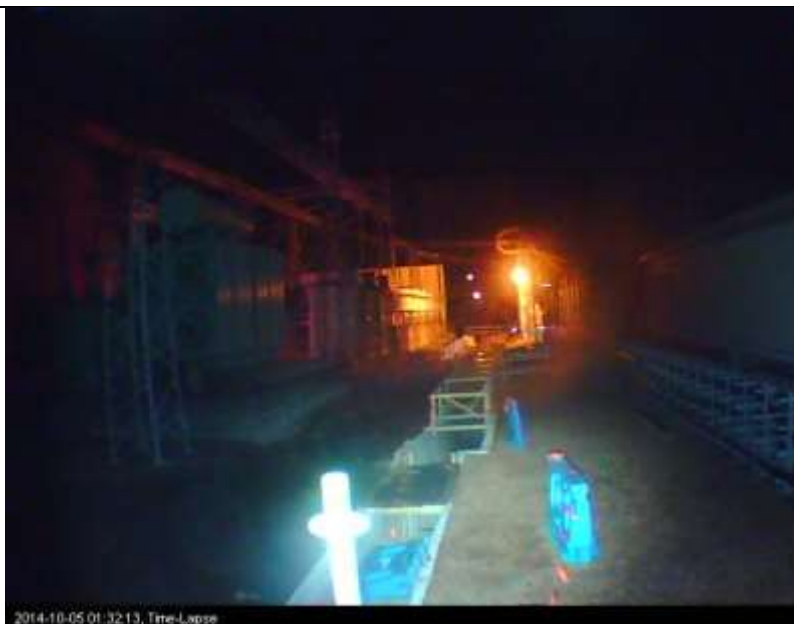
At 190.72 minutes after the first fault and 71.40 minutes after the second, Figure 58 there was clear evidence of i) light reflected from the region of the cable trench that passed between T11 and T10, this being in the general region of the faulted transition joint, 3B0, at 73 m and 2) of a smoke cloud. The fault sequence in Figure 43 shows that the cable failures had been localised around 73 m chainage and were the moving eastwards towards Gavin Street.

**Figure 58** CCTV at 02:32:13, 190.72 m after 1<sup>st</sup> fault, 71.4m after 2<sup>nd</sup>: mauve light reflections of fire between and above T11 and T10. Halo of smoke.

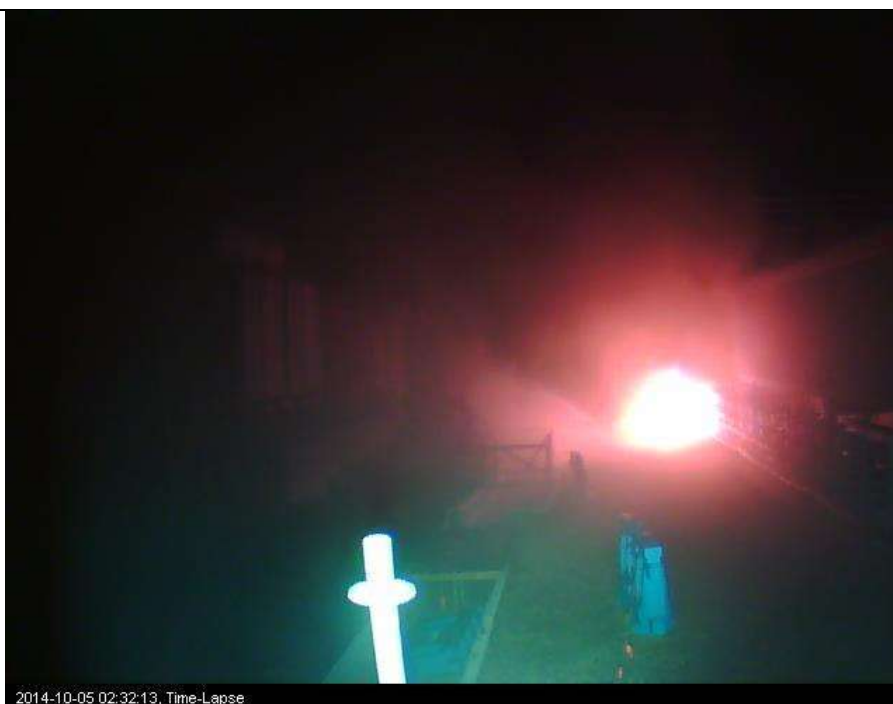
Figure 59 shows that at 250.72 minutes the fire had emerged out of the exit of West end of the trench and was close to reaching the corner of the 33 kV Switchroom. The field of view contains dense smoke. The fire had already travelled preferentially 23m to the East of the faulted transition joint towards Gavin Street and the last cable, 11 kV PILC McNab K19, 2C0, had already faulted at 223.48 minutes after the first fault.

**Figure 59** CCTV at 02:32:13, 250.72 m after 1<sup>st</sup> fault, 131.4m after 2<sup>nd</sup>: Free fire from trench exit close to 33 kV Switchroom corner. Dense smoke

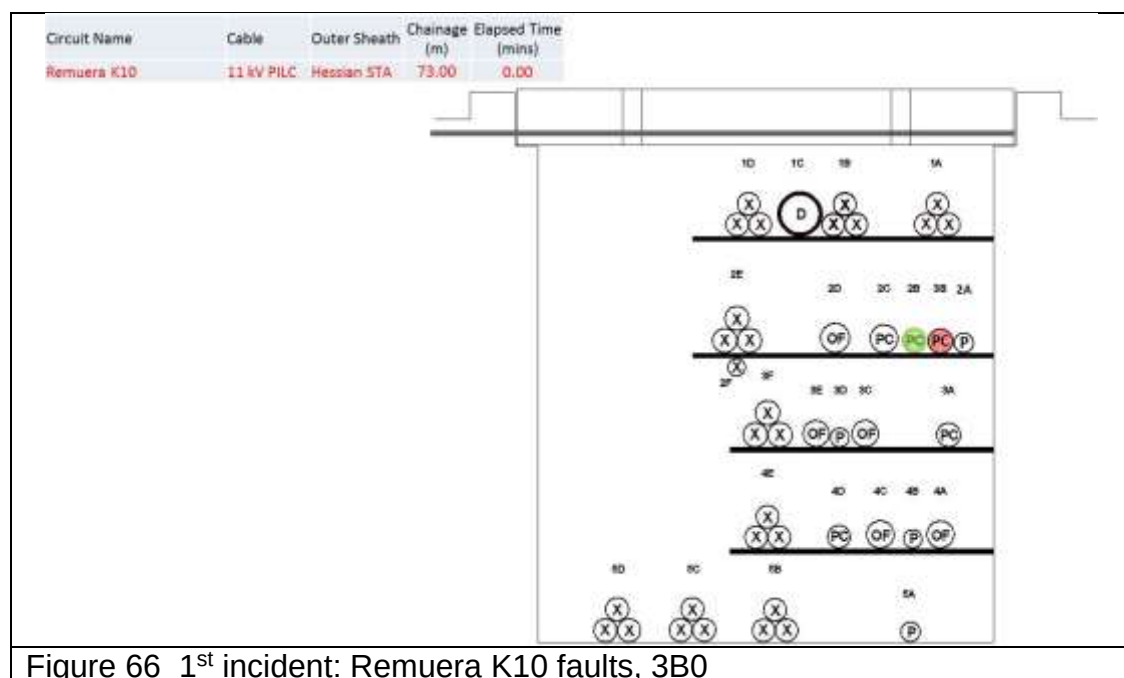
Figure 66 1<sup>st</sup> incident: Remuera K10 faults, 3B0

**1st Cable Incident, 3B0, Diagram in Figure 66**

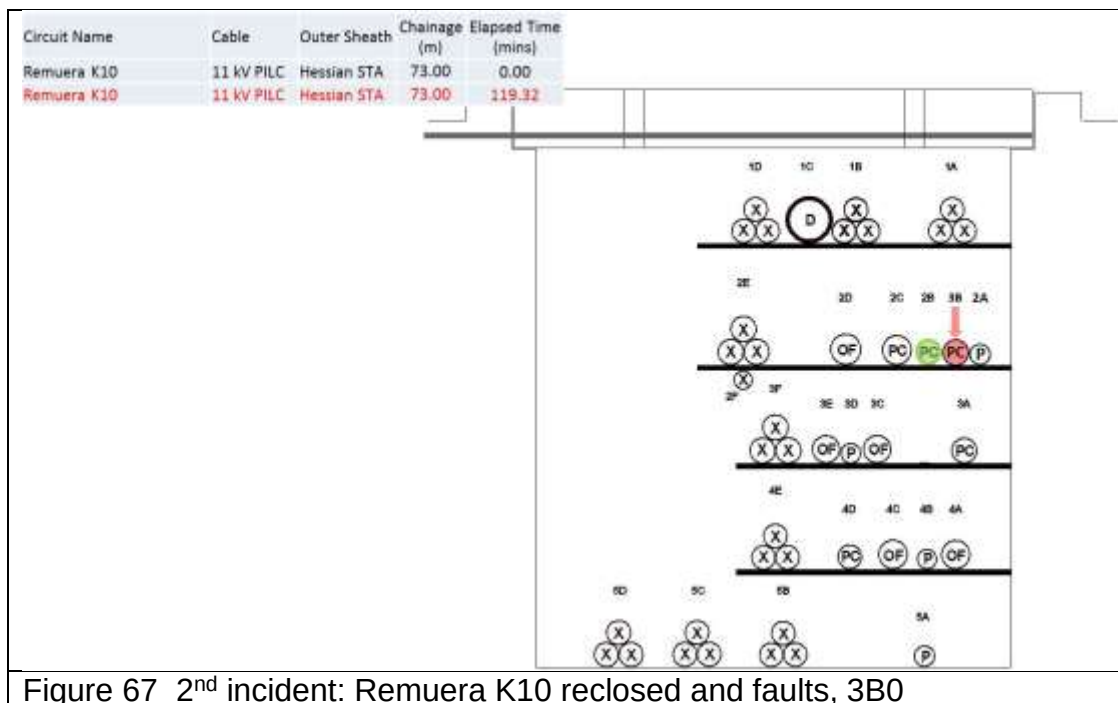
Figure 67 2<sup>nd</sup> incident: Remuera K10 reclosed and faults, 3B0

Occurred 119.32 min after the first trip. The Remuera K10 failed PILC to XLPE transition joint, faulted electrically for a second time when the circuit breaker was reclosed. The fault was at the same position in the transition joint 3B0 at 73 m chainage on Level 2. The arc crater in the conductors, Figure 68, is common to the first and second faults, which are indistinguishable.

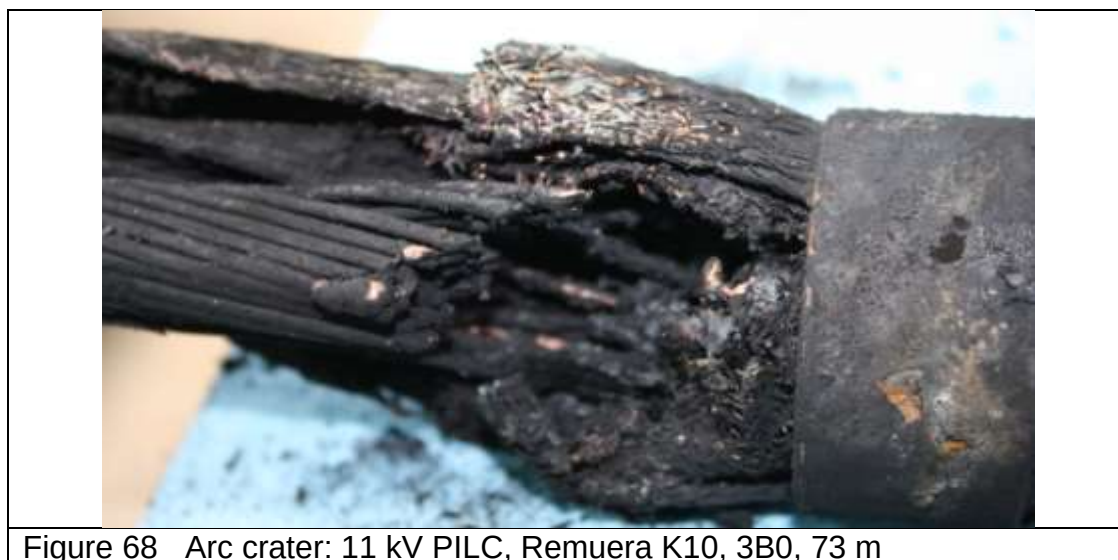
Figure 68 Arc crater: 11 kV PILC, Remuera K10, 3B0, 73 m

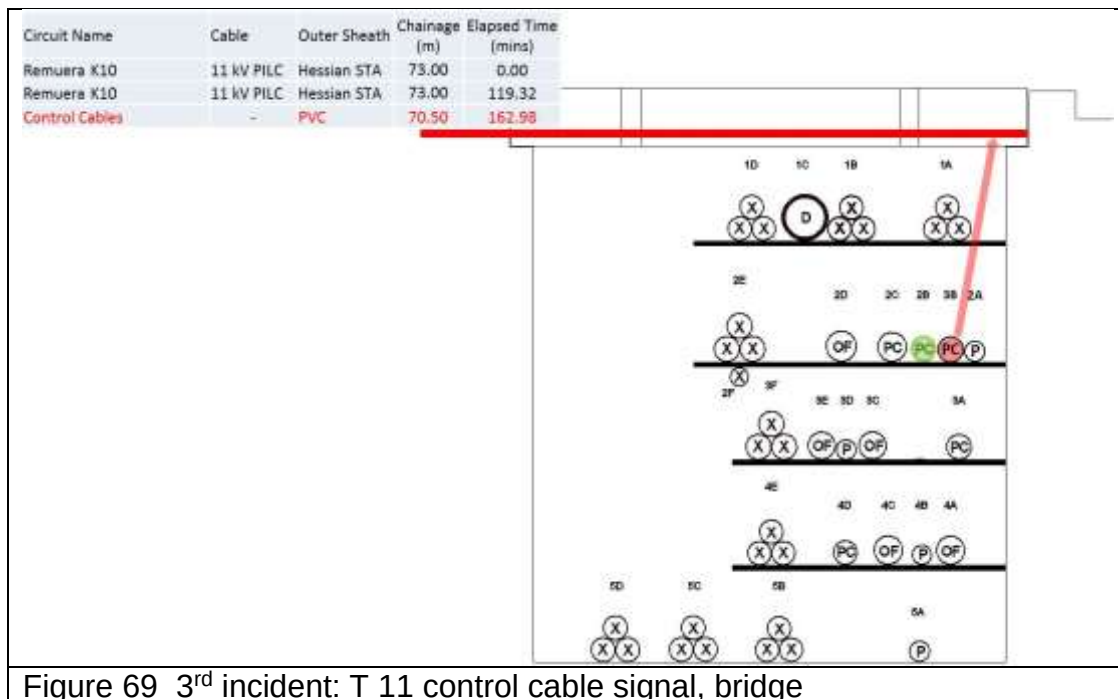
Figure 69 3<sup>rd</sup> incident: T 11 control cable signal, bridge

Occurred 43.67 min after the second trip. An alarm signal was received from the low voltage control cables for transformer T11 that crossed a cable bridge between the concrete cover tiles that passed over the trench at 70.5 m; 1.5 m to the East of the centre of the failed joint 3B0 and 650 mm from its end. The timber covered metal bridge had no floor, Figure 44, and supported the control cables on lateral metal hangers. Thus the control cables were exposed to the heat and their insulation would have been degraded and melted by the hot air and flames from the transition joint and surrounding cables. It is possible that the increased supply of air through the bridge drew the fire into an eastwards direction.

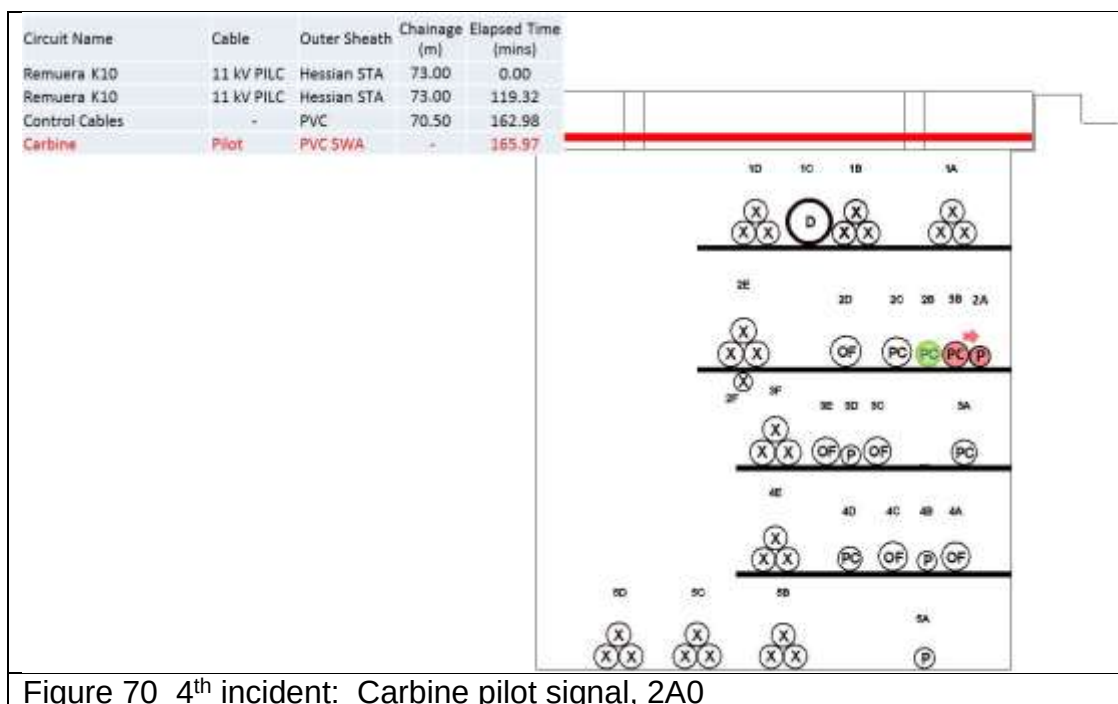
Figure 70 4<sup>th</sup> incident: Carbine pilot signal, 2A0

Occurred 2.98 min later. A differential protection blocked signal was received from the Carbine pilot cable, 2A0, which is adjacent to the failed joint on Level 2. This signal indicated fire damage had been caused to the pilot cable.

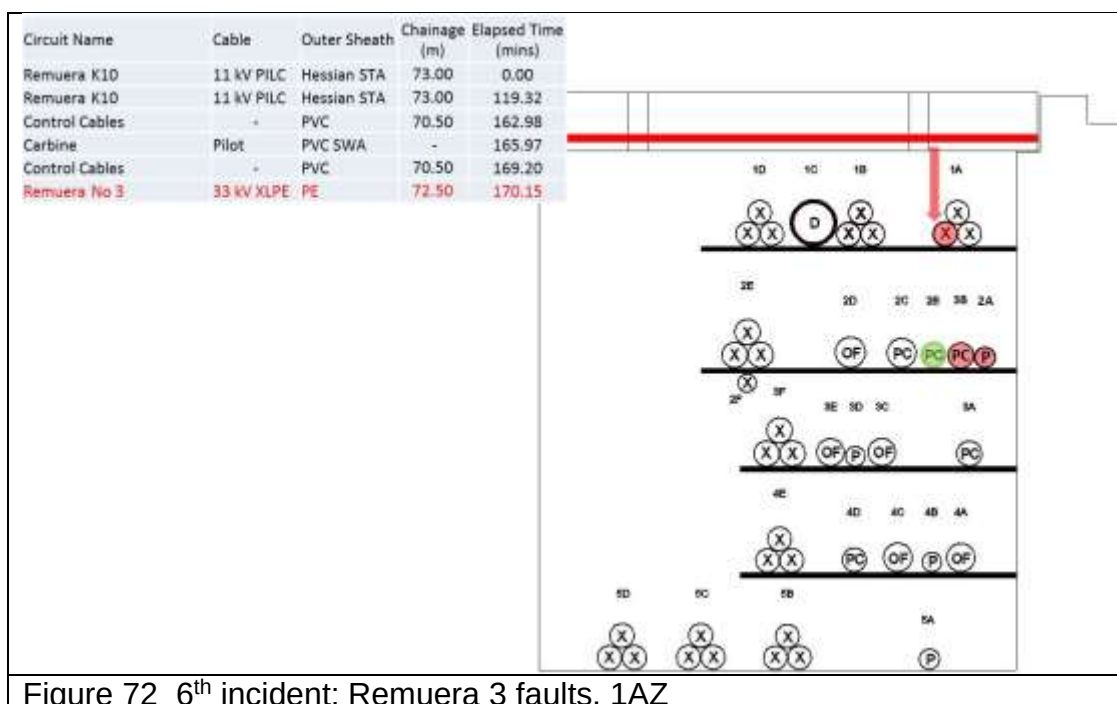
Figure 72 6<sup>th</sup> incident: Remuera 3 faults, 1AZ

Occurred 0.95 minutes later. 33 kV Remuera 3, 1AZ, XLPE cable at 72.5 m, faulted and tripped. The fault position (denoted by power arc burning to the metallic components) was located approximately 0.5 m east of the centre of joint 3B). The arc crater is shown in Figure 73. This is still in the immediate vicinity of the transition joint as the joint was 1800 mm long, extending 850mm from its centre on the PILC side and 950mm from its centre on the XLPE side.

This group of three XLPE cables was cleated in trefoil formation to the Level 1 support arm immediately above the failed joint. The group would have been heated directly by flames and hot air for 50.83 minutes after the second arc and 170.15 minutes after the first arc. The XLPE cables had therefore taken a comparatively long time to be thermally degraded to a condition in which electrical failure of the insulation occurred.

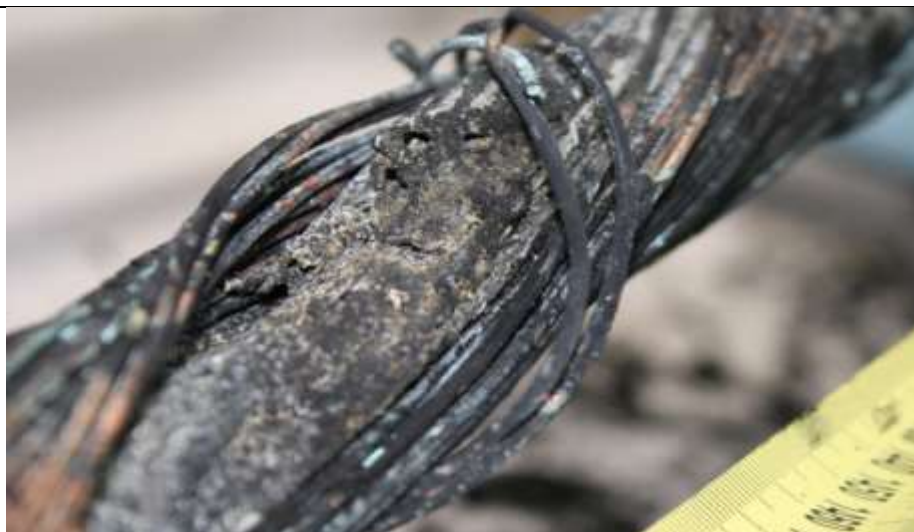
Figure 73 Arc crater: 33 kV XLPE, Remuera 3, 1AZ, 72.5 m

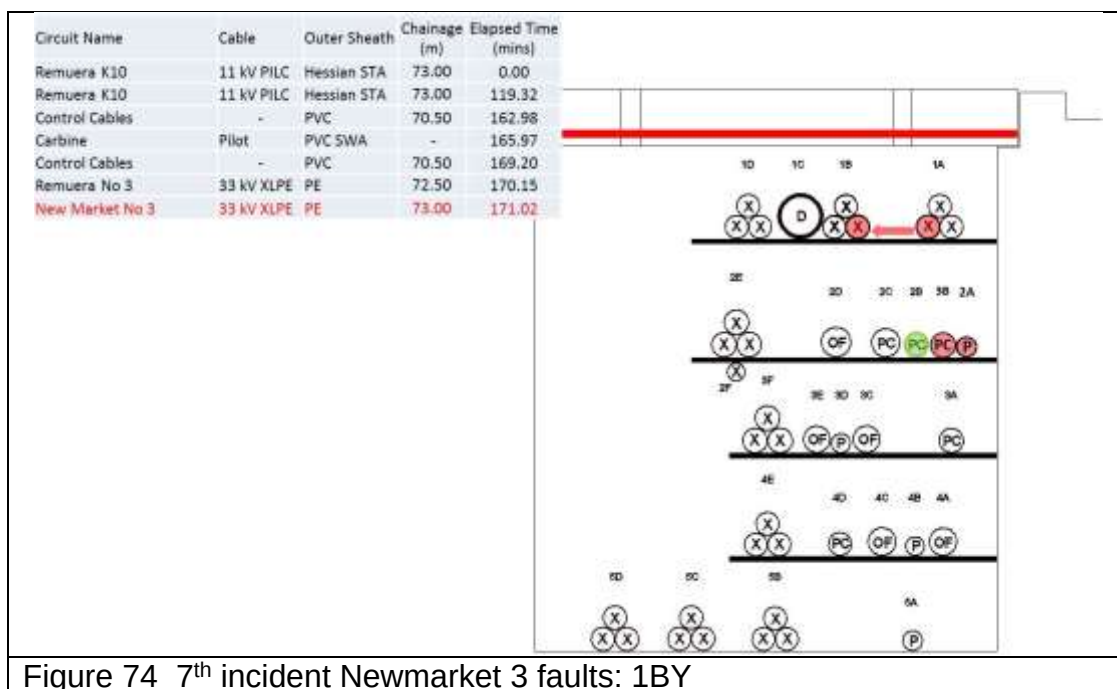
Figure 74 7<sup>th</sup> incident Newmarket 3 faults: 1BY

Occurred 0.87 minutes later. 33 kV Newmarket 3, 1BY, XLPE cables, faulted and tripped. This cable is next to the previous cable 1AY to have tripped and is above the transition joint 3B0. The arc crater is shown in Figure 75.

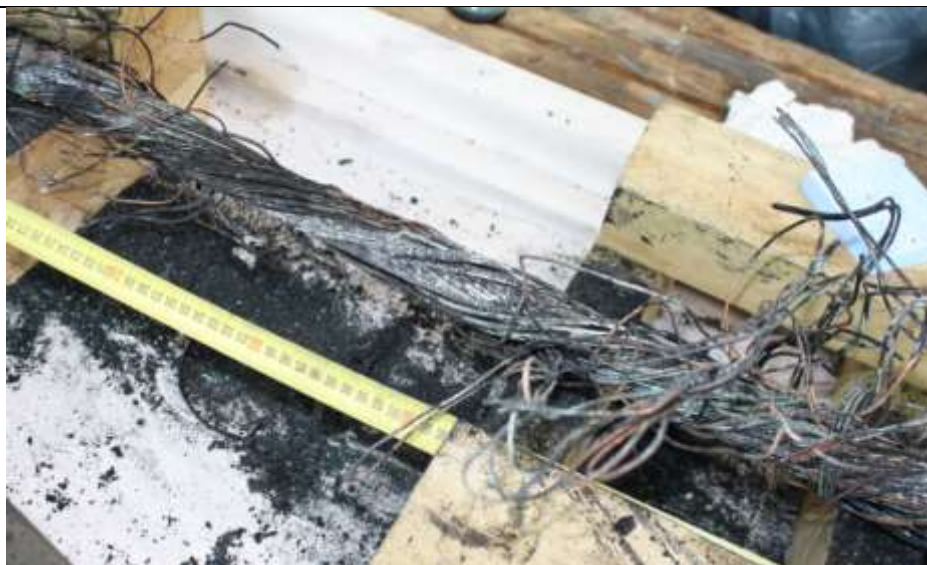
Figure 75 Arc crater: 33 kV XLPE, Newmarket 3, 1B, 73 m, Y Phase

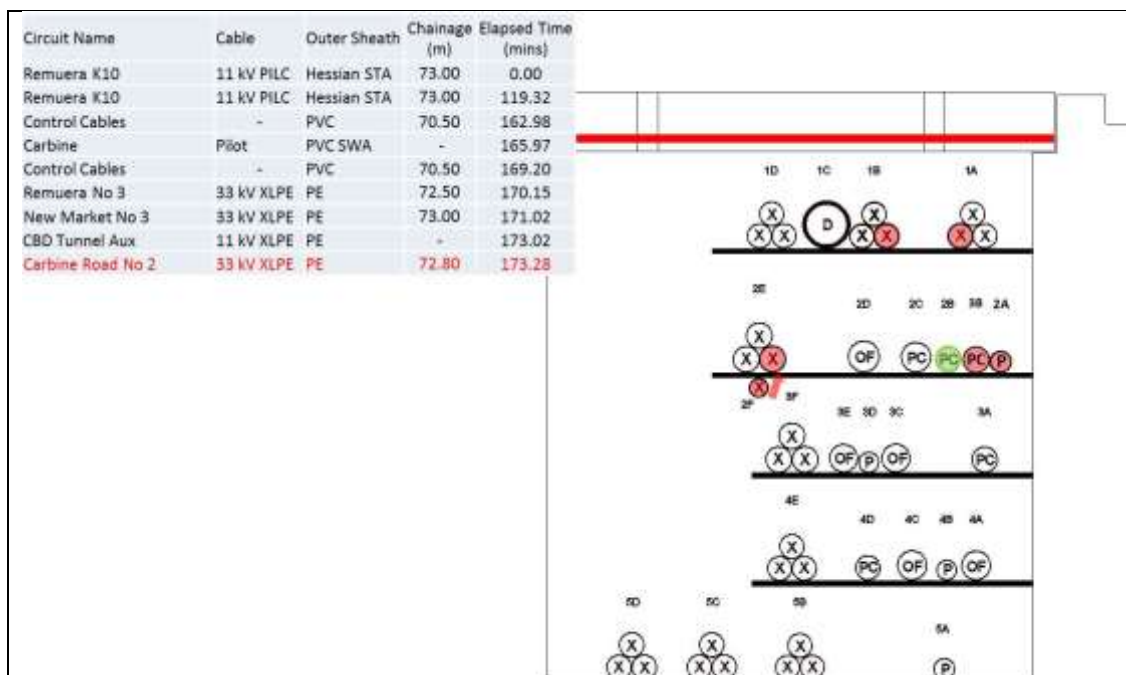
Figure 77 9<sup>th</sup> incident: Carbine Road 2 faults, 2EY

Occurred 0.27 minutes later. 33 kV Carbine Road 2, 2EY, XLPE cables at 72.8 m, faulted and tripped. The arc crater is shown in Figure 78. It is likely that the PVC duct 1C and XLPE cable 1D were alight and that burning polymer had fallen onto 2E below in Level 2.

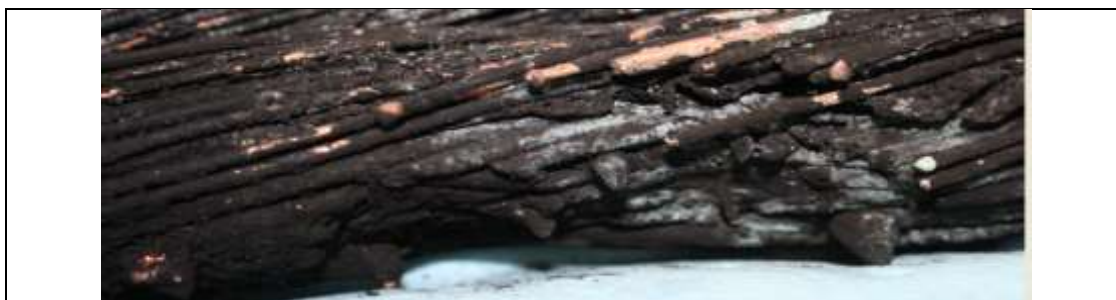
Figure 78 Arc crater: 33 kV XLPE, Carbine Road 2, 2EY, 72.8 m

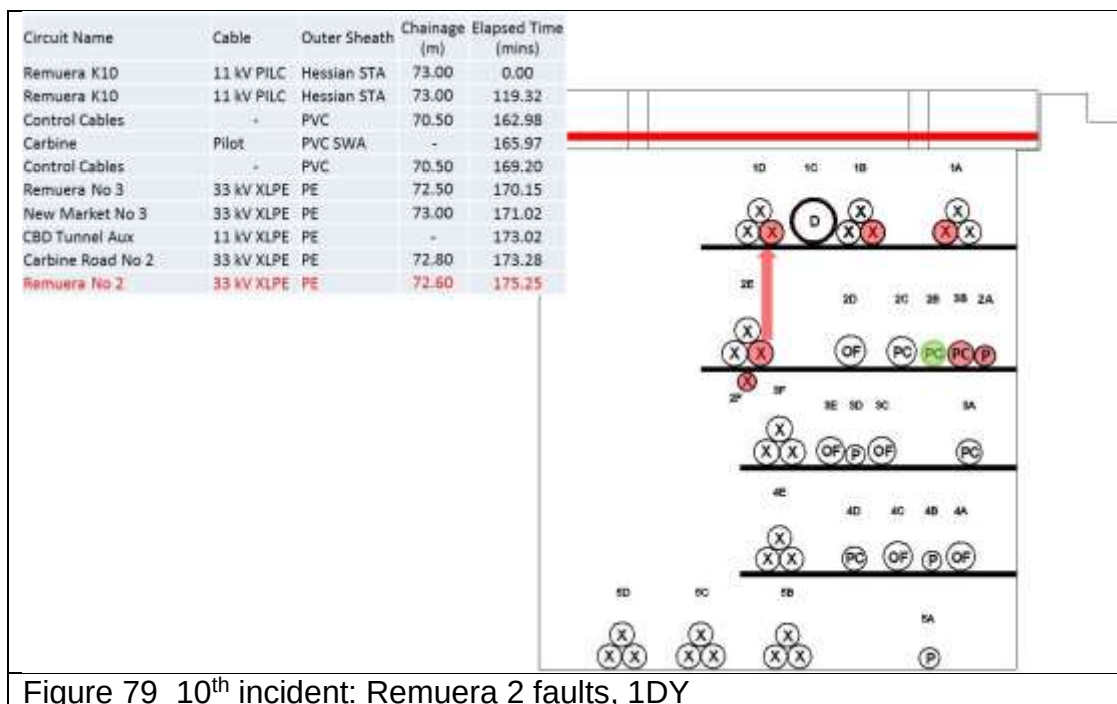
Figure 79 10<sup>th</sup> incident: Remuera 2 faults, 1DY

Occurred 1.97 minutes later. 33 kV Remuera 2, 1DY, XLPE cable at 72.6 m, faulted and tripped. The arc crater is shown in Figure 80. It is likely that fire had spread across the top row from 1A to 1B to 1C and then 1D. 2E below had faulted 2 minutes before and this would have accelerated its demise.

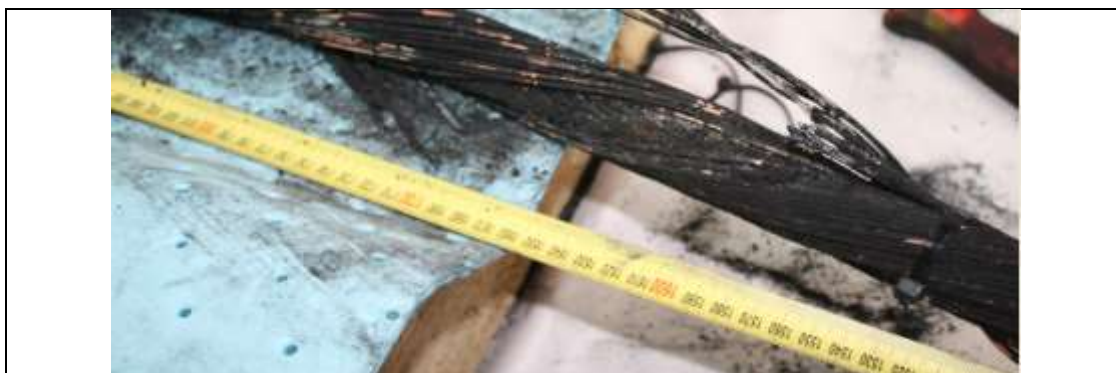
Figure 80 Arc crater: 33 kV XLPE, Remuera 2, 1DY, 72.6 m,

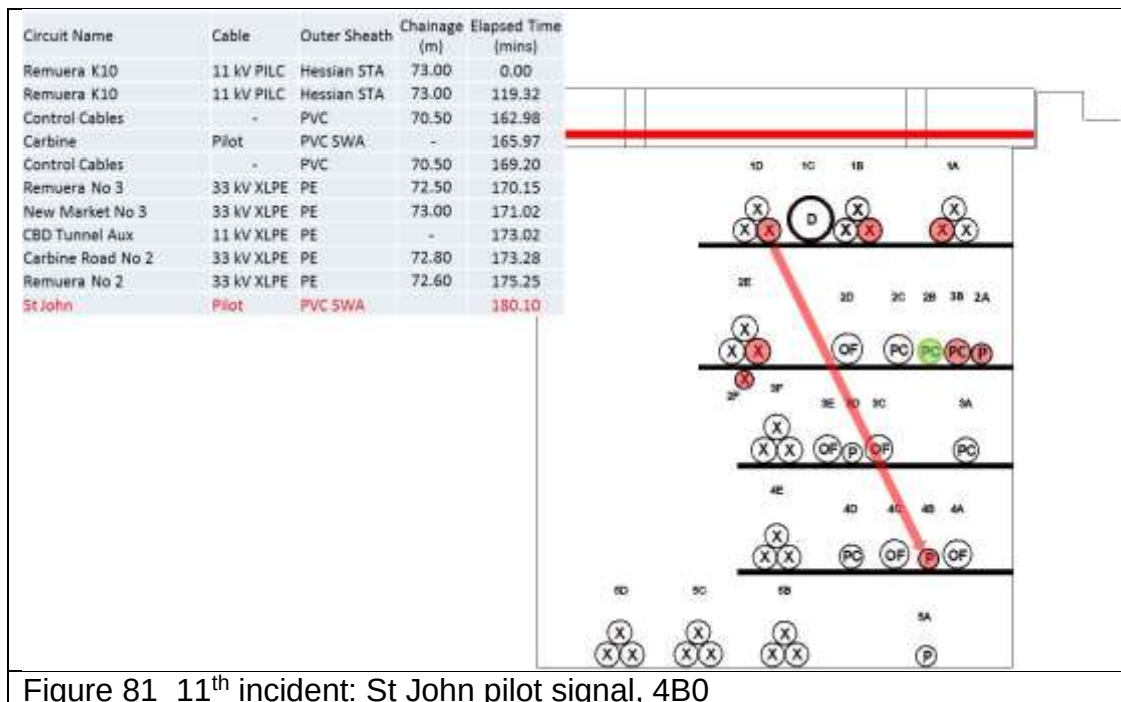
Figure 81 11<sup>th</sup> incident: St John pilot signal, 4B0

Occurred 4.85 minutes later. St Johns Pilot, 4B, signalled a differential protection blocked alarm. The pilot cable is two layers below the failed transition joint with a gap between cables in Level 3. It is likely that burning polymer from the joint and impregnating compound from the PILC cable had spread fire downwards.

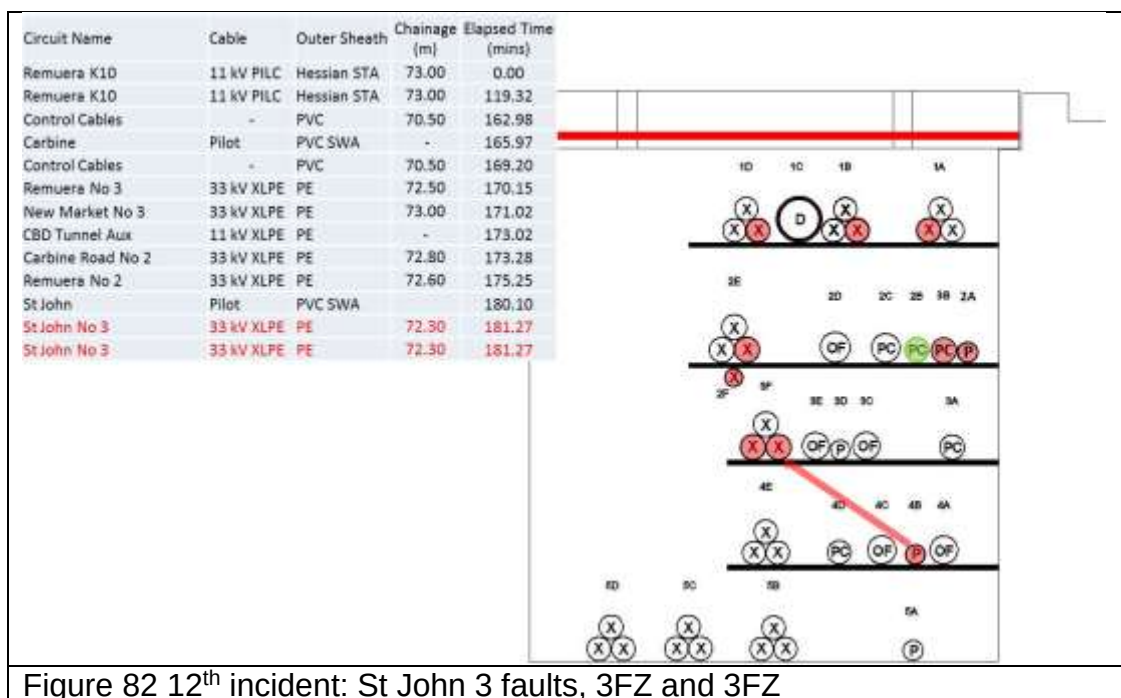
Figure 82 12<sup>th</sup> incident: St John 3 faults, 3FZ and 3FZ

Occurred 1.17 minutes later. St Johns 3, 3FX and Y, at 72.3 m, XLPE cables faulted and tripped. The arc crater is shown in Figure 83. It is likely that burning polyethylene had fallen from 2E, which had faulted 8 minutes before.

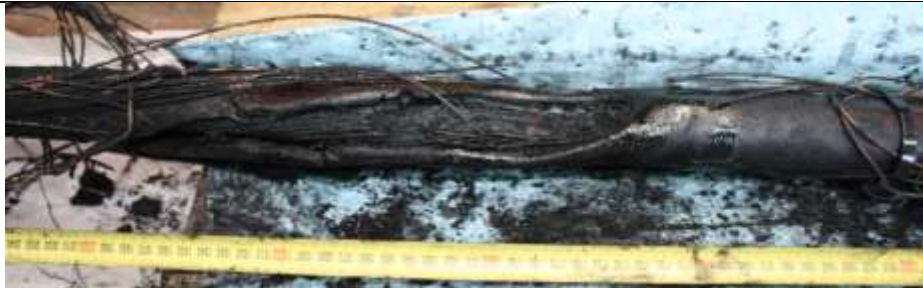
Figure 83 Arc crater: 33 kV XLPE, St John 3, 3FZ, 72.3 m,

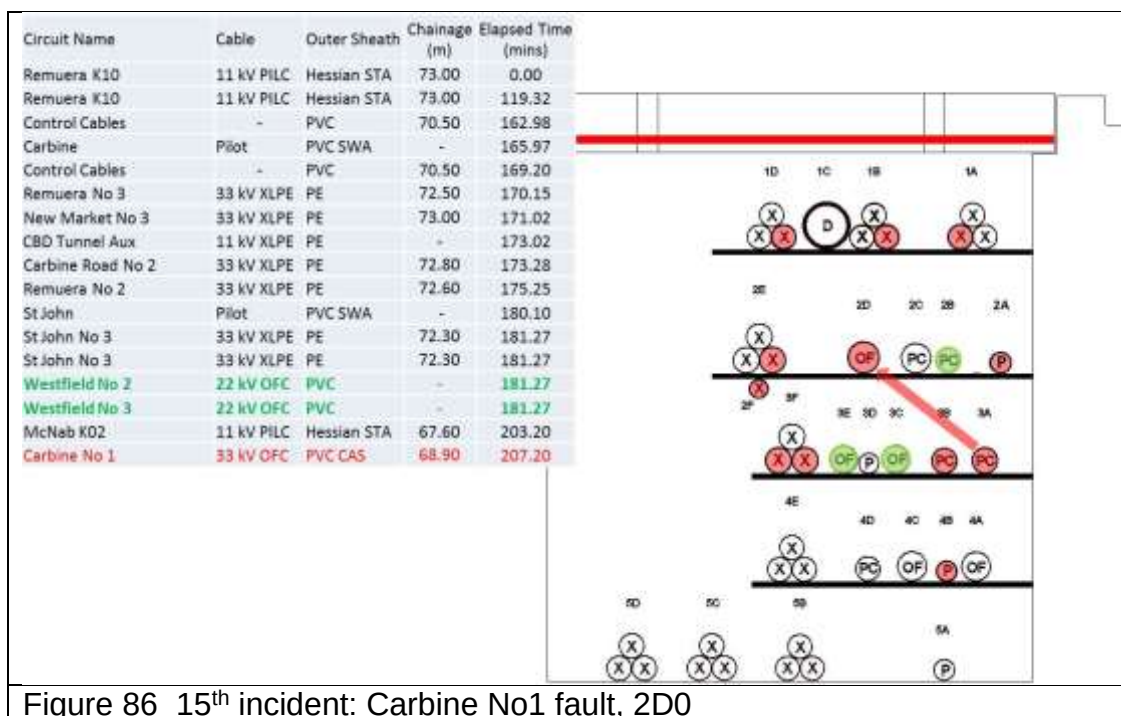
Figure 86 15<sup>th</sup> incident: Carbine No1 fault, 2D0

Occurred 4.0 m minutes later and 207.2 minutes after the failure of the transition joint, 33 kV Carbine N° 1, 2D0, OF cable at 68.9 m, faulted and tripped. The arc crater is shown in Figure 87. The fault position is 4.1 m eastwards from the centre of the failed transition joint. This is a significant event as this cable was on the same Level 2 as the failed transition joint and had burning cables above, below and on either side. The oil would have expanded until it exceeded the storage capacity of the oil storage tanks. The pressure would then have risen exponentially to a value capable of bursting the aluminium sheath or one of the accessories. The sheath would become plastic and its hoop strength reduce before the temperature approached the melting point of 660°C (aluminium sheaths are extruded at ~425°C). The sheath is therefore likely to burst in a mechanically weak point somewhere within the fire region. The paper insulation would have been thermally degraded by the high temperature. The drop in pressure and the admittance of air and hot gas into the insulation would cause electrical failure. The addition of hot oil and vapour into the fire would spread the fire along the trench and underneath the cables and so significantly increase its intensity.

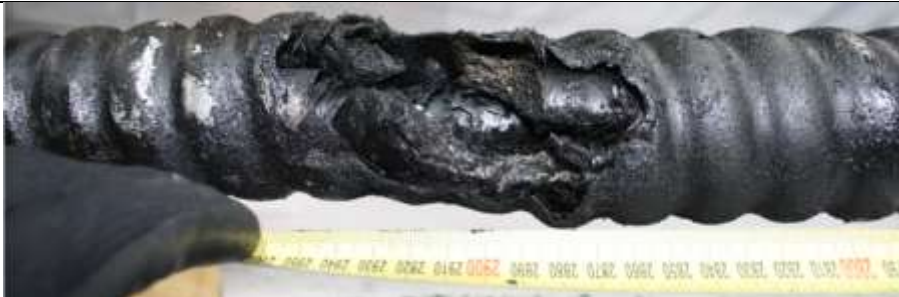
Eventually either the external fire or an internal cable fault and arc breached the aluminium sheath of the OF cable as shown in Figure 87. The increased intensity of the fire damage seen in this trench region is attributed to the release of cable oil and spread of fire. Smaller holes were found to have been melted in the aluminium sheath of 2D0 close to the fault hole as shown in Figure 53.

Figure 87 Arc crater: 33 kV OF, Carbine 1, 2DO, 68.9 m

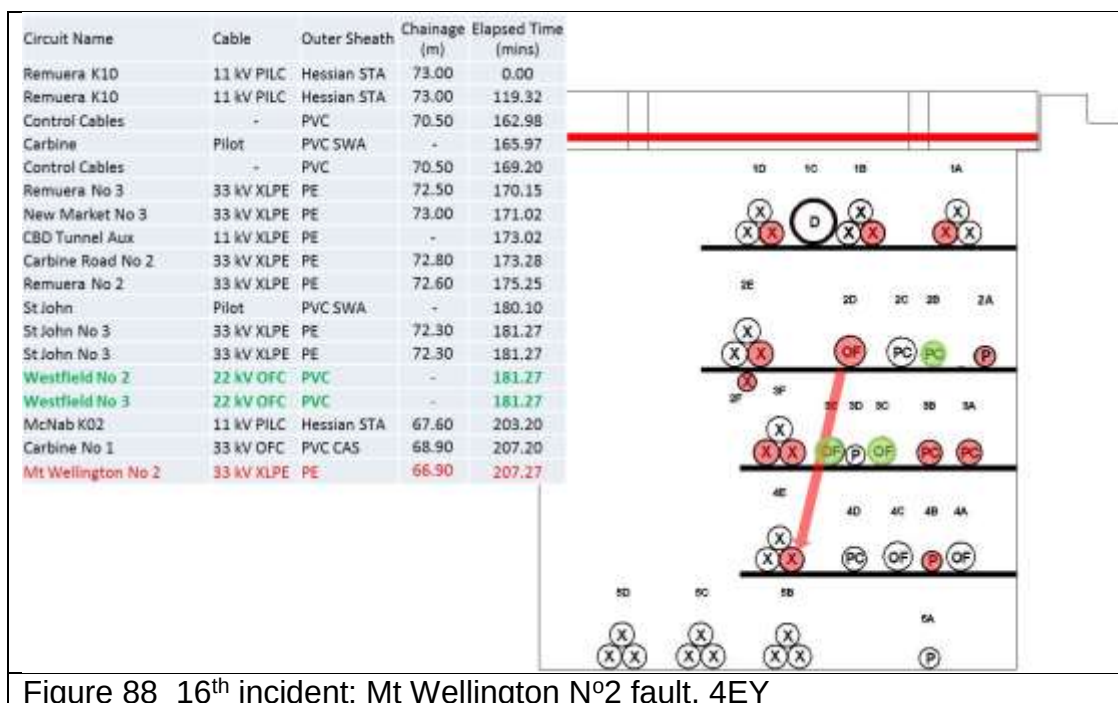
Figure 88 16<sup>th</sup> incident: Mt Wellington N°2 fault, 4EY

Occurred 0.07 minutes later than 2D0 above. 33 kV Mt Wellington No 2, 4EY, XLPE cable at 66.9 m, faulted and tripped. This was the first oil filled cable to fail in the cable trench. The arc crater is shown in Figure 91. This cable would have experienced burning PE from 3F above it, which had faulted 26 minutes before.

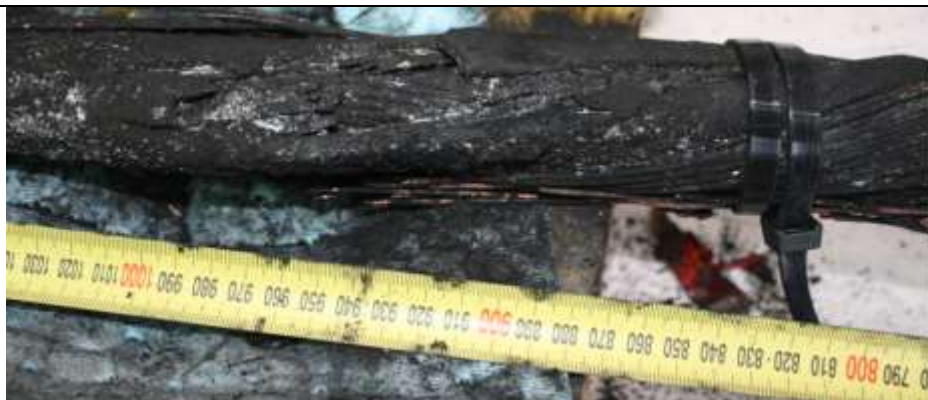
Figure 89 Arc crater: 33 kV XLPE, Mt Wellington N°2, 4EY, 66.9 m

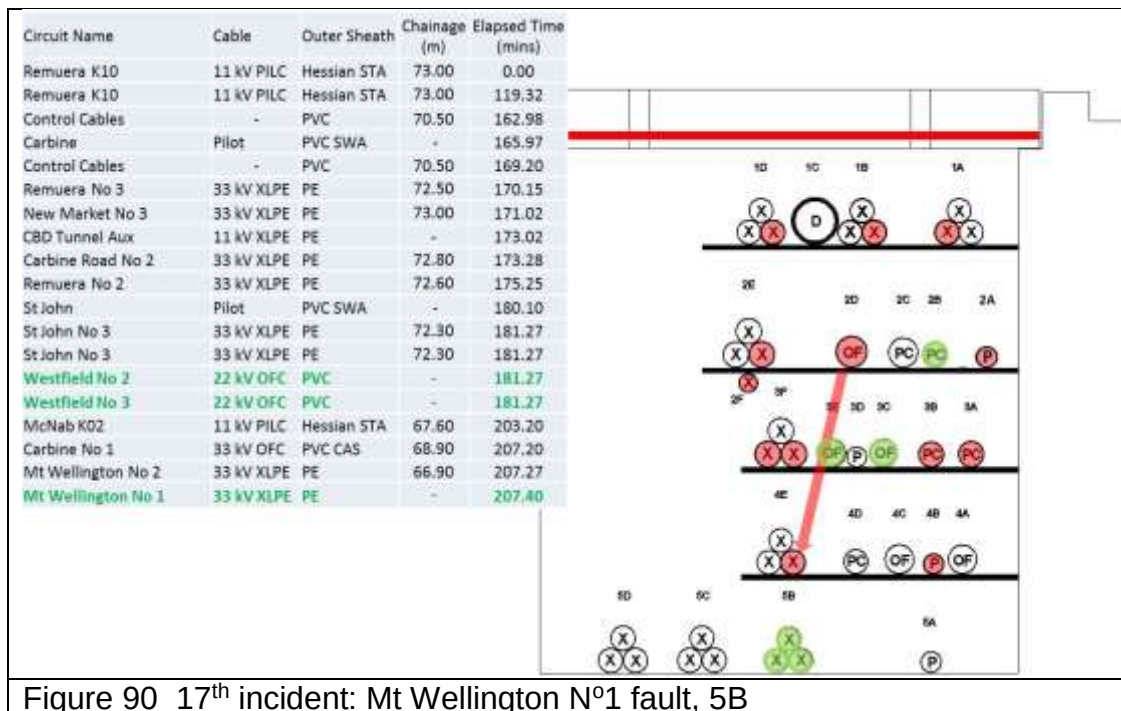
Figure 90 17<sup>th</sup> incident: Mt Wellington N<sup>o</sup>1 fault, 5B

**17<sup>th</sup> Cable Incident, 5B, Diagram in Figure 90**

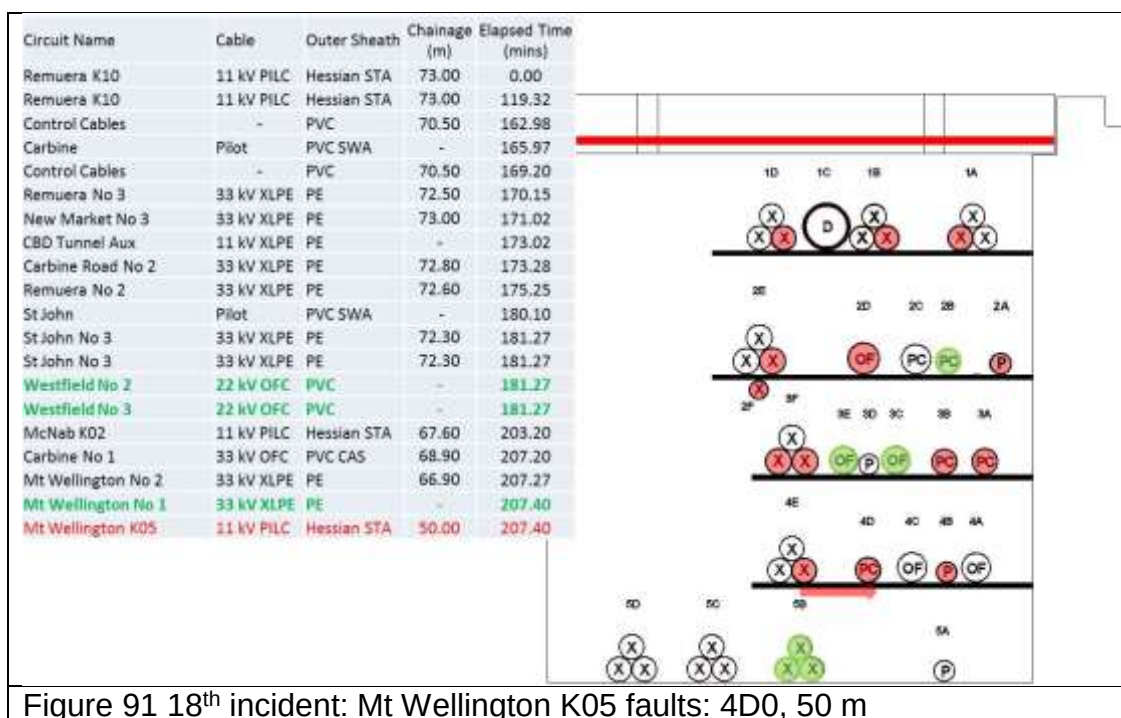
Figure 91 18<sup>th</sup> incident: Mt Wellington K05 faults: 4D0, 50 m

**18<sup>th</sup> Cable Incident, 4D0, Diagram in Figure 91**

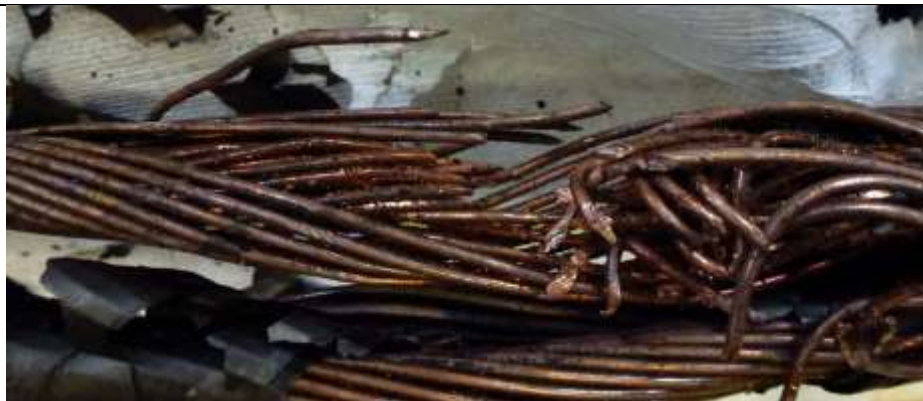
Figure 92 Arc crater: 11 kV PILC, Mt Wellington K05, 4D0

Occurred 0 minutes later (at 207.40 minutes), at the same time as the previous incident, 5B, i.e. 207.40 minutes 11 kV Mt Wellington K05, 4D0, PILC cable at 50 m faulted, as shown by the arc crater in the conductor in Figure 92. However there is no record of this circuit having electrically tripped. It has therefore been taken for the purpose of this report that it faulted at the time of Mt Wellington substation losing power when Mt Wellington No 1 tripped.

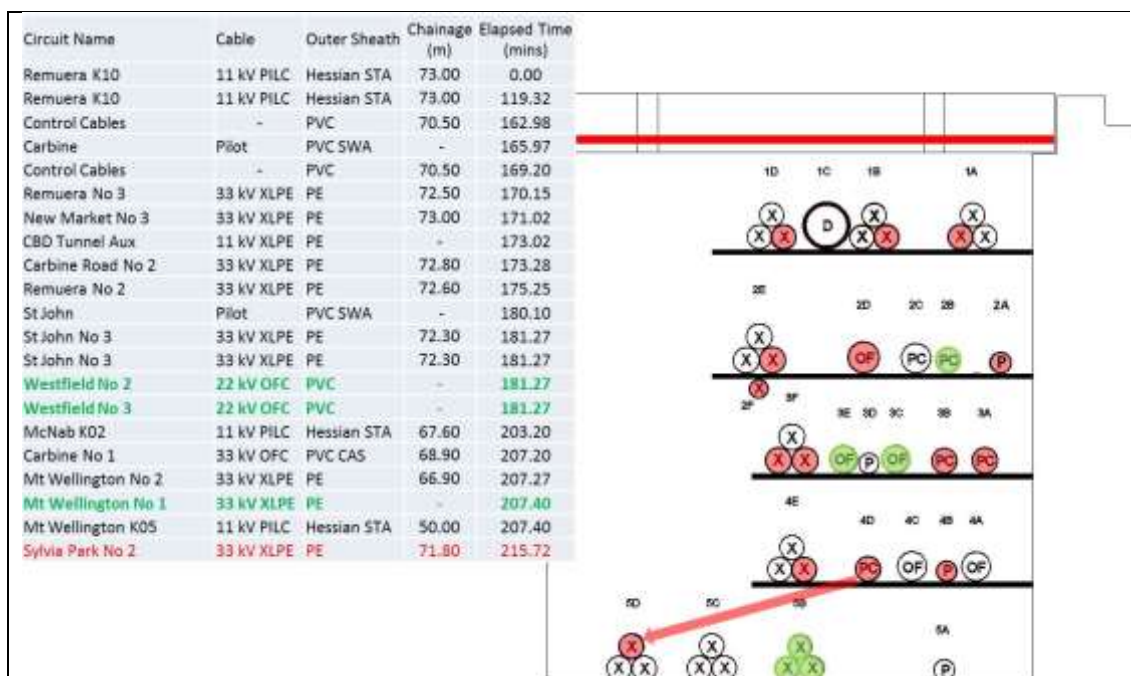
Figure 93 19<sup>th</sup> incident: Sylvia Park No 2 faults: 5DX

#### **19<sup>th</sup> Cable Incident, 5DX, Diagram in Figure 93**

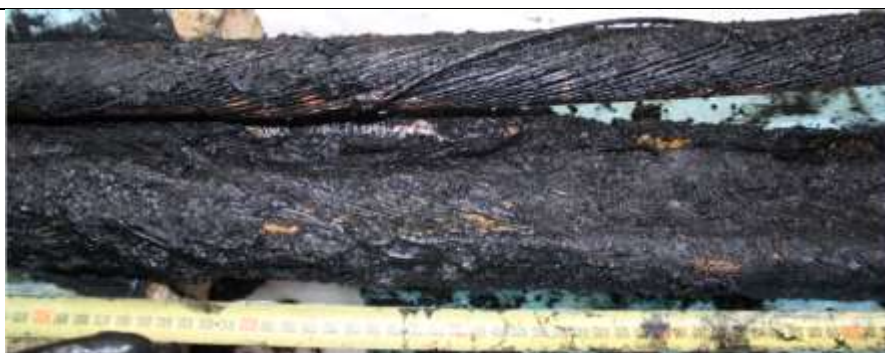
Figure 94 Arc crater: 33 kV XLPE, Sylvia Park No 2, 5DX, 71.8 m

Occurred 8.32 minutes later. 33 kV Sylvia Park No 2, 5DX, XLPE cable at 71.8 m, faulted and tripped. The arc crater is shown in Figure 94. This cable had been laid in the access way. It failed close to the fault in the OF cable 2D0 at 68.9m, which had faulted 9 minutes before.

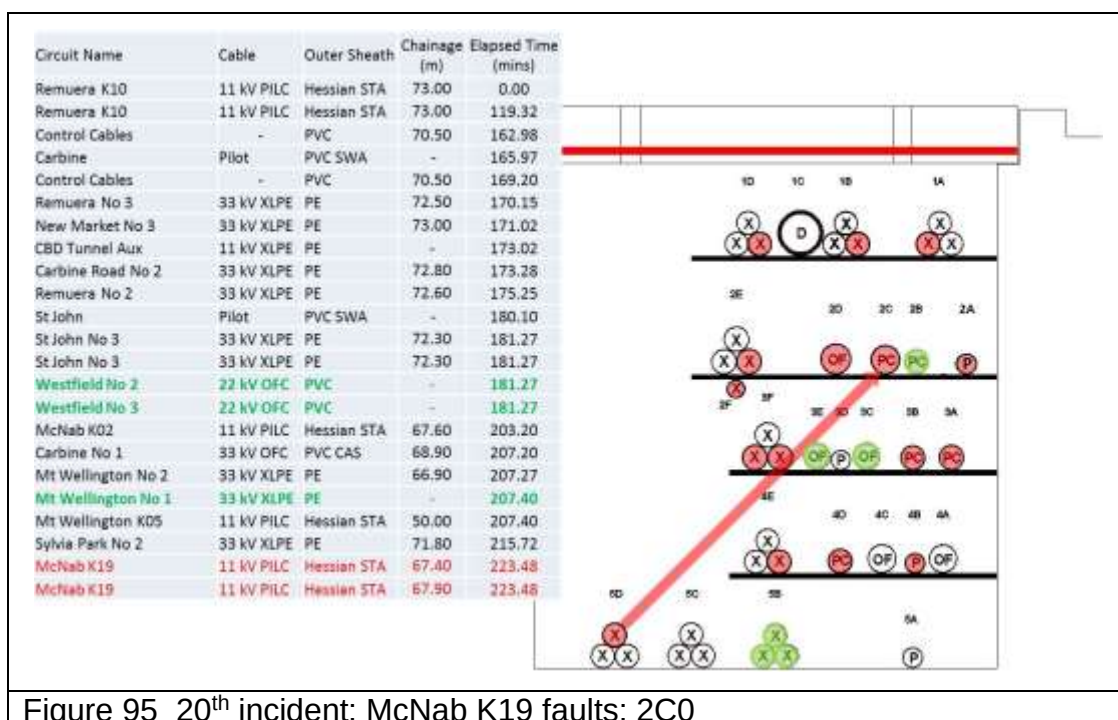
Figure 95 20<sup>th</sup> incident: McNab K19 faults: 2C0

#### **20<sup>th</sup> Cable Incident, 2C0, Diagram in Figure 95**

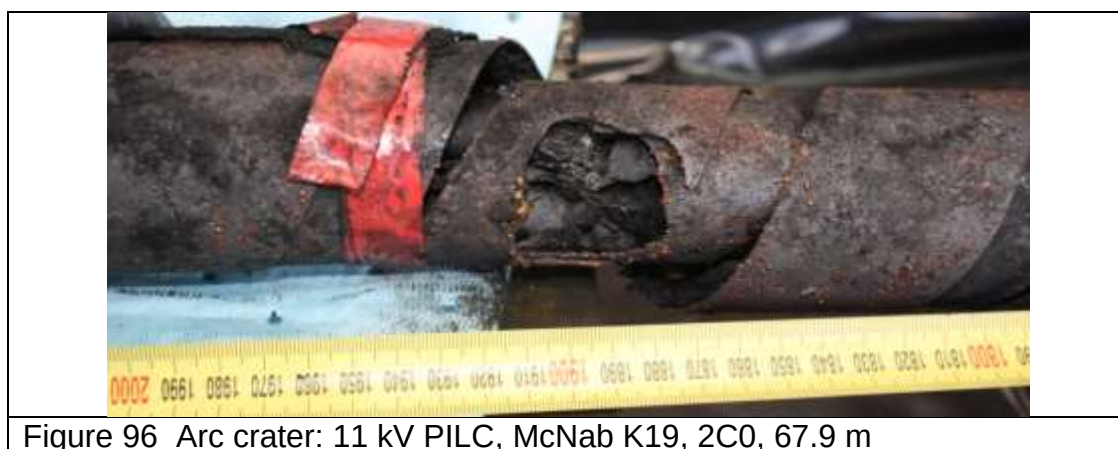
Figure 96 Arc crater: 11 kV PILC, McNab K19, 2C0, 67.9 m

Occurred 7.77 minutes later. 11 kV McNab K19, 2C0, at 67.9 m, faulted and tripped. The arc crater is shown in Figure 96. The cable is effectively adjacent to (1 m to the East) the faulted OF cable 2D at 68.9 m. It failed 16.28 minutes after cable 2D. 2C0 was next to the faulted transition joint and survived 104.17 minutes after its failure. It is possible that burning oil accelerated its failure.
