# Penrose substation fire inquiry report

9 November 2015

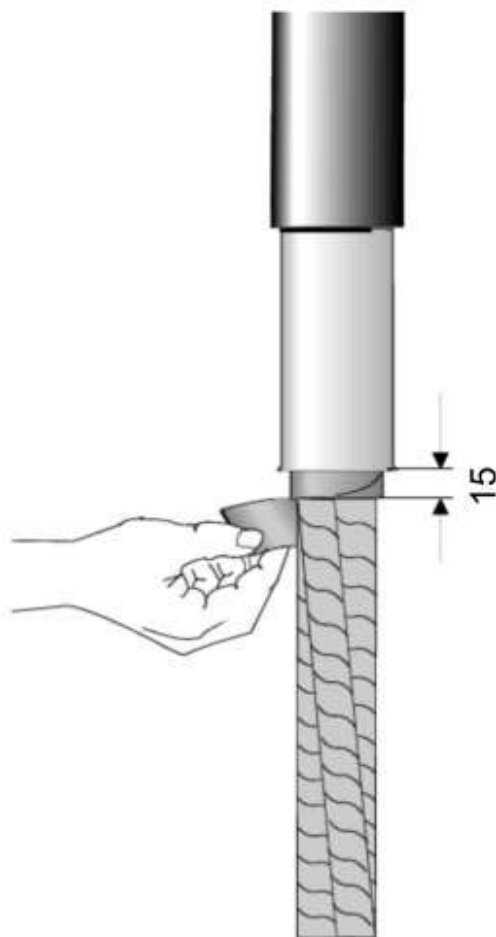
Figure 102 4 Remove and form step in belt insulating tapes

Note: The yellow void filling tape adhered to and pulled off the belt tapes.  
The step length shown of 15 mm is the length of the jute filler protrusion

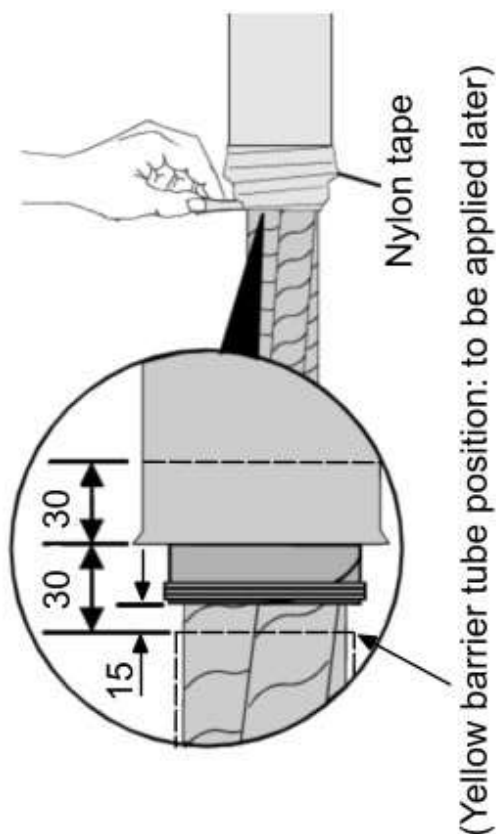
Figure 103 5 Apply nylon protective tapes over core insulation in crutch

Note: 30 mm is the distance to the start of the yellow barrier tube.  
The 30 mm overlap onto the lead sheath is denoted by a grey stain

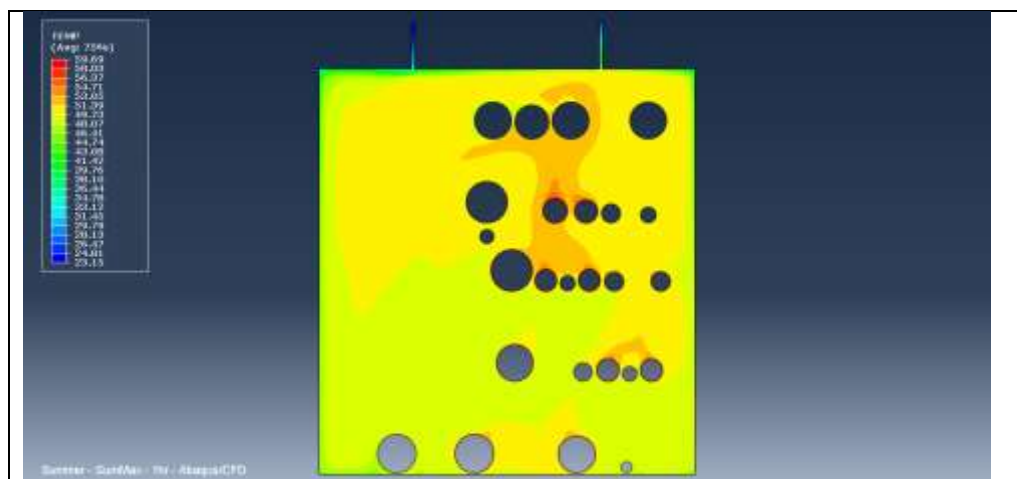
Figure 116 Air temperature contour plot: continuous loading at Summer peak currents

Figure 116 is a convection contour plot that shows the resultant air temperature in the cable trench.

- iii) The air over the 33 kV XLPE cables is at lower temperatures. The air rising over 3B, the Remuera K10 circuit in which the first failure occurred, was at a lower temperature (in the years prior to 2014 in which it carried load). The lower air temperatures result from the ratio of the low current loading compared to the rated current carrying capacity of the particular conductor size and cable.

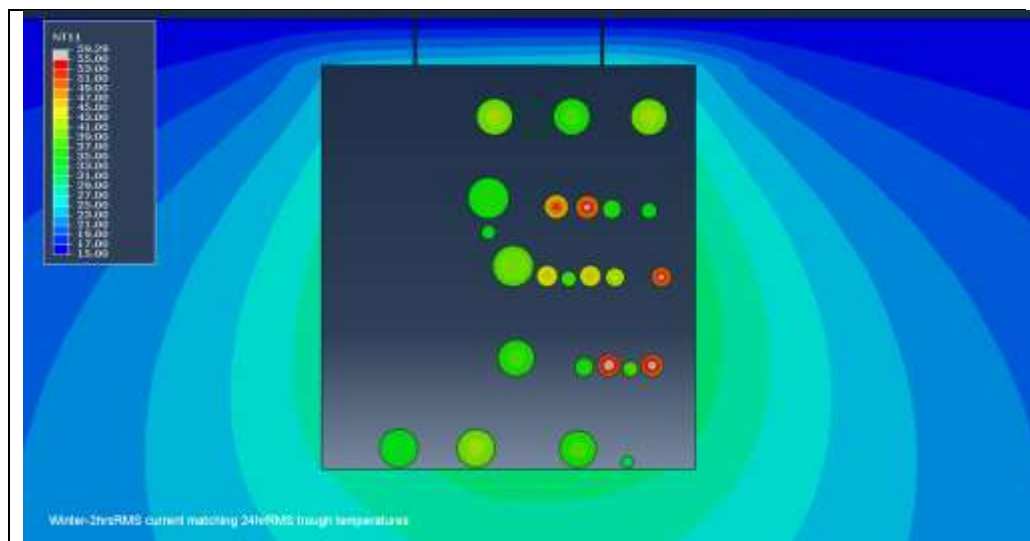
Figure 121 Winter cyclic rating: cable and ground temperatures

Figure 121 (Abaqus Standard-algorithm) shows that the highest temperature profile external to the inner lining of the trench occurs through the concrete roof and is indicative of a higher heat flow. The temperature of the roof inner surface from Figure 119 is 30°C giving a temperature drop of 15 °C to the external ambient of 15 °C.

The mean air temperature in the trench for the 24 hour RMS constant load was 30 °C. The mean air temperature for the 2 hour RMS cyclic rating was 33 °C. Thus the maximum trench air temperature variation that between day and night, assuming a night ambient of 15 °C will be  $< (33 - 15) = 18$  °C.

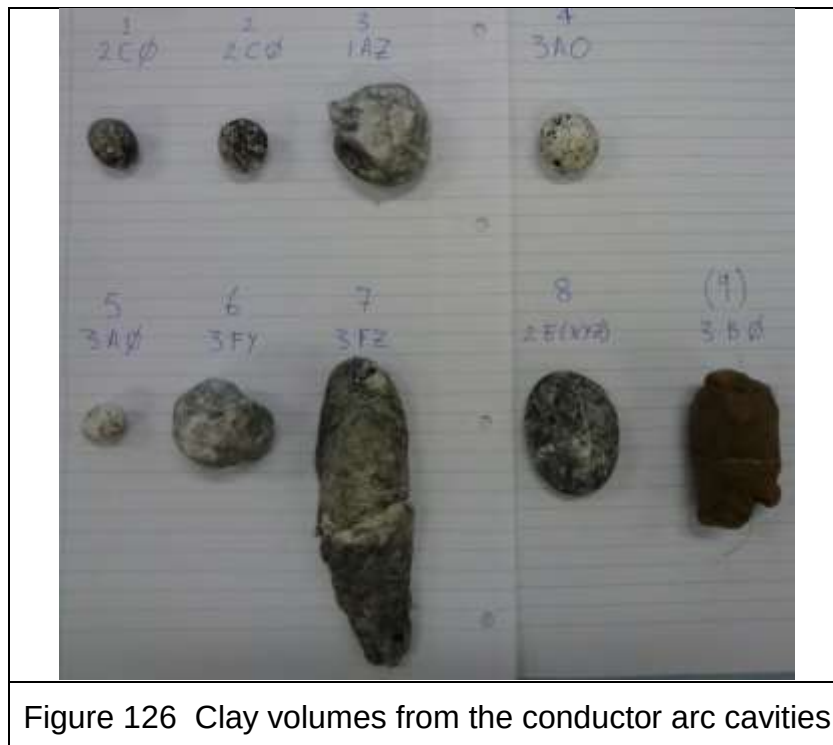
Figure 126 Clay volumes from the conductor arc cavities

A comparison of the conductor volumes eroded by the power arcs for six of the electrical faults is shown in Figure 126. The volumes were obtained by measuring the clay and plasticine impressions of the fault cavities. The plasticine mould for 3BO accurately depicts the shape and the volume of the cavity. The other clay samples accurately record the volume but not the shape of the cavities.

- The measured arc erosion volume in the failed 11 kV PILC transition joint 3BO was 27.3 mL, this being produced by two 0.55 s shots of 4,200 A fault current.
- The 3BO transition joint crater volume is very significantly larger than those in the other 11 kV PILC faults i.e. 3A has 4.9 mL and 2C has 1.6 and 3 mL.
- The failed 3BO transition joint is one of the three faults to have large arc crater volumes, the other two being 33 kV XLPE cables; 1A has a volume of 25.8 mL and 3F has 24.4 mL.
- By inspection the volumes are seen to have a dependency on fault current magnitude and duration and hence on arc energy.

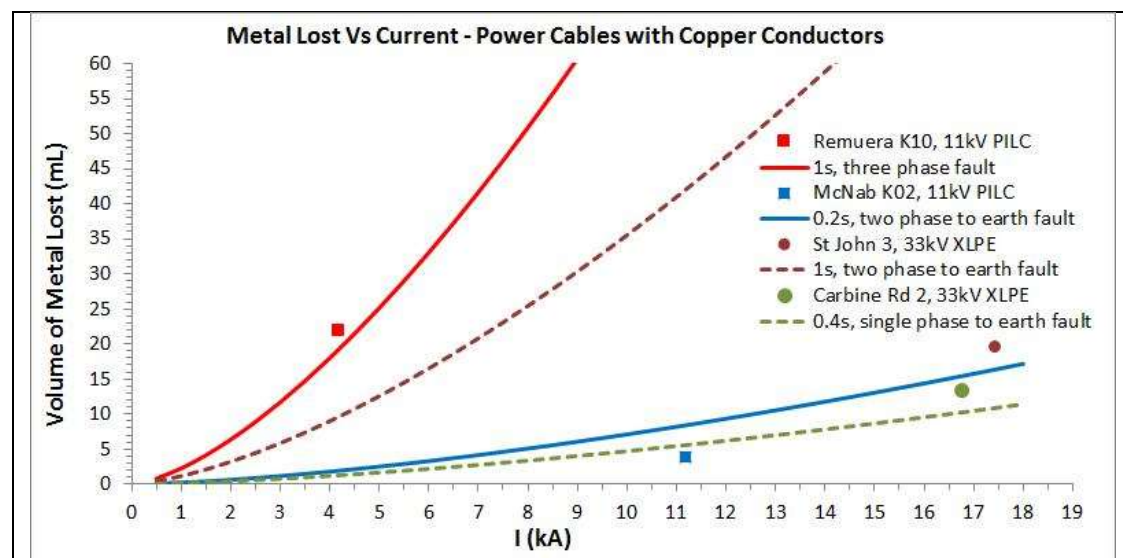
Figure 127 Volume of copper lost vs fault current

The curves in the graph in Figure 114 were drawn to illustrate the dependence of lost copper volume on fault time and current according to Stanback. For the purpose of the illustration each line represents a constant fault duration together with a multiplying factor to represent the number of power arcs present during fault between the phase conductors and the number of ends of power arcs that contributed to the erosion. The co-ordinates of measured metal lost and fault duration were then plotted in Figure 114 for four faults that had copper conductors and in Figure 128 for three faults that had aluminium conductors.

The Author concluded that the fault co-ordinates were sufficiently close to the 'Stanback expression' curves to have confidence that:

- The volumes of the metal lost had a logical dependence on the magnitude of fault current and duration

- The two cumulative faults did inject high arc energy into the Remuera K10 transition joint.

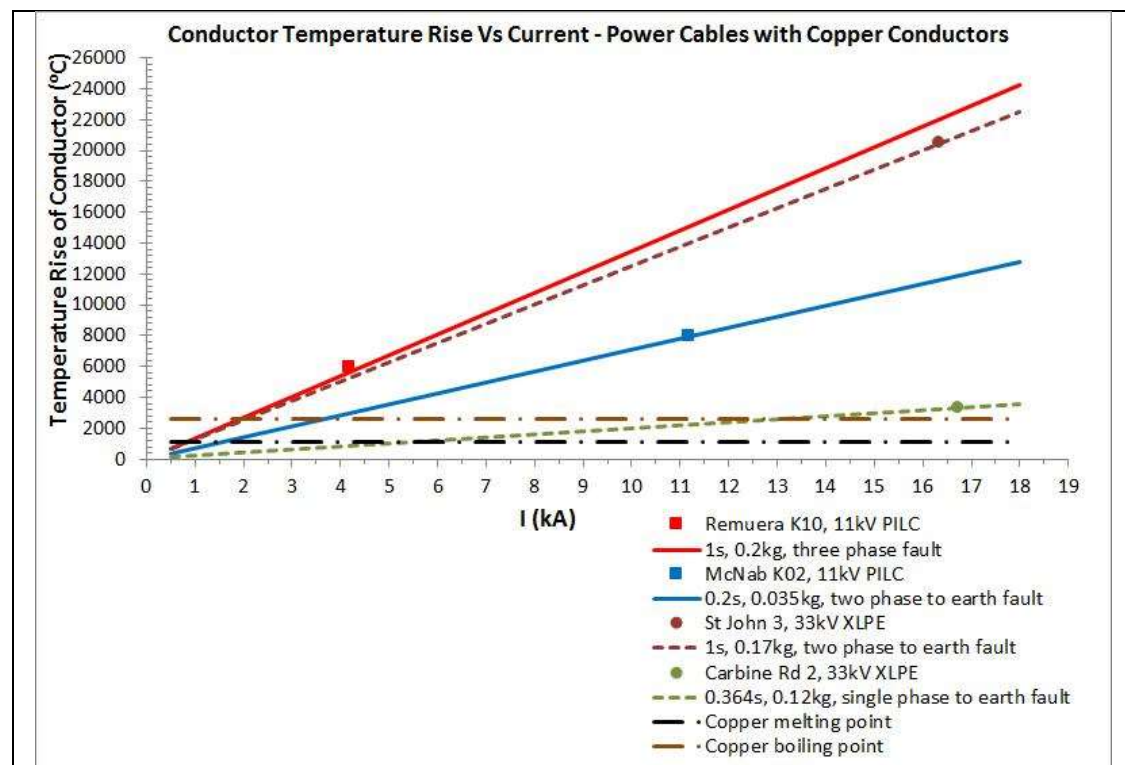
Figure 129 Temperature rise vs fault current for set fault durations

Figure 129 plots the calculated temperature rise against the fault current for different fault times for the measured mass of metal lost from four faulted copper conductor circuits.

Figure 129 shows that:

1. Taking 100% efficiency for the conversion of fault into thermal energy the temperature rises were significantly greater than i) the melting point of copper and ii) of the fire ignition temperatures of the insulating and protective layers surrounding the joints and cables, Table 7.
2. Taking a 50% efficiency for conversion of fault into thermal energy the temperature rise in the vicinity of the arc for the Remuera K10 transition joint of ~ 3000°C is much greater than the ignition temperature of the materials.

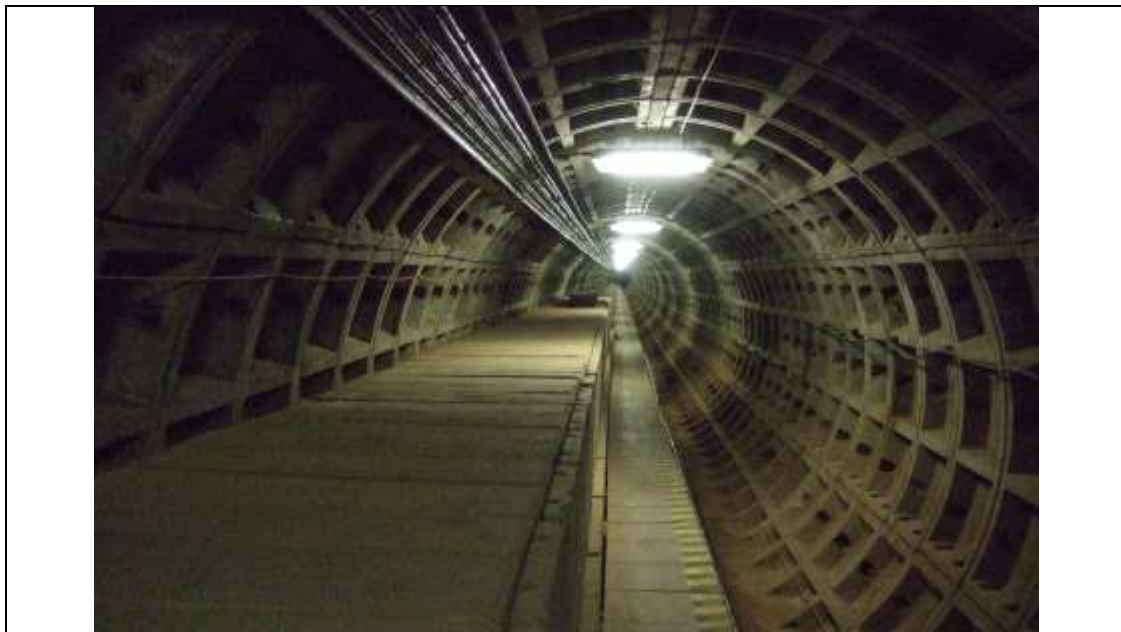
Conventional oil filled cables were then laid in a CBS (cement bound sand) filled concrete trough installed within the tunnel and the test completed satisfactorily without fire spread or harm to the cable. This installation method had previously been used by the CEGB for oil filled cables installed in the Wimbledon tunnel, Figure 130. The method was later used in the first installations of 132 kV XLPE cable in London Electricity's new cable tunnels. The method was eventually discontinued in favour of fire retardant cable sheaths as the method increased

Figure 130 Wimbledon tunnel containing a cable trough
