OIA request - 2 March 2017 South Island AUFLS event

Determining the causes of the 2 March 2017 under-frequency events

Field Issues Investigation Report

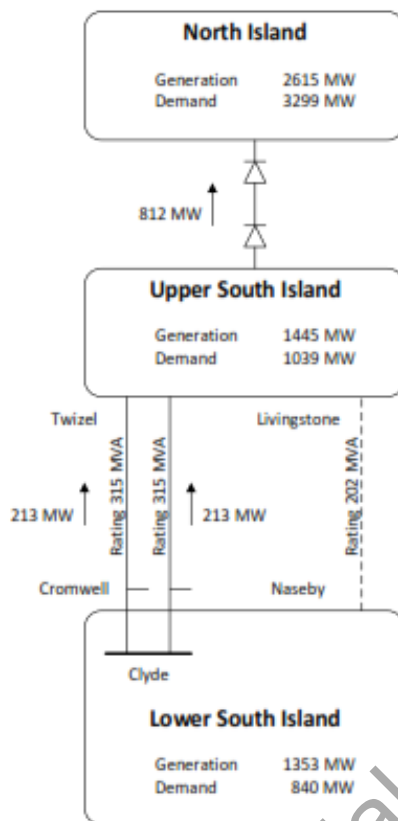
Figure 3: Three island representation of system split.

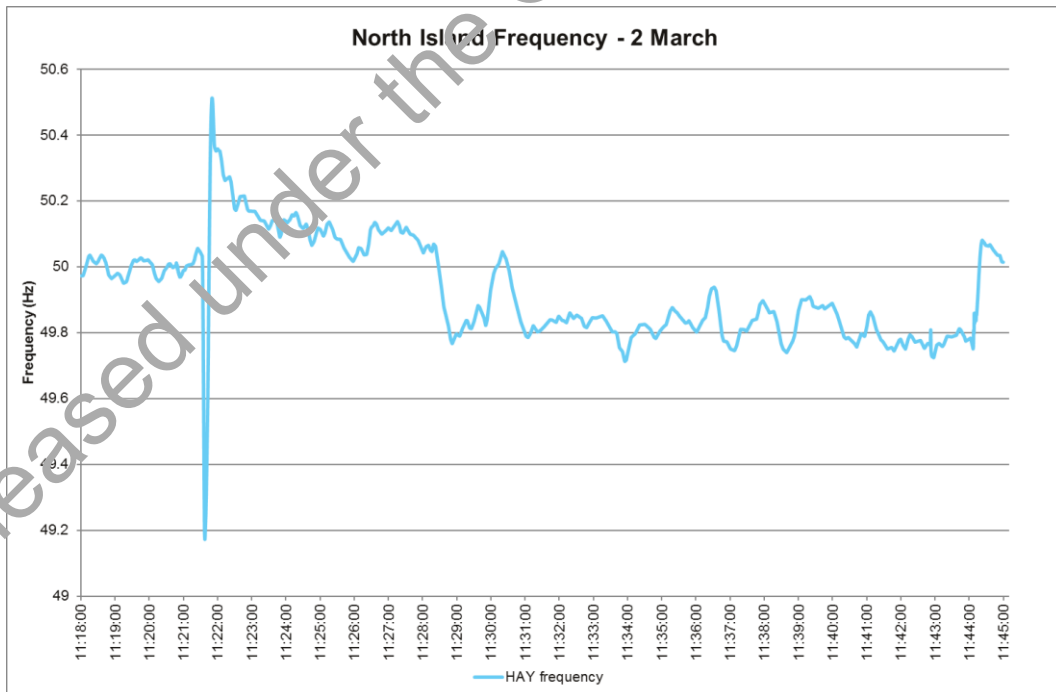
Figure 2 – North Island frequency for the same period.

Figures 1 and 2 show the frequency response in the South Island and North Island to the event. The South Island chart is plotted using phasor measurements unit readings at Twizel (TWZ) and Roxburgh (ROX), reflecting the frequencies of each of the electrical islands that formed.

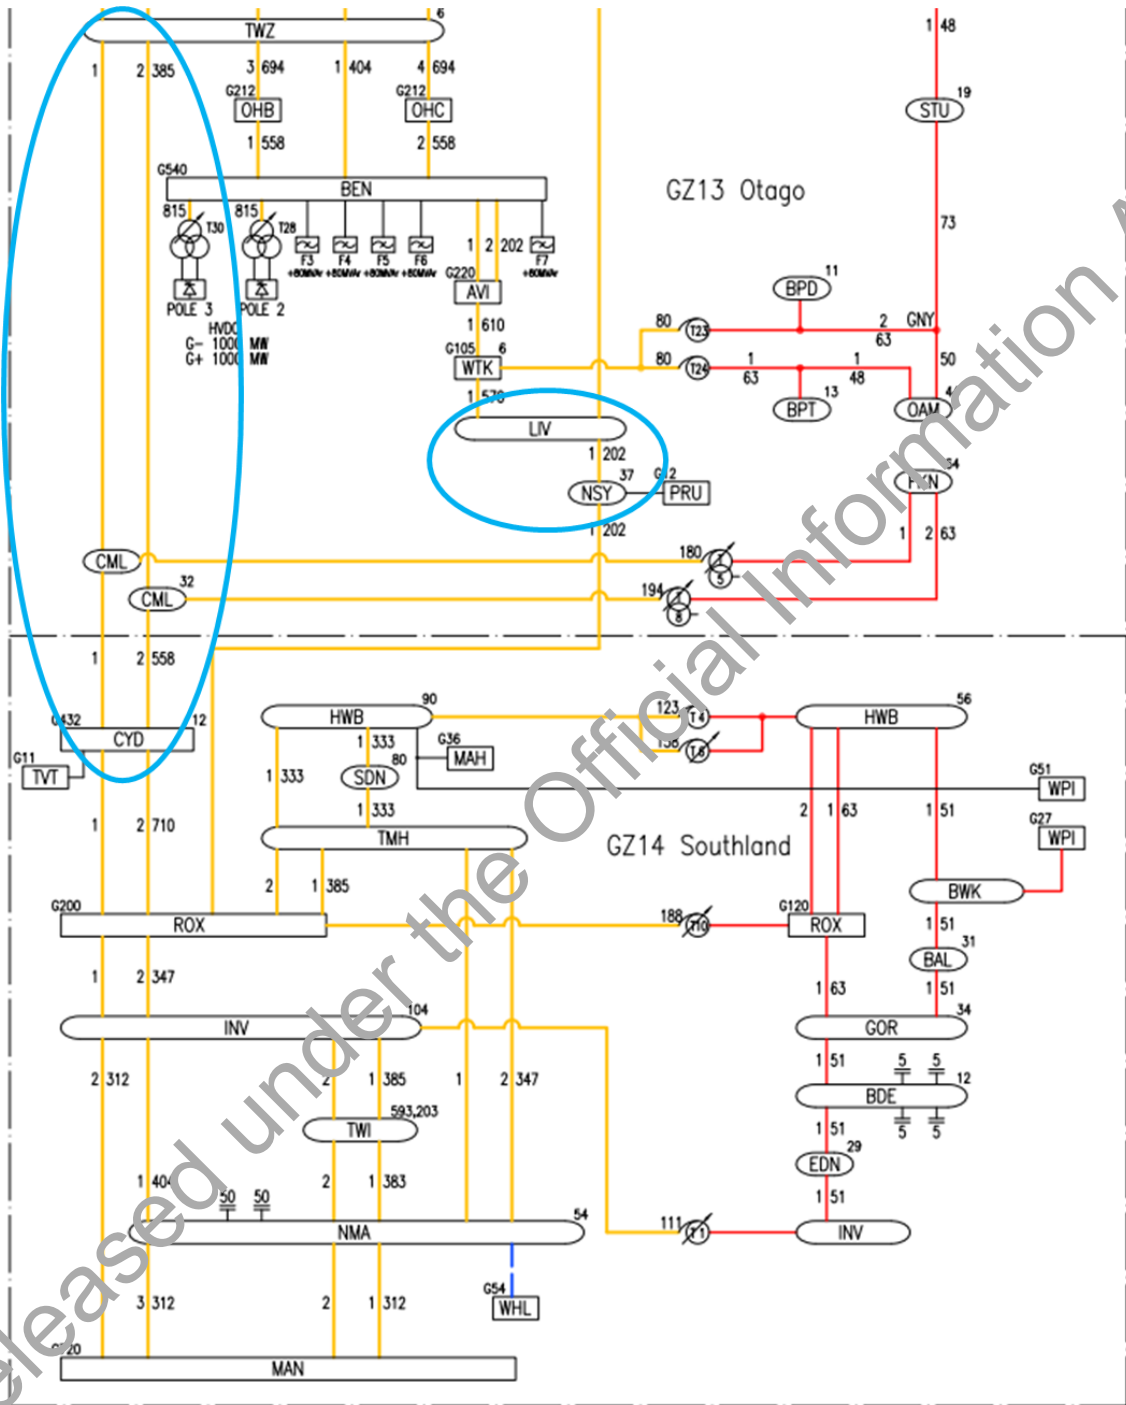
APPENDIX A – LOWER SOUTH ISLAND POWER SYSTEM

The South Island core grid consists of two major groups of generation in geographically separated areas connected by three 220 kV transmission circuits: The Clyde-Cromwell-Twizel 1 and 2 circuits on a common tower and a single Livingston-Naseby circuit on an alternate route. A line diagram of the system is in Appendix A.

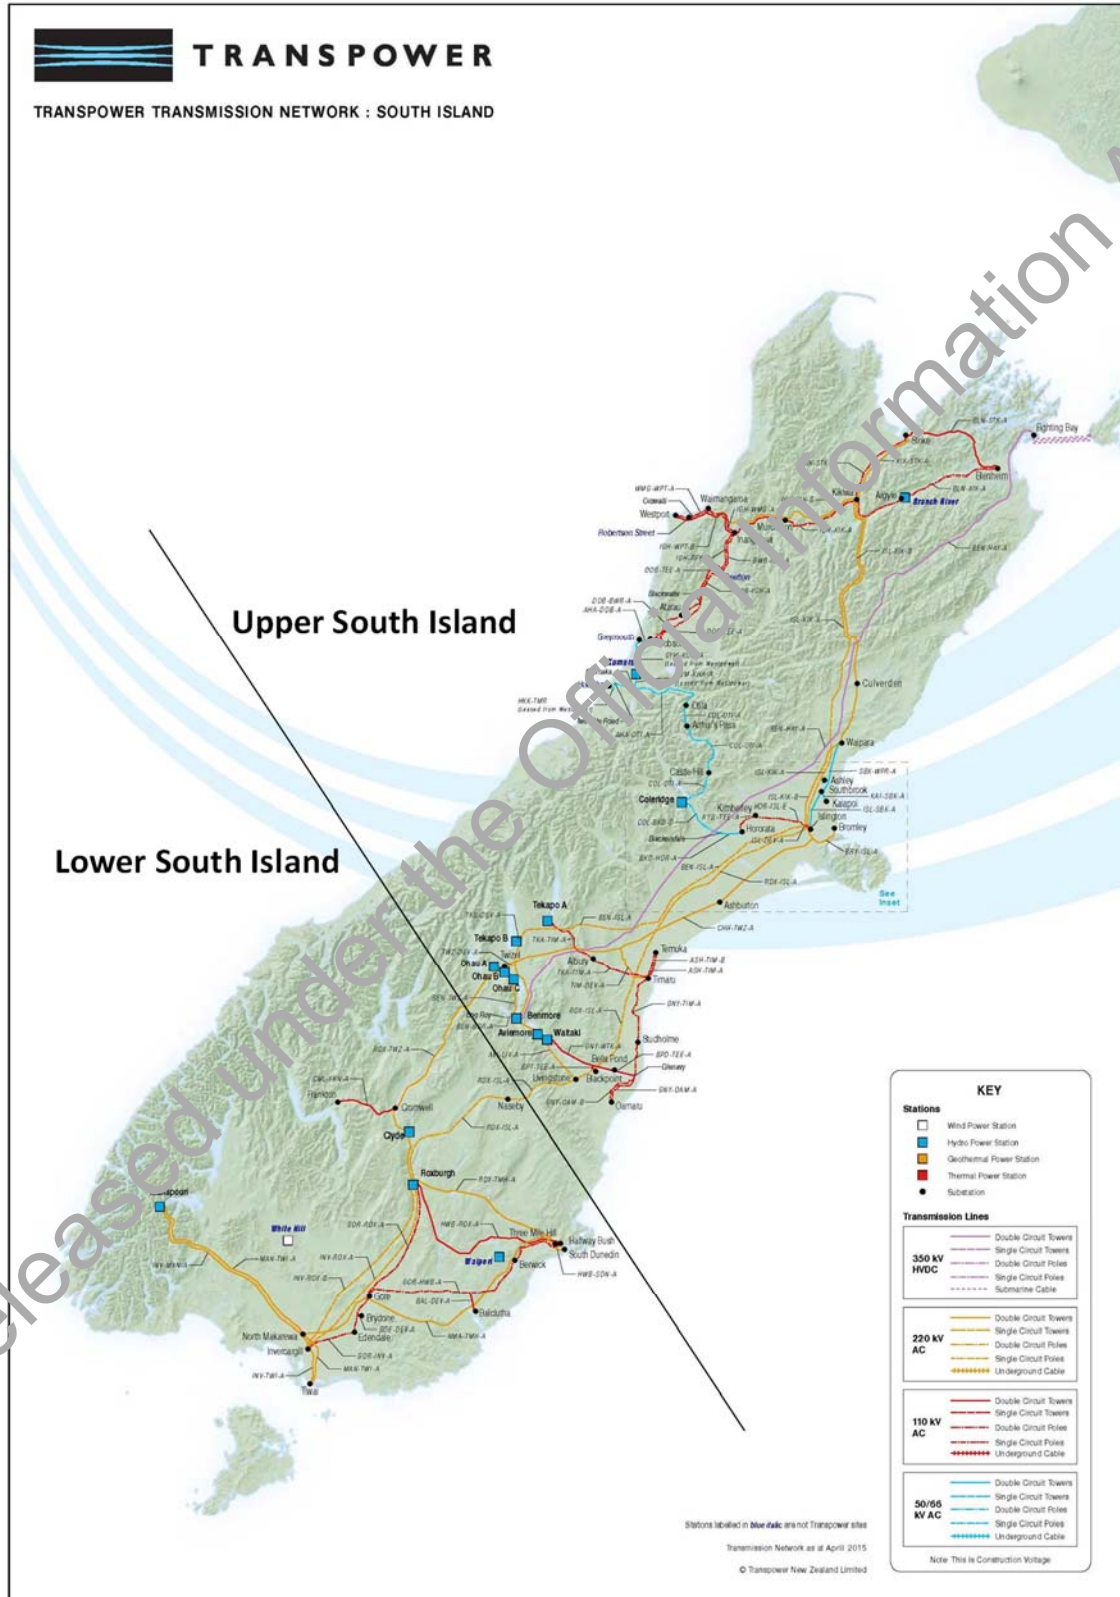
Figure 1. Geographical View of System Split

Figures 1,2, and 3 show the South Island network just prior to the system split from a geographical viewpoint, single line diagram, and three island representation.

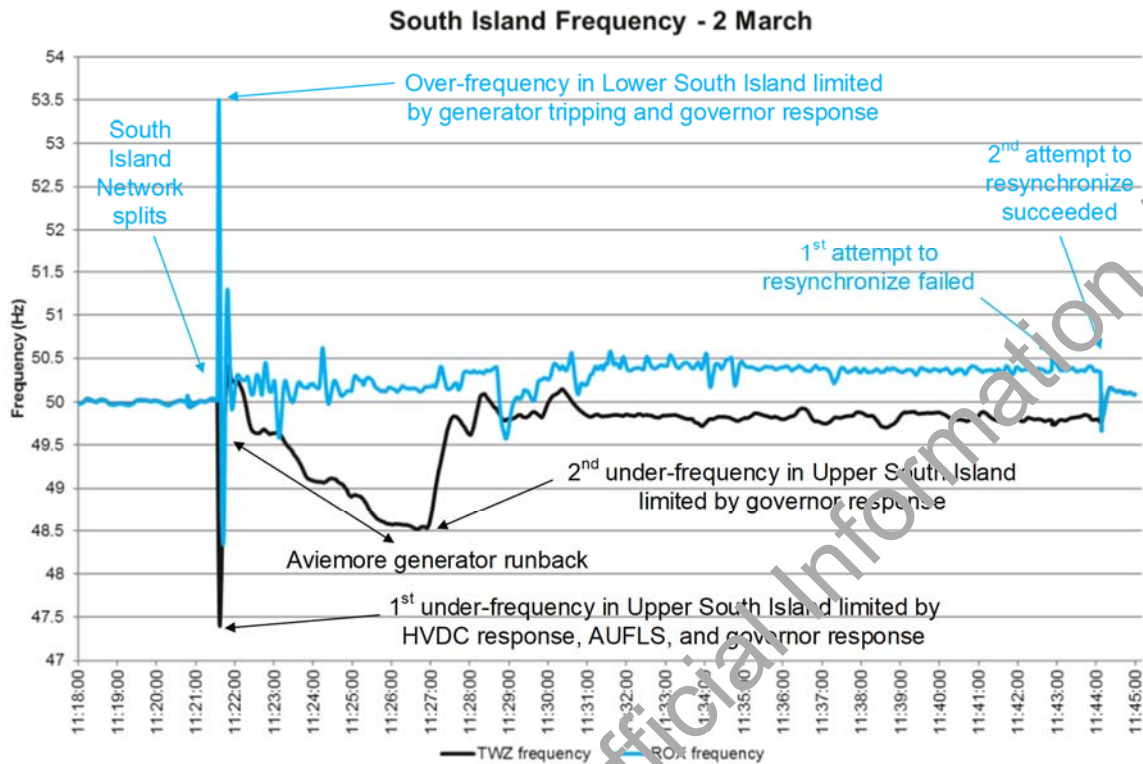
Figure 4A. Frequency Fluctuations in the Upper and Lower South Islands

Figure 4A shows the frequency fluctuations in the Upper South Island and Lower South Island. Figure 4B shows the frequency fluctuations in the North Island. The splitting resulted in an excess 426 MW generation in the Lower South Island which was 51 % above the Lower South Island demand. The frequency rapidly rose and was limited to 53.5 Hz by a combination of governor response and over-frequency tripping of 2 generators at Manapouri and 1 generator at Clyde. (The over-frequency tripping scheme is set to 53 Hz and was not designed for this scenario but was intended to limit frequency rise for a tripping of the HVDC bipole.)

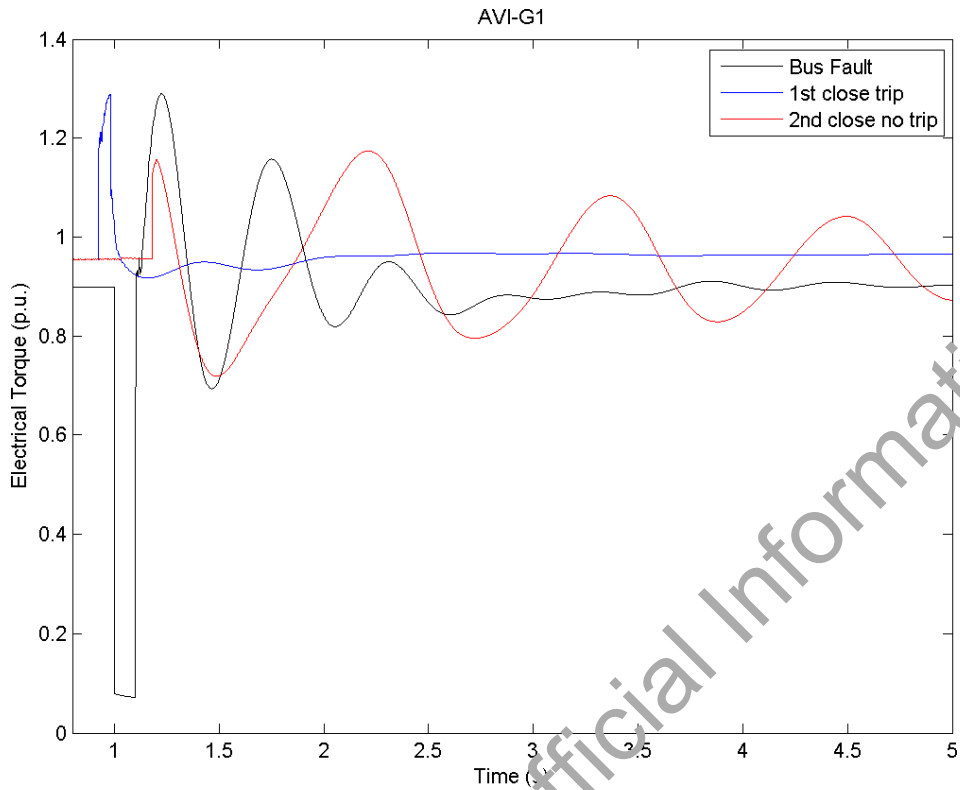
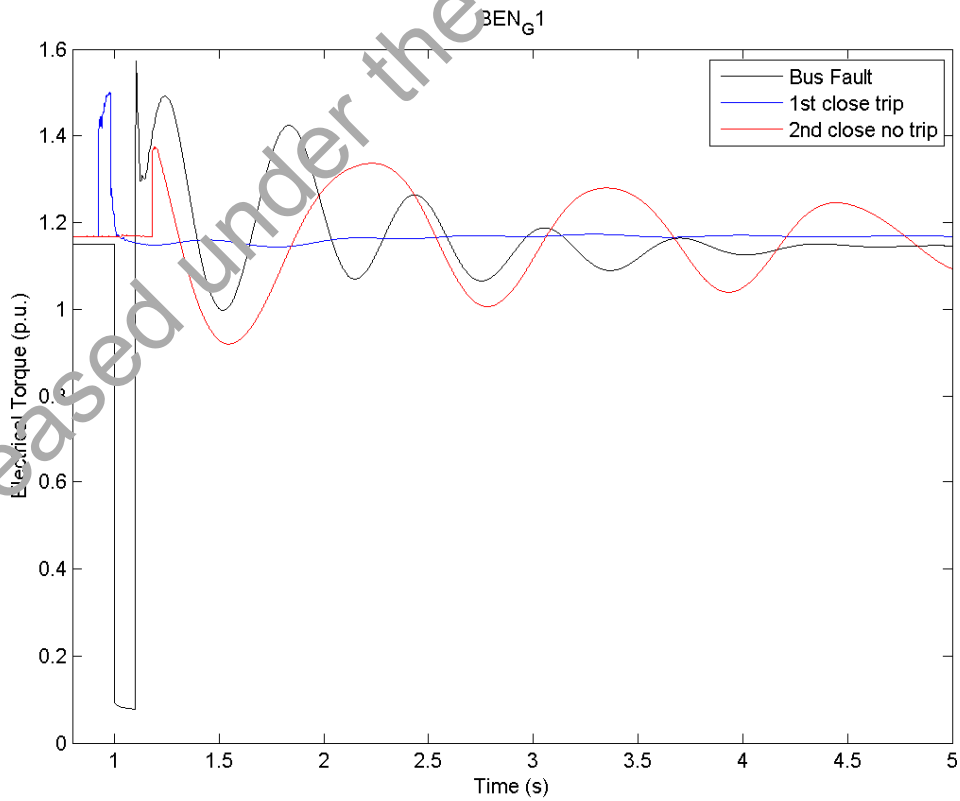
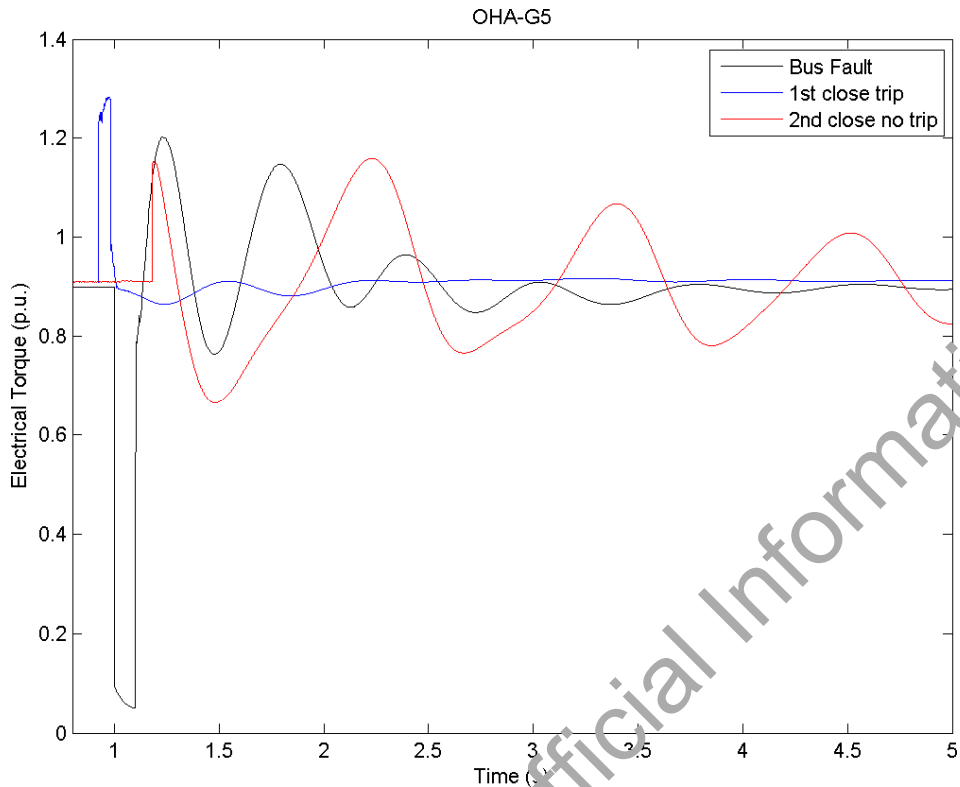
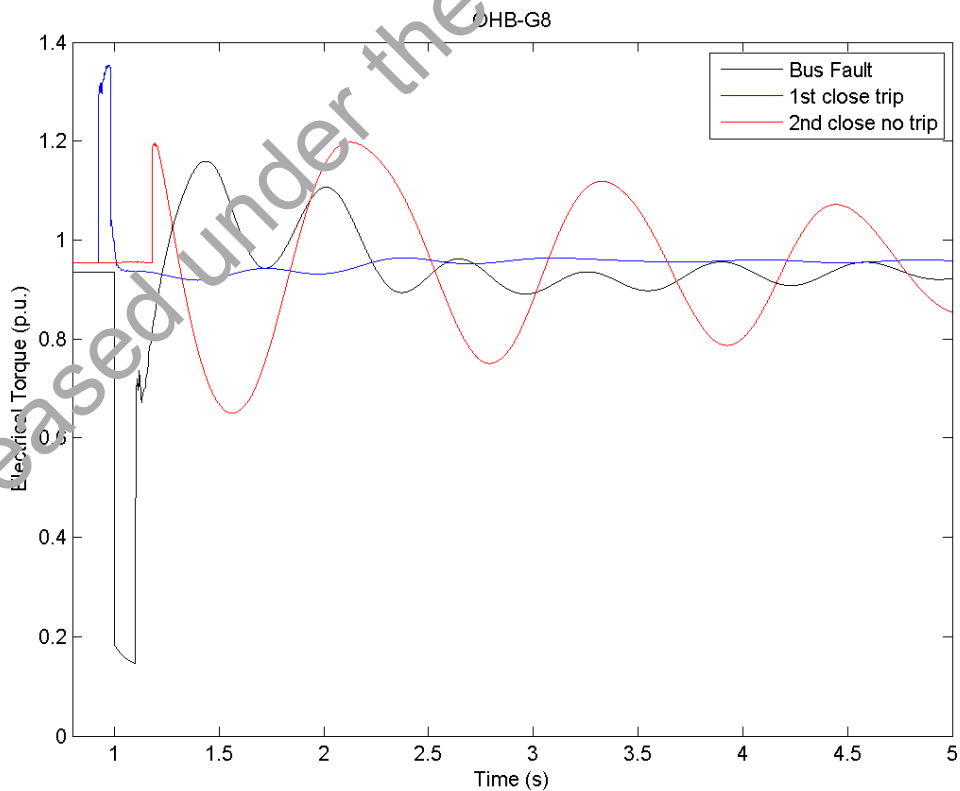
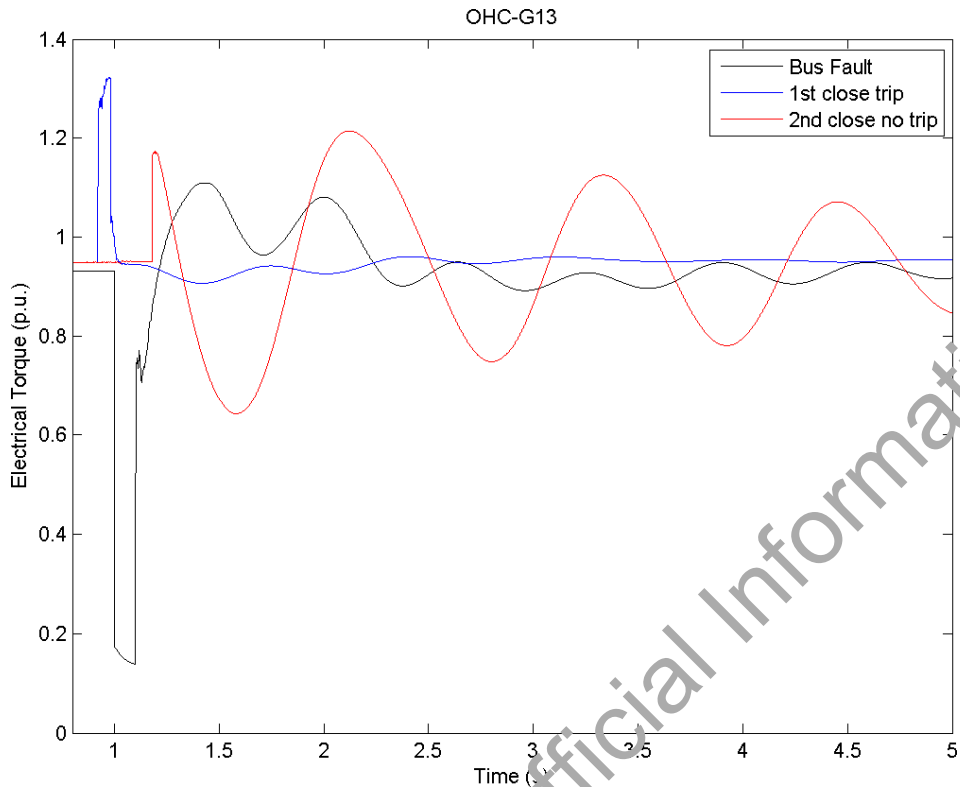
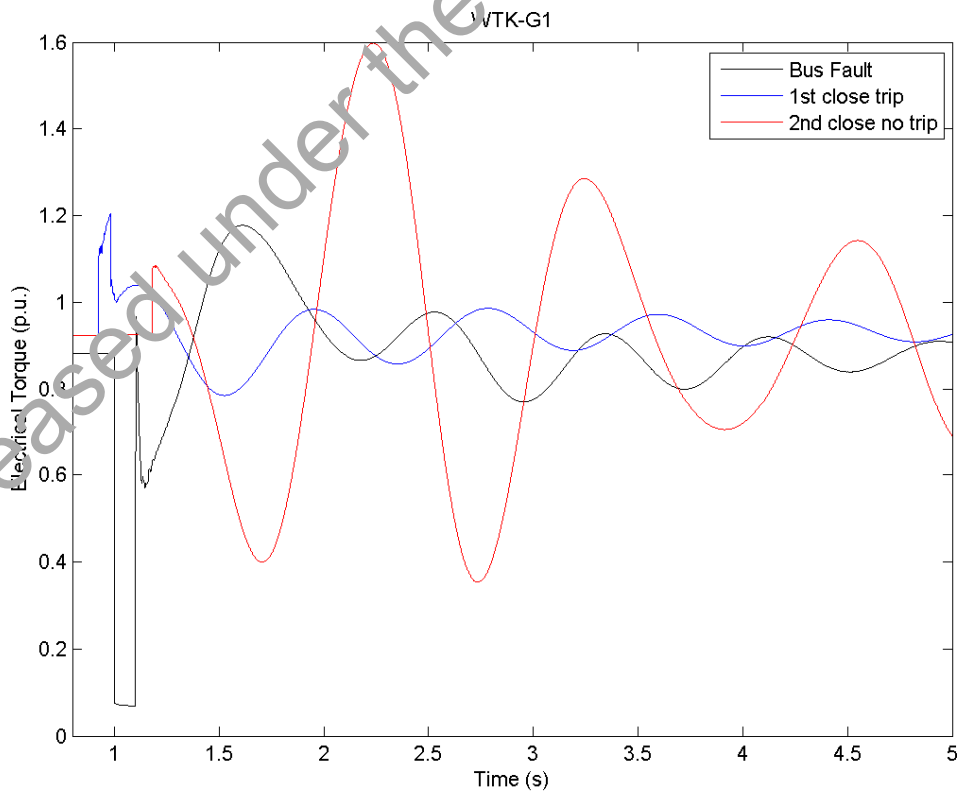
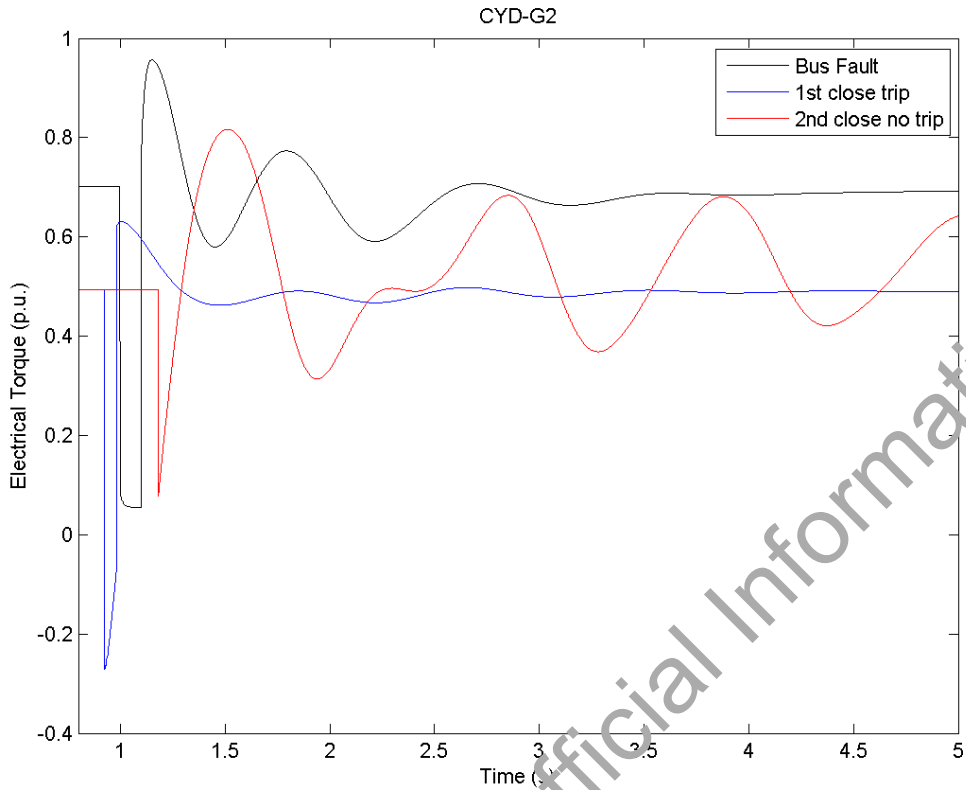
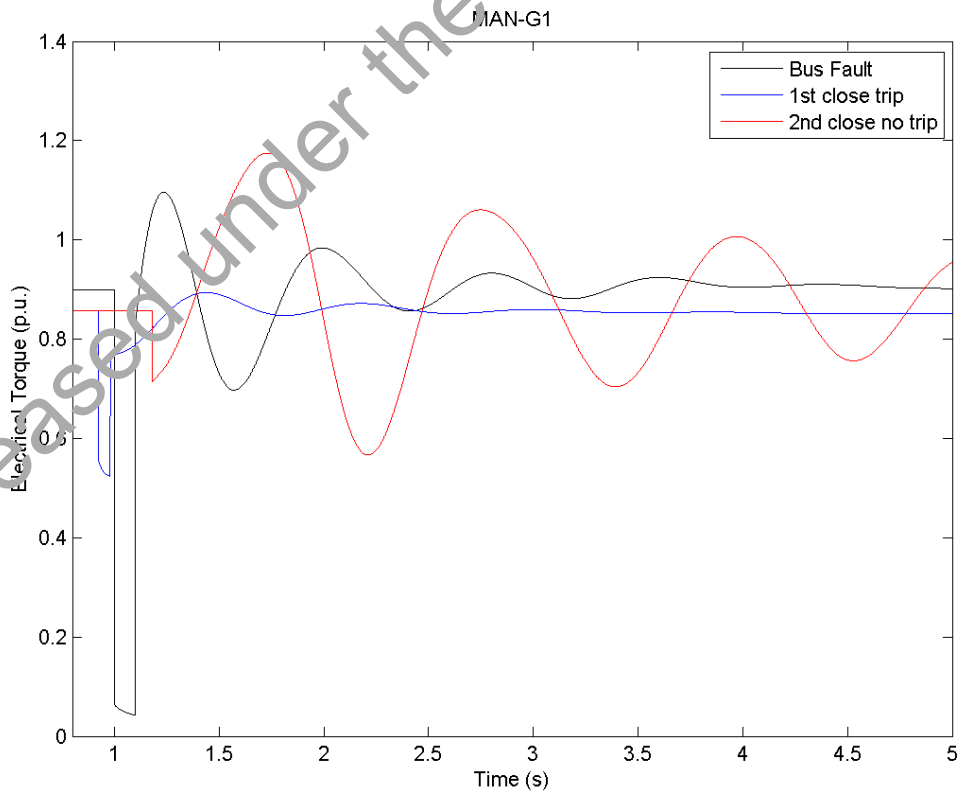
Figures 6A – 6I plot the transient electrical torques at a number of generators in the South Island. Table 2 compares the peak torques from the plots.

Generator	Bus Fault	1 st Re-synch	2 nd Re-synch	1 st Re-synch Short line
Upper South Island				
Aviemore	1.3	1.3	1.1	1.8
Benmore	1.6	1.5	1.4	2.1
Ohau A	1.2	1.3	1.2	1.9
Ohau B	1.2	1.4	1.2	2.1
Ohau C	1.1	1.3	1.2	2.0
Waitaki	1.0	1.2	1.6	1.6
Lower South Island				
Clyde	0.9	-0.3	0.8	-1.7
Manapouri	1.1	0.9	1.2	0.9
Roxburgh	0.7	-0.6	0.6	-2.3

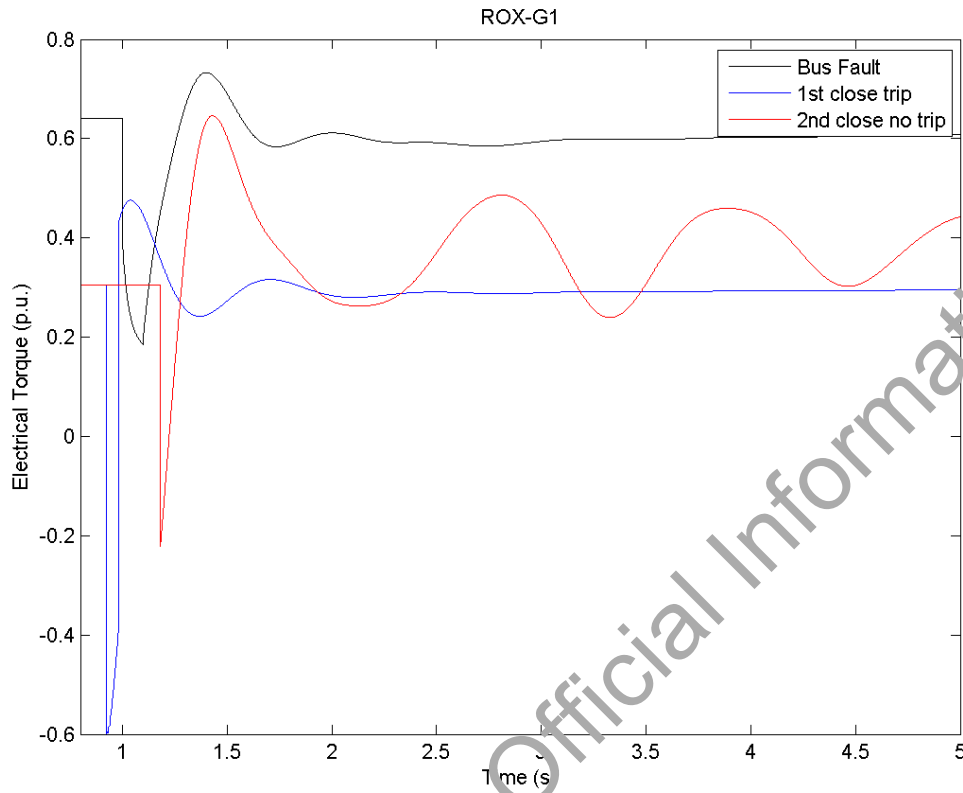
Figure 7A. Effect of Short Line Re-Synchronization at Aviemore

The engineers carrying out the simulations had expected that the electrical torques associated with the re-synchronizations would be considerably higher than that seen in the simulations. A possible reason for this was the effect of the impedance of the long Clyde-Cromwell-Twizel circuits which acted to limit the synchronizing currents. This was tested by repeating the simulation for the 1st re-synchronization, but with the impedance of the Clyde-Cromwell-Twizel circuits reduced to 1% of their actual value. Figures 7A-7I and Table 2 show that the reduced impedance results in significantly higher values of the peak electrical torque.

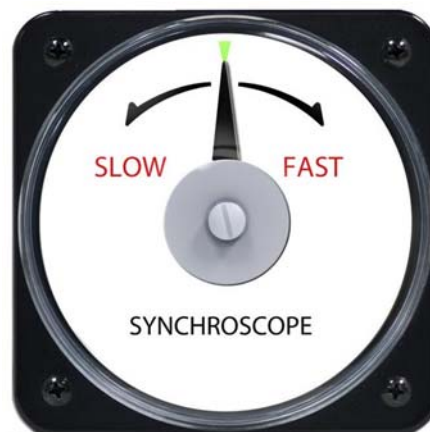
Figure 9. Synchroscope

Historically, manual synchronization was carried out locally at selected stations using a synchroscope similar to that shown in Figure 9. Synchroscopes were frequently used for connecting generators to the grid, and occasionally for reconnecting islands in the grid. The operator would control generators to adjust voltage and frequency until the voltage magnitude, voltage phase, and frequency were matched, and then close the circuit breaker. As a matter of professional pride, operators would try to make the synchronization as smooth and ‘bumpless’ as possible. They were very conscious of a bad bump which would result in a visible light flicker and a shudder in the power station.

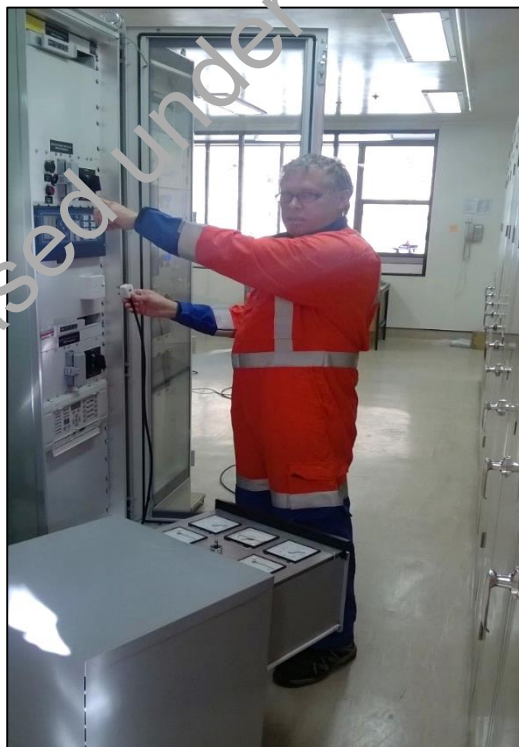
Use of Synchronising
Trolley

1. Select the circuit breaker most convenient to be the reconnection point. Carry out switching to provide the required configuration.
2. Plug the synchronising trolley into the sockets to suit the scenario (e.g. upper south island the running frequency and lower south island the incoming frequency).
3. Establish a telephone connection to the generator selected as the frequency keeper in the incoming island.
4. Raise/lower speed and voltage until a match is achieved as indicated on synchronising trolley meters.
5. Close selected circuit breaker.
6. Re-establish normal system configuration.

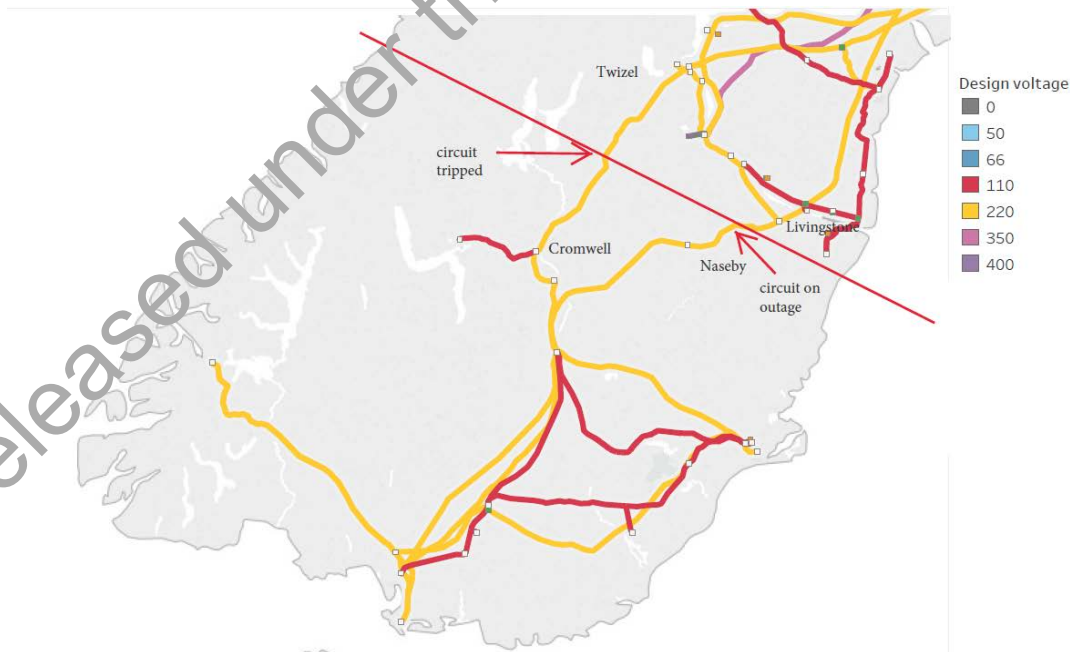
Figure 1: Map of electrical island

21. An unexpected generation reduction of about 160 MW at Meridian Energy Limited’s (Meridian’s) Aviemore plant caused the frequency in the upper part of the split to fall again. An incorrect setting in the Aviemore generator governor controls caused the generation output to decrease. Meridian moved quickly to manual control, restoring generation output at Aviemore at 11:28—7 minutes into the event.

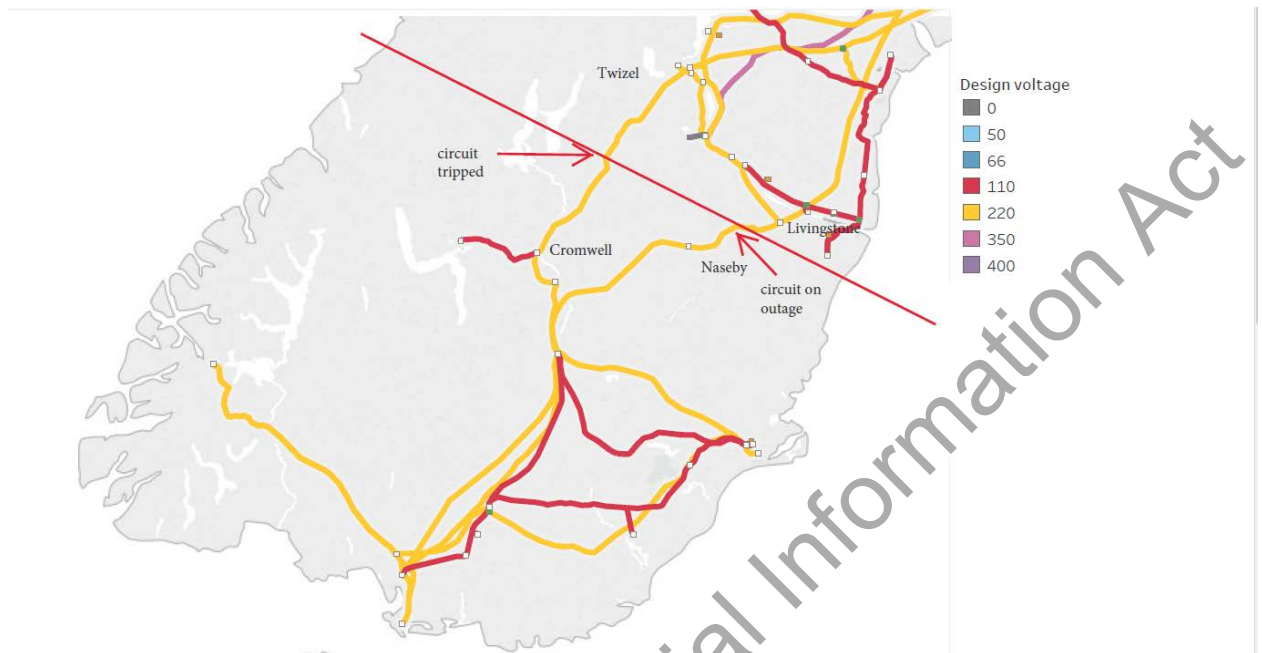
Figure 1: Map of electrical islands

12. At 11:20, the testing tripped the line circuit breakers at the Twizel substation on the two Clyde circuits, electrically islanding the lower part of the South Island. At 11:28, the system operator's security coordinator decided to stabilise the South Island grid by joining the two electrical islands.
