**ELECTRICITY INDUSTRY PARTICIPATION CODE
DISTRIBUTED UNMETERED LOAD AUDIT REPORT**

NZTA WAIPA AND TRUSTPOWER

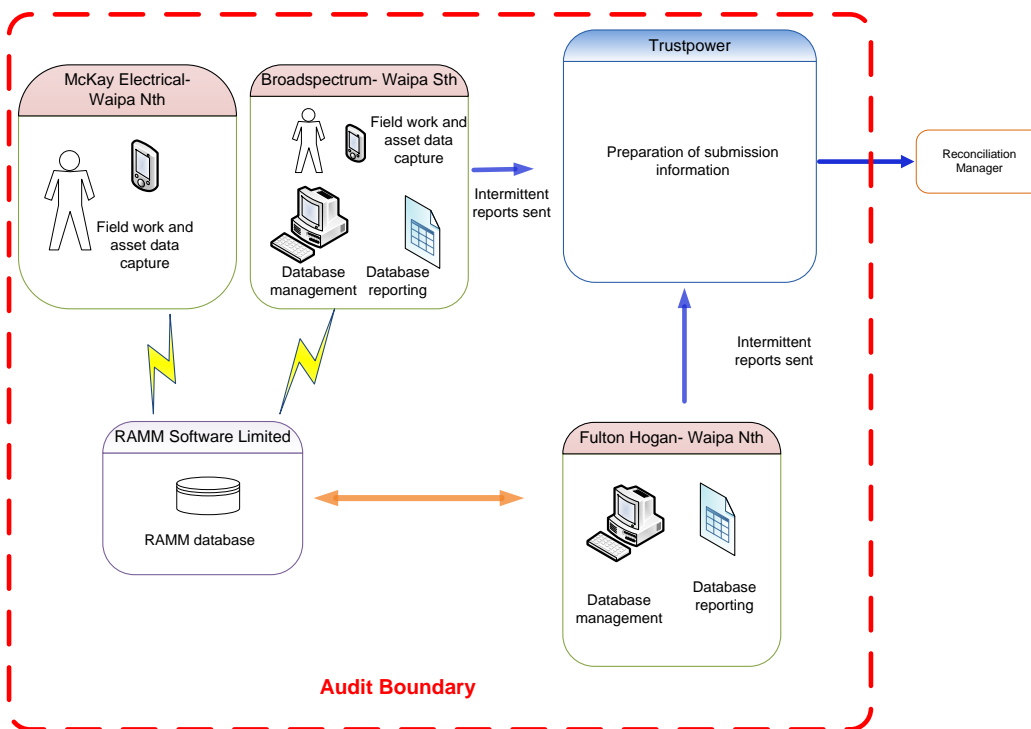
The scope of the audit encompasses the collection, security and accuracy of the data, including the preparation of submission information based on the database reporting. The diagram below shows the audit boundary for clarity.
