ELECTRICITY INDUSTRY PARTICIPATION CODE  
DISTRIBUTED UNMETERED LOAD AUDIT REPORT

HAMILTON CITY COUNCIL AND GENESIS  
ENERGY

Prepared by: Rebecca Elliot

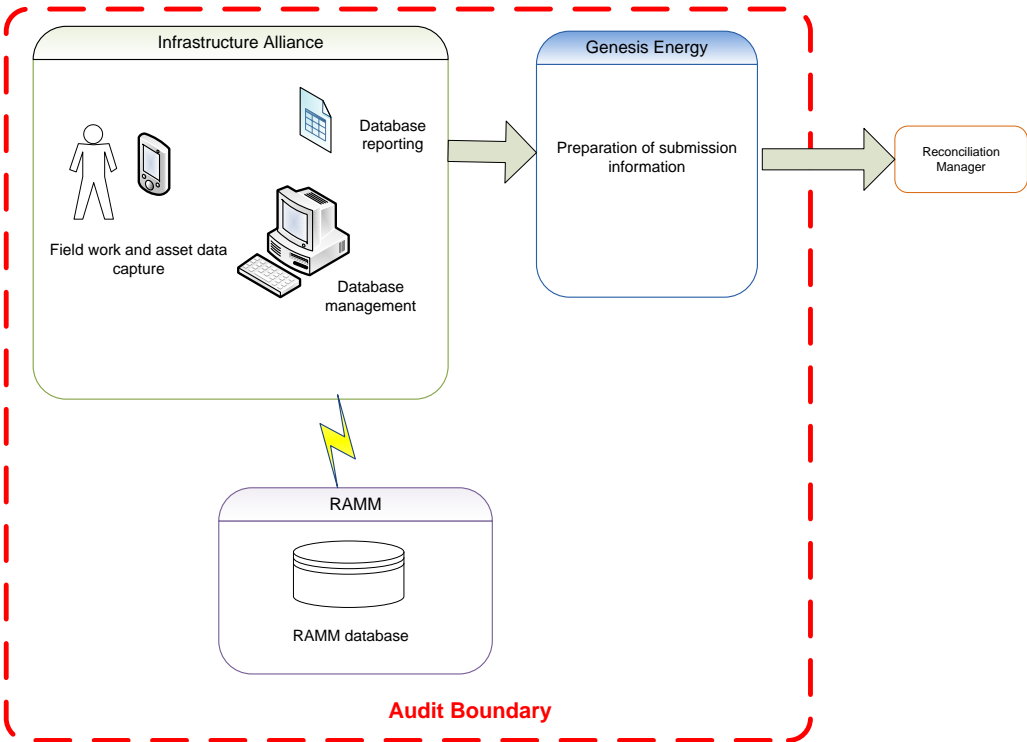
The scope of the audit encompasses the collection, security and accuracy of the data, including the preparation of submission information based on the database reporting. The diagram below shows the audit boundary for the current arrangements for clarity.

The database is remotely hosted by RAMM Software Ltd and is managed by Infrastructure Alliance, on behalf of HCC, HCC being Genesis’s customer. Infrastructure Alliance is a joint venture between HCC and Downer which provides infrastructure management across all of HCC assets. They provide reporting to Genesis on a monthly basis.
