# ELECTRICITY INDUSTRY PARTICIPATION CODE DISTRIBUTED UNMETERED LOAD AUDIT REPORT

# GORE DISTRICT COUNCIL AND MERIDIAN ENERGY

Prepared by: Tara Gannon Date audit commenced: 19 March 2018 Date audit report completed: 19 April 2018 Audit report due date: 1 June 2018

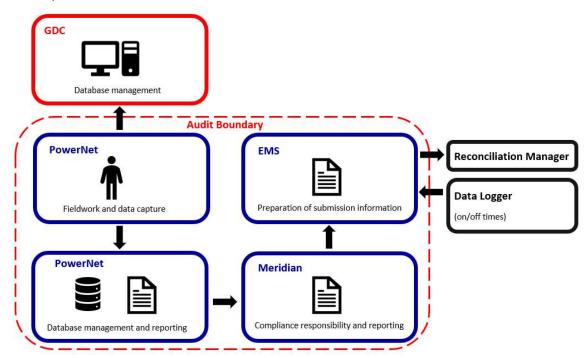
The scope of the audit encompasses the collection, security and accuracy of the data, including the preparation of submission information based on the database reporting. The audit focusses on the PowerNet database, because it is used for submission. The diagram below shows the audit boundary for clarity.
