## ELECTRICITY INDUSTRY PARTICIPATION CODE DISTRIBUTED UNMETERED LOAD AUDIT REPORT

# OTOROHANGA DISTRICT COUNCIL AND TRUSTPOWER

Prepared by: Rebecca Elliot Date audit commenced: 20 February 2018 Date audit report completed: 18 May 2018 Audit report due date: 1 June 2018

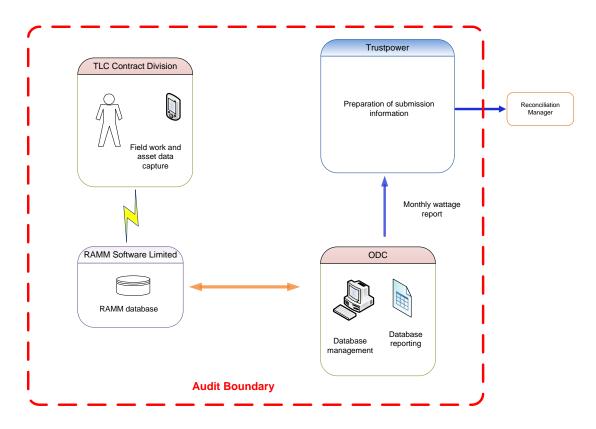
The scope of the audit encompasses the collection, security and accuracy of the data, including the preparation of submission information based on the database reporting. The diagram below shows the audit boundary for clarity.
