# Electricity Industry Participation Code Audit Report

**For**  
**Genesis Energy Limited**

**Marlborough District Council**  
**Marlborough NZTA & Port of Marlborough**

**Distributed Unmetered Load**  
**Prepared by Rebecca Elliot – Veritek Ltd**

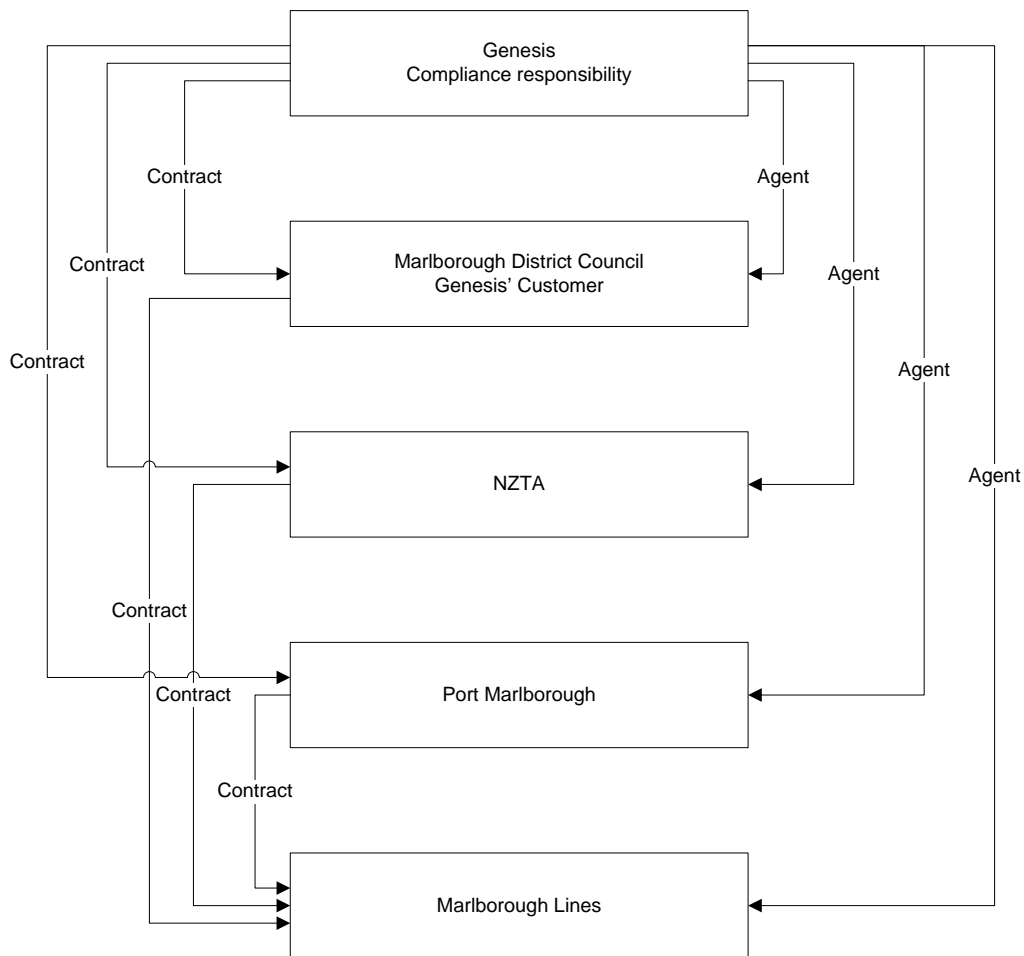
The diagram below shows the relationships from a compliance and contractual perspective.

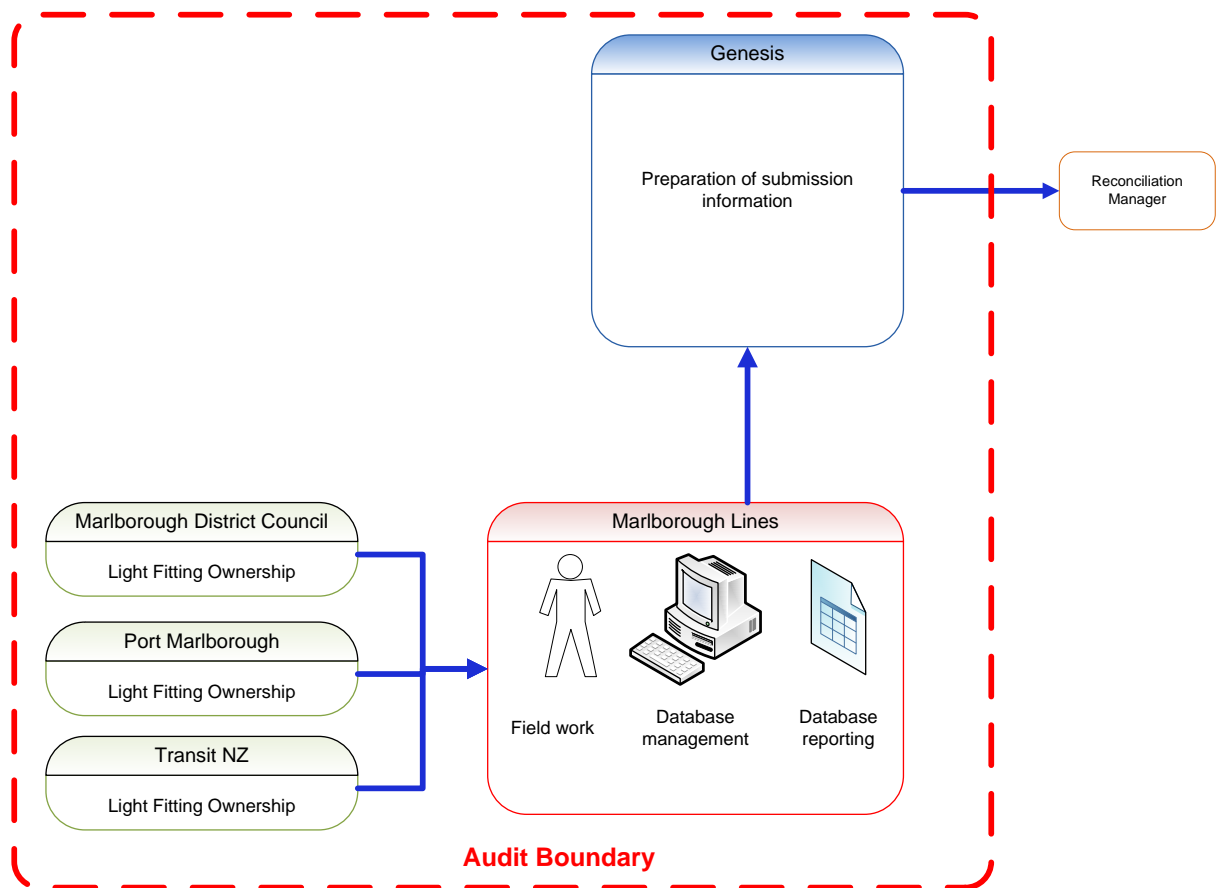
Marlborough Lines manage the installation, maintenance and database management of the DURL for Marlborough District Council (MDC), NZTA and PMNZ. Reporting is provided to Genesis on a monthly basis. The scope of the audit encompasses the collection, security and accuracy of the data, including the preparation of submission information based on the database reporting. The diagram below shows the audit boundary for clarity.
