**ELECTRICITY INDUSTRY PARTICIPATION CODE
DISTRIBUTED UNMETERED LOAD AUDIT REPORT**

**CENTRAL HAWKE'S BAY DISTRICT COUNCIL
AND GENESIS ENERGY**

Prepared by: Tara Gannon

Date audit commenced: 23 February 2018

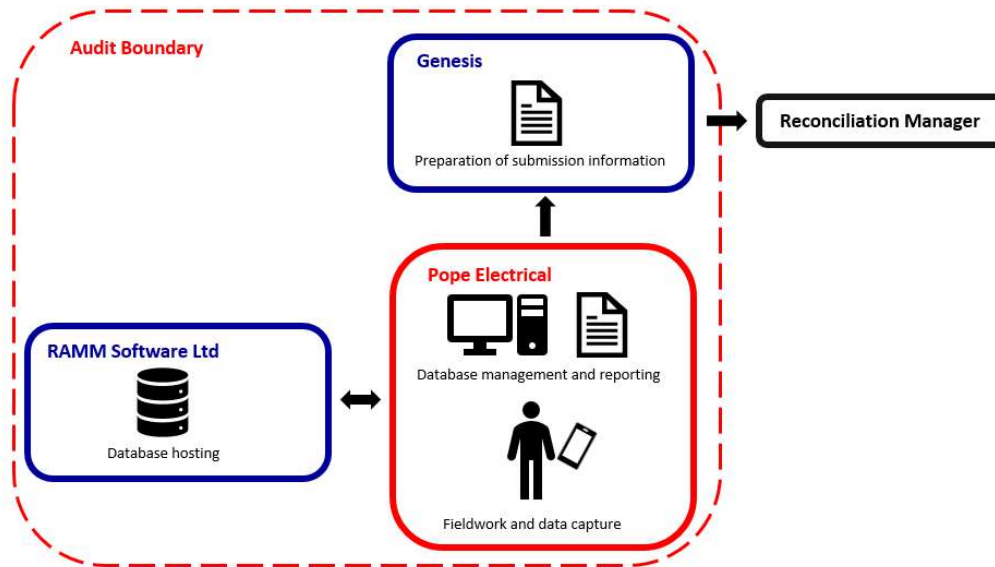
The scope of the audit encompasses the collection, security and accuracy of the data, including the preparation of submission information based on the database reporting. The diagram below shows the audit boundary for clarity.
