**ELECTRICITY INDUSTRY PARTICIPATION CODE
DISTRIBUTED UNMETERED LOAD AUDIT REPORT**

**TARARUA DISTRICT COUNCIL AND
CONTACT ENERGY**

Prepared by: Tara Gannon

Date audit commenced: 8 May 2018

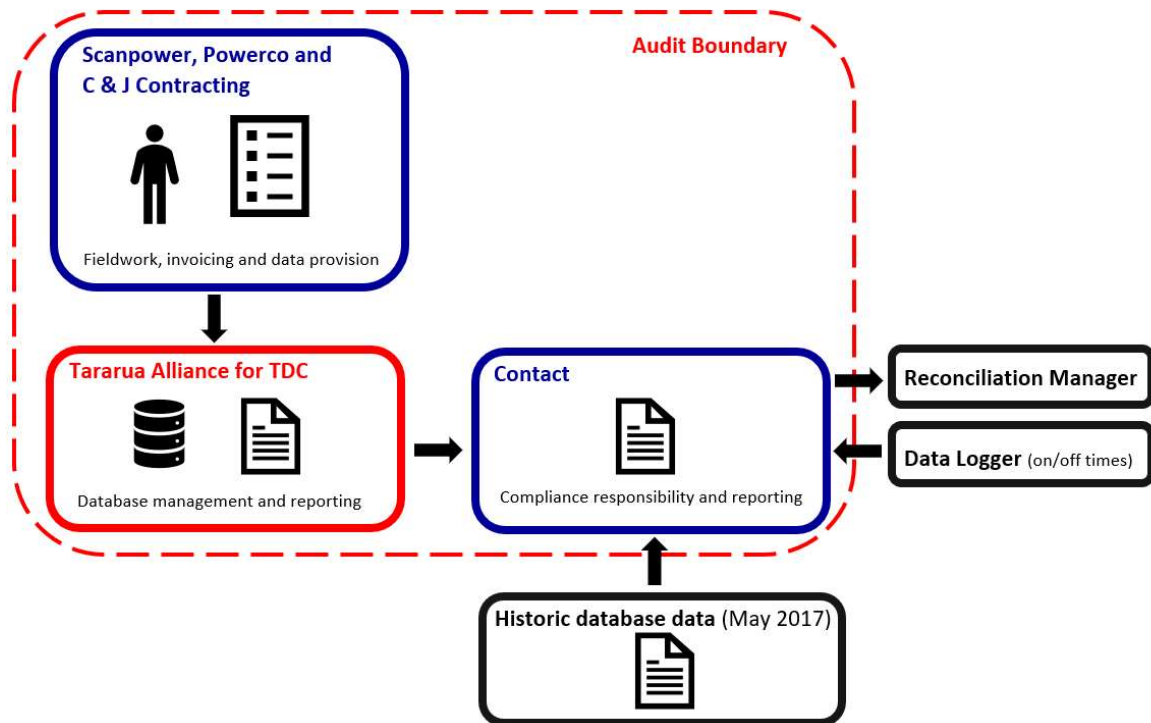
The scope of the audit encompasses the collection, security, and accuracy of the data, including the preparation of submission information based on the monthly reporting. The diagram below shows the flow of information and the audit boundary for clarity.

Historically there has not been regular reporting from the database to Contact. A report from RAMM was provided by Tararua Alliance in April 2018, and they intend to supply monthly reports to Contact from now on. There are some issues with the accuracy of the data provided, and Contact intends to work with Tararua Alliance to resolve these issues and then migrate to using the monthly submission data.
