**ELECTRICITY INDUSTRY PARTICIPATION CODE
DISTRIBUTED UNMETERED LOAD AUDIT REPORT**

**NZTA WAIPUKURAU AND MERIDIAN
ENERGY**

Date audit commenced: 23 February 2018

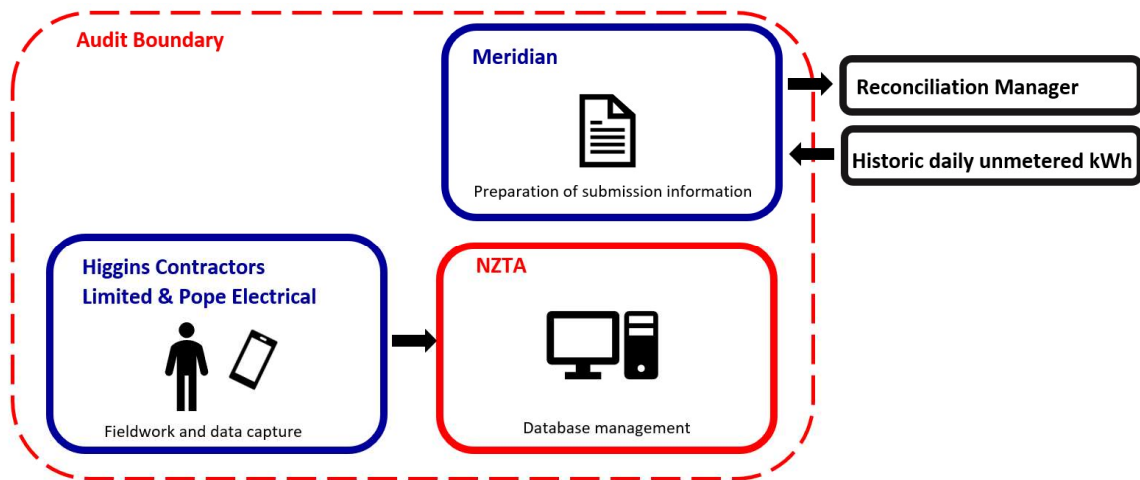
The scope of the audit encompasses the collection, security and accuracy of the data, including the preparation of submission information based on the database reporting. The diagram below shows the audit boundary for clarity.
