Electricity Industry Participation Code Audit Report

Mercury NZ Limited

**Palmerston North Airport Distributed Unmetered
Load**

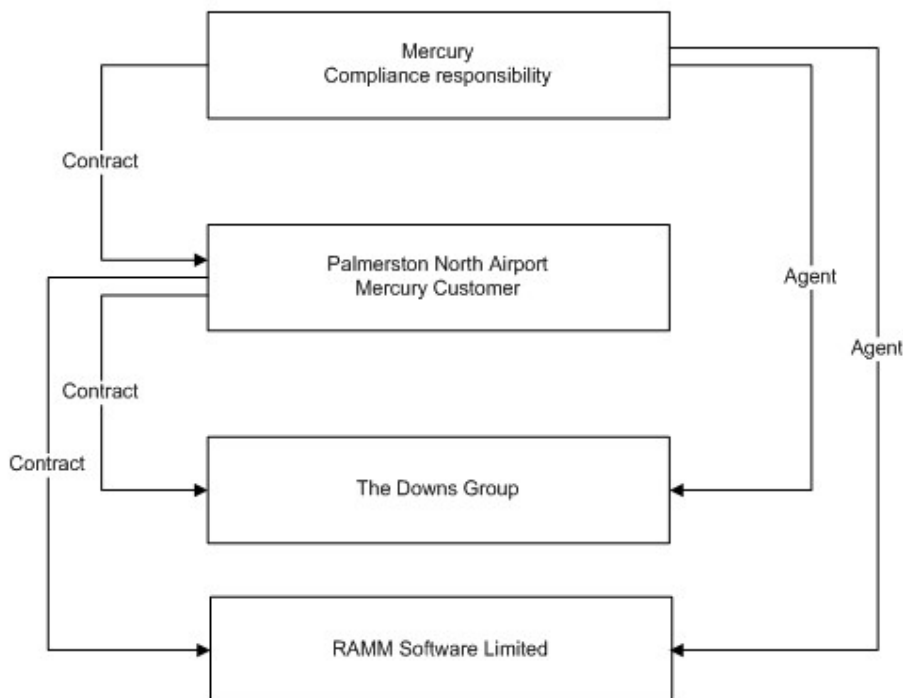
The diagram below shows the relationships from a compliance and contractual perspective.
