Electricity Industry Participation Code Audit Report

Contact Energy Limited

**Masterton District Council
Distributed Unmetered Load**

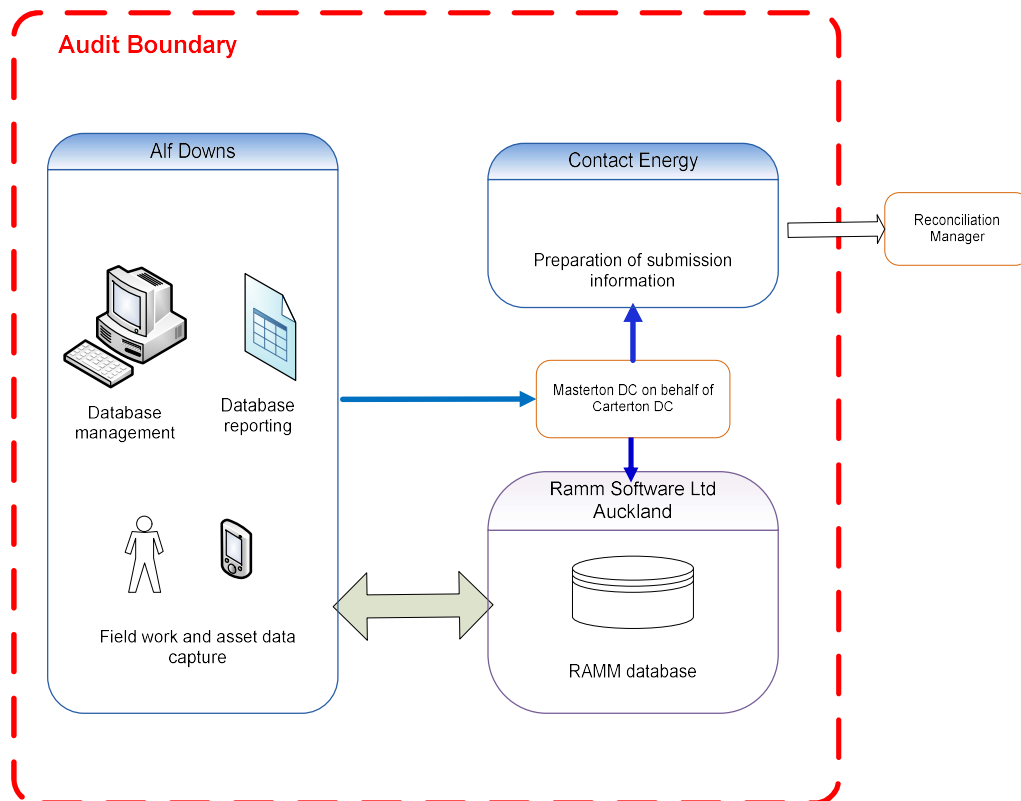
Monthly reporting from the database is provided to Contact. The scope of the audit encompasses the collection, security and accuracy of the data, including the preparation of submission information based on the database reporting. The diagram below shows the audit boundary for clarity.
