ELECTRICITY INDUSTRY PARTICIPATION CODE
DISTRIBUTED UNMETERED LOAD AUDIT REPORT

DUNEDIN CITY COUNCIL
AND CONTACT ENERGY LIMITED

Prepared by: Steve Woods

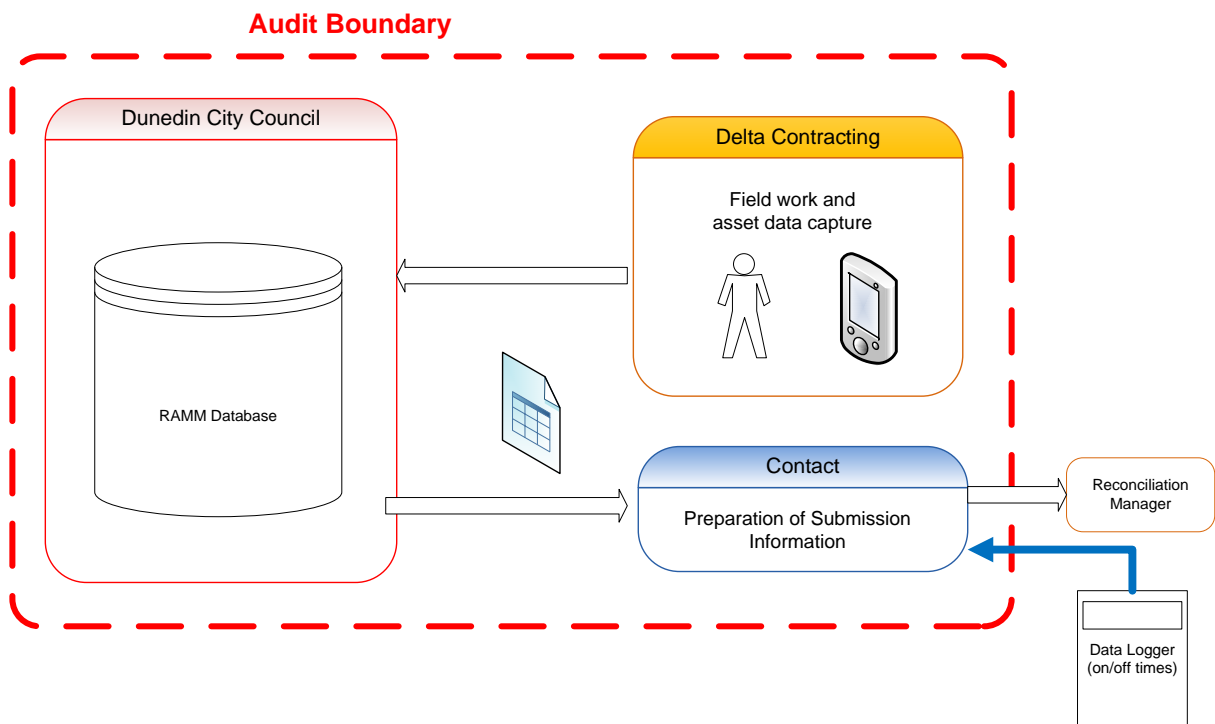
The database is remotely hosted by RAMM Software Ltd. The field work, asset data capture and database population is conducted by Delta contracting. The scope of the audit encompasses the collection, security and accuracy of the data, including the preparation of submission information based on the database reporting. The diagram below shows the audit boundary for clarity.
