Electricity Industry Participation Code Audit Report

Contact Energy Limited

**Kāpiti Coast District Council
Distributed Unmetered Load**

Prepared by Tara Gannon – Veritek Ltd

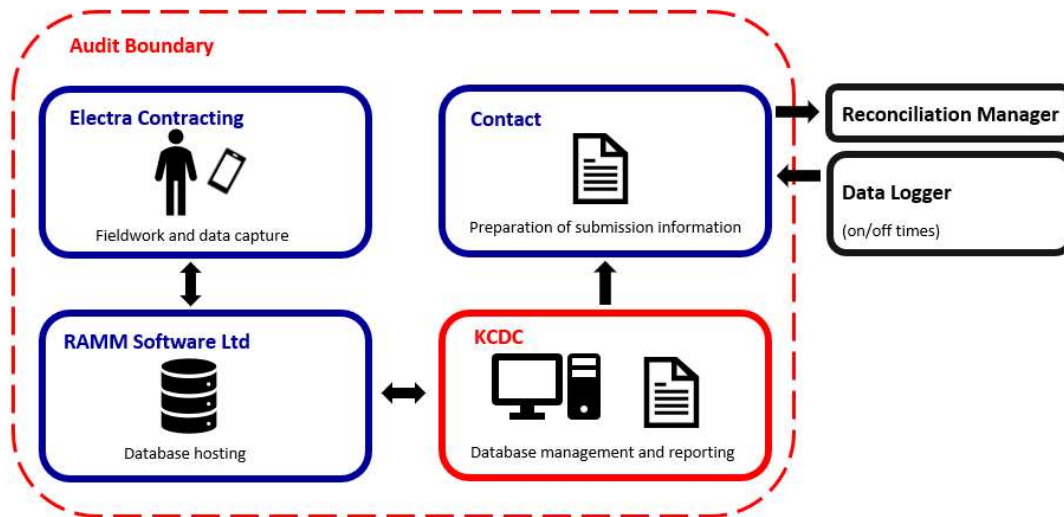
The scope of the audit encompasses the collection, security and accuracy of the data, including the preparation of submission information based on the spreadsheet reporting. The diagram below shows the current flow of information and the audit boundary for clarity.
