ELECTRICITY INDUSTRY PARTICIPATION CODE DISTRIBUTOR AUDIT REPORT

TOP ENERGY

Prepared by: Ewa Glowacka Date audit commenced: 6 September 2018 Date audit report completed: 26 October 2018 Audit report due date: 27-Oct-18

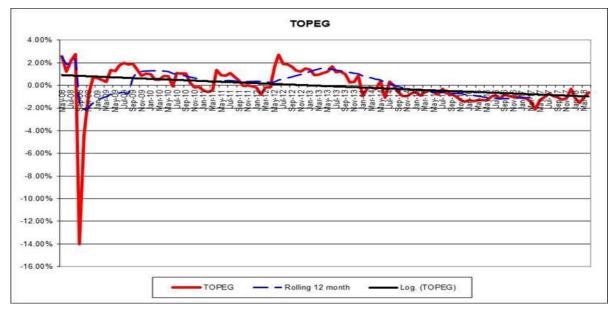
Below is shown graphs of UFE provided by the Authority. According to the Guidelines, UFE is expected to be within \pm 1% over the course of any 12-month period. 14-month UFE around -1.12%.
